# Queen Street Toilet Block Structural Assessment

March 2011

# QUEEN STREET TOILET STRUCTURAL REPORT

**Report Date: 17<sup>th</sup> March 2011**

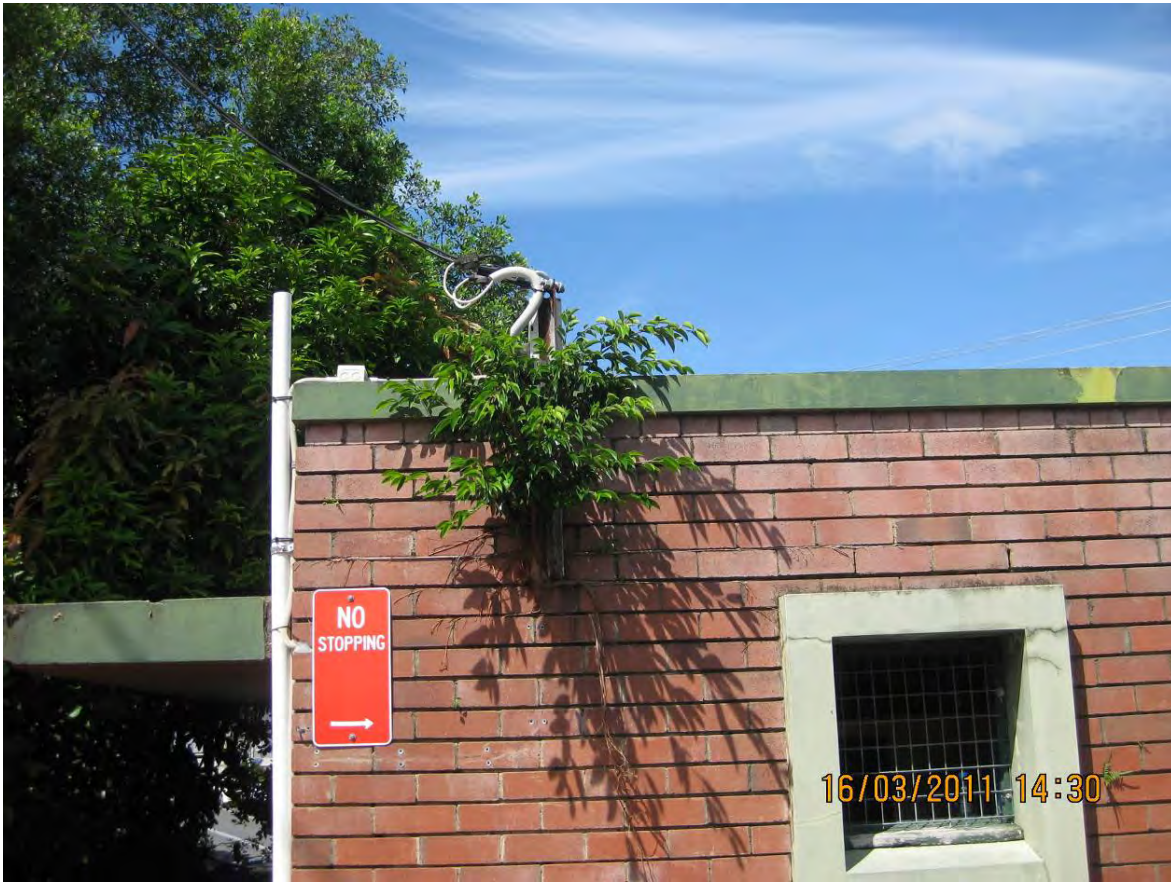
Figure 1 – Fig tree

The north-west section of the parapet wall above the roof slab has a fig tree with roots traversing along the damp-proof course (Figure 1). The roots are wedging the brick courses apart, thus rotating the parapet eastward. Some minor cracking of the parapet concrete capping is present and given its shape (length to width), the movement could be attributed to daily temperature variations.

- a) Poison tree and ferns on parapet immediately.
- b) Remove trees overhanging north side of building and clean gutters. Poison the tree trunks if species and mature size is not suitable adjacent to masonry buildings.

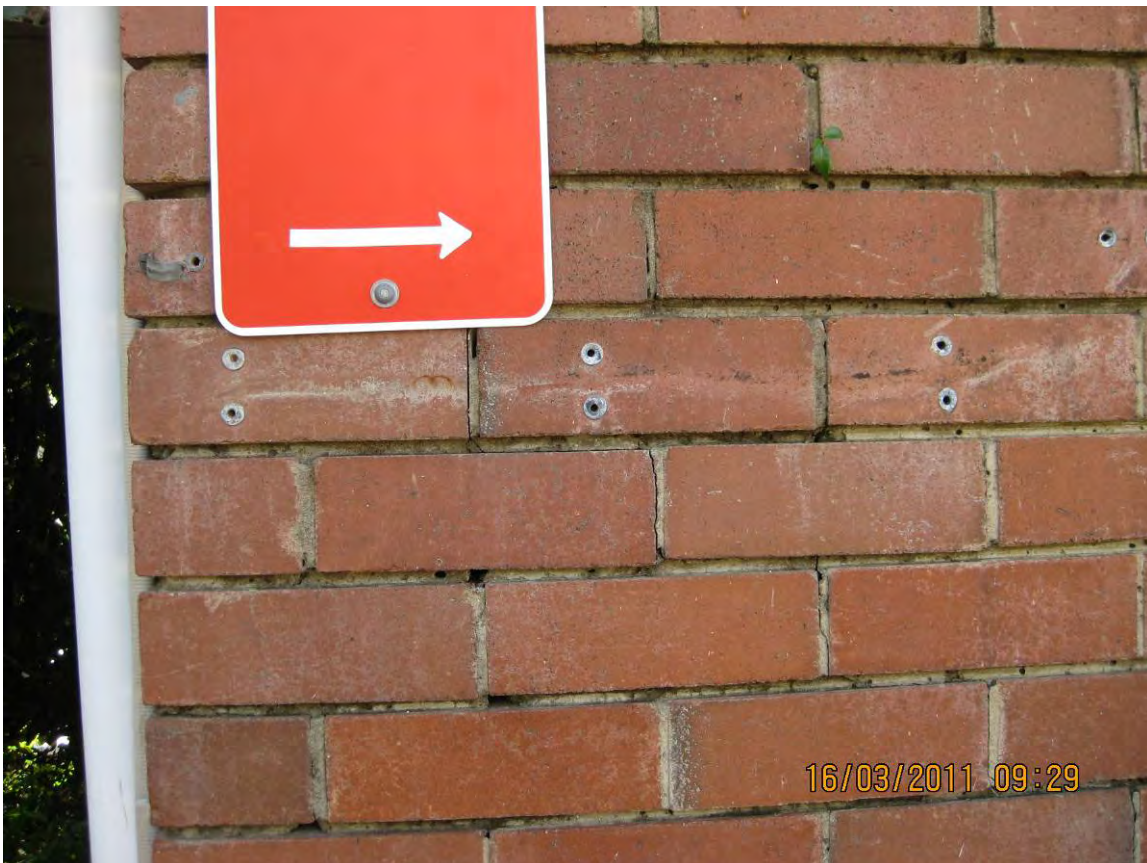
Figure 2 – Western wall crack

The western cavity brick wall contains an approximately 45 degree inclined movement crack (Figure 2). The crack commences at roof slab support level and is angled down and to the right (south). The western brick wall is adjoining road asphalt at its base and is engaged at the top to the roof slab positioned over the inner leaf masonry. The dark coloured roof slab would expand each day under the influence of the sun and air temperature. There is a fine inclined crack on the northern wall at this corner (Figure 3). Two possible scenarios, which could be attributed to the damage are possible. First is the N-W corner is dropping due to settlement (proximity of buried pipeline) or secondly the brickwork at the corner is moving with the slab and not allowing the roof slab to slip freely. A look at the grouted gutter over (Figure 4) suggests the gutter is grouted to and adhering to the brick parapet. A new water-main and hydrant is positioned midway along the north wall, which may be causing some local sinking at this N-W corner, however it is more likely the temperature movement of the roof is causing these inclined cracks.

- c) Patch asphalt hole along western wall which may introduce moisture changes to the foundations (swelling clay soils crack walls).
- d) Pressure clean top of roof slab and coat with flexible membrane, preferably white to reduce temperature affects. Seal larger roof cracks.

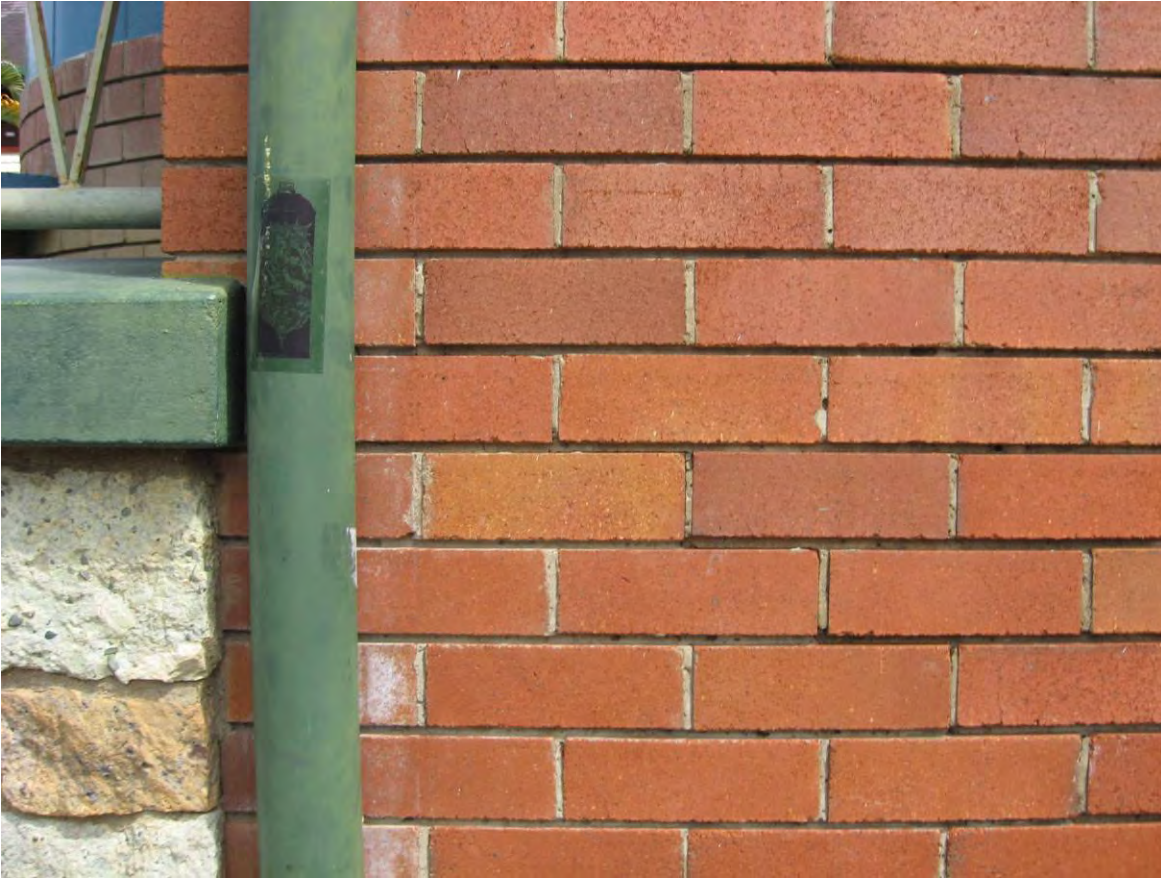
Figure 5 – Eastern Wall Crack

The South East corner has a fine movement crack where the top of the southern curved retaining wall butts mid-height to the eastern masonry wall of the building (Figure 5).

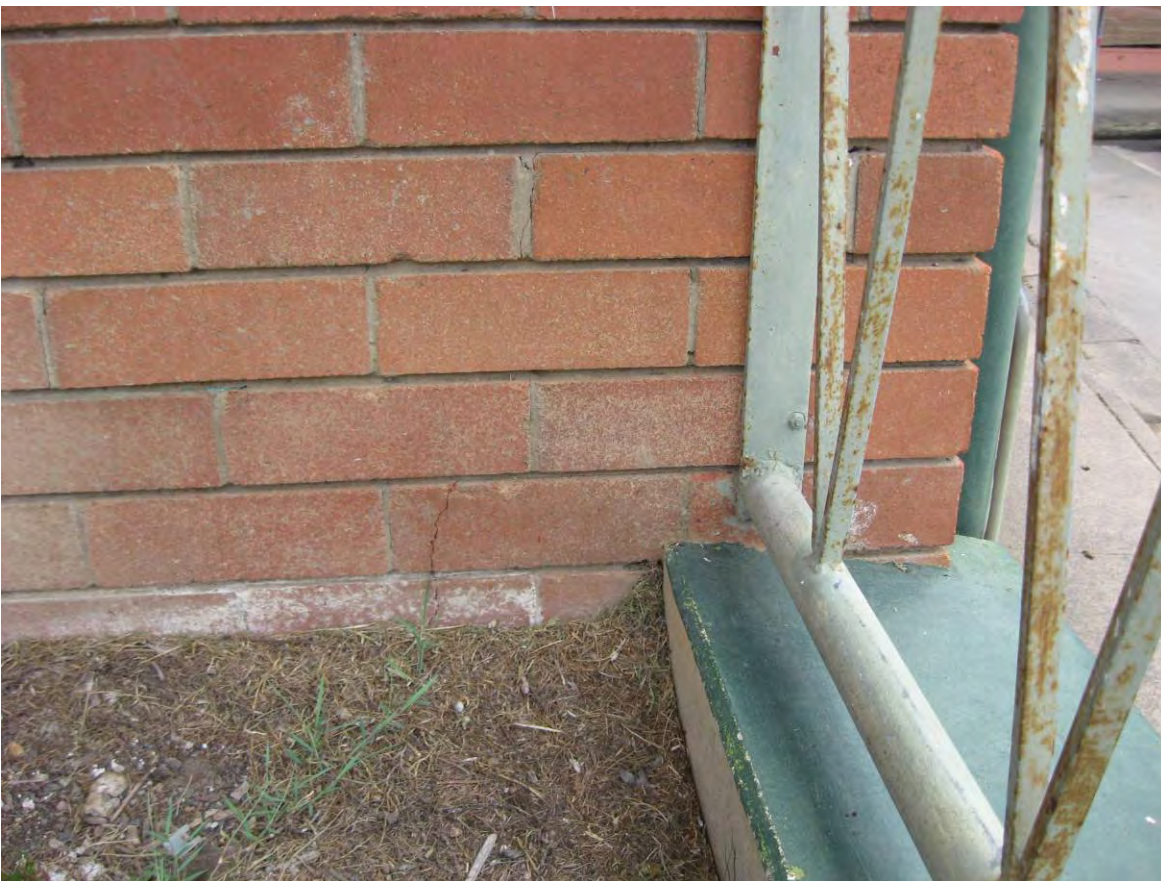
Figure 6 – South east corner

Two cracks are visible at this junction. Firstly a splitting of the lower bricks 300mm along the southern wall from the corner. Retained fill earth pressures are pushing the eastern wall outwards at the junction (Figure 6). Secondly the inclined crack, commencing behind the downpipe and inclined down to the right (north) is accordingly the result of earth pressures at this retaining wall junction.

- g) Rectify damage to masonry doorways if possible. Remove protruding bolts.
- h) Repair broken steel pipe handrail above retaining wall.
- i) Confirm retaining wall backfill has method of surface runoff and ground-water egress (agriculture pipe) outlet, or weep holes.

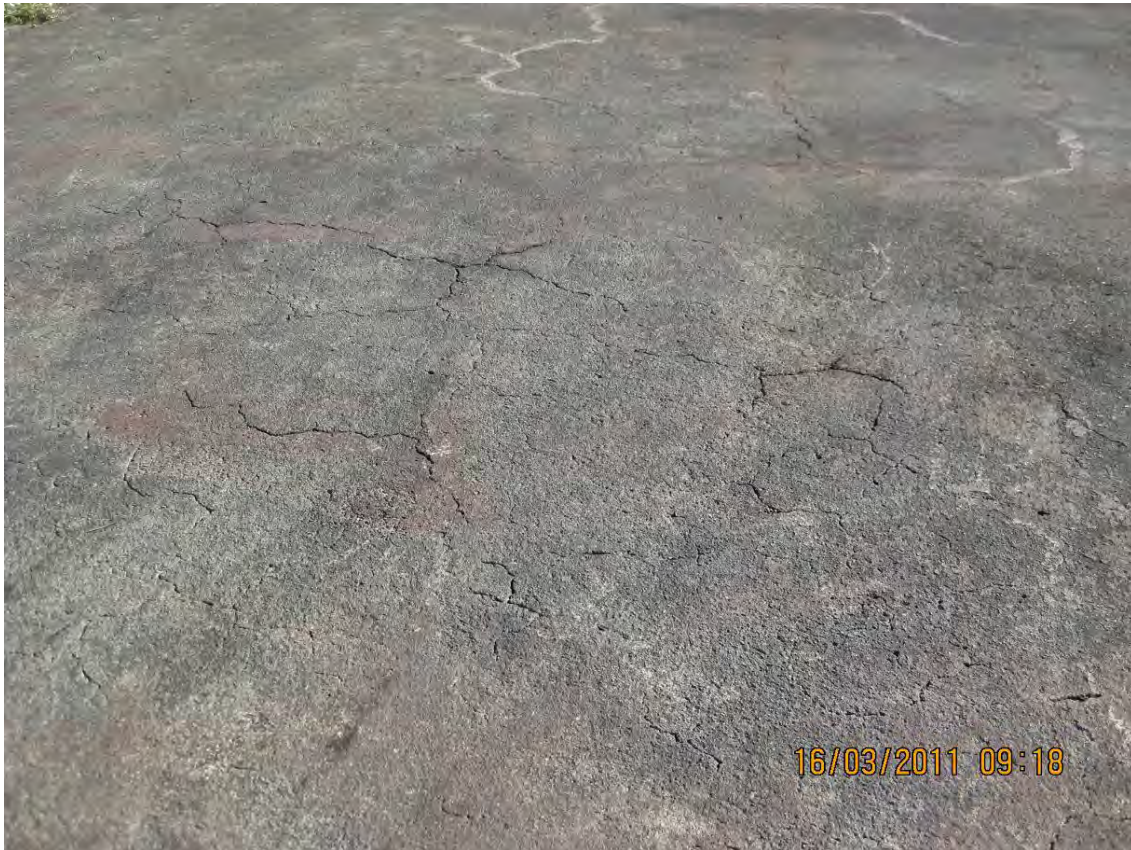
Figure 7 – Roof Slab Cracks

The roof slab is in reasonable condition given it is more than half a century old (Figure 7). Some flexural cracking has occurred on the upper surface cantilevered over the northern wall. Other shrinkage and temperature cracking occurs over the central support wall between the male and female toilets. Water damaged soffits above the eastern wall are positioned directly below roof slab cracking (Figure 8). A roof pressure clean and coating with flexible membrane is recommended. The painting of the ceilings and soffit with permeable paint should reduce overall moisture within the slab. The proximity of overhanging trees has caused a build up of leaf debris within the gutters and water ponds on the roof (Figure 9). Pruning and removal of trees close to the building would mitigate this impact.

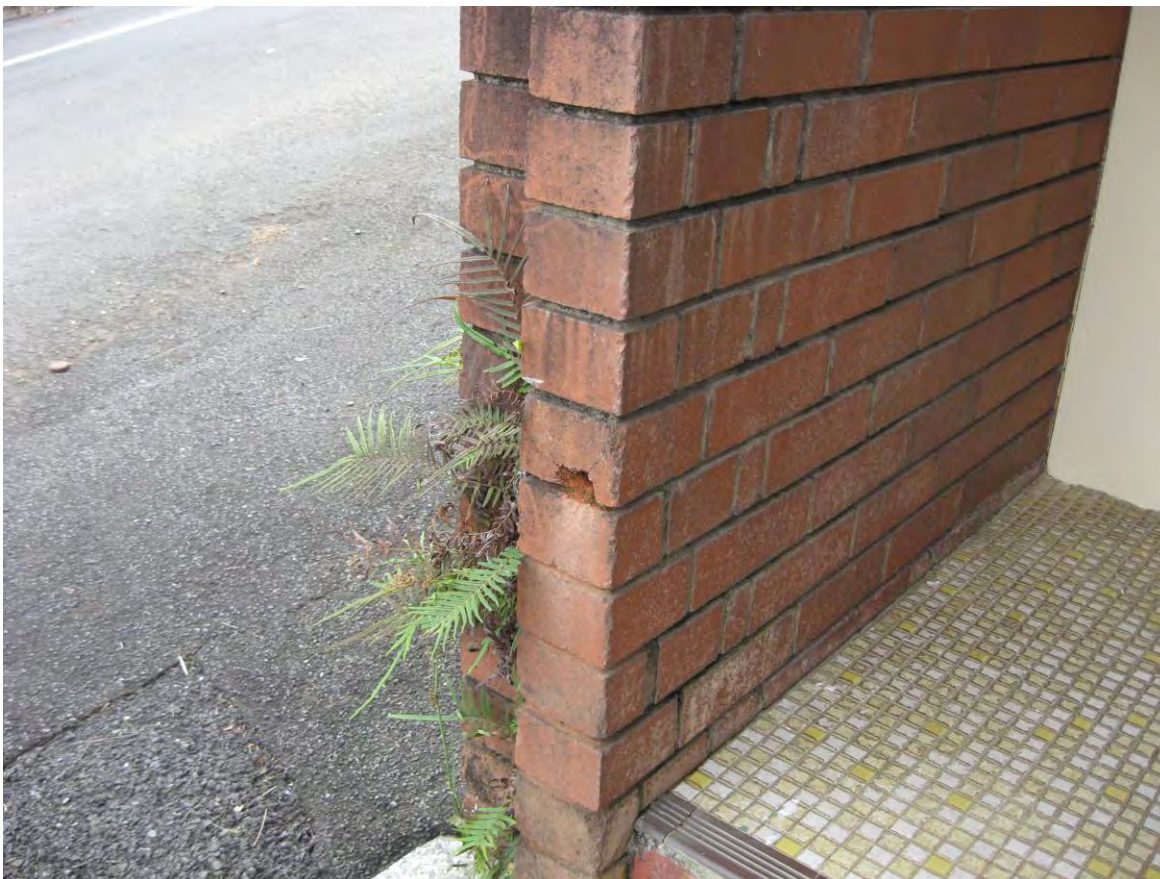
Figure 10 – Bolt damage to doorway

The toilet was recently closed to the public and maintenance staff fitted ply formboard sheets to the doorways. Significant damage to feature masonry doorway trims occurred from poorly positioned dyna-bolts, one of which expanded when tightened to split the brick (Figure 10). The maintenance staff should have used smaller sized (non-expanding) masonry screw anchors into the mortar beds leaving a simple repair utilising matching coloured mortar. The damage is disastrous and some bolts remain protruding from brickwork doorways at present. A professional repair and possible brick replacement will be required if the building is given historic significance. Further assessment of the repair is needed given the buildings possible heritage value.
