The following Arborist Report was prepared by, LUKE PAGE Arborist for Tweed Shire Council on the request of Tweed Shire Council, (TSC) New South Wales.

This Health Assessment Report provides information relating to the health of forty five street trees located on Murwillumbah CBD Central Business District Brisbane Street, Wollumbin Street Commercial street and Murwillumbah street.

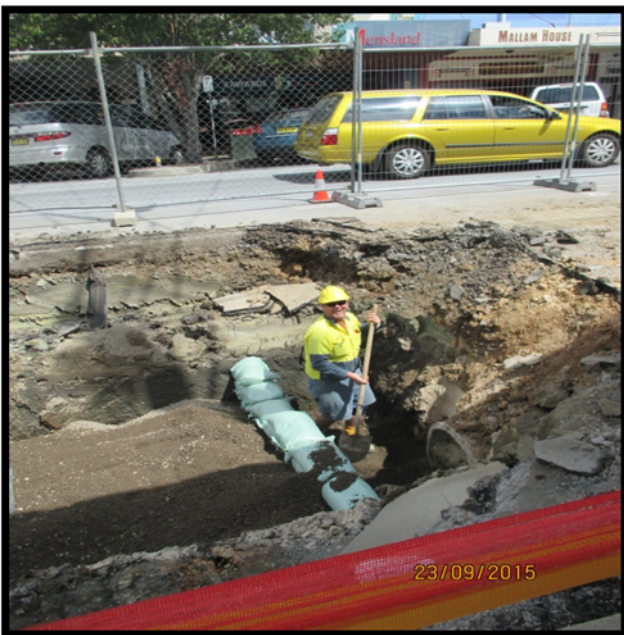
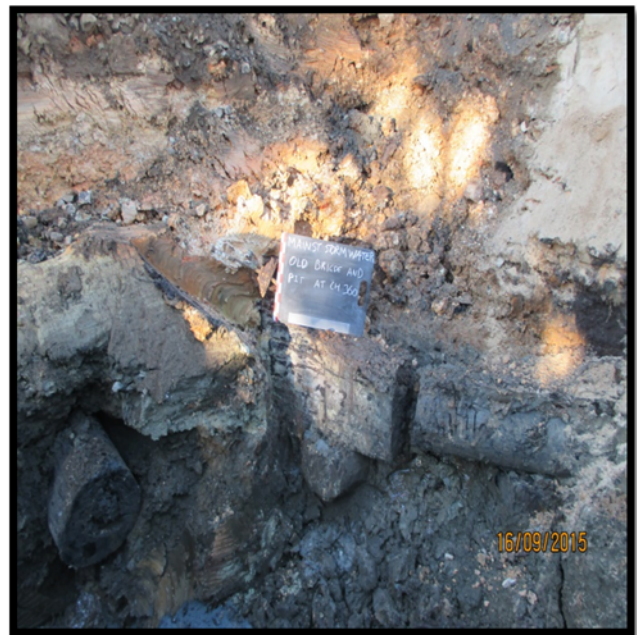
The soils which consist of heavy compacted wet clay and had strong kerosene smell due to the practices used of old to keep the dust at bay. The trees were planted at a depth of around 1.5m depth and back filled with a garden loam. Root barrier was installed at a depth of 600mm and concrete kerbing and roads were reinstated. The areas around all Subject Trees have poor to no aeration due to the heavy infrastructure and heavy clay soils.

Photos- Soil structure through the CBD Murwillumbah 2015

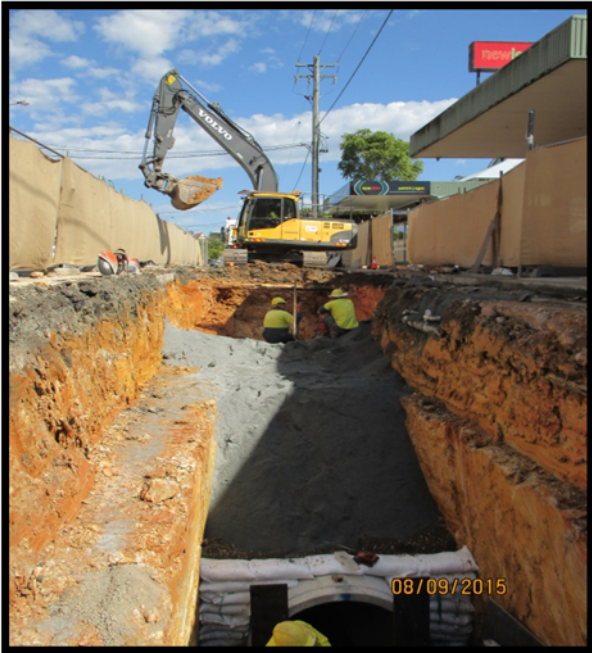
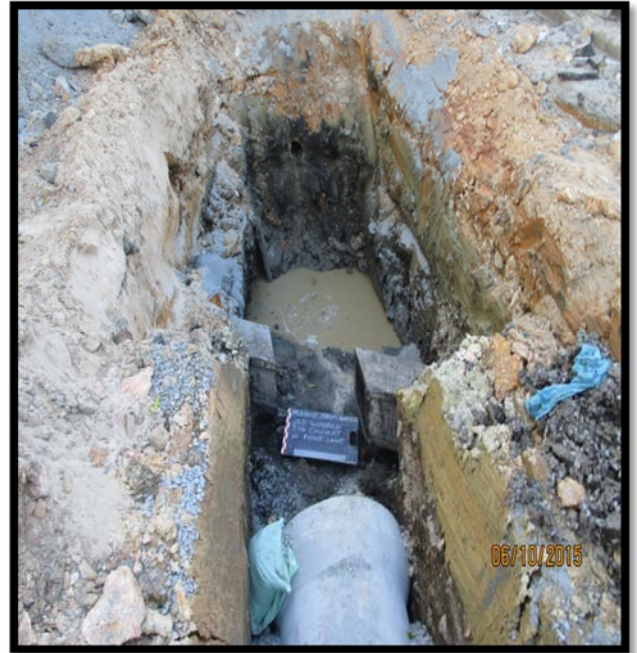
The trees were planted in at a depth of around 1.5m depth and back filled with garden loam. Root barrier was installed at a depth of 600mm and concrete kerbing and roads were reinstated. The areas around all Subject Trees have poor to no aeration due to the heavy infrastructure and hardscapes (concrete/Asphalt).

Photos- Soil structure through the CBD Murwillumbah 2015

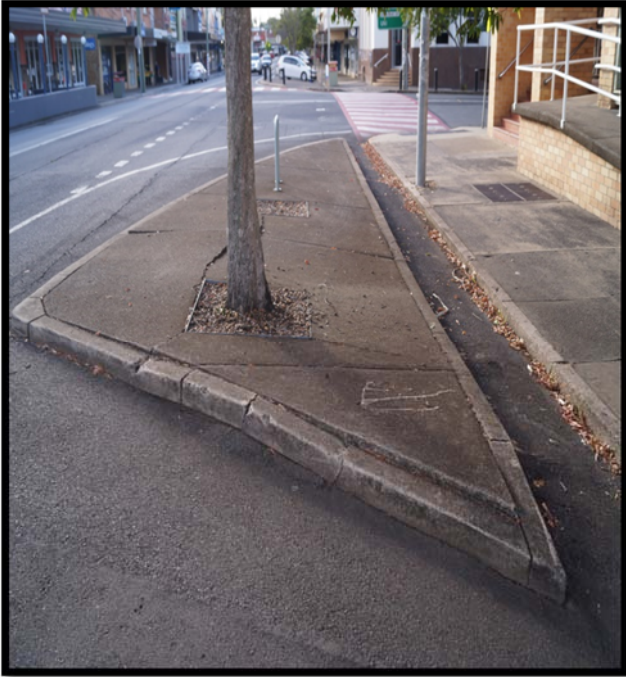
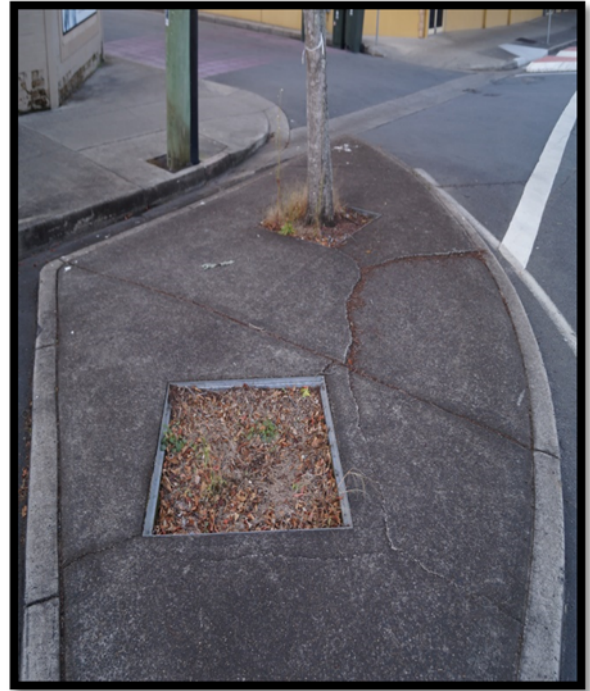
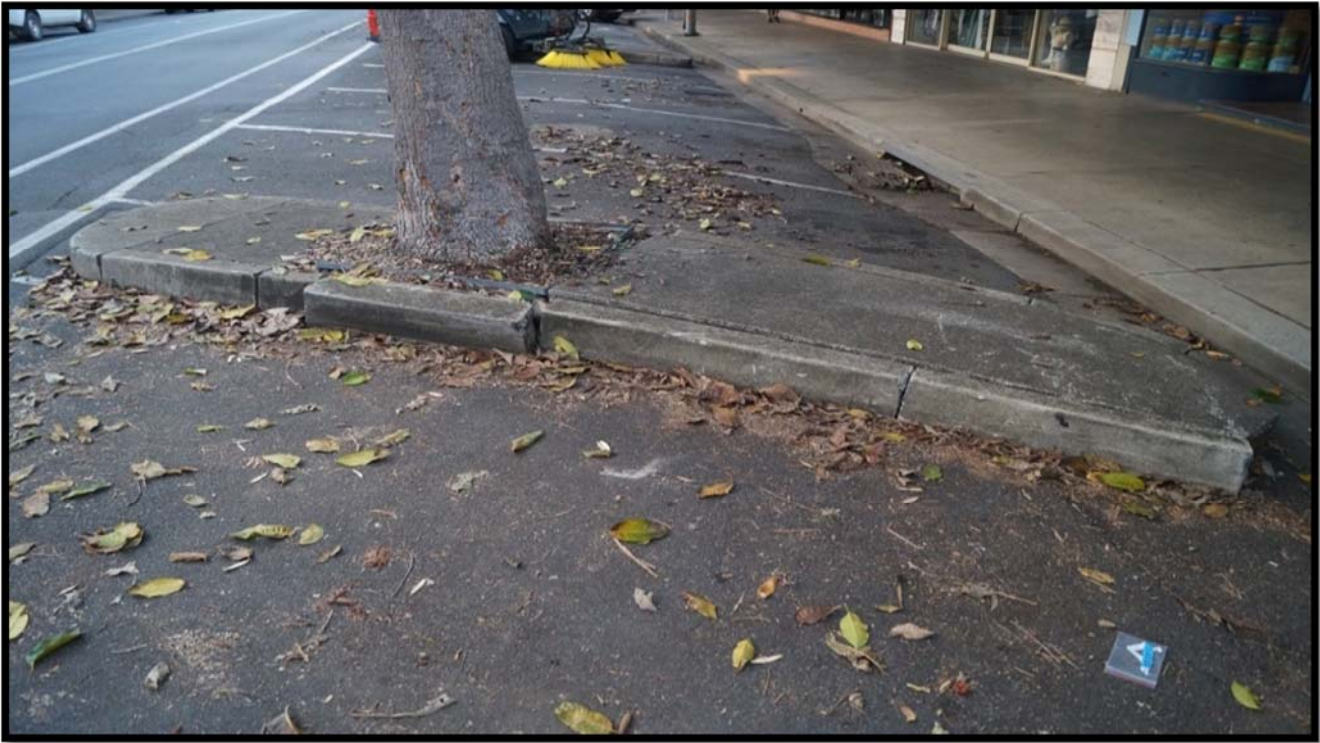
Photos- Infrastructure damage throughout the CBD Murwillumbah

Mechanical Damage - This is where roots can be severed, soil is compacted or disturbed and bark can be bruised or scraped. The areas around all Subject Trees have poor to no aeration due to the heavy infrastructure oxygen becomes limited and roots decline or die. All these events can lead to weaker trees and are prone to stress. Subject Trees have had some mechanical damage at one point from trunk, branch and root damage are all present.

On the recommendations which are given below about Subject Trees No. 5, 6, 37 and Subject Tree No. 1, 2, 3, 4, 7-36, 38-45 all subject trees are in slow decline due to the lack of availability of modern urban tree infrastructure. The removal and replacement of any trees in the CBD Central Business District of Murwillumbah needs a change of design, installation of stratacell modules and construction of the surrounds which these assets need for a productive and healthy establishment.
