Impact of Wake on Tweed River Bank Erosion Study

For: Tweed Shire Council

JANUARY 18, 2012

Project Name:	Impact of Wake on Tweed River Bank Erosion Study
Project Number:	3001906
Report for:	Tweed Shire Council

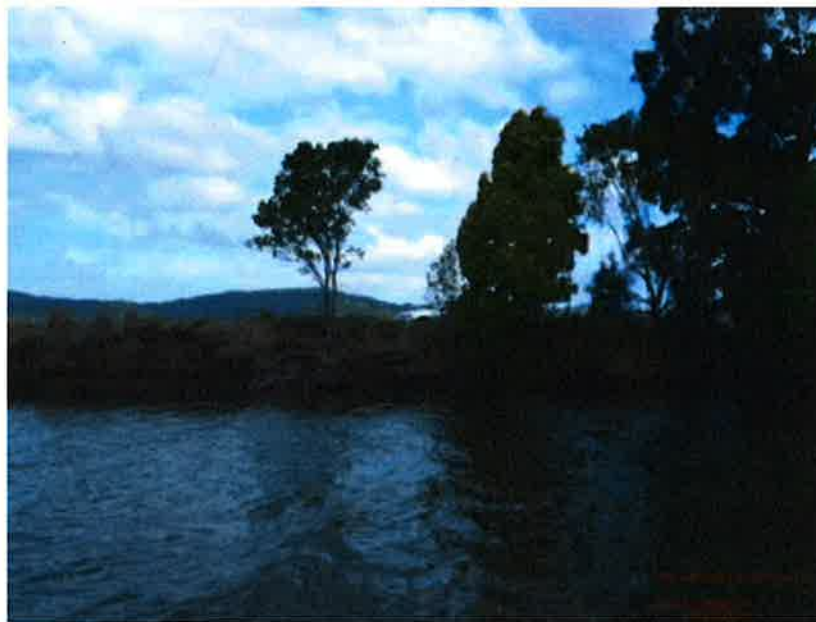
Figure 31 **Erosion at gap of vegetation in Tweed River**

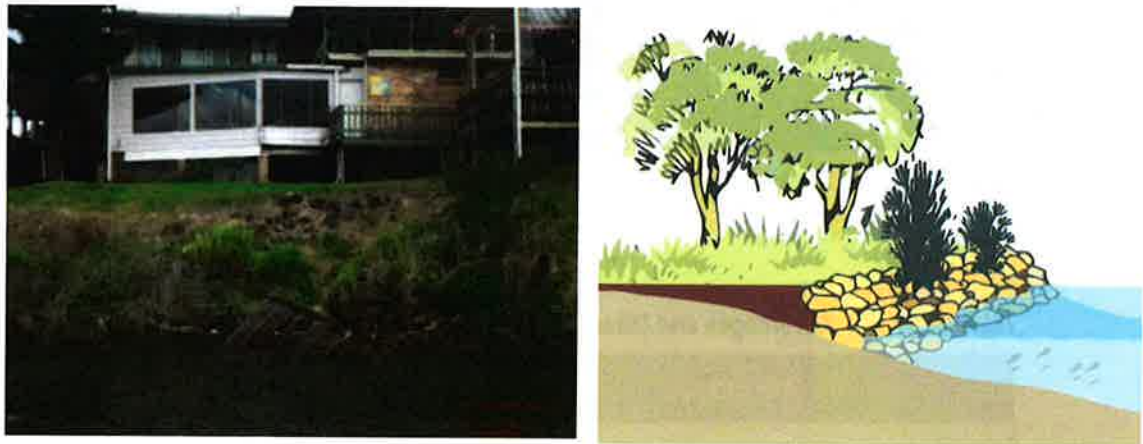
Figure 36 Dumped materials at Tweed River (left) and possible solution from DECCW, 2009 (right)

In areas where various building material have been dumped, these materials could be replaced by sloped rock revetments allowing mangrove seedlings to establish amongst the gaps between the rocks (**Figure 36**). This will improve the visual aspect and the level of protection against erosion.

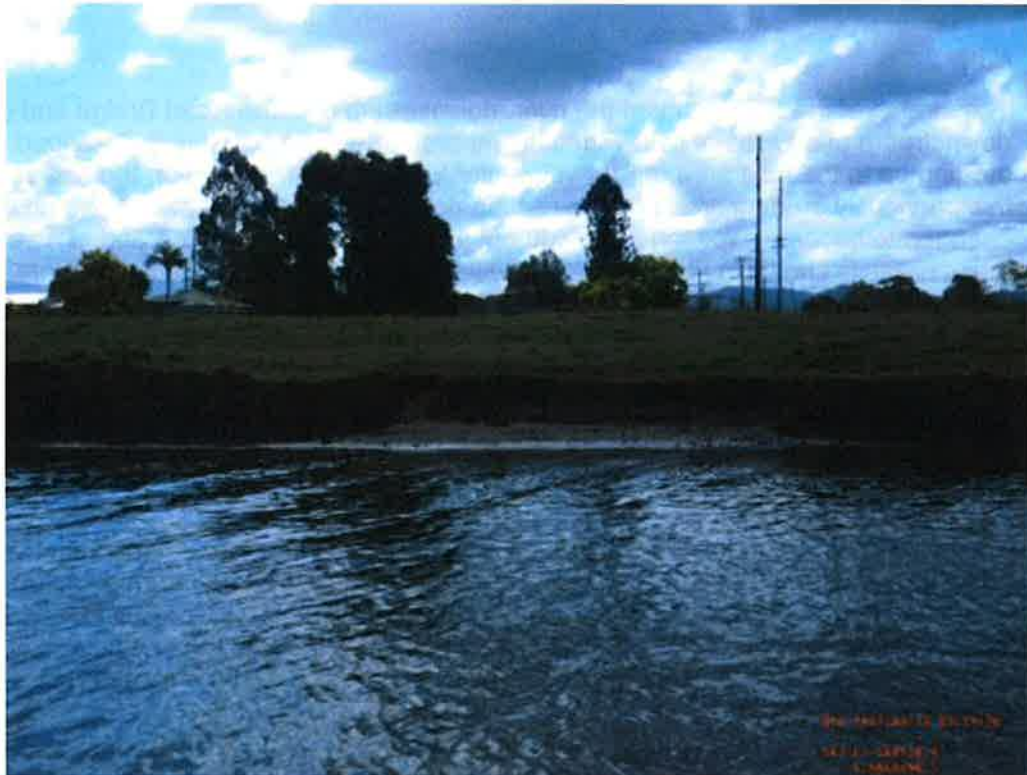
Figure A1 Photograph of the new area of erosion in Map 1.

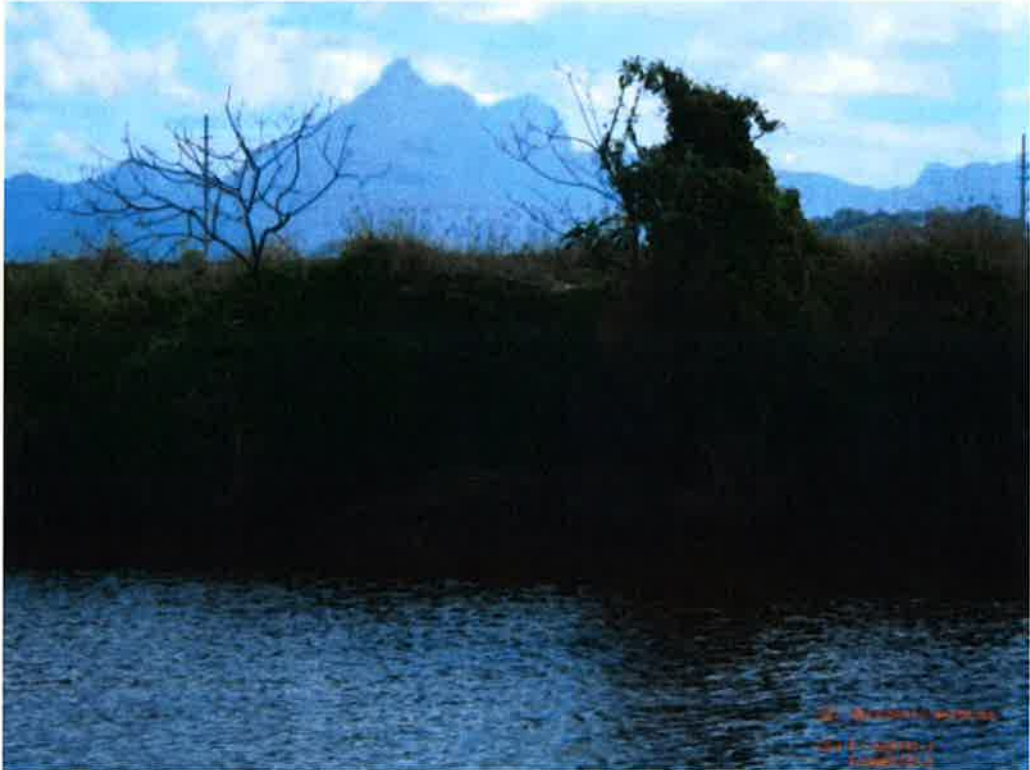
Figure A2 Photograph of a section within Map 2 which was previously recorded as eroding but is now exposed area without visible erosion.

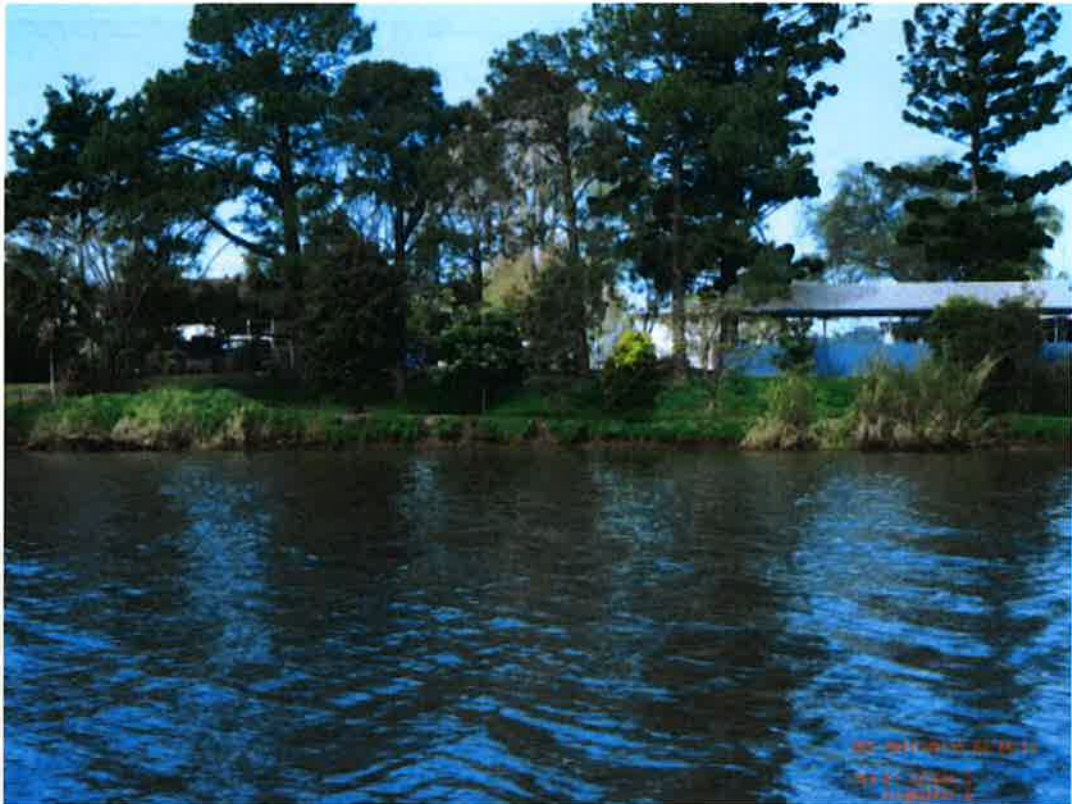
Figure A3 Photograph of a section within Map 2 which was previously recorded as exposed but is now visibly eroding.

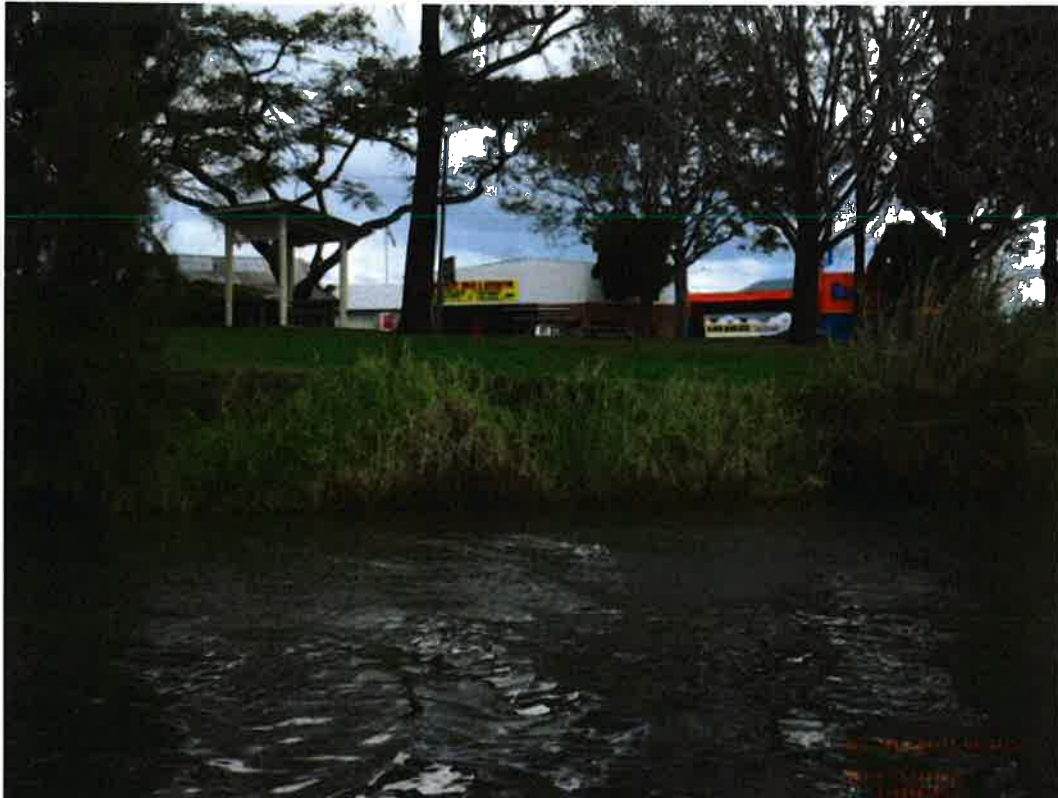
Figure A4 Photograph of a section within Map 3 which was previously recorded as eroding and is now lightly vegetated.

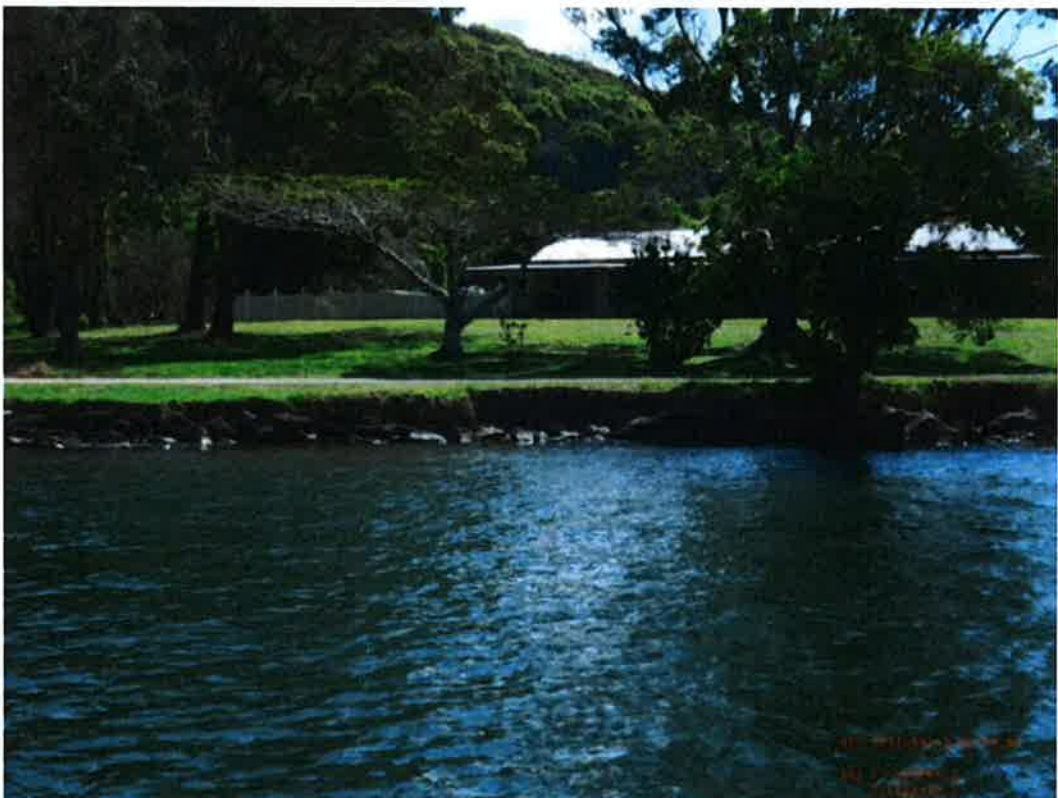
Figure A5 Photograph of a section within Map 5 which was previously recorded as having light vegetation and now has ad-hoc defences in place.

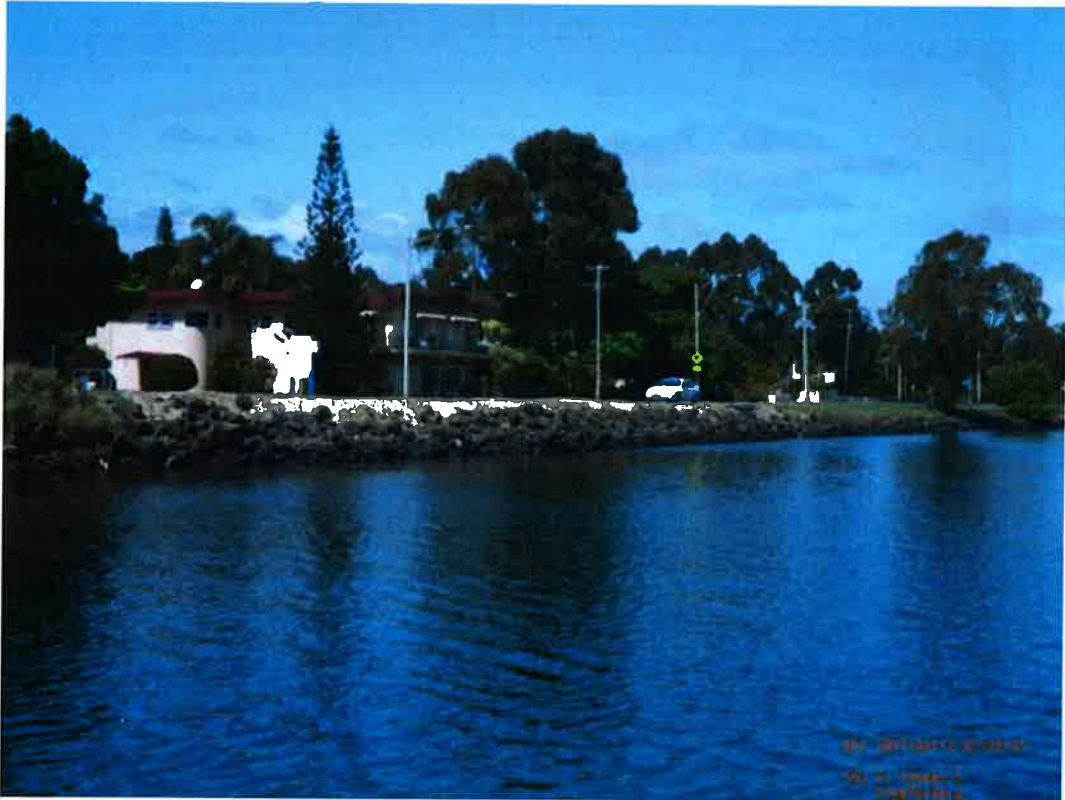
Figure A6 Photograph of a section within Map 5 which was previously recorded as eroding and now has a rock revetment in place.

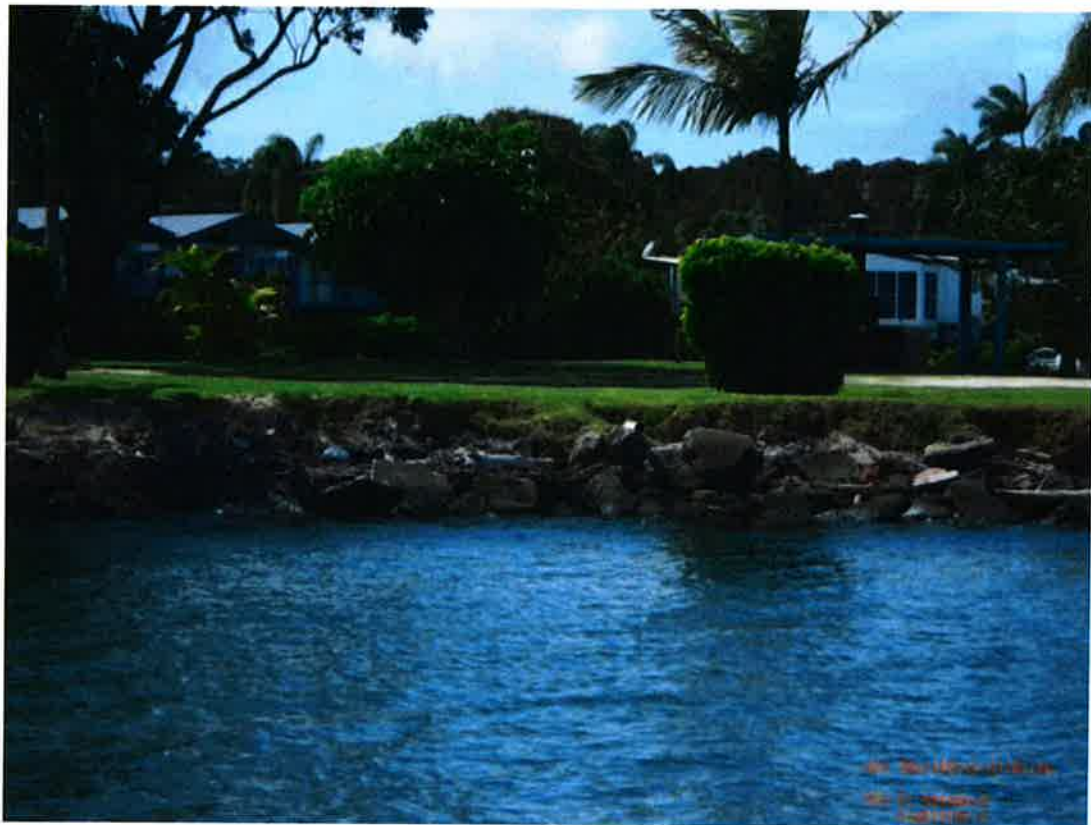
Figure A7 Photograph of a section within Map 5 which was previously recorded as eroding and now has ad-hoc poor defences in place.

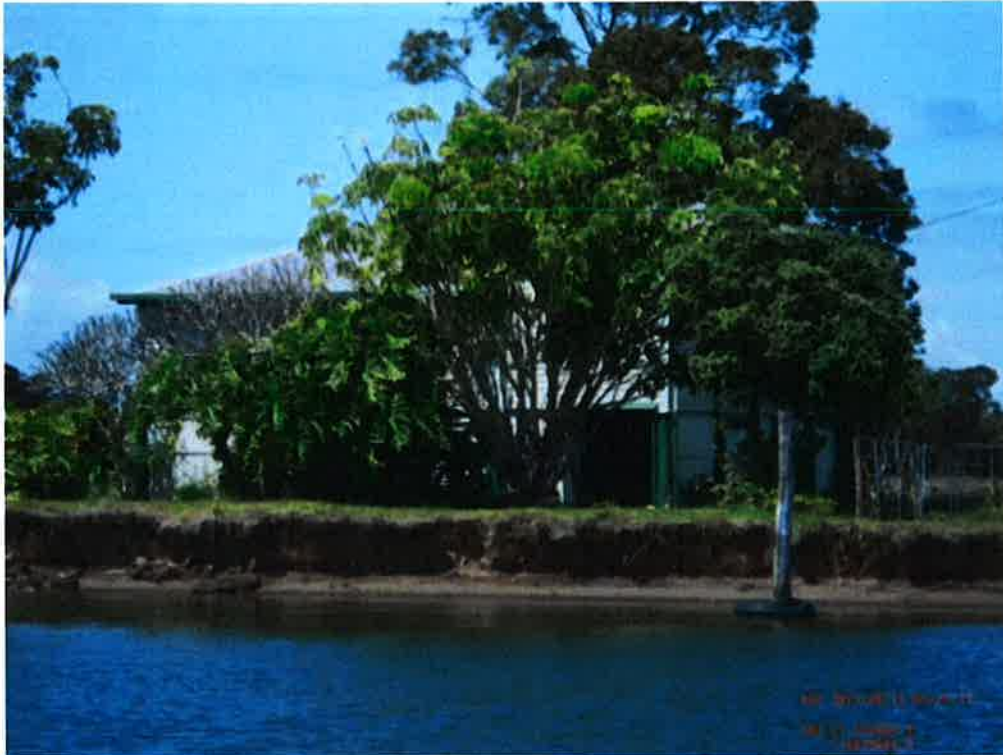
Figure A8 Photograph of an example eroding section of river bank within the Tweed River.

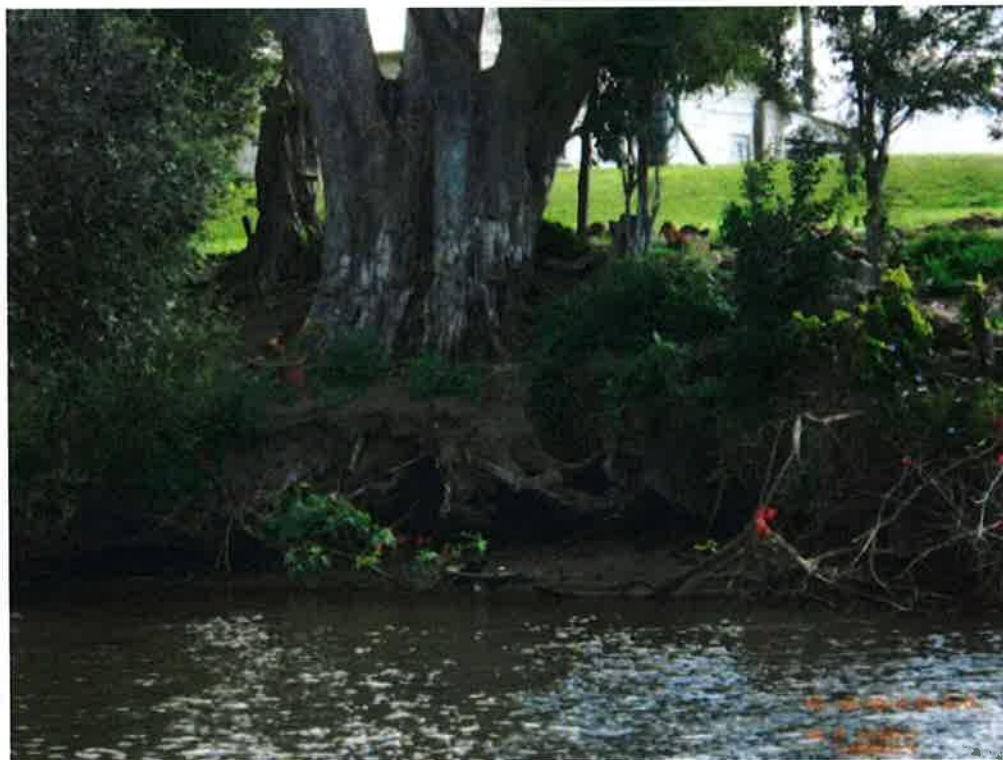
Figure A9 Photograph of an example section of river bank experiencing undercutting within the Tweed River.

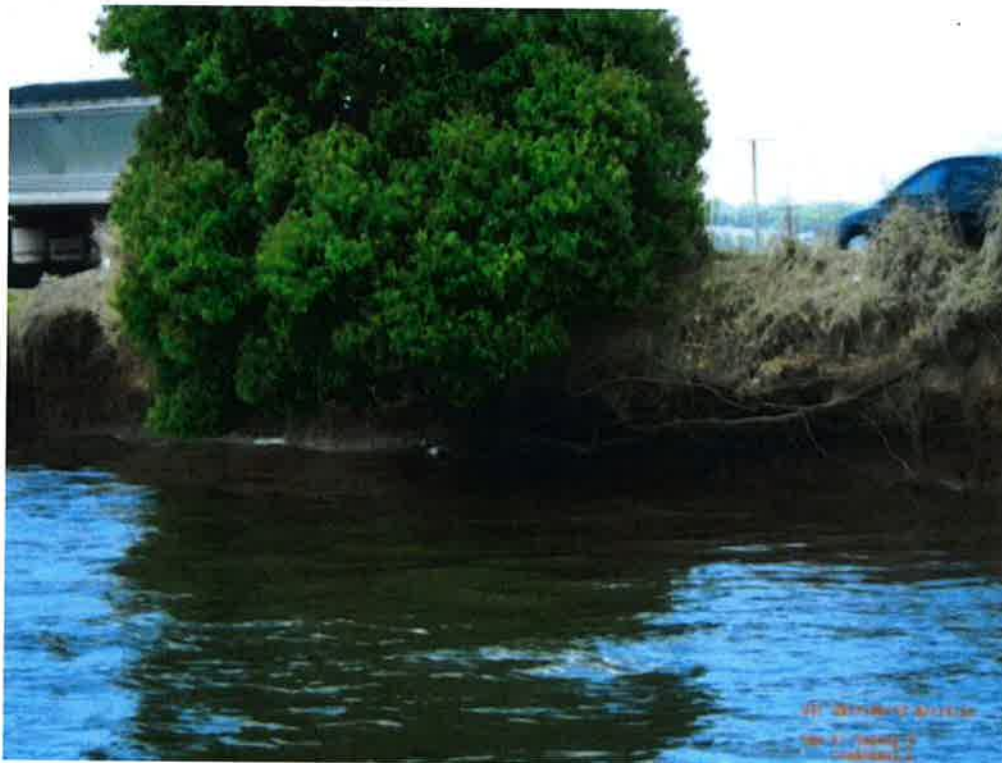
Figure A10 Photograph of an example section of river bank experiencing undercutting within the Tweed River.

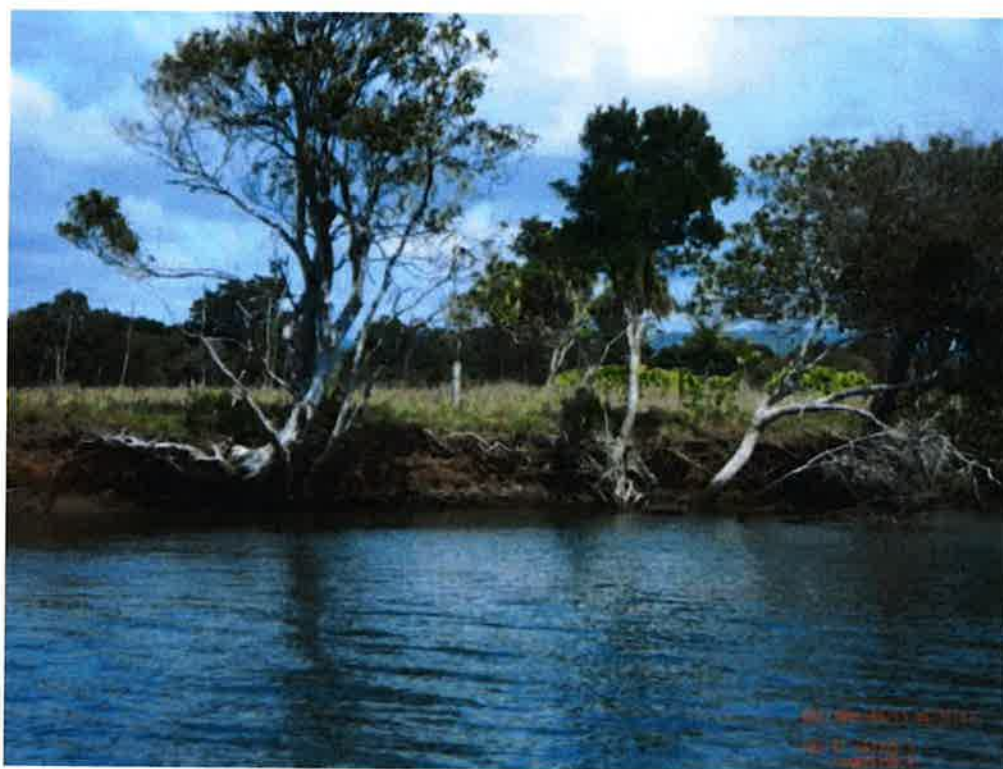
Figure A11 Photograph of an example section of river bank experiencing erosion resulting in a loss of riparian vegetation within the Tweed River.

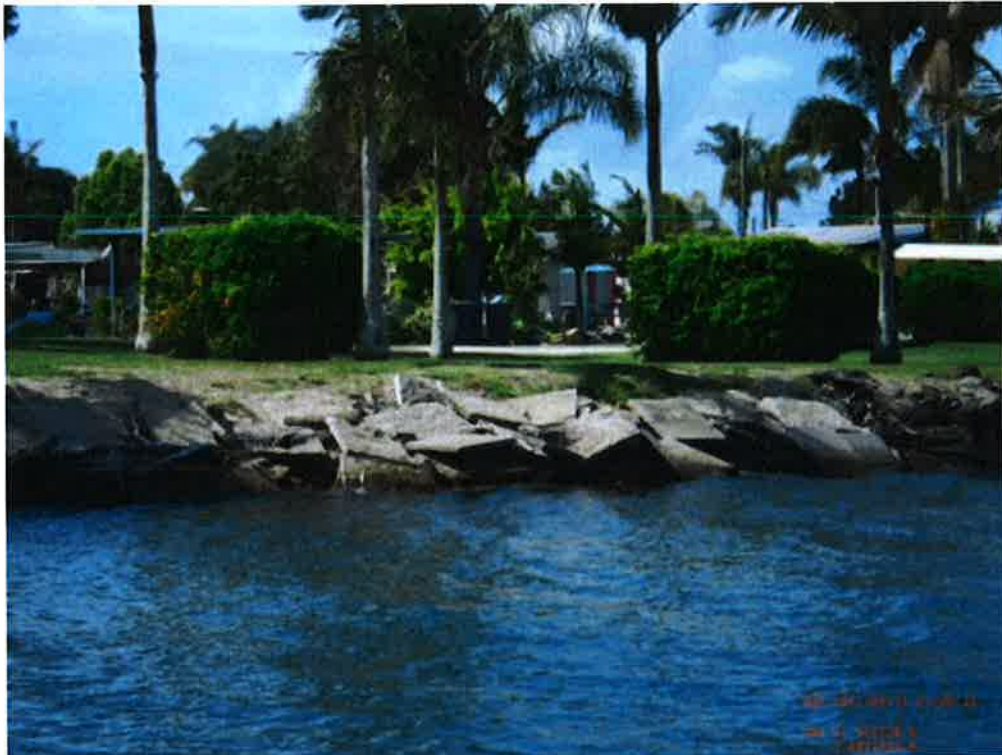
Figure A12 Photograph of an example section of river bank with ad-hoc river bank defences in place in the Tweed River.

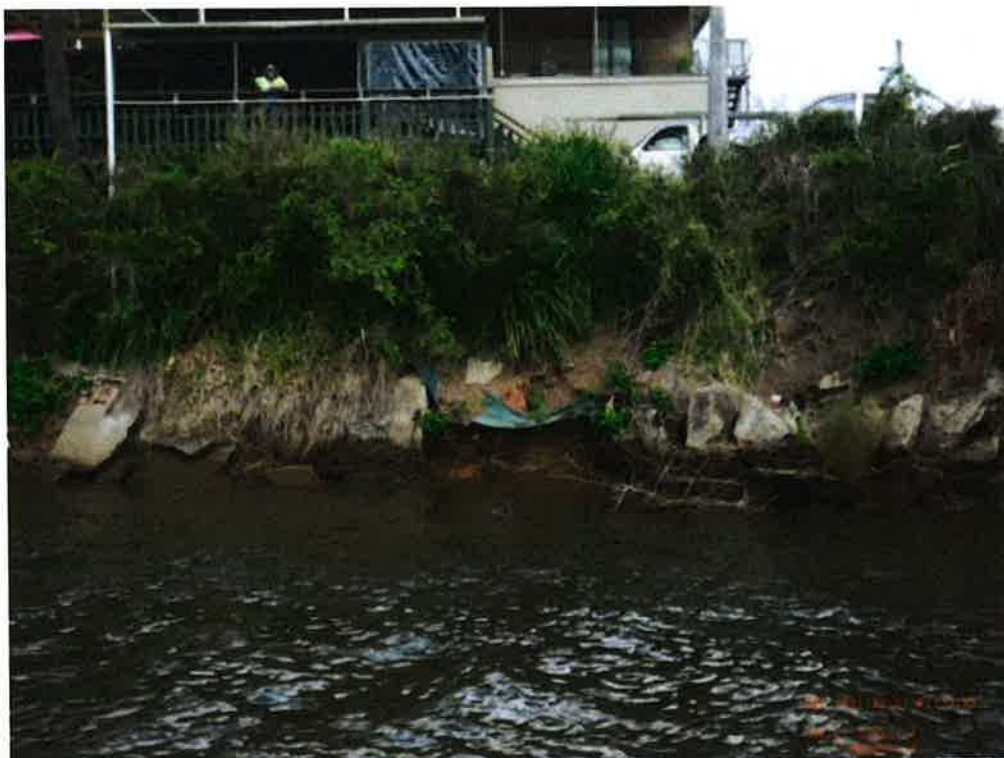
Figure A13 Photograph of an example section of river bank with ad-hoc river bank defences in place in the Tweed River.

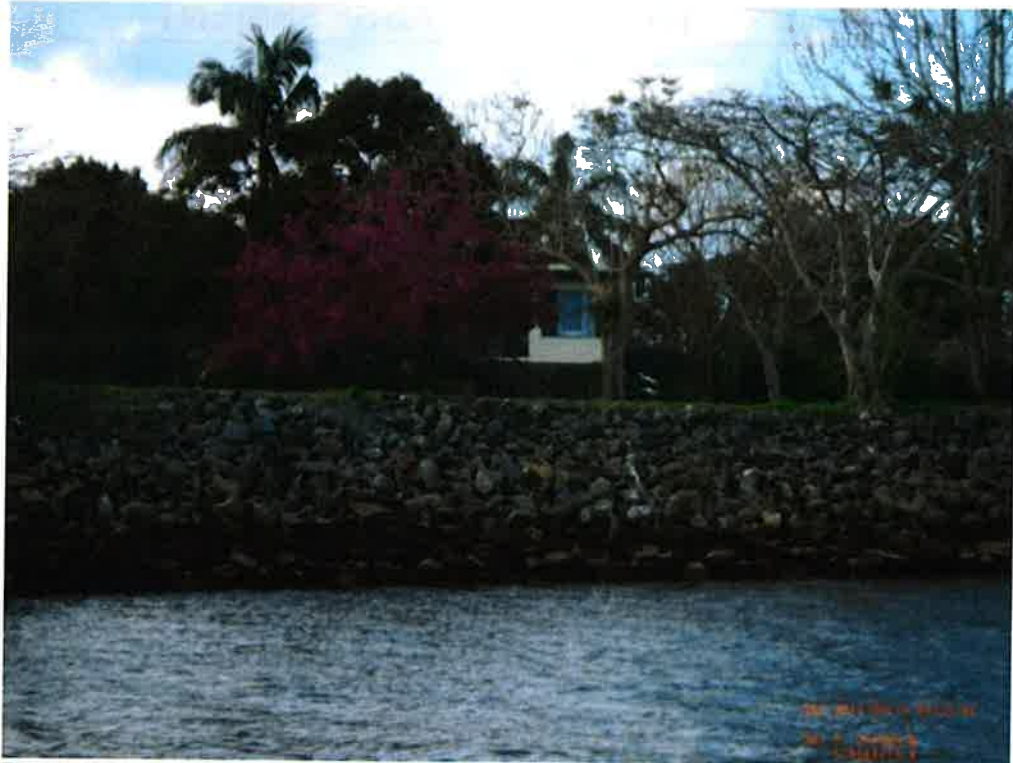
Figure A14 Photograph of an example section of river bank with a well designed rock revetment in place along the Tweed River.

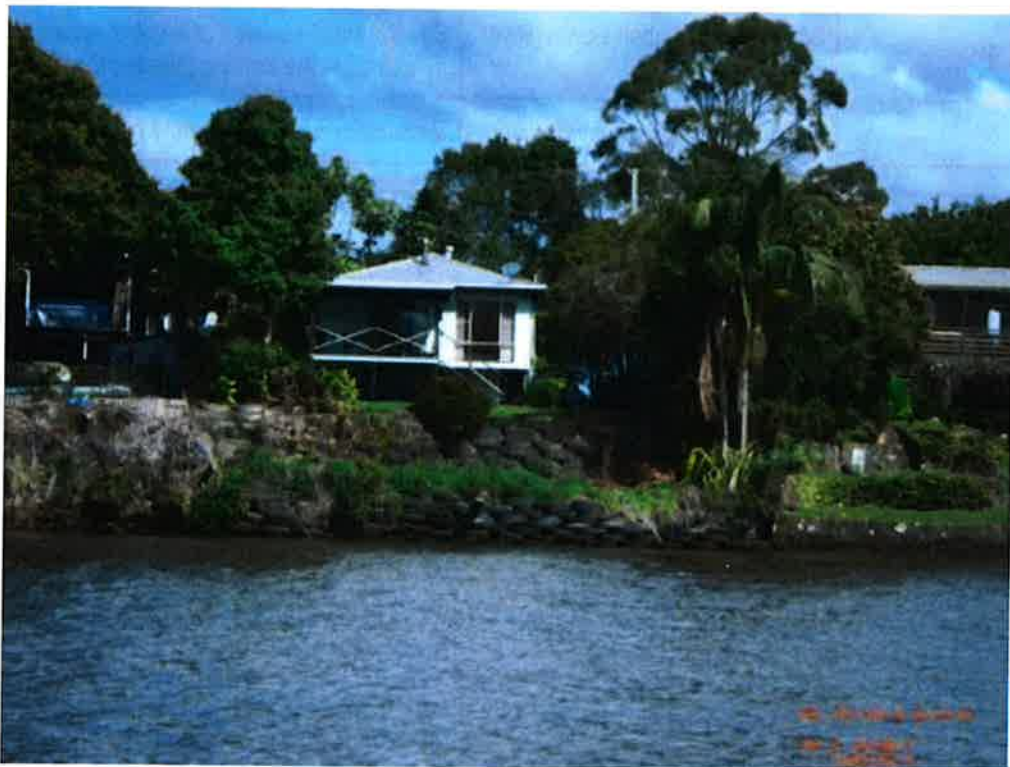
Figure A15 Photograph of an example section of river bank demonstrating the variable river bank defence structures implemented along private land, with a concrete seawall joining up to a tyre seawall.

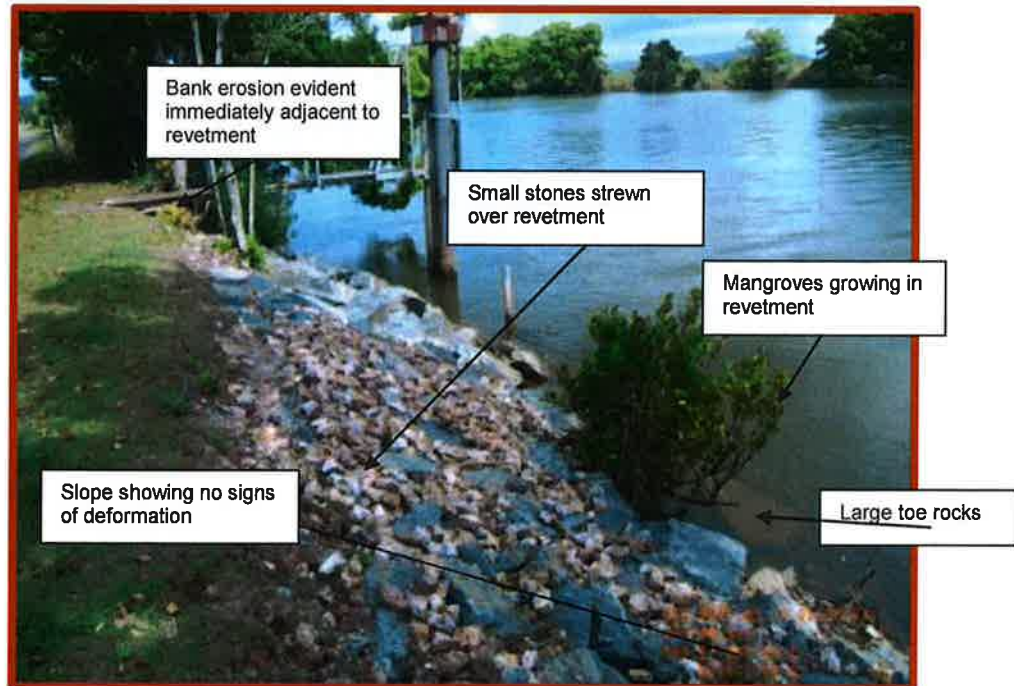
The newly constructed sections were intact and well constructed, though discontinuous. Geofabric was present behind the revetment in the newly constructed sections. These sections showed no sign of slumping, armour dislodgement, overtopping or deformation. However, smaller armour rocks were scattered over the revetment, as shown in Figure B3. Severe bank erosion was evident immediately adjacent to the revetment.

Figure B4 Revetment at Tumbulgum foreshore, looking west

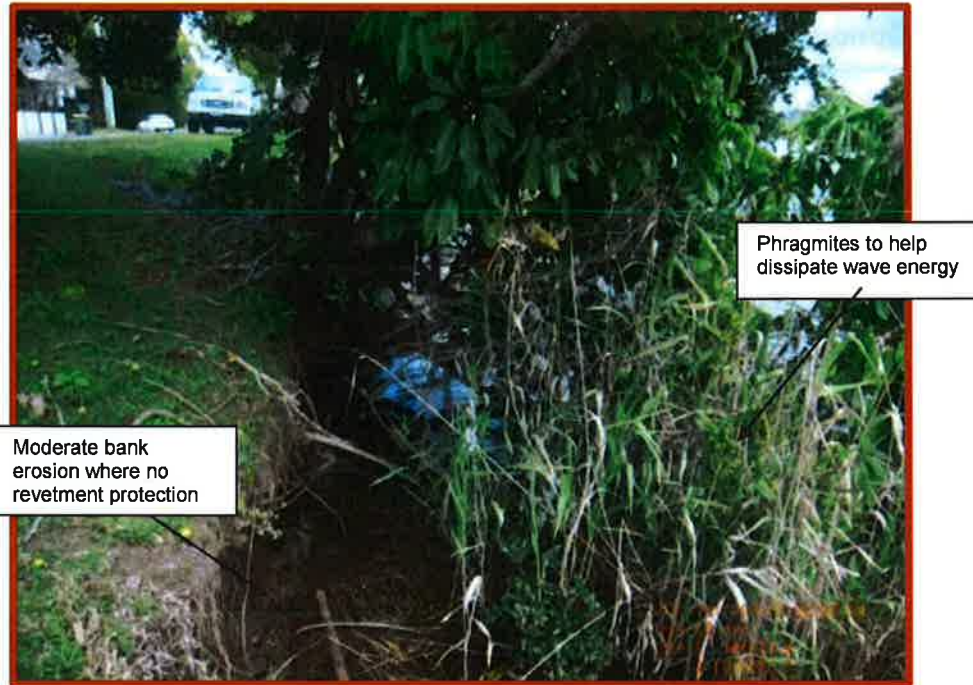
Sections of foreshore where there was a gap in the revetment had undergone significant erosion, as illustrated in Figure B4. This erosion is threatening foreshore vegetation in some locations. Phragmites in front of these sections appeared to not be effective in reducing the erosion.

Figure B5 Eroded unprotected section at Tumbulgum foreshore

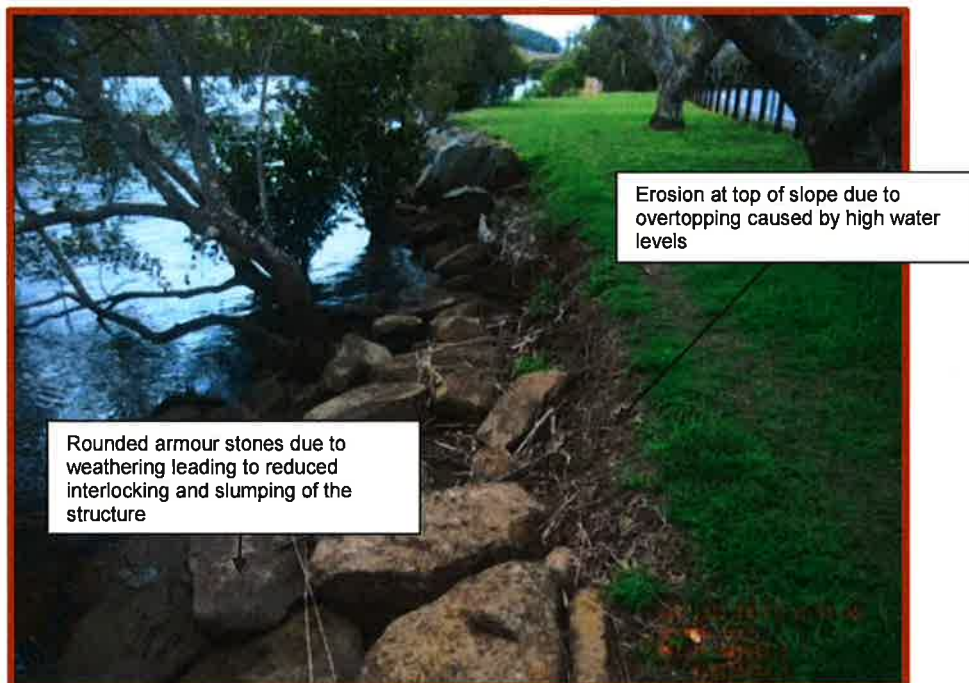
Sections of revetment further east along the foreshore, near the boat ramp, were inspected and found also to be generally in good condition. However, as these areas consisted of older construction, the armour stones had become rounded due to weathering and no longer provided sufficient interlock. Some slumping of the revetment protection had occurred, with some erosion at the top of the slope due to a low crest level and overtopping of the crest when the river levels are high. The older construction also appeared to lack geotextile or rock underlay, and this appears to be contributing to erosion of the slope, as loss of material was occurring through the larger voids in the armour. Typical affected sections are shown in Figures B5 and B6.

Figure B6 Erosion occurring at top of slope due to overtopping at a low-crested section

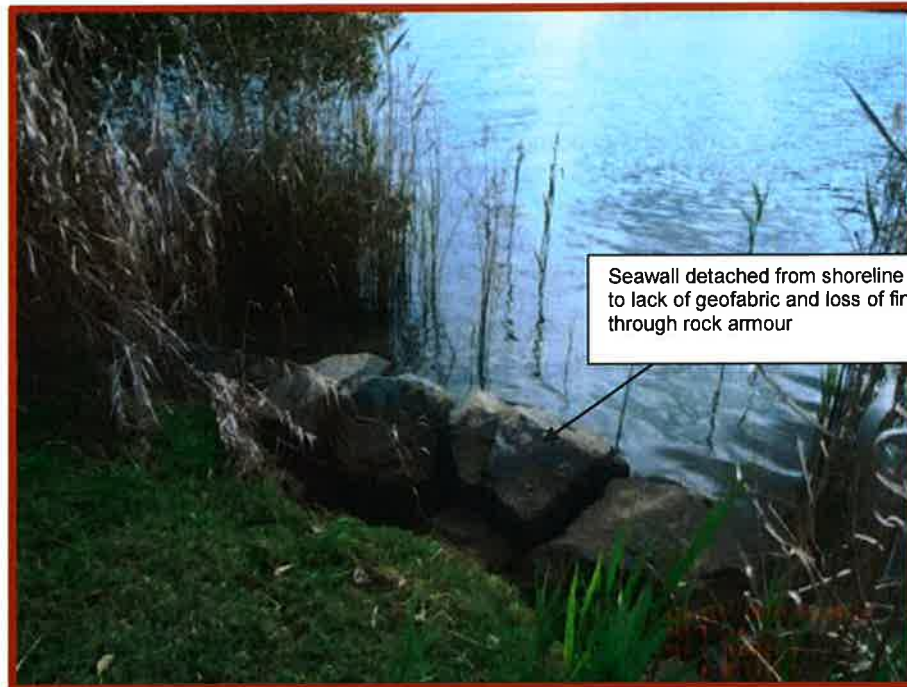
Some older sections of revetment had suffered erosion on their landward side, probably due to lack of geofabric and overtopping of the wall when the river level is high. Moderate riverbank erosion was evident in sections where the revetment was discontinuous.

Figure B7 Detached section of revetment due to continuing erosion caused by lack of geofabric

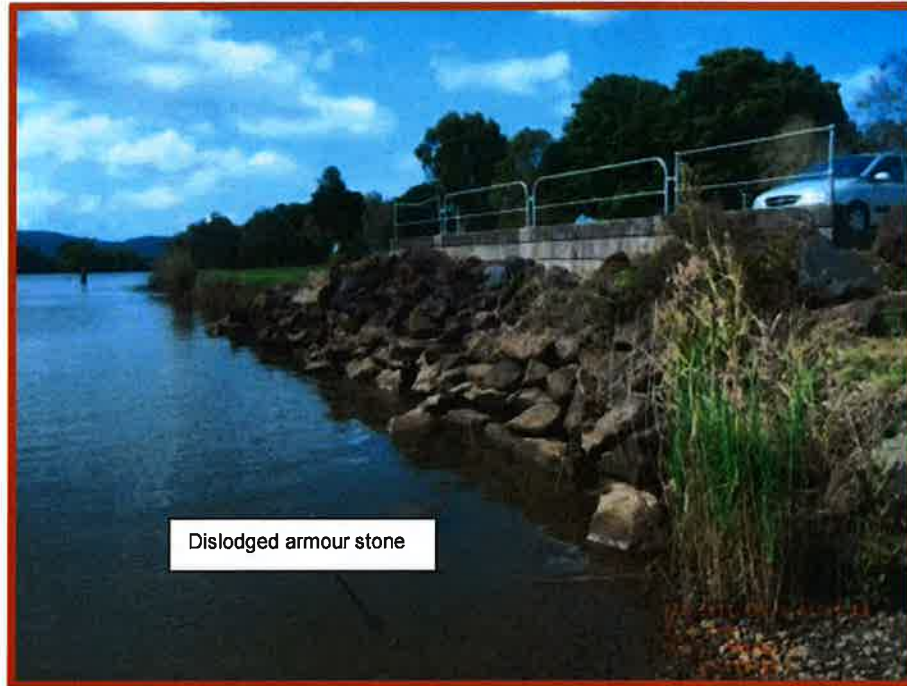
The revetment adjacent to the boat ramp in Condong is shown in Figure B8. The revetment is in fair condition, with some displacement of individual armour stones as shown in Figure B8. However, severe bank erosion is occurring both upstream and downstream of the site. The revetment appears to have kept its profile shape and stones appear to be well interlocked.

Figure B8 Revetment adjacent to boat ramp at Condong

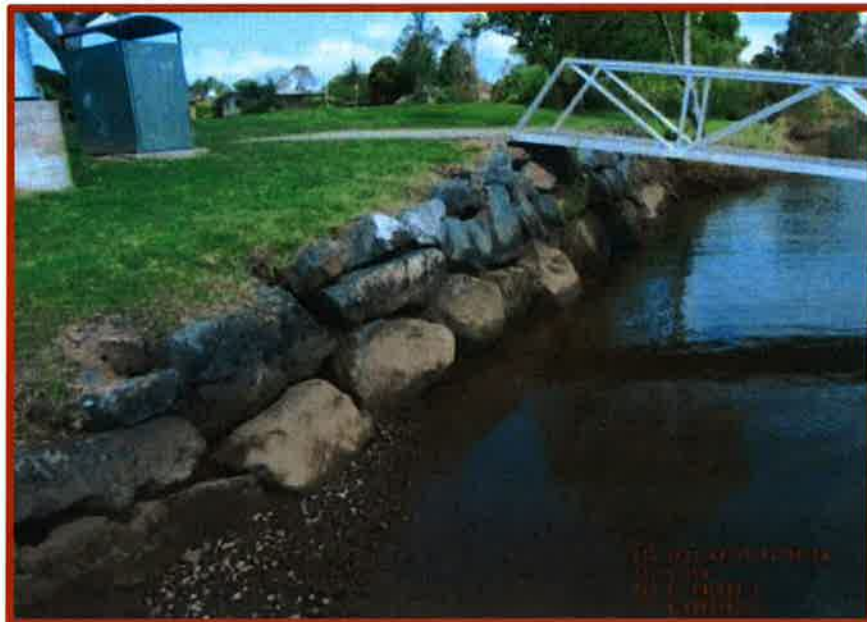
A revetment on the upstream side of the boat ramp is shown in Figure B9. This revetment consists of specially placed block-shaped armour stones, acting as a seawall placed at a near vertical angle. This seawall is in good condition.

Figure B9 Seawall on upstream side of boat ramp at Condong

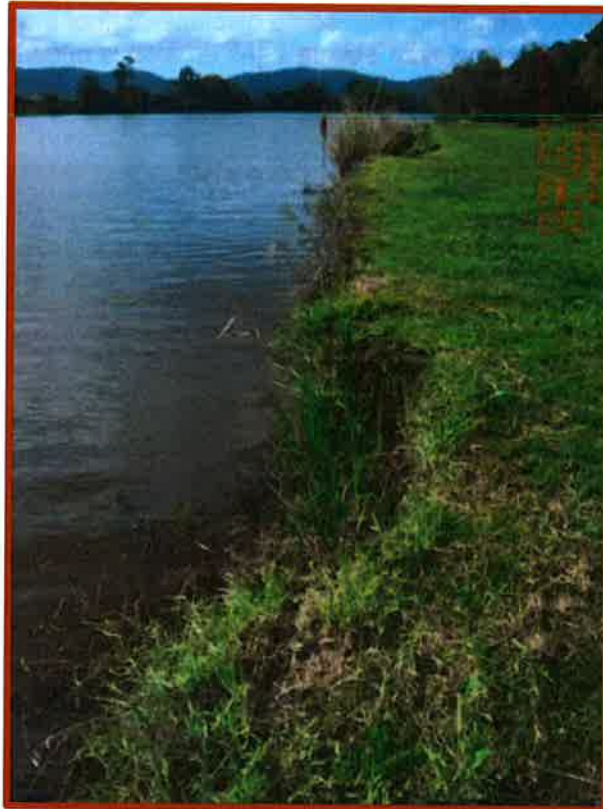
Severe bank erosion is noted immediately adjacent to the seawall and revetment, as shown in Figure B10.

Figure B10 Bank erosion immediately downstream of revetment at Condong boat ramp

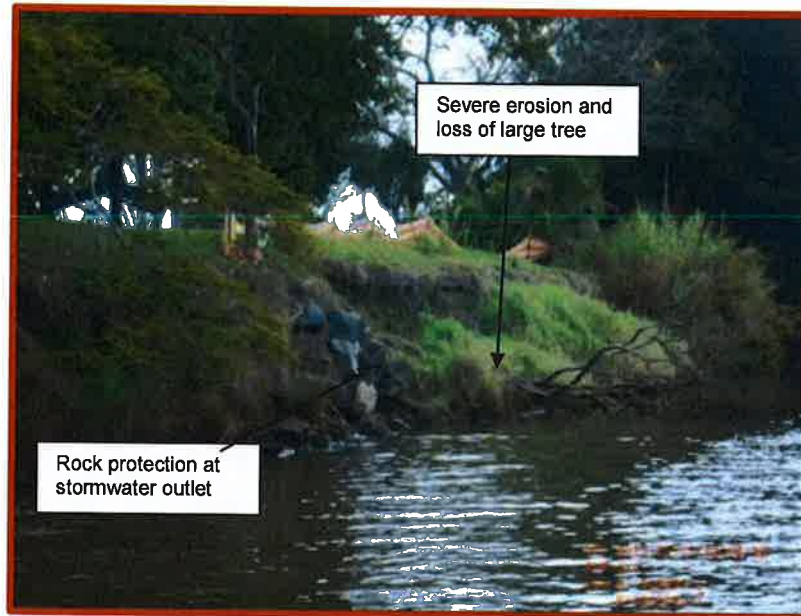
Figure B12 Severe erosion at Budd Park

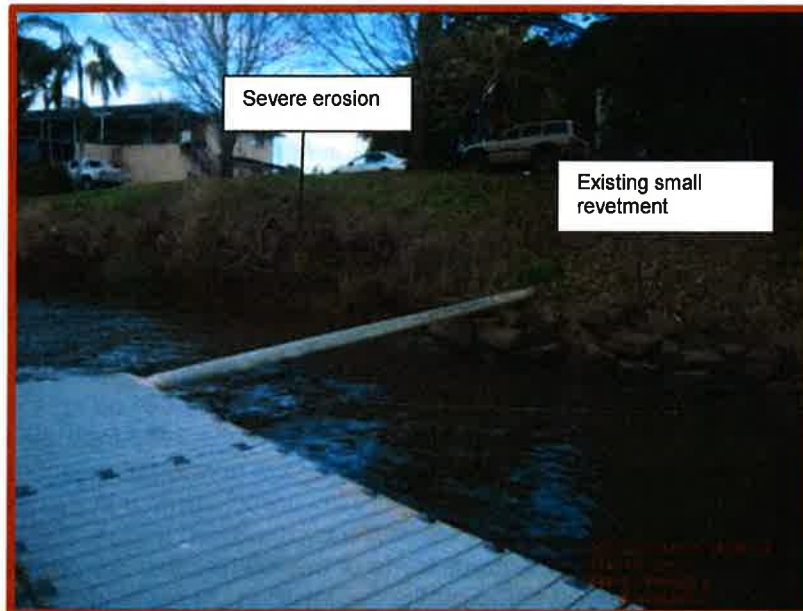
Figure B13 Existing revetment and adjacent erosion at Budd Park

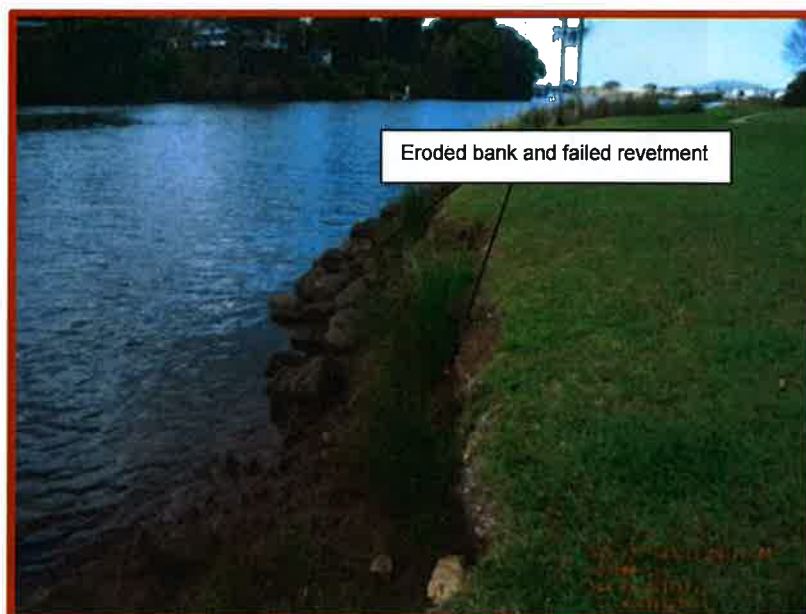
Figure B14 Failed rock protection

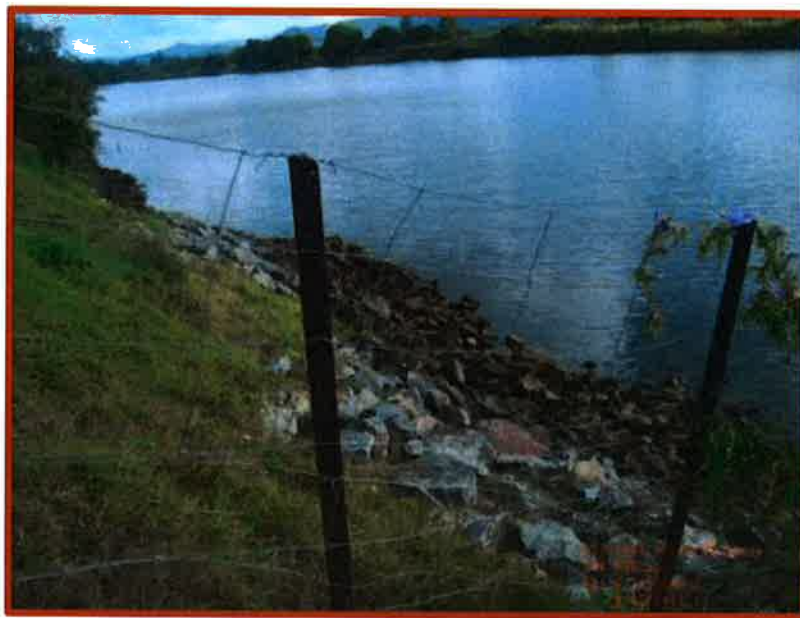
Figure B15 Revetment at South Murwillumbah Levee with slumping of toe rock and deformation of profile

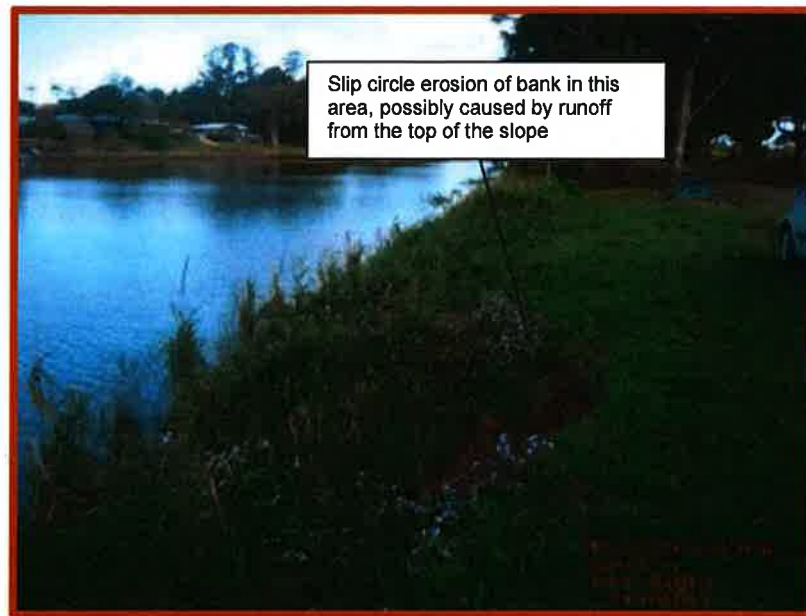
Figure B16 Erosion occurring upstream of Commercial Road area

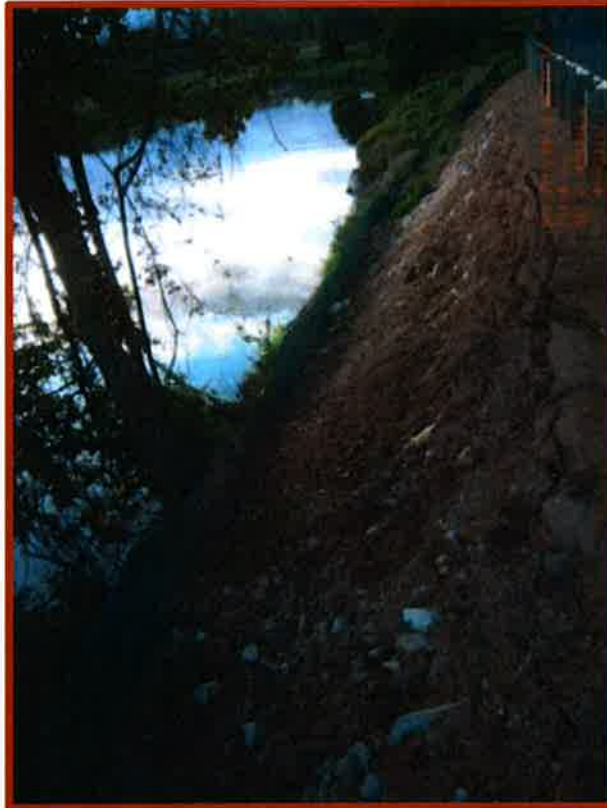
Figure B21 Unprotected embankment – Rous River (centre)

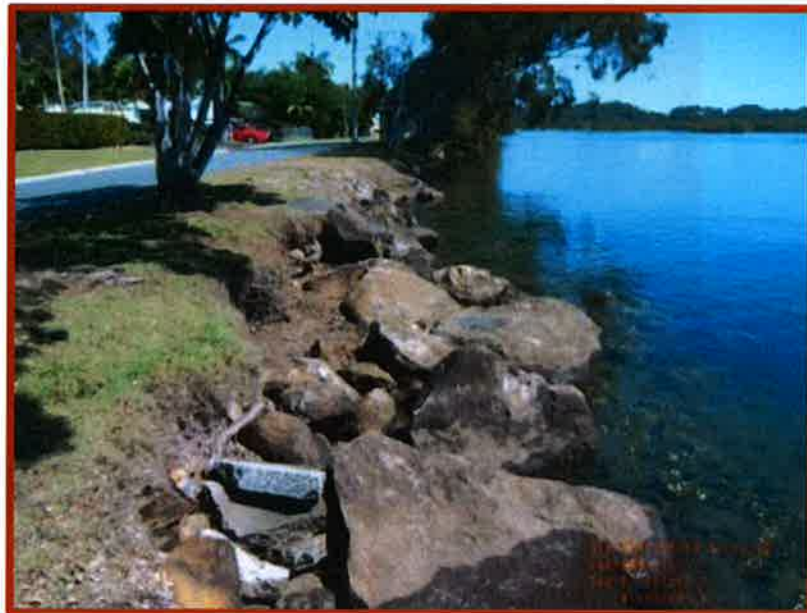
Figure B25 *Severe erosion due to revetment overtopping and lack of geofabric underlay*

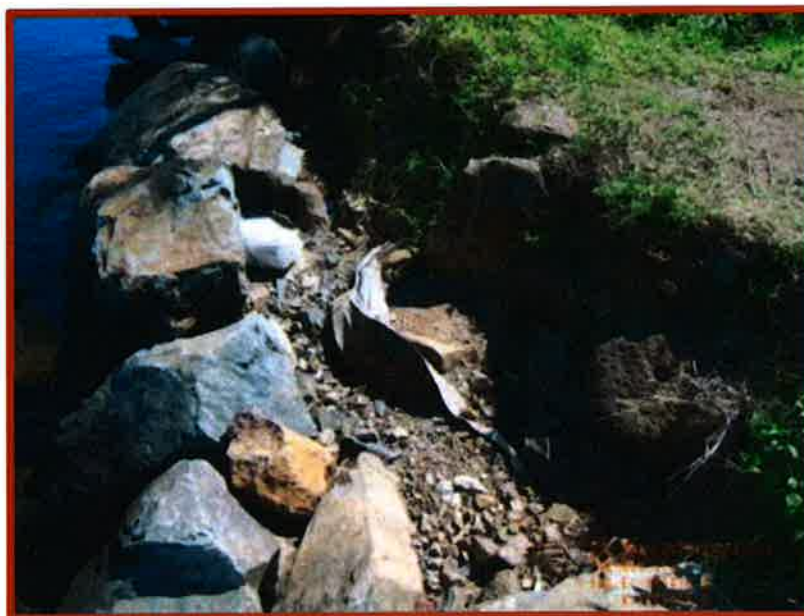
Figure B31 Severe erosion and failed revetment at eastern side of Oxley Cove adjacent to Bosun Boulevard
