Impact of Wake on Tweed River Bank Erosion Study

For: Tweed Shire Council

JANUARY 18, 2012

Project Name:	Impact of Wake on Tweed River Bank Erosion Study
Project Number:	3001906
Report for:	Tweed Shire Council

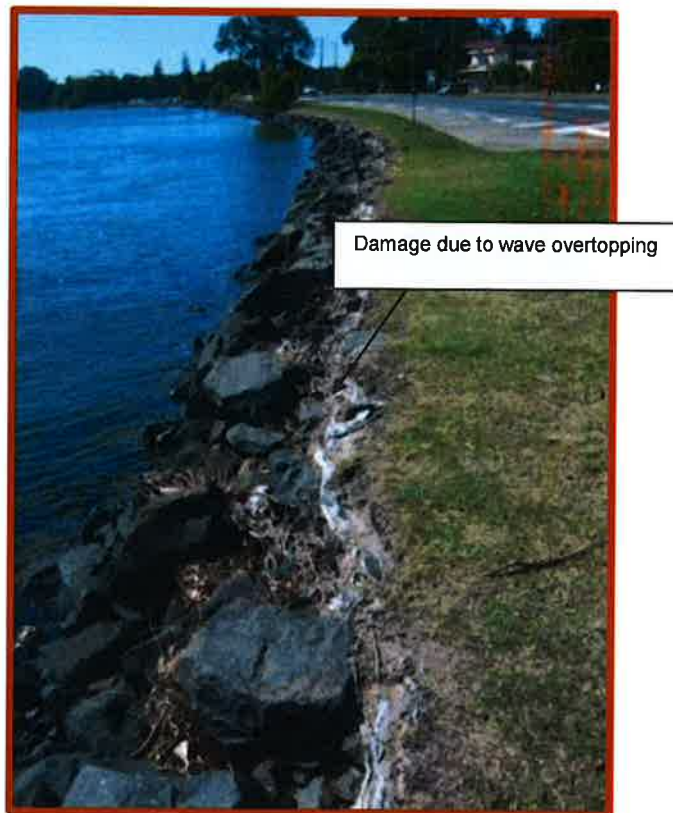
Figure B36 *Revetment with insufficient crest width showing some damage due to overtopping*

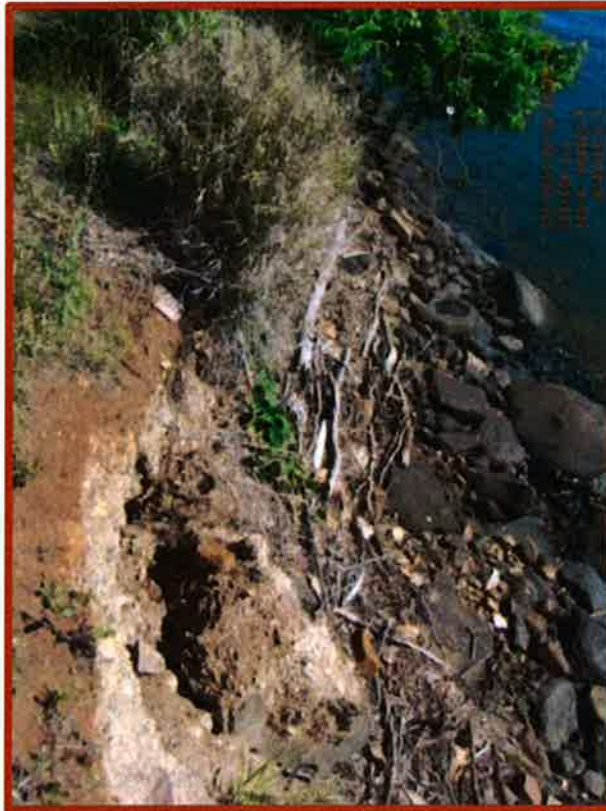
Figure B37 Section of embankment at Chinderah suffering erosion
