Tweed Riverbank Erosion Management Plan 2014

TWEED SHIRE COUNCIL | TOGETHER FORWARD

The purpose of the Tweed River Estuary Bank Management Plan 2014 is to provide a schedule of works to stabilise riverbank erosion on public land (to be undertaken by Council), as well as updated design advice for works required on private land.

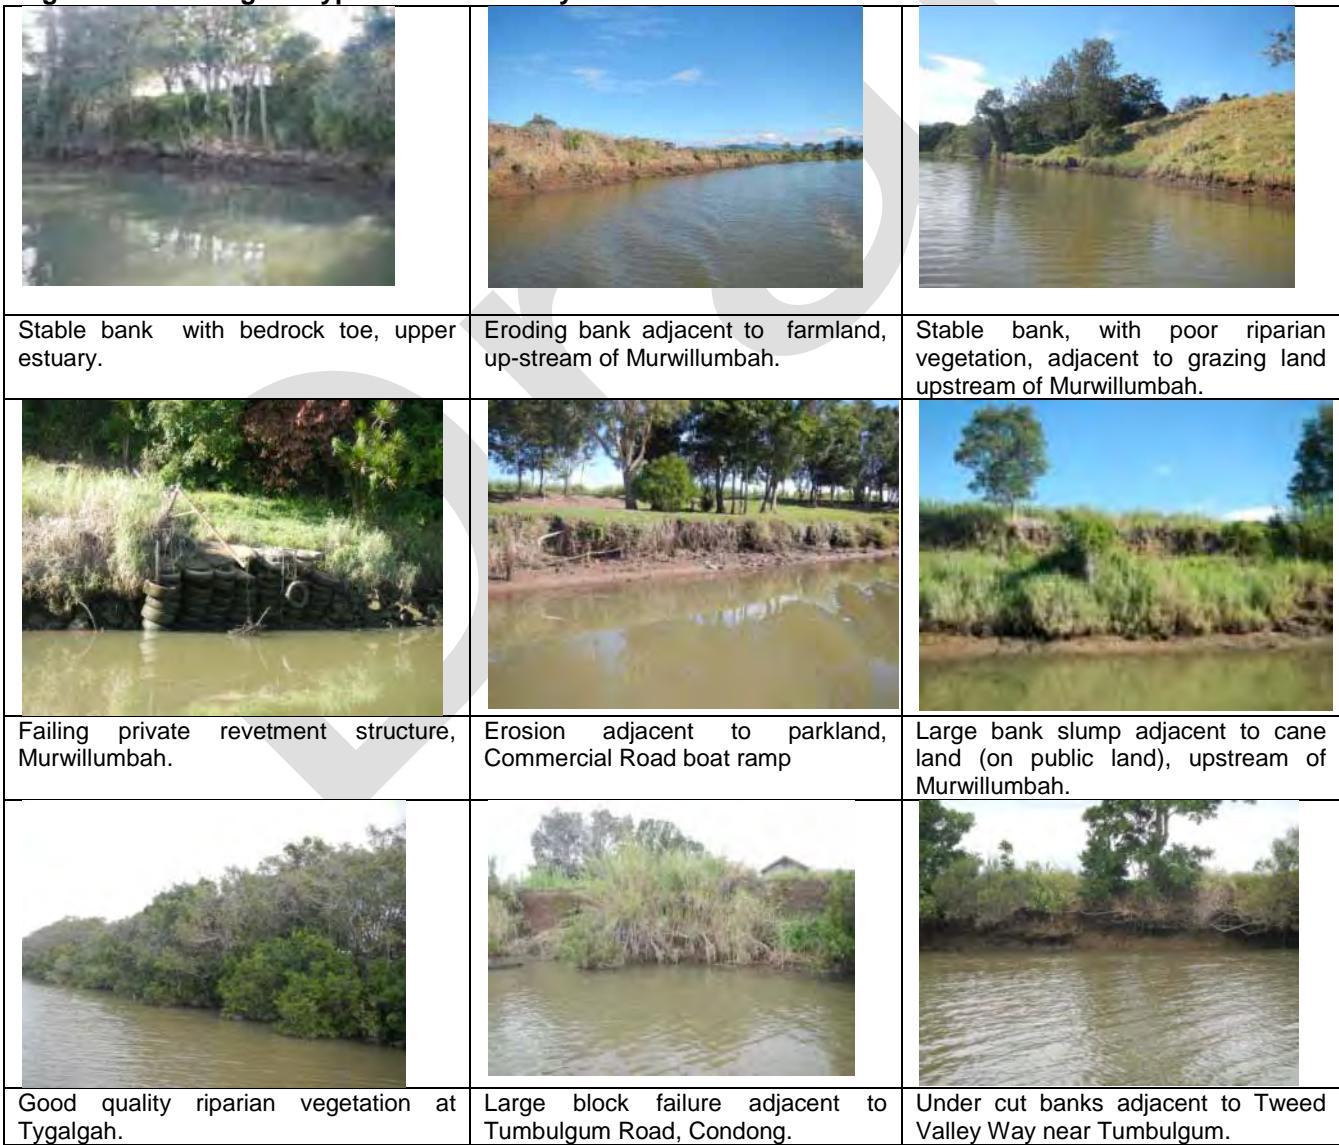
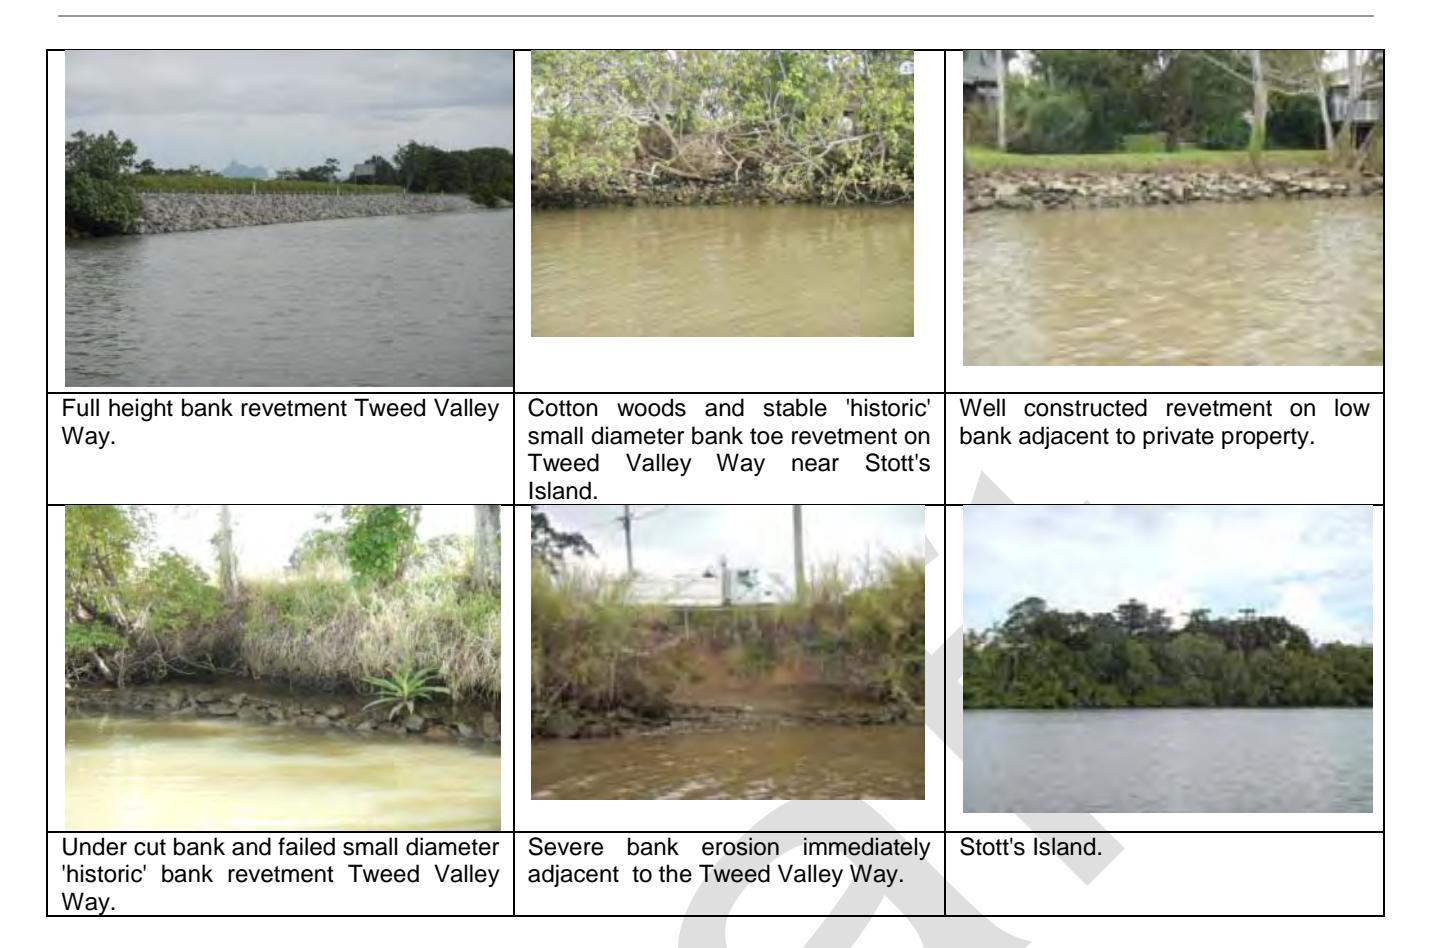
Figure 1. The range of typical bank stability conditions.

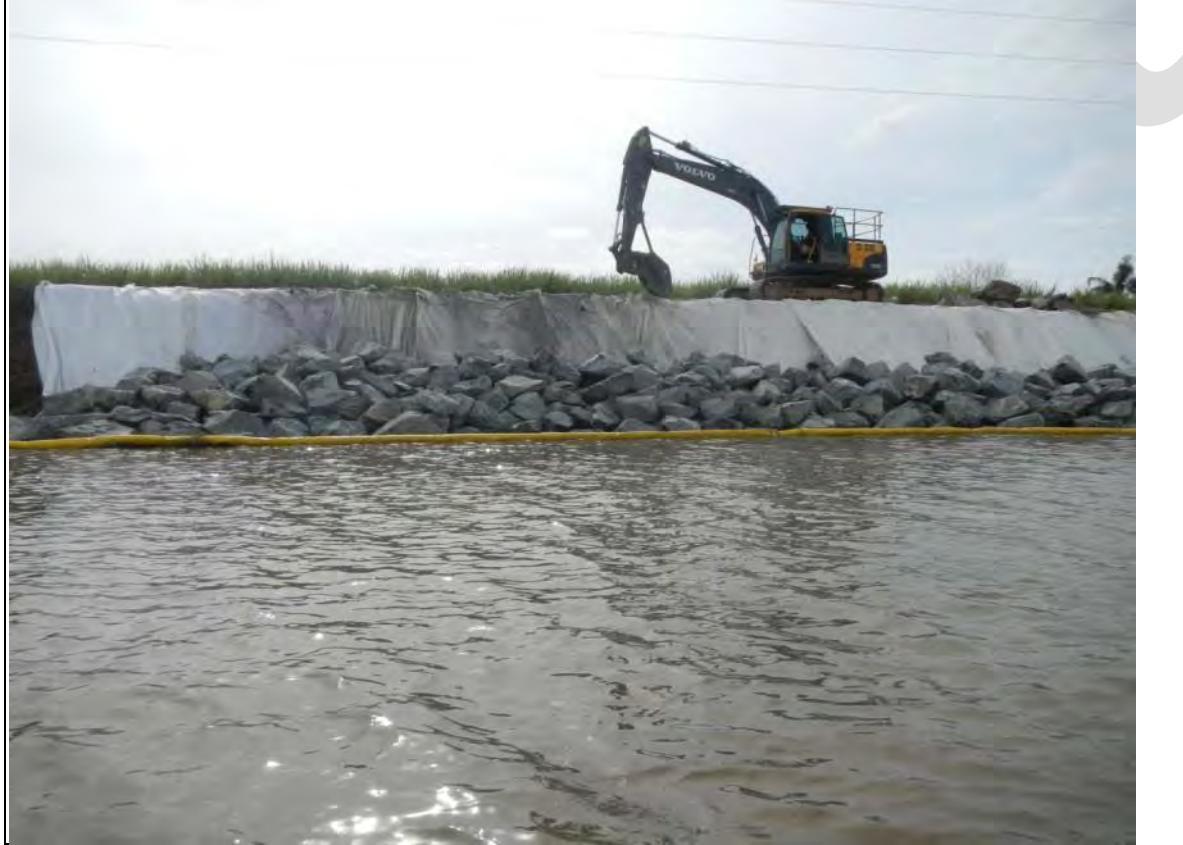
Figure 2. Reactive riverbank erosion stabilisation works being constructed adjacent to Tumbulgum Road, Tygalgah.

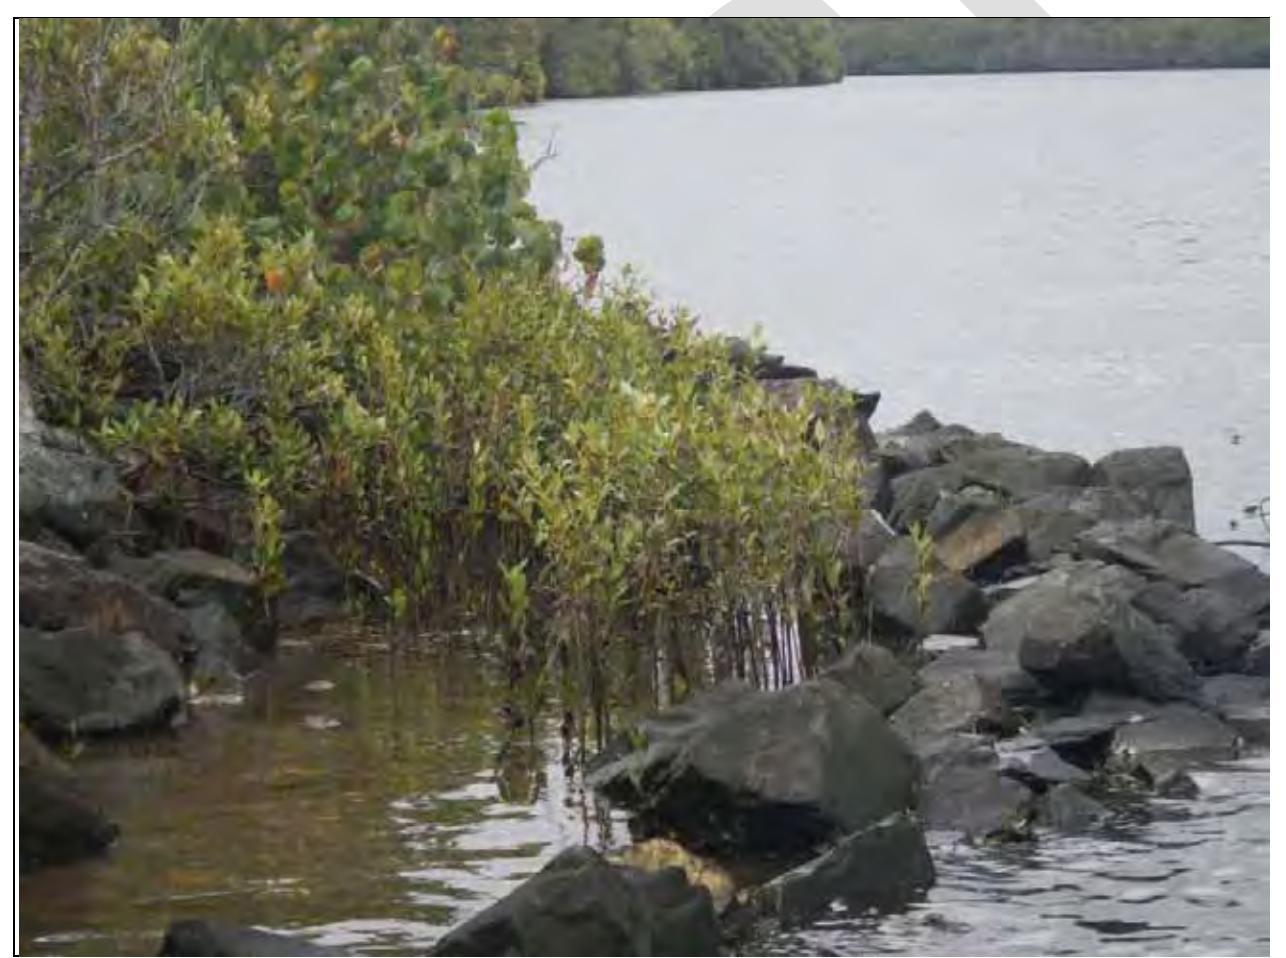
Figure 2. Rock fillets constructed on Chinderah bay drive showing natural mangrove recruitment. This area provides excellent fish habitat, a high level of erosion protection and will eventually have a very low visual impact.

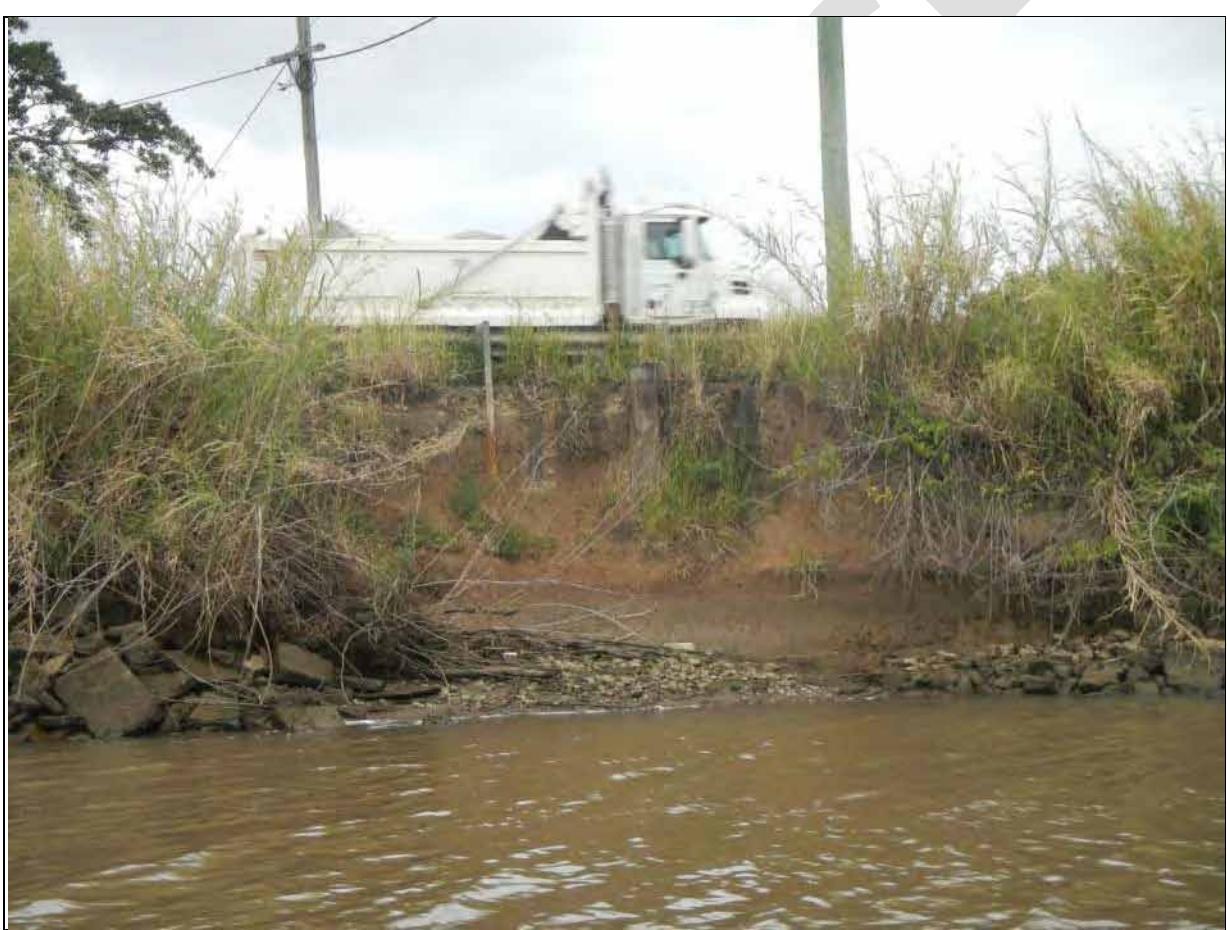
Figure 3. Bank slip adjacent to the Tweed Valley Way near Stotts Island. Road safety barrier anchor posts can be seen exposed in the top of the bank.

In the priority reach, it is unlikely, given the degraded nature of the riverbanks and the potential for banks to slip following floods, that bank erosion can be prevented exclusively through enhanced vessel or vegetation management. Bank erosion will need to be remediated through a structural approach as described above.

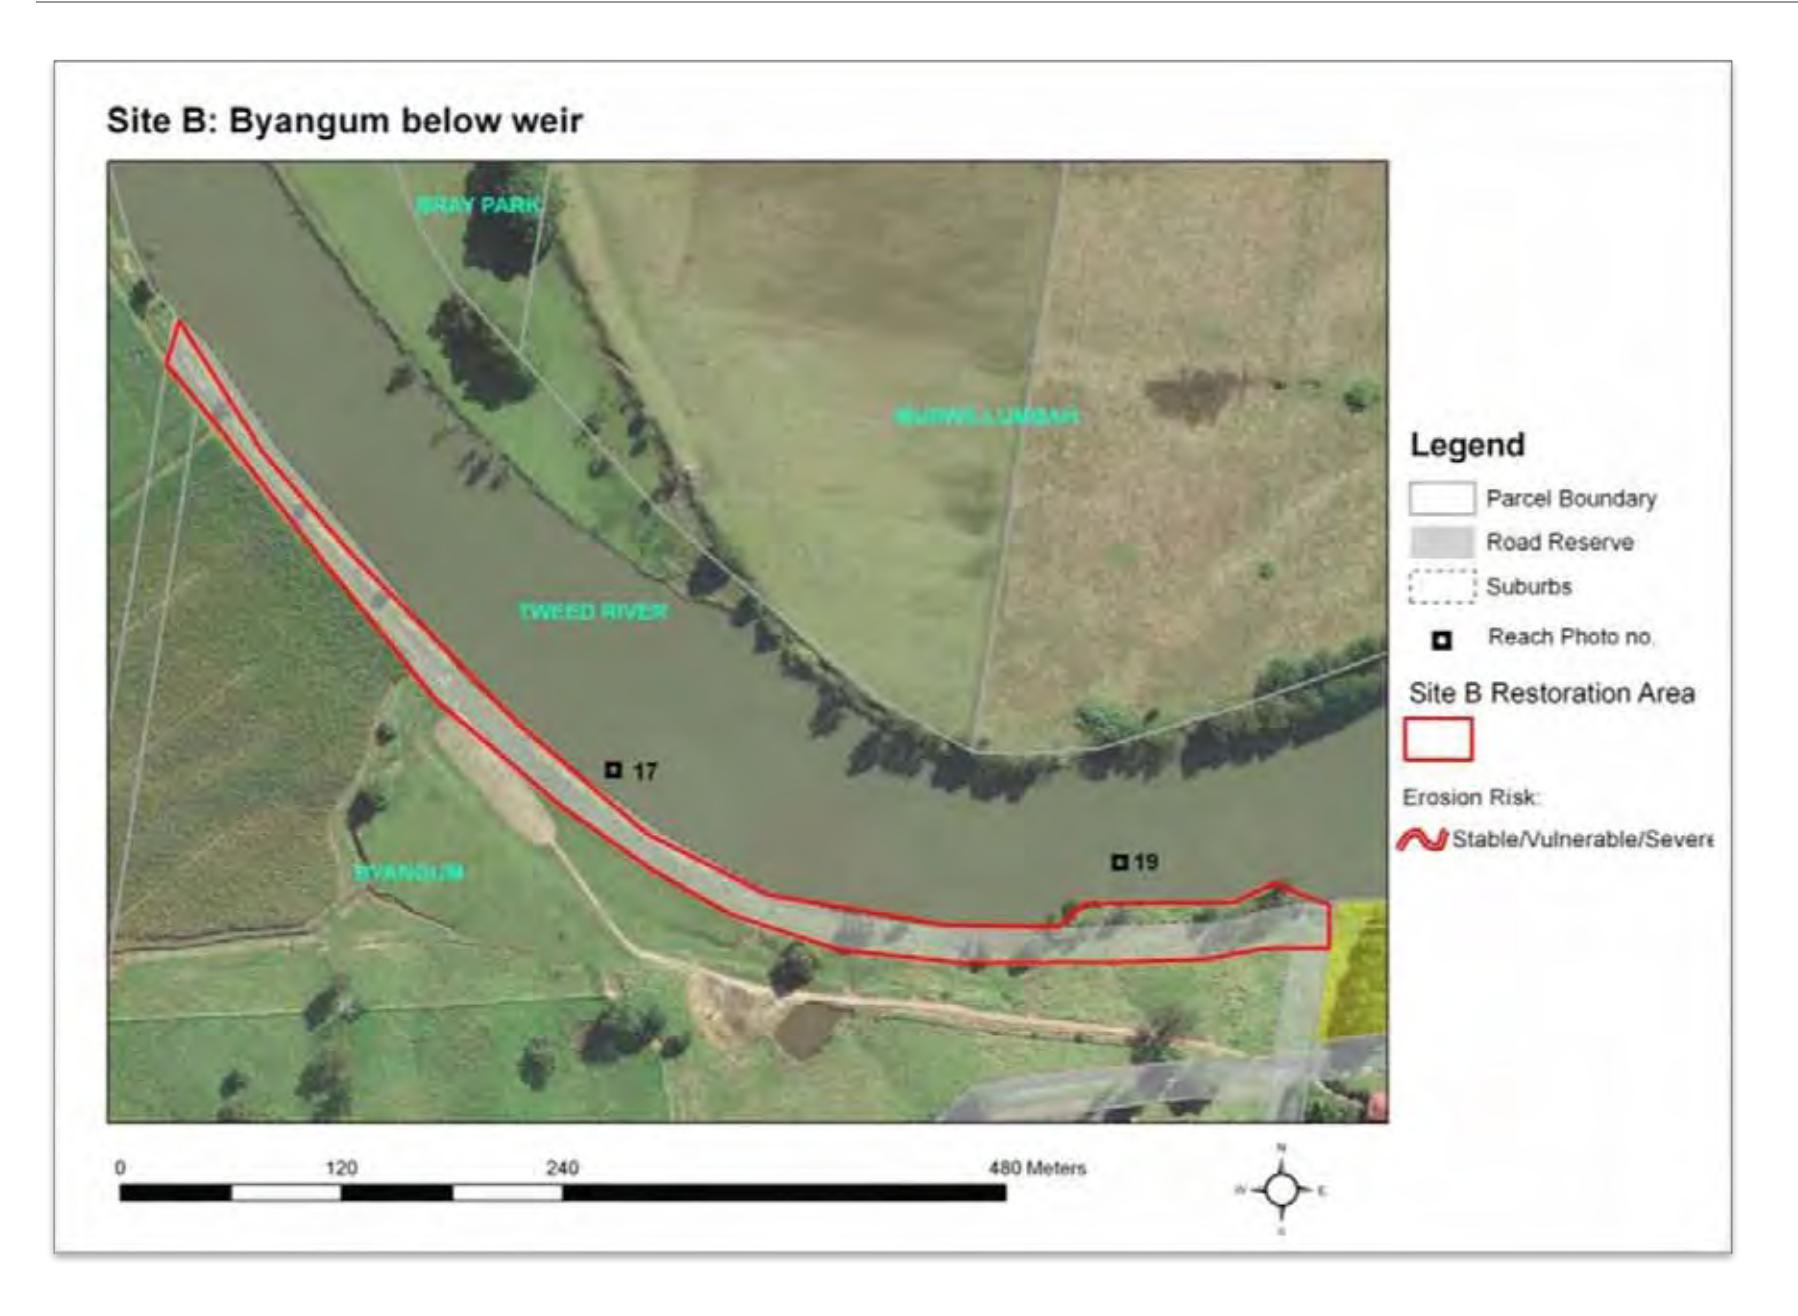
Site B - Bank Restoration Activities

Length (m)	765m
Width (m)	10 - 30
Area m ²	15,092
Bank height (m)	1-4
Erosion Risk	Upstream section: Vulnerable. Mid-section: Severe. Downstream section: Stable
	(bedrock control).
Tenure	Road Reserve (plus small area of Crown waterway)
Restoration activity and priority	Revegetation. High priority over the longer term as this section will continue to
	erode without management intervention.
Constraints/opportunities	Requires consultation with cane farmer.
	 Vertical sections of bank require battering.
	 Possible rock armouring along toe if bank continues to be undercut.
	Work should ideally begin before revegetation of Site A opposite bank which
	may increase scour potential due to deflected flows.
	Detailed restoration plan required.
Photo 17 – severe erosion on mid-section of site, grassed bank	
	Photo 19 – Downstream section of site. Bank is stable due to bed rock control on
	right bank.

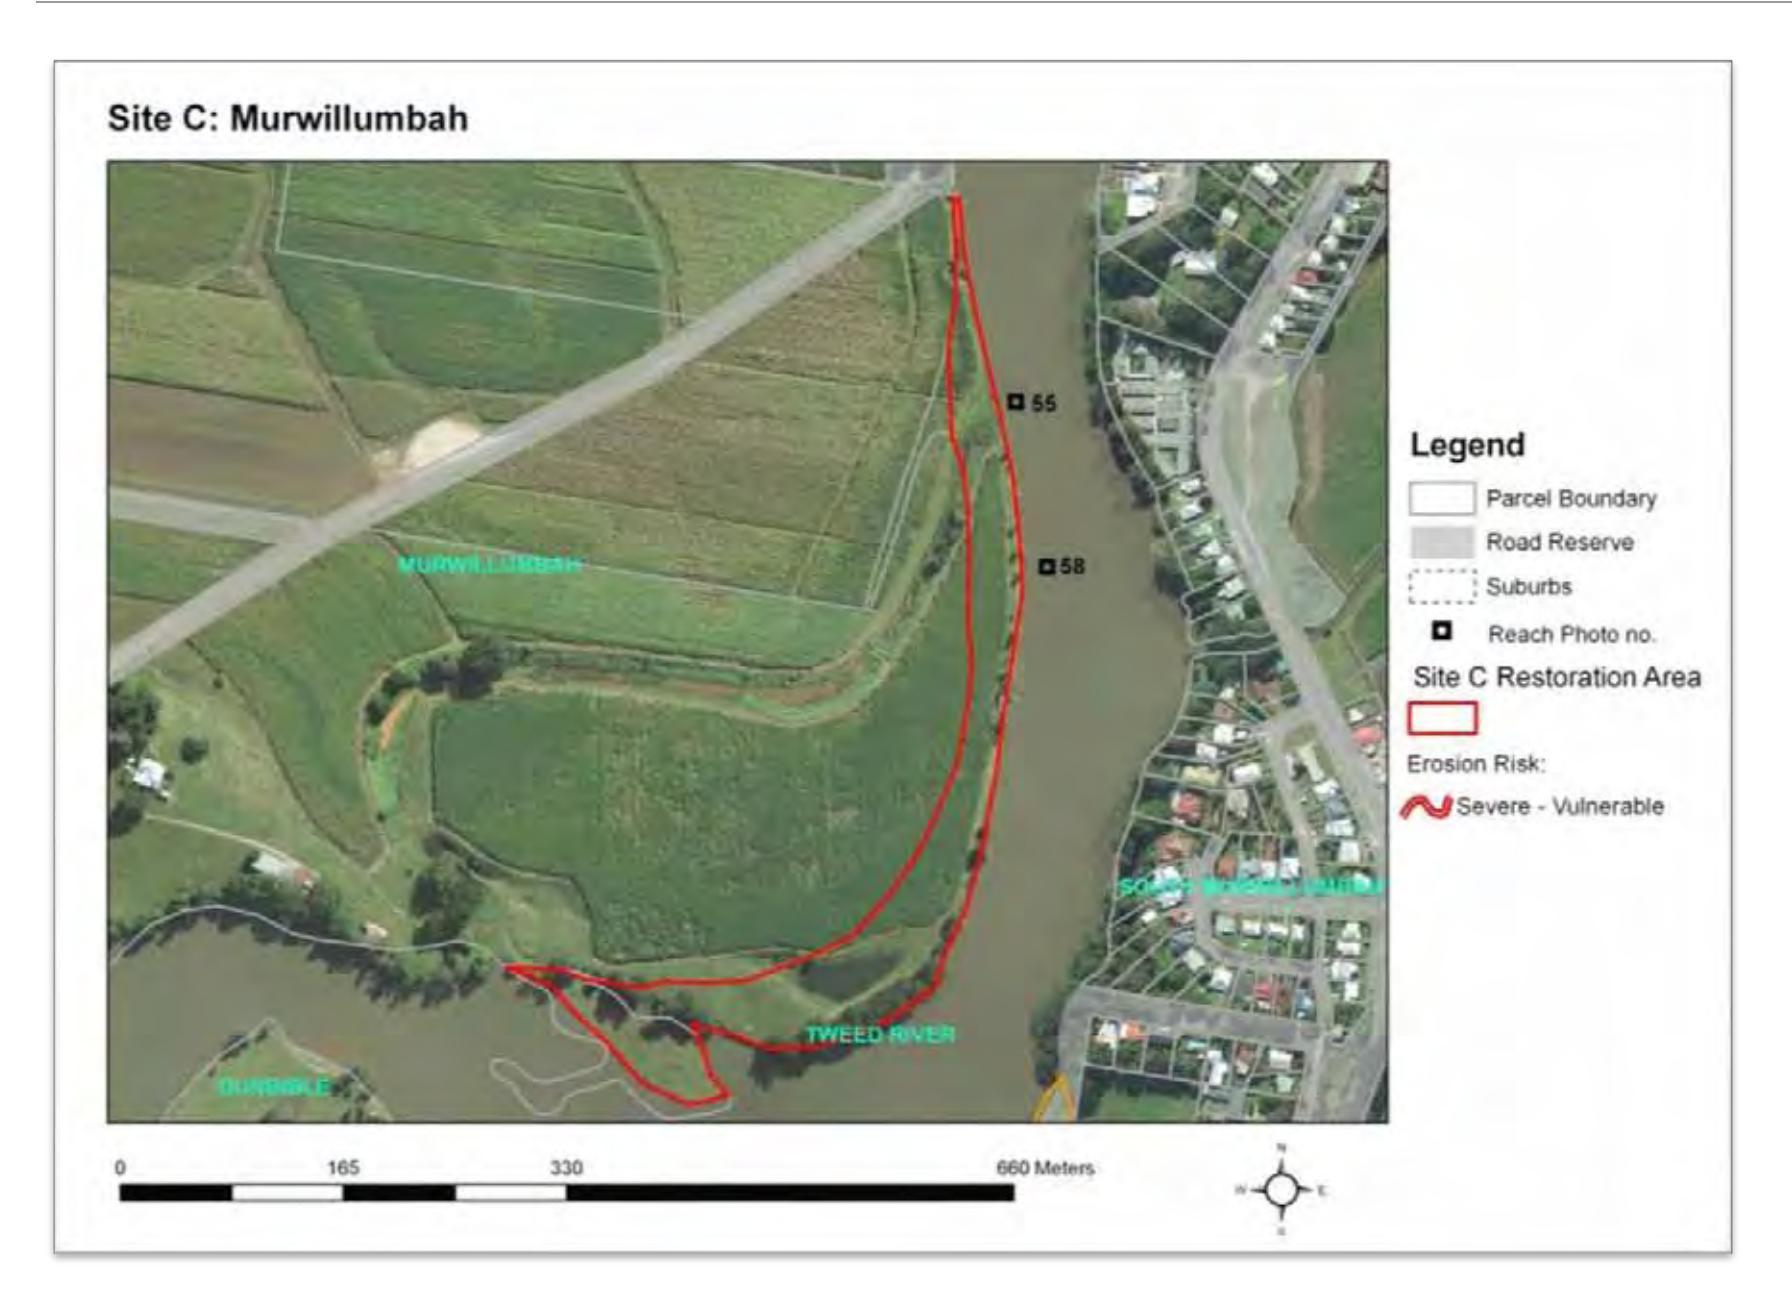
Site C - Bank Restoration Activities

Length (m)	1000m
Width (m)	Up to 65m
Area m ²	34,500
Bank height (m)	1-4
Erosion Risk	Severe along most of site with some areas of mass failure (slumping).
	Vulnerable along low-lying upstream section of site.
Tenure	Crown Land (waterway) and small area of TSC Crown Land
Restoration activity and priority	Revegetation. High priority over the long term due to large area of Crown Land available.
Constraints/opportunities	Narrow riparian zone, mostly less than 7m to existing cane headland.
	 Bank is slumping in sections, and may require battering to stabilise.

• Camphor laurel on bank at bend in river in process of being undercut, these
	could be progressively removed to allow native regrowth.
	• This is a large area of Crown waterway with extensive area of cane under
	cultivation by two adjacent landowners. Requires consultation prior to
	restoration planning.
Photo 55 – looking upstream	Photo 58 – showing bank slump with cane land on top of bank.

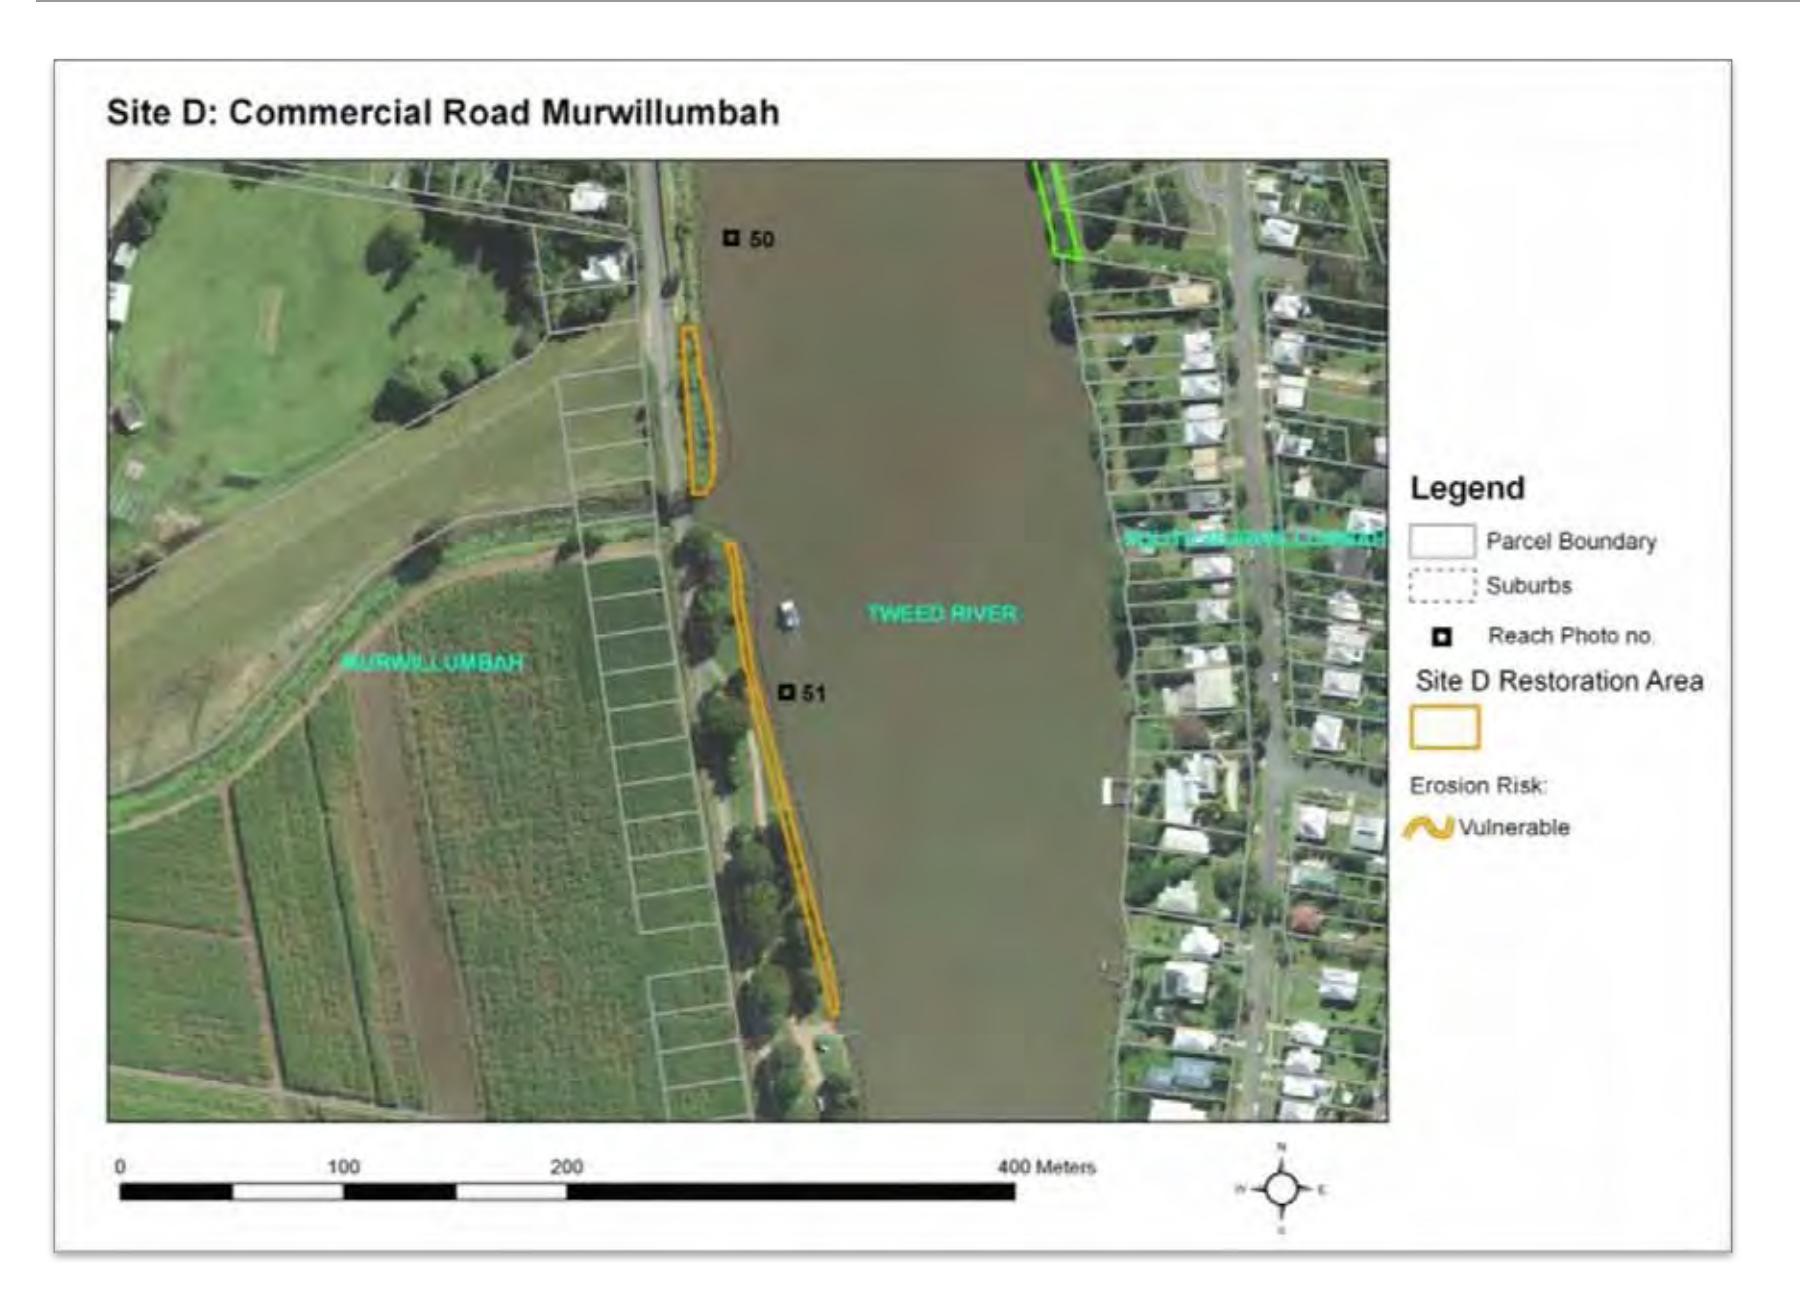
Site D - Bank Restoration Activities

Length (m)	285m
Width (m)	7-10m
Area m ²	1335
Bank height (m)	~1.0
Erosion Risk	Vulnerable, recent slumping as bank continues to become undercut.
Tenure	Road Reserve
Restoration activity and priority	Rock toe revetment and investigate potential for fillets. High priority as bank continues to erode.
Constraints/opportunities	 Existing rock revetment along toe at upstream end of site (towards boat ramp) may be adequate to protect bank. Limited width for revegetation due to car parking/public recreation space
	 Requires detailed design which maximises opportunities to incorporate vegetation.
	 Investigate appropriateness of revegetation inside of levy wall to Murwillumbah Bridge (not mapped as part of this study).
Photo 50 – rock revetment of slump downstream of site D	Photo 51 – active bank erosion adjacent to boat ramp.

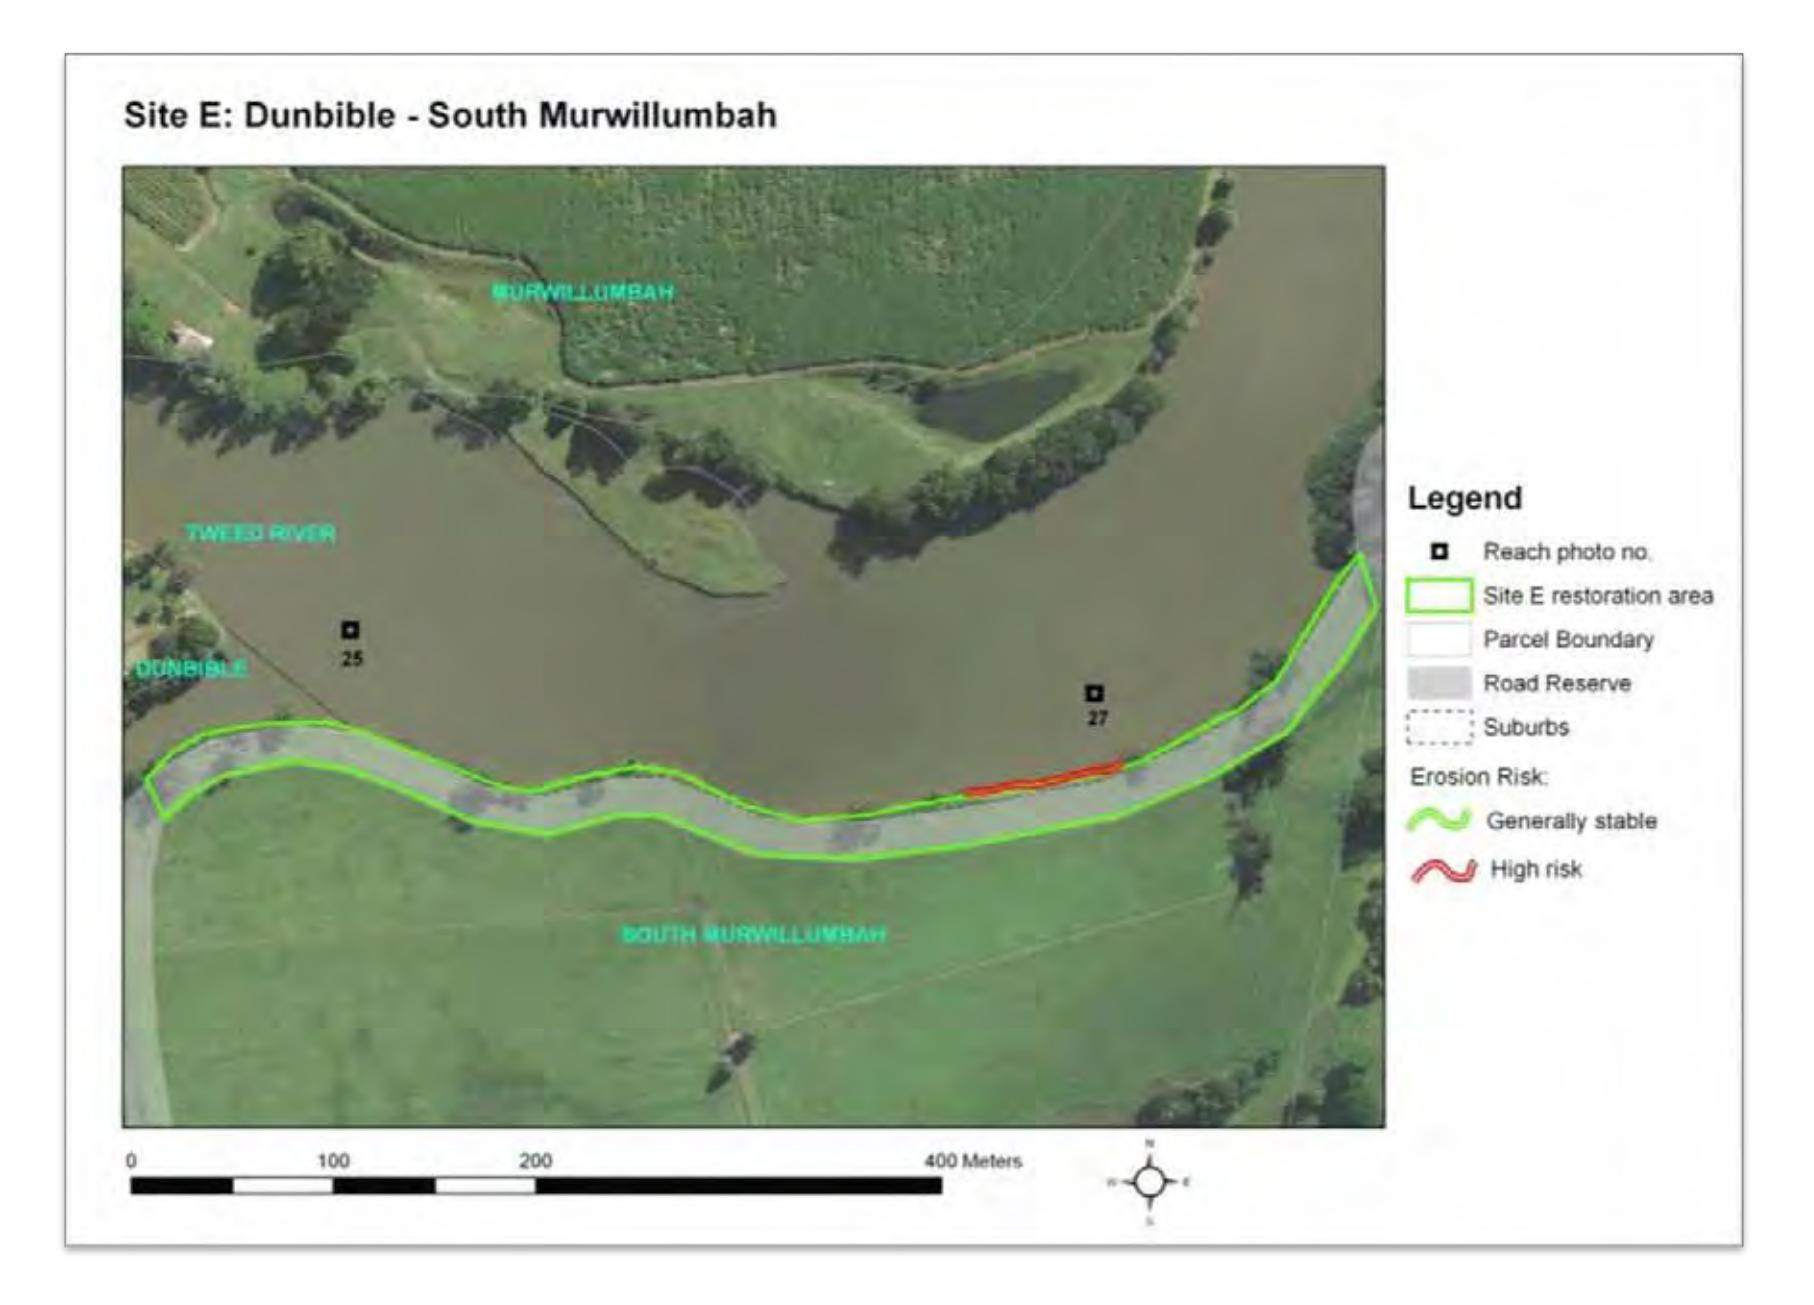
Site E - Bank Restoration Activities

Length (m)	600m
Width (m)	20m
Area m ²	14,194
Bank height (m)	1-4
Erosion Risk	Generally stable, 70m section of severe erosion (photo 27 below)
Tenure	Road Reserve
Restoration activity and priority	Revegetation. High priority.
Constraints/opportunities	 Negotiate with adjacent landowner for stock exclusion fencing.
	 Investigate impact on views from Art Gallery.
	 Battering could help stabilise eroding section of bank.
	 Road reserve ~20m wide, revegetation could be undertaken in stages.
Photo 25 – Site E right bank	Photo 27 – active bank erosion

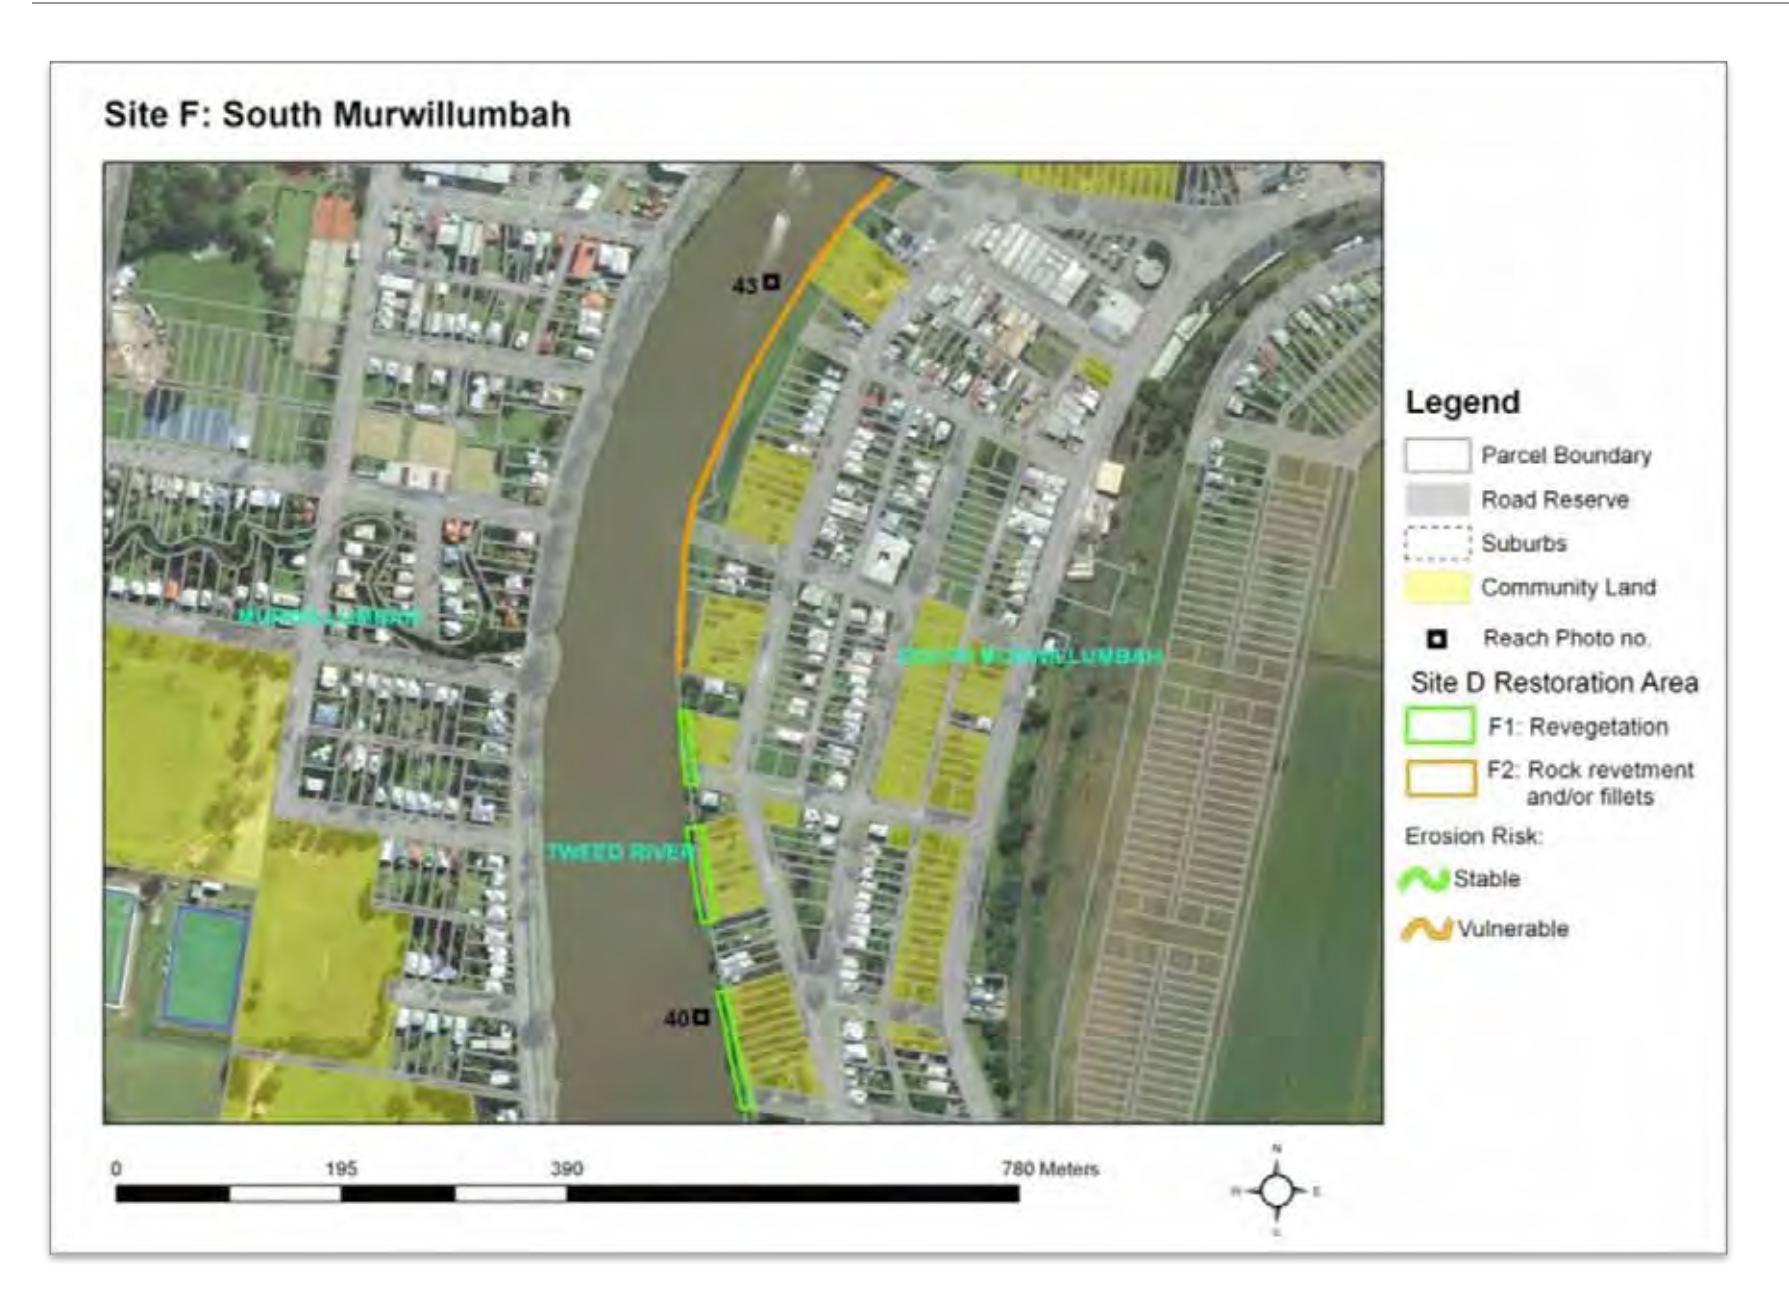
Site F - Bank Restoration Activities

Width (m) ~10m Area m ² 5735 Bank height (m) ~1.0 Erosion Risk Generally stable - vulnerable Tenure Community Land (Tweed Shire Council), Crown Waterway Restoration activities and priority Revegetation in upstream areas: Medium Priority. Rock revetment/fillets along bank adjacent to levy bank: Medium priorit Constraints/opportunities • Sections of bank are slumping along this reach - requires in need/potential for battering or rock revetment. • Tidal bench present along lower section of this site, investigate roc • Potential to revegetate riverside of levy bank, consult with Council • Requires consultation with South Murwillumbah community (revimpact on access/views). • Requires consultation with South Murwillumbah community (revimpact on access/views).	
Area m ² 5735 Bank height (m) ~1.0 Erosion Risk Generally stable - vulnerable Tenure Community Land (Tweed Shire Council), Crown Waterway Restoration activities and priority Revegetation in upstream areas: Medium Priority. Rock revetment/fillets along bank adjacent to levy bank: Medium prioriti Constraints/opportunities • Sections of bank are slumping along this reach - requires in need/potential for battering or rock revetment. • Tidal bench present along lower section of this site, investigate roc • Potential to revegetate riverside of levy bank, consult with Council • Requires consultation with South Murwillumbah community (revimpact on access/views). • Requires consultation with South Murwillumbah community (revimpact on access/views).

Rock revetment/fillets along bank adjacent to levy bank: Medium priori Constraints/opportunities • Sections of bank are slumping along this reach - requires need/potential for battering or rock revetment. • Tidal bench present along lower section of this site, investigate roc • Potential to revegetate riverside of levy bank, consult with Council • Requires consultation with South Murwillumbah community (revimpact on access/views). • Impact on access/views).	
 Constraints/opportunities Sections of bank are slumping along this reach - requires need/potential for battering or rock revetment. Tidal bench present along lower section of this site, investigate roc Potential to revegetate riverside of levy bank, consult with Council Requires consultation with South Murwillumbah community (revimpact on access/views). 	ty.
	investigation of k fillet potential. engineers. vegetation may
Photo 40 – Site E1 showing slump at drain outlet

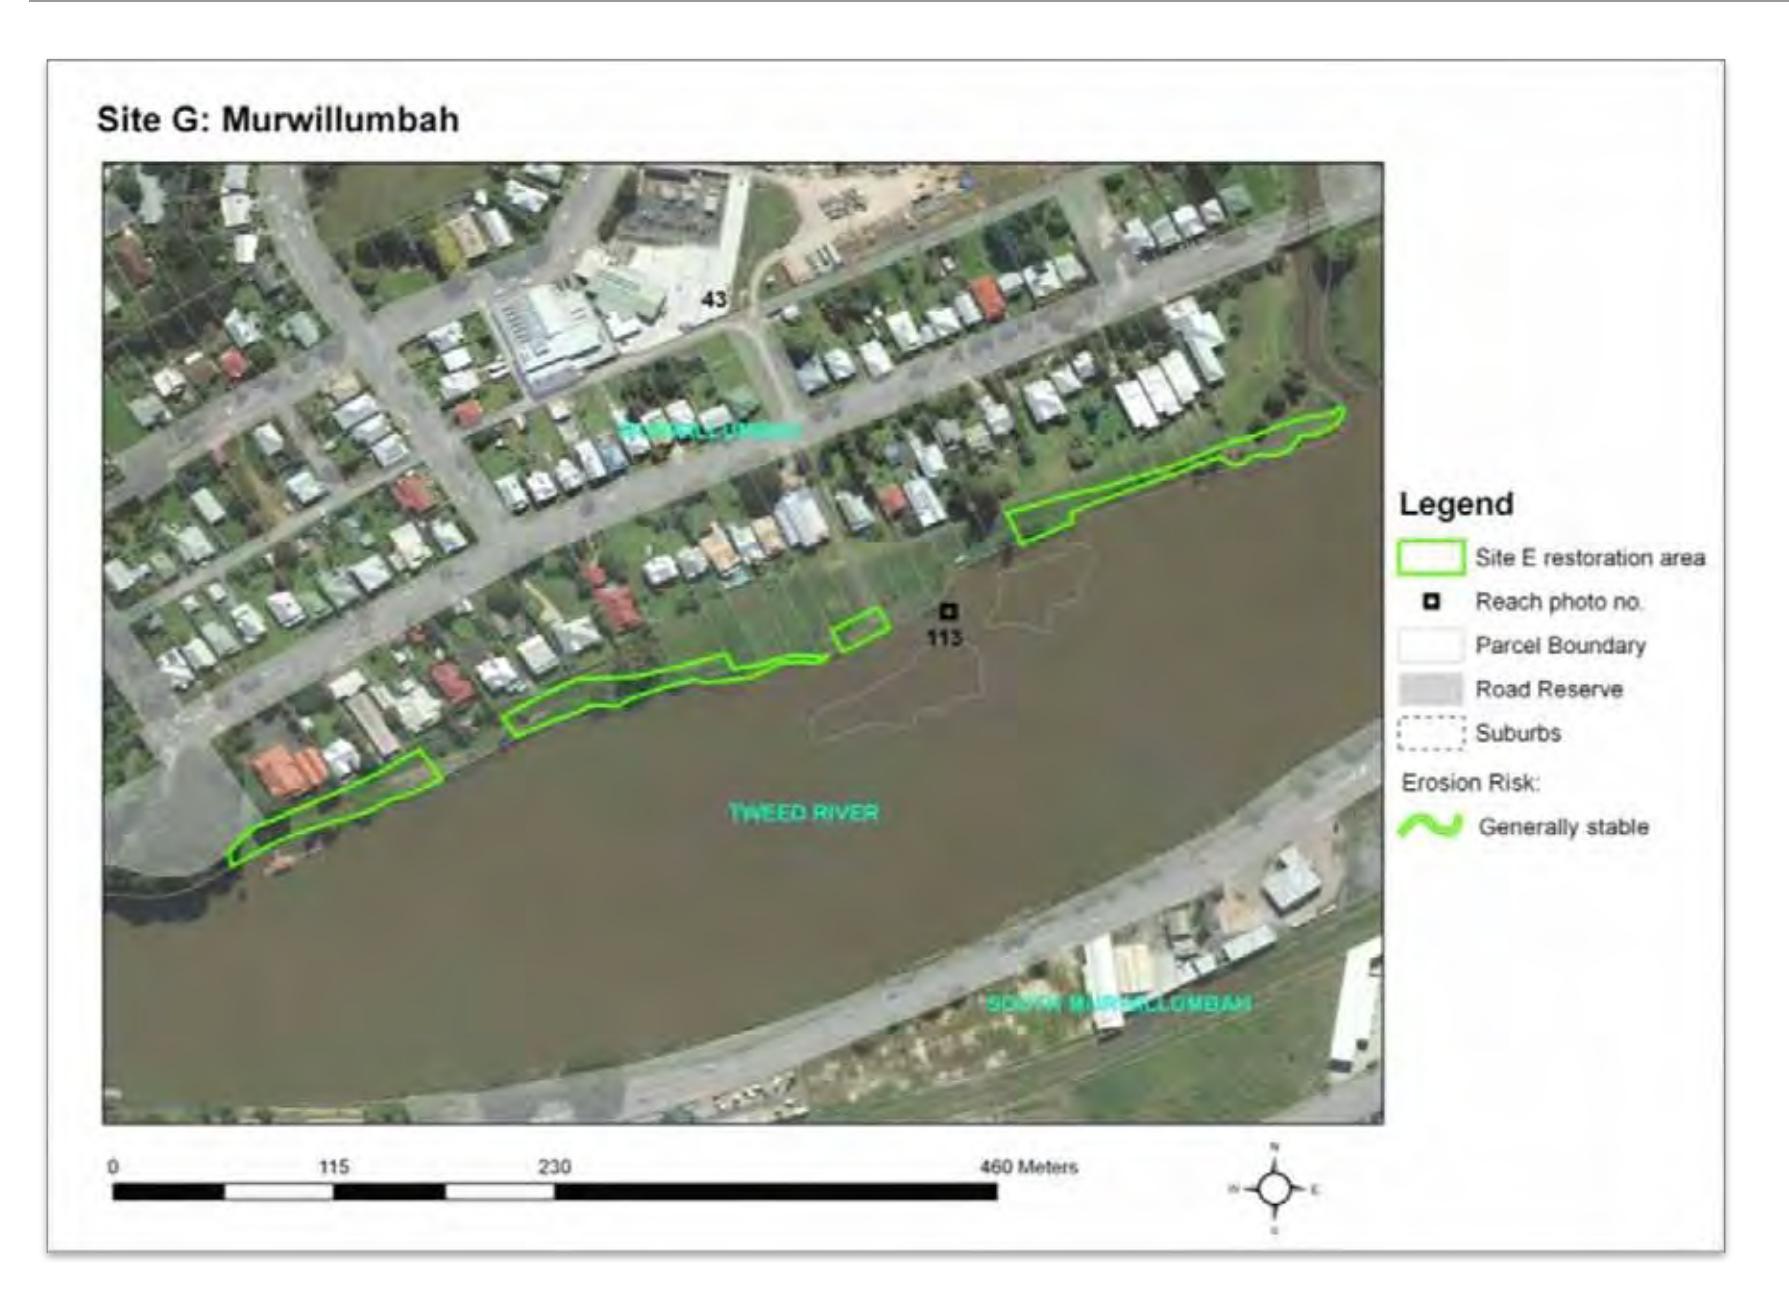
Site G - Bank Restoration Activities

Length (m)	445 (combined)
Width (m)	7-15
Area m ²	5200
Bank height (m)	~1.0
Erosion Risk	Generally stable with minor erosion along the bank toe
Tenure	State Crown
Restoration activity and priority	Rock revetment +/- fillets +/- revegetation.
	Low priority unless erosion becomes worse.
Constraints/opportunities	• Revegetation could block views and river access of adjacent houses, therefore low potential
	for planting trees.
	 Possible to batter and stabilise with lomandra/phragmites in higher risk areas.
	• Tidal bench along much of this reach, potential to stabilise bank toe with rock revetment
	and/or install rock fillets.
	Crown Lands licence required for environmental enhancement structures (e.g. rock fillets).
Photo 113 – showing minor erosion along bank toe
