Tweed Riverbank Erosion Management Plan 2014

TWEED SHIRE COUNCIL | TOGETHER FORWARD

The purpose of the Tweed River Estuary Bank Management Plan 2014 is to provide a schedule of works to stabilise riverbank erosion on public land (to be undertaken by Council), as well as updated design advice for works required on private land.

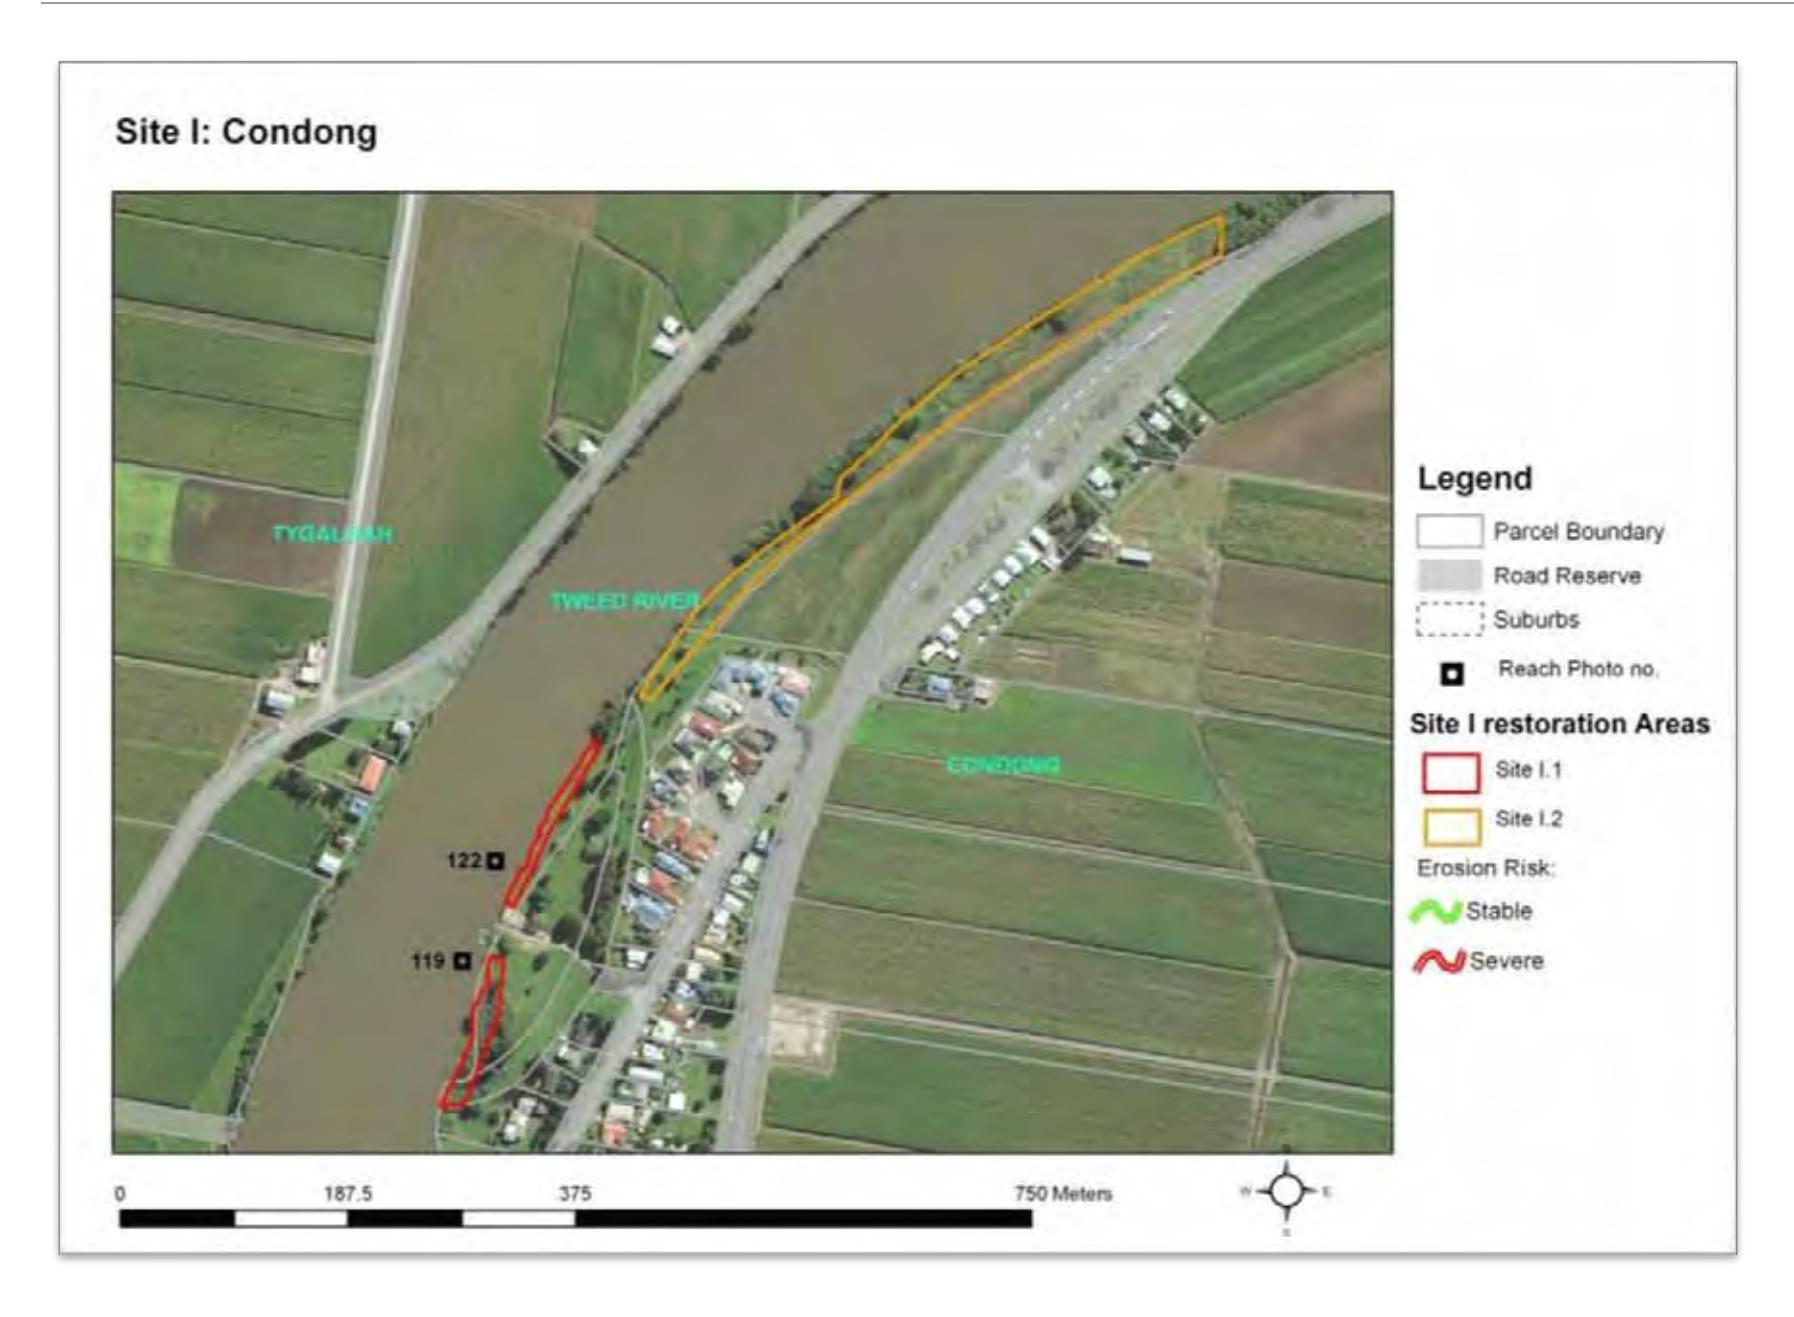
Site I - Bank Restoration Activities

Length (m)	900 (combined)
Width (m)	7-25
Area m ²	19019
Bank height (m)	<1-3
Erosion Risk	High risk / severe particularly downstream of boat ramp. Vulnerable (undercutting) in downstream site I.2.
Tenure	TSC Crown Land (Public Recreation Reserve) and Waterway (Crown Land)
Restoration activities and priority	Toe revetment and rock fillets. High
	Requires detailed design which maximises opportunities to incorporate vegetation.
Constraints/opportunities	• Erosion severe along recreation reserve bank. Investigate battering/fillets potential. Need approval
	from Manager Recreation Services + community consultation.
	 Revetment is required in association with planting and a trial of rock fillets upstream of the pontoon.

• Downstream area I.2 adjacent to cane land has high restoration potential. Mangroves line the bank
	along most of this zone, loss of sediment around roots. Potential revegetation/buffer zone of 1.35ha
	up to 25m wide.
Photo 119 – bank toe erosion above boat ramp	Photo 122 – bank toe erosion downstream of boat ramp

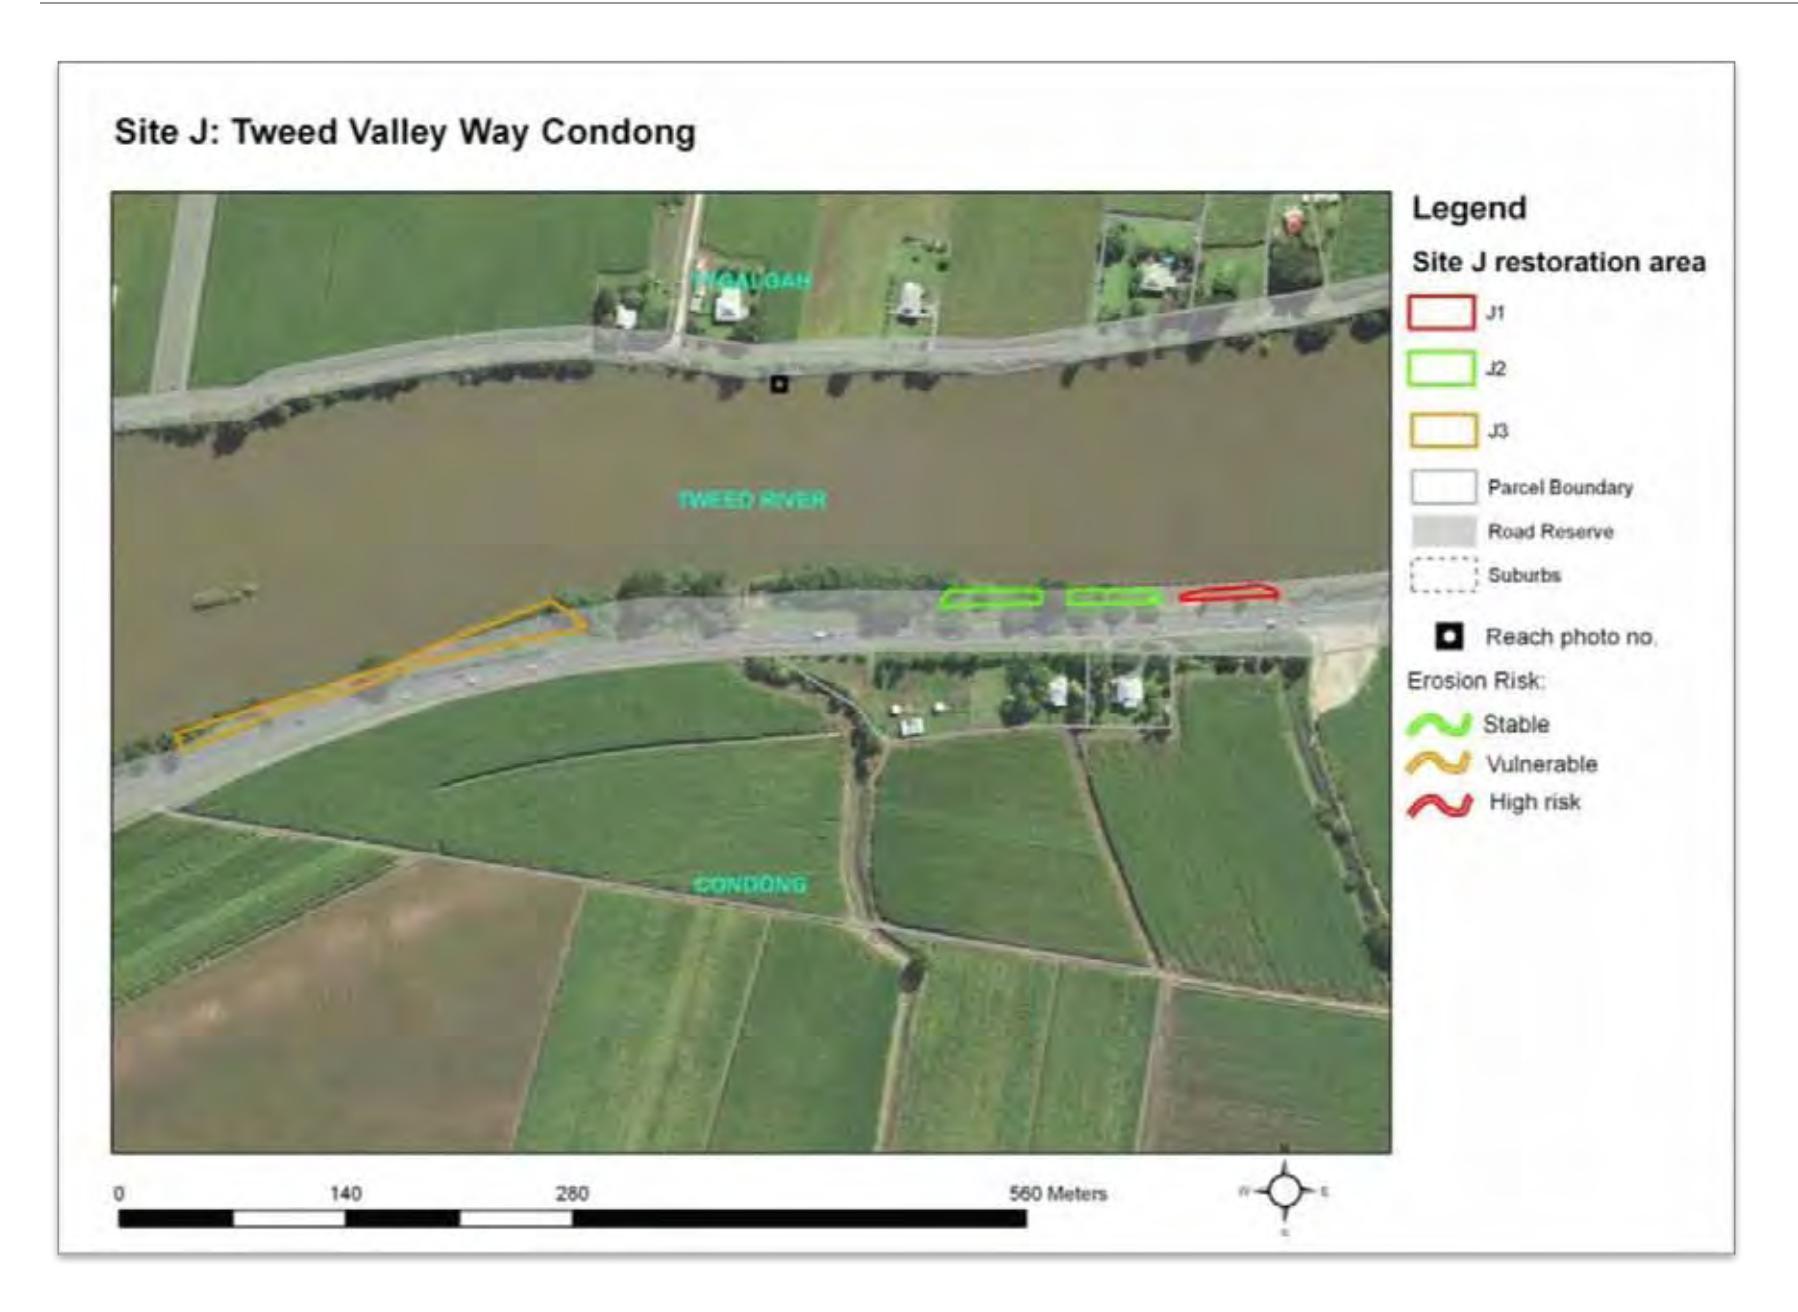
Site J - Bank Restoration Activities

Length (m)	415 (combined)
Width (m)	7-20
Area m ²	3778
Bank height (m)	<1-3
Erosion Risk	Bank is vulnerable to erosion along most of Site J, stable where cottonwoods are along
	bank toe, area of severe erosion between flood gates.
Tenure	TSC Road Reserve
Restoration activities and priority	Revegetation. Moderate priority due to narrow extent between River and Tweed Valley
	Way and weedy condition of vegetation.
Constraints/opportunities	 Potential to increase cottonwoods along the lower bank.
	Good linkage to Condong Site I.
	· Generally these areas are very weedy. Mangroves and cotton woods exist
	throughout site.
	 Powerlines along Road side needs to be accounted for in site plans.
Photo 129 – bank undercutting increases risk of failure especially	Photo 134 – Bahna grass provides some bank protection but does not protect bank from
where camphor laurel occur.	slumping if toe is eroding.
	·

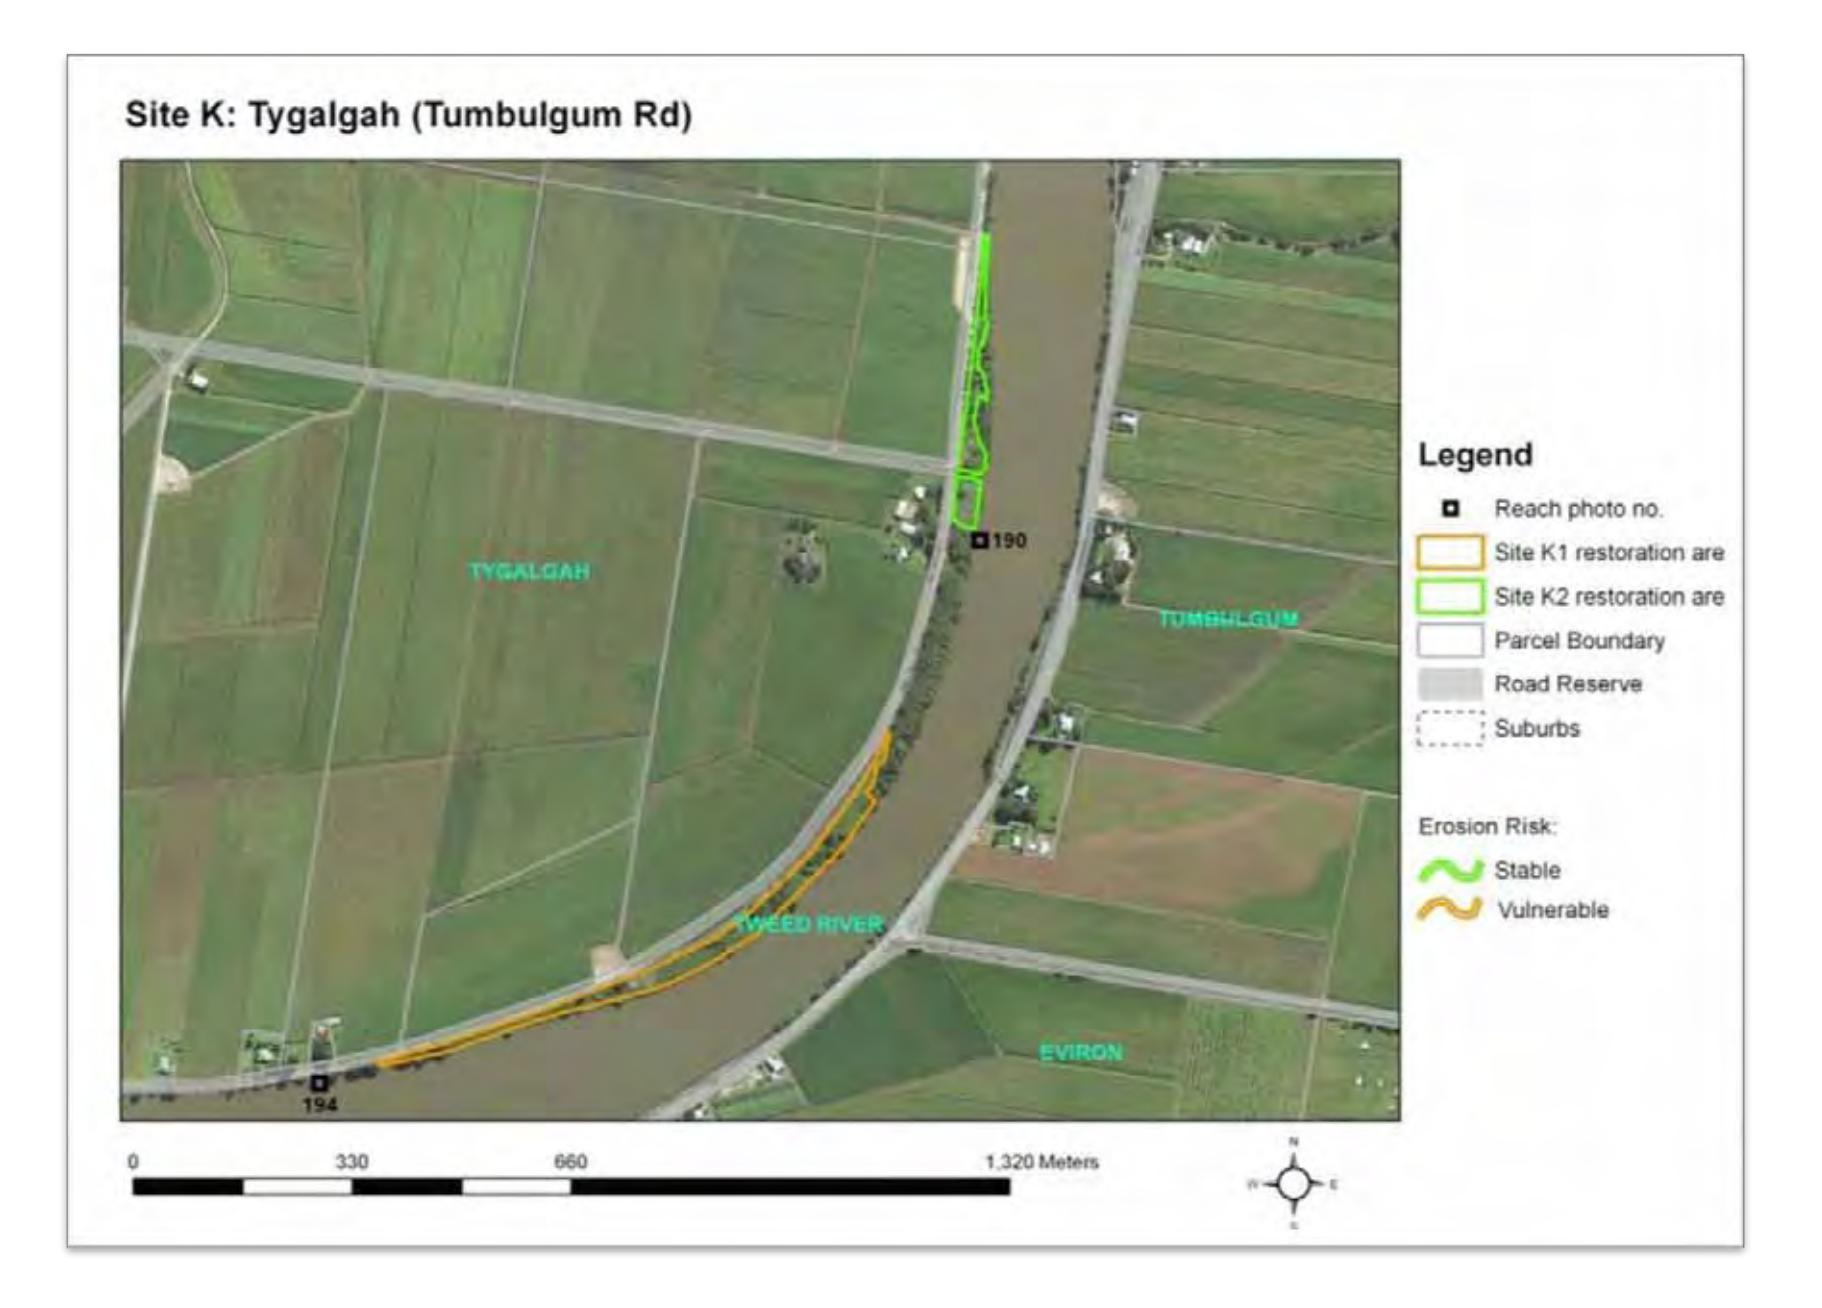
Site K - Bank Restoration Activities

Length (m)	1385 (combined)
Width (m)	7-30
Area m ²	29020
Bank height (m)	<1.0 – 2m
Erosion Risk	Bank is vulnerable to erosion along upstream site and stable, protected by mangrove
	and phragmites on downstream site.
Tenure	Waterway (Crown Land)
Restoration activities and priority	Revegetation. High Priority. Good width available, the most significant reach of
	mangroves upstream of Stotts Island. Existing vegetation (except mangroves) is very
	weedy.
Constraints/opportunities	• Priority revegetation site due to length and width and buffer to mangrove habitat.

• Area upstream of site is experiencing bank failure and there is a narrow area
	between River and Tumbulgum Rd, little opportunity to batter. Investigate fillets and
	bank revetment.
	 Potential view blockage issues in Site K1 opposite homestead.
Photo 190 – Mangroves along reach.	Photo 194 – bank erosion immediately upstream of site (note this area is too narrow to revegetate and may require alternative approaches (fillets and or toe revetment).

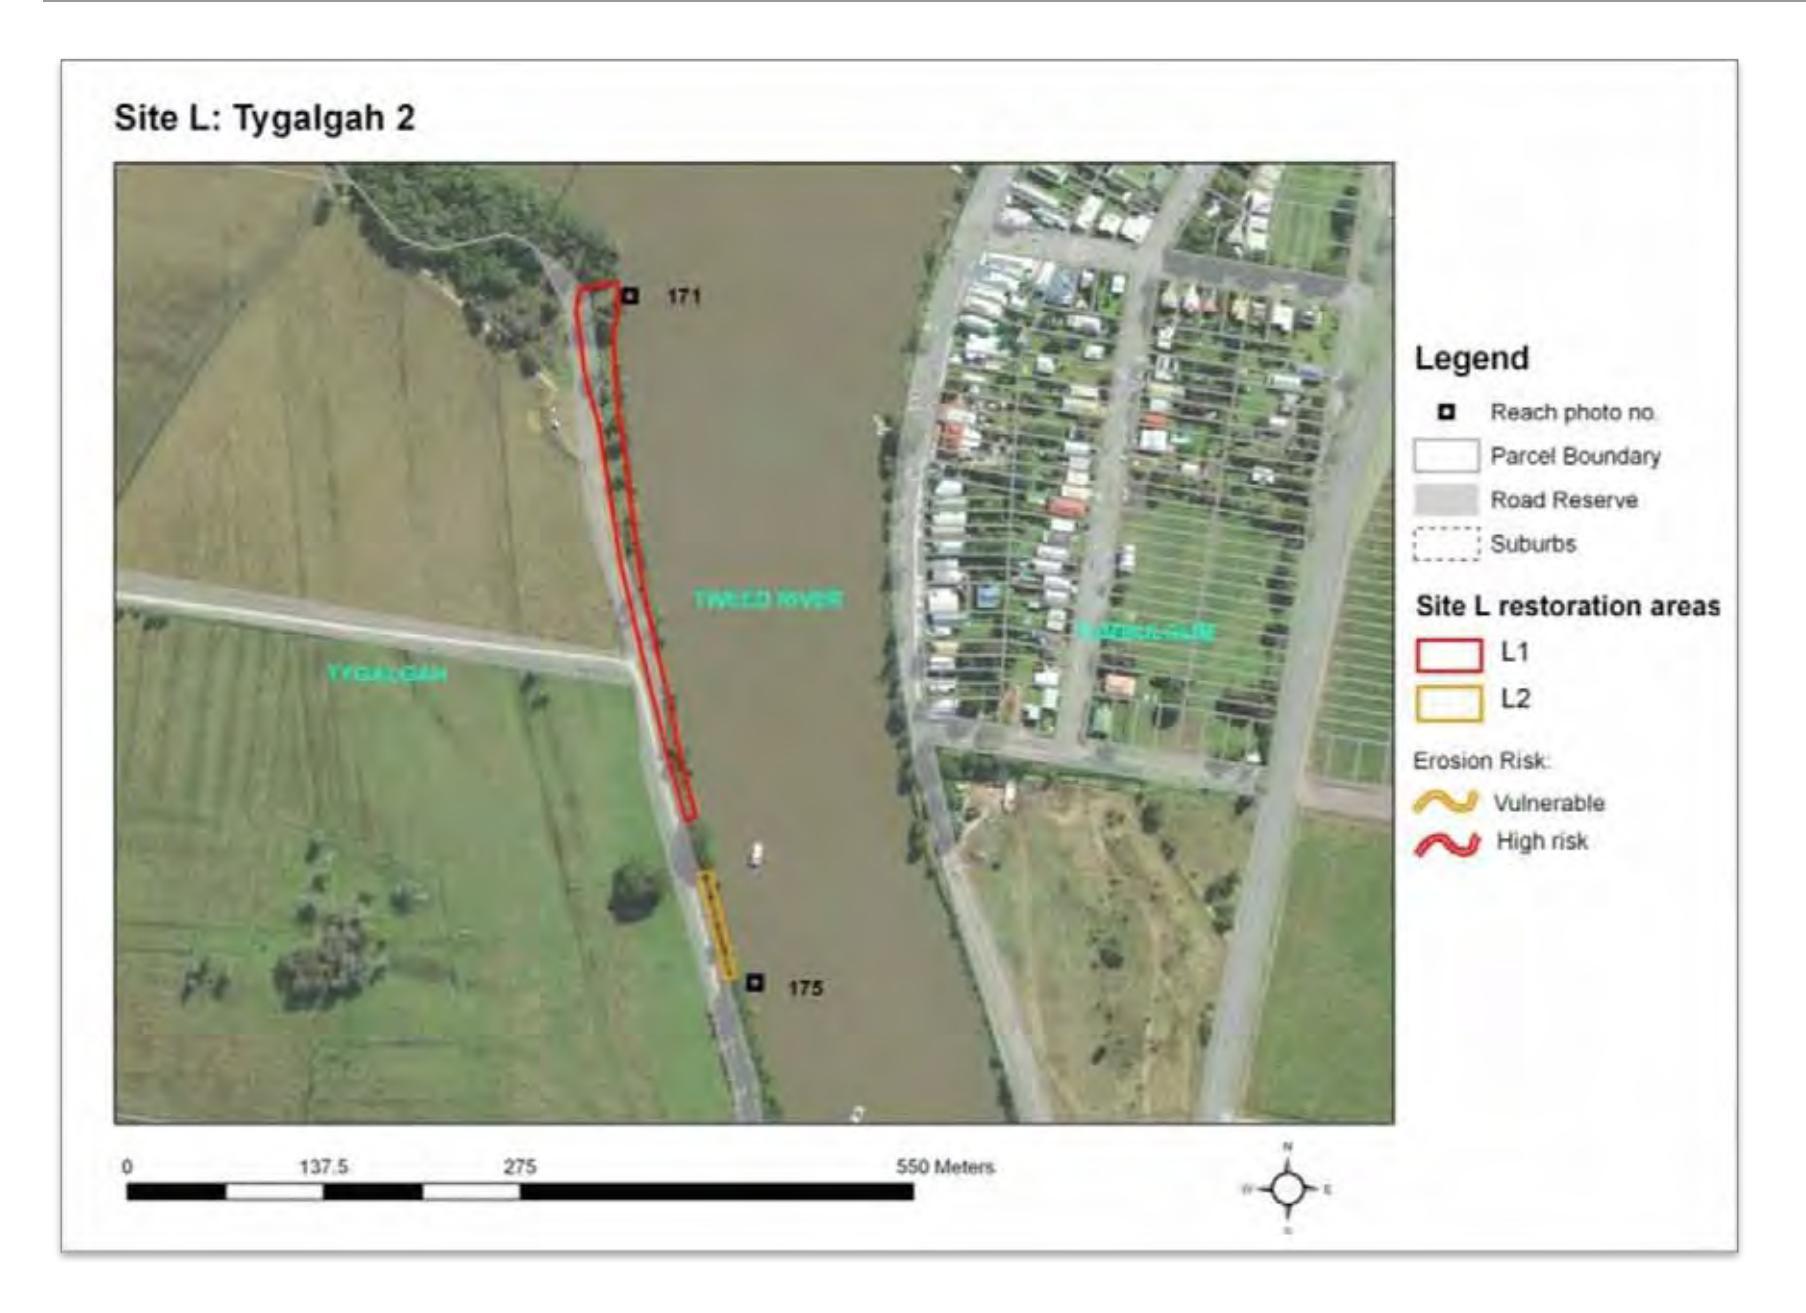
Site L - Bank Restoration Activities

Length (m)	455 (combined)
Width (m)	7-30
Area m ²	5946
Bank height (m)	<1-3
Erosion Risk	Active and recent erosion of the low bank, which is vulnerable to ongoing damage of
	mangrove root systems by waves and cattle.
Tenure	Road Reserve & Waterway (Crown Land)
Restoration activities and priority	Revegetation and stock exclusion fencing. High priority.
Constraints/opportunities	• Good width available, especially on the downstream reach. Good connectivity to
	mangroves at Rous River mouth.
	• Camphor laurels are present along much of this reach, being undercut which may
	lead to eventual collapse.
	Site requires fencing, consult with land manager.
Photo 171- Downetream site L bank erosion possibly evacerbated	Deta 175 appropriate laural along bank abouing underguting (apto photo taken at high
by grazing.	
- , <u>g</u>

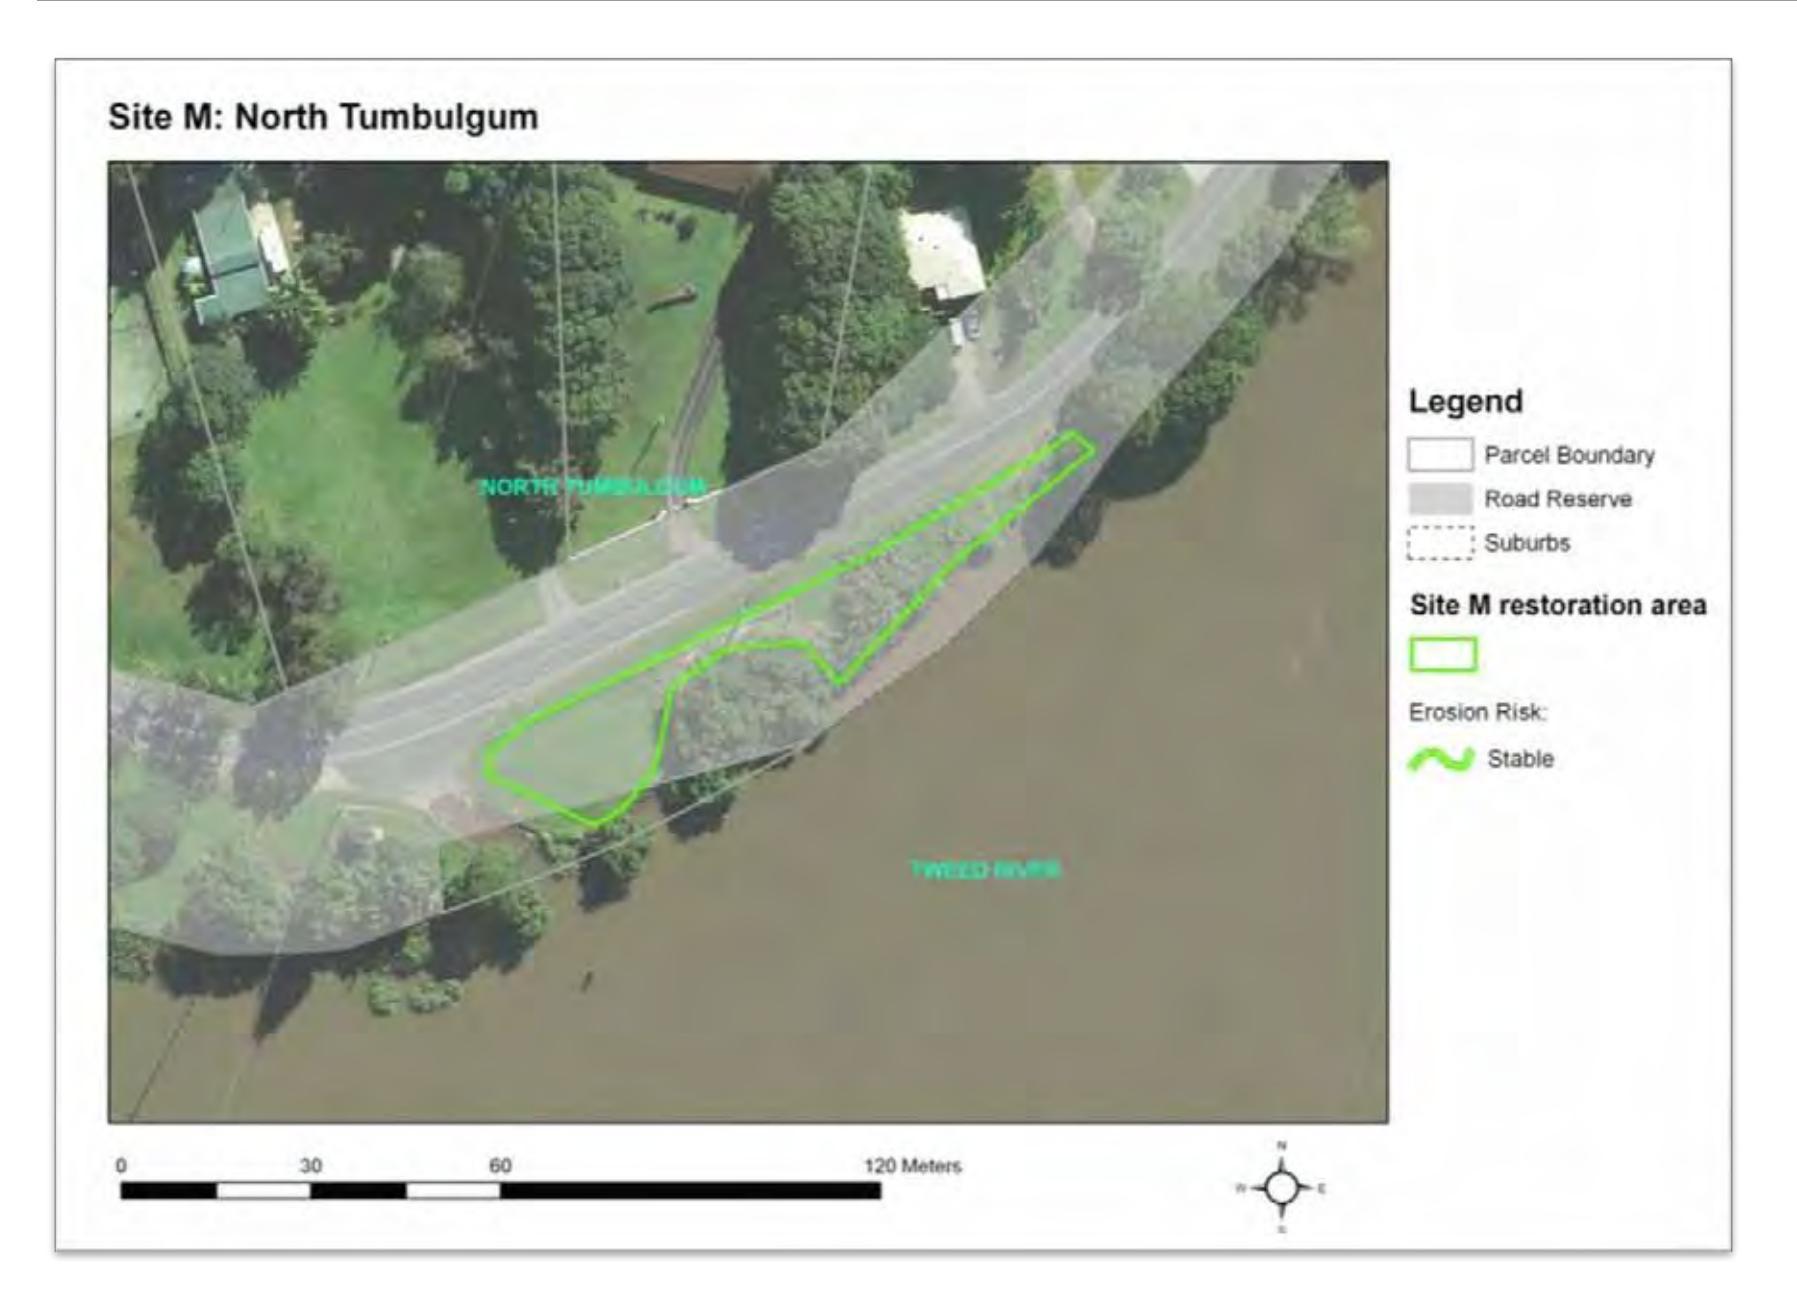
Site M - Bank Restoration Activities

Length (m)	100
Width (m)	7-20
Area m ²	1013
Bank height (m)	<1-3
Erosion Risk	Bank is fairly stable due to mangrove protection of toe, however recent erosion is occurring in the
	downstream edge of this area and further along the bank downstream to Tumbulgum Bridge.
Tenure	Road Reserve
Restoration activities and priority	Revegetation Medium-Low priority. Small area.
Constraints/opportunities	• Very narrow riparian area between river and road on bank experiencing severe erosion downstream of this site.

• Battering may help stabilise area in photo below. Broad tidal bench would allow rock fillets, bedrock exposed downstream of this site.
Photo 267– Bank erosion on downstream end of this s	site.
