# Tweed River Bank Erosion Management Plan 2014

The purpose of the Tweed River Estuary Bank Management Plan 2014 is to provide a schedule of works to stabilise river bank erosion on public land (to be undertaken by Council), as well as updated design advice for works required on private land.

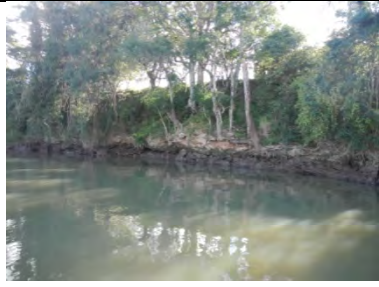
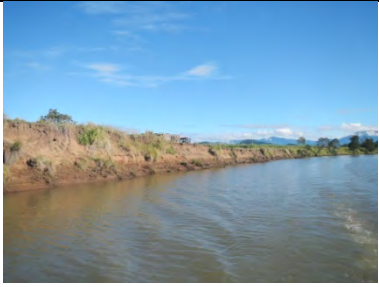
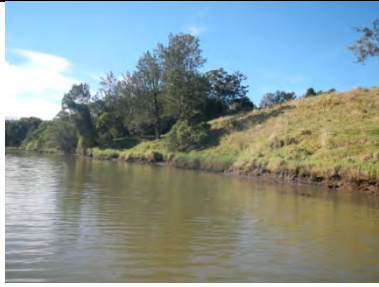
Stable bank with bedrock toe, upper estuary.	Eroding bank adjacent to farmland, up-stream of Murwillumbah.	Stable bank, with poor riparian vegetation, adjacent to grazing land upstream of Murwillumbah.

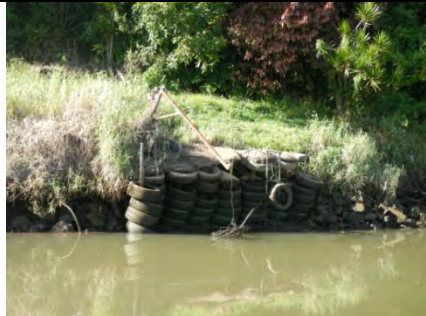
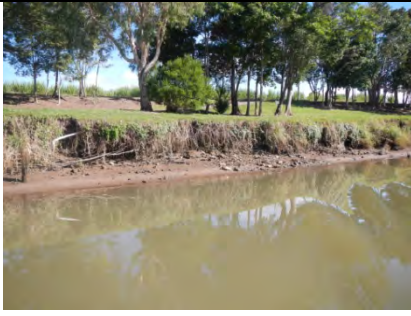
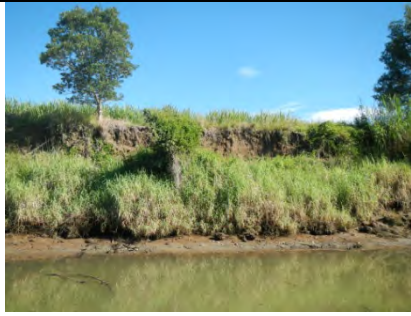
Failing private revetment structure, Murwillumbah.	Erosion adjacent to parkland, Commercial Road boat ramp	Large bank slump adjacent to cane land (on public land), upstream of Murwillumbah.

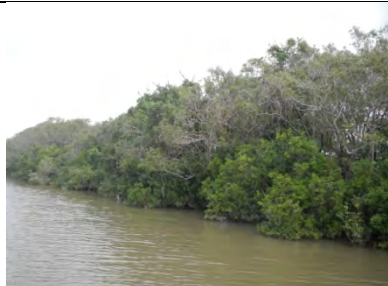
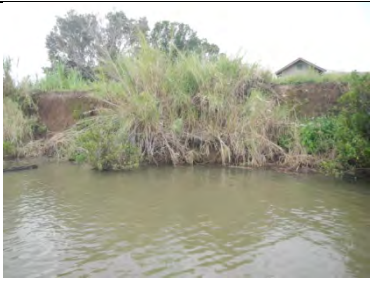
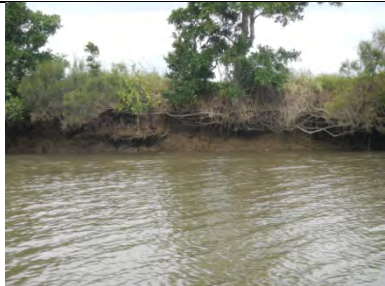
Good quality riparian vegetation at Tygalgah.	Large block failure adjacent to Tumbulgum Road, Condong.	Under cut banks adjacent to Tweed Valley Way near Tumbulgum.

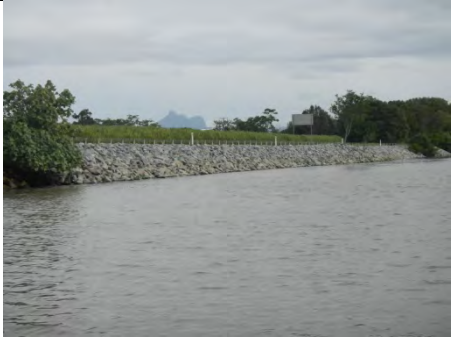
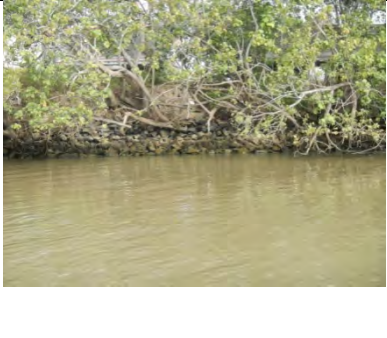
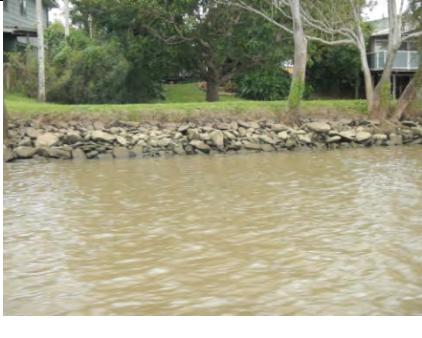
<p>Full height bank revetment Tweed Valley Way.</p>	<p>Cotton woods and stable 'historic' small diameter bank toe revetment on Tweed Valley Way near Stott's Island.</p>	<p>Well constructed revetment on low bank adjacent to private property.</p>

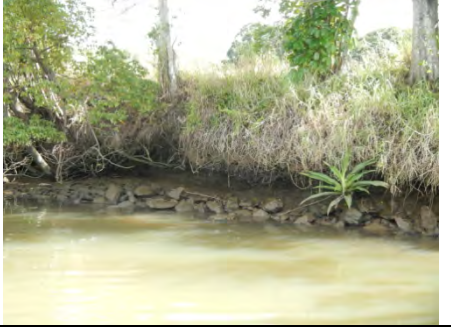
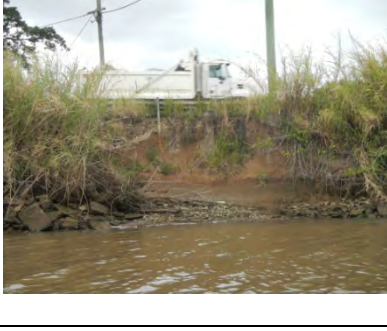
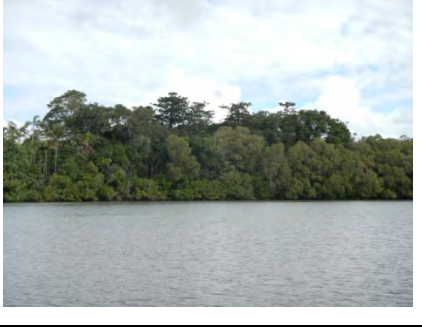
<p>Under cut bank and failed small diameter 'historic' bank revetment Tweed Valley Way.</p>	<p>Severe bank erosion immediately adjacent to the Tweed Valley Way.</p>	<p>Stott's Island.</p>

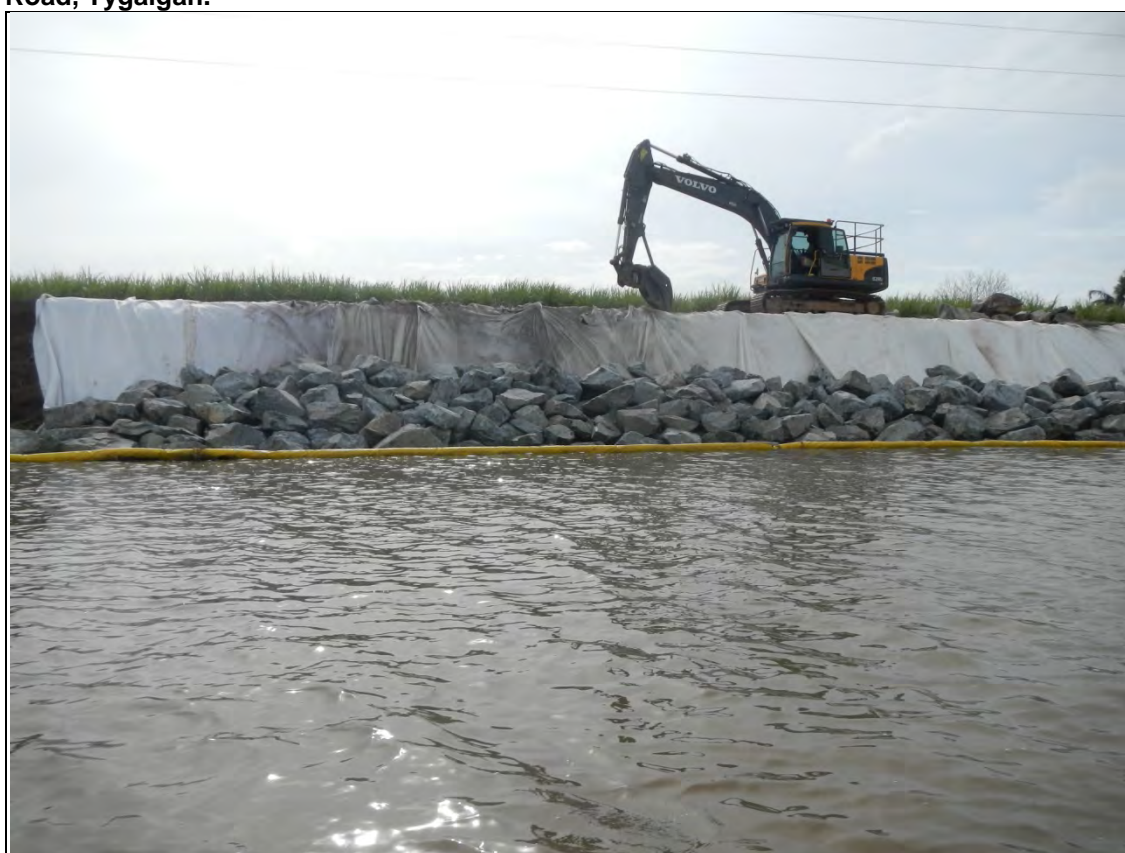
**Figure 2. Reactive river bank erosion stabilisation works being constructed adjacent to Tumbulgum Road, Tyngalga.**

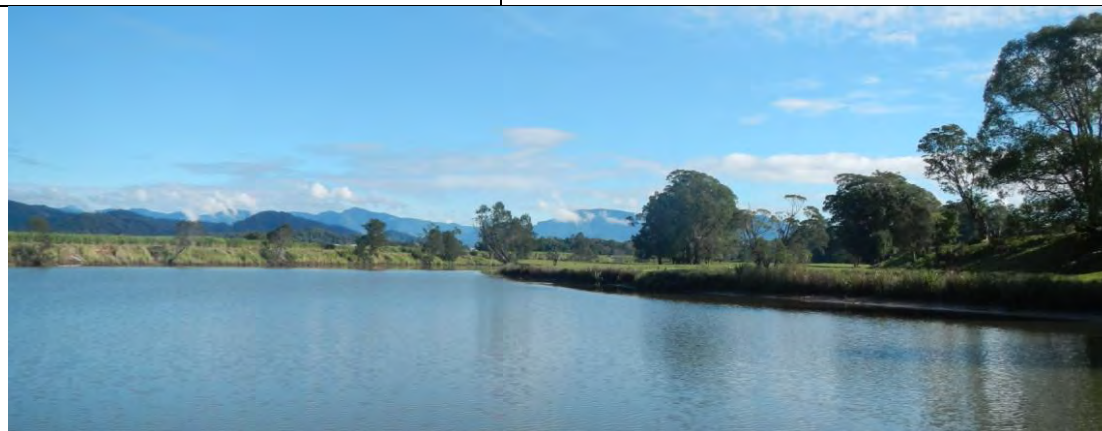
Length (m)	750m
Width (m)	Up to 100m
Area m <sup>2</sup>	50,837
Bank height (m)	1-2
Erosion Risk	Stable with some minor undercutting becoming worse towards downstream end of site.
Tenure	Crown Land (waterway)
Restoration activity and priority	Revegetation. High priority over the longer term given it is the largest floodplain in study area under Crown ownership.
Constraints/opportunities	<ul style="list-style-type: none"> <li>• Very large area to revegetate (5+ ha).</li> <li>• Currently grazed by adjacent landowner.</li> <li>• Potential for vegetation to increase flows to opposite vulnerable bank (Site B).</li> <li>• Detailed restoration plan required.</li> </ul>

Photo 08– looking upstream, site A located on the floodplain at right of photo.

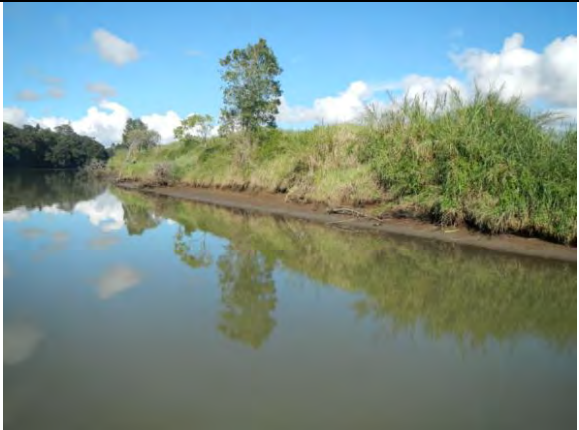
Length (m)	1000m
Width (m)	Up to 65m
Area m <sup>2</sup>	34,500
Bank height (m)	1-4
Erosion Risk	Severe along most of site with some areas of mass failure (slumping). Vulnerable along low-lying upstream section of site.
Tenure	Crown Land (waterway) and small area of TSC Crown Land
Restoration activity and priority	Revegetation. High priority over the long term due to large area of Crown Land available.
Constraints/opportunities	<ul style="list-style-type: none"> <li>• Narrow riparian zone, mostly less than 7m to existing cane headland.</li> <li>• Bank is slumping in sections, and may require battering to stabilise.</li> <li>• Camphor laurel on bank at bend in river in process of being undercut, these could be progressively removed to allow native regrowth.</li> <li>• This is a large area of Crown waterway with extensive area of cane under cultivation by two adjacent landowners. Requires consultation prior to restoration planning.</li> </ul>

<p>Photo 55 – looking upstream</p>

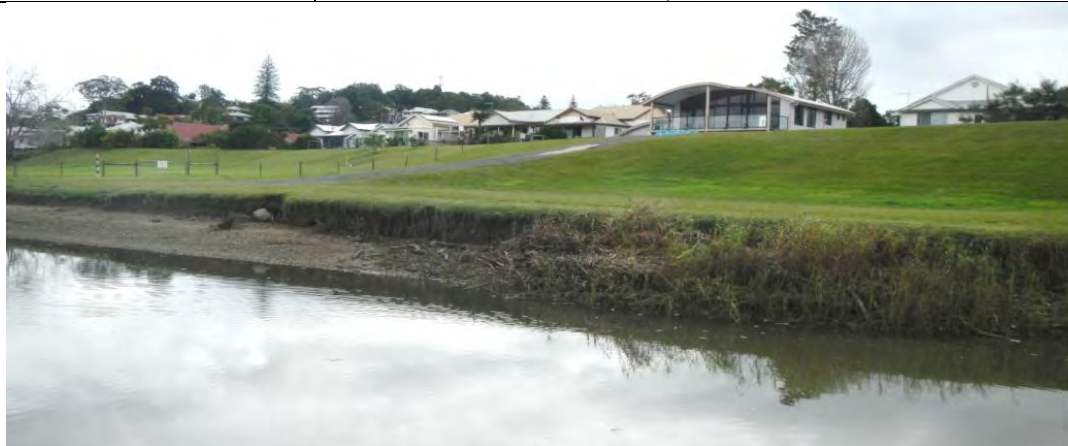
Length (m)	445 (combined)
Width (m)	7-15
Area m <sup>2</sup>	5200
Bank height (m)	~1.0
Erosion Risk	Generally stable with minor erosion along the bank toe
Tenure	State Crown
Restoration activity and priority	Rock revetment +/- fillets +/- revegetation. Low priority unless erosion becomes worse.
Constraints/opportunities	<ul style="list-style-type: none"> <li>• Revegetation could block views and river access of adjacent houses, therefore low potential for planting trees.</li> <li>• Possible to batter and stabilise with lomandra/phragmites in higher risk areas.</li> <li>• Tidal bench along much of this reach, potential to stabilise bank toe with rock revetment and/or install rock fillets.</li> <li>• Crown Lands licence required for environmental enhancement structures (e.g. rock fillets).</li> </ul>

Photo 113 – showing minor erosion along bank toe

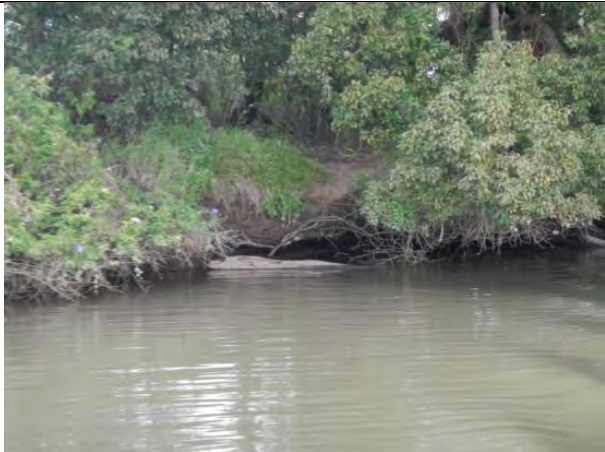
<p>Photo 129 – bank undercutting increases risk of failure especially where camphor laurel occur.</p>

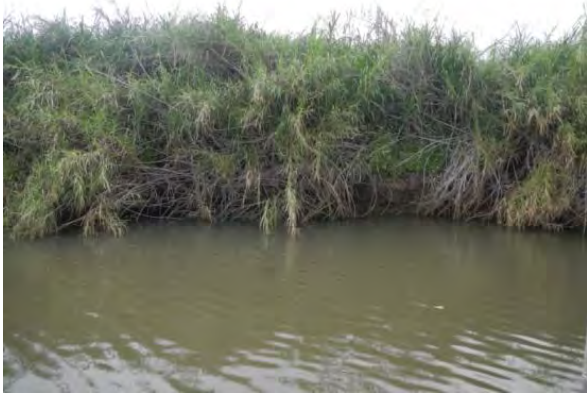
<p>Photo 134 – Bahna grass provides some bank protection but does not protect bank from slumping if toe is eroding.</p>

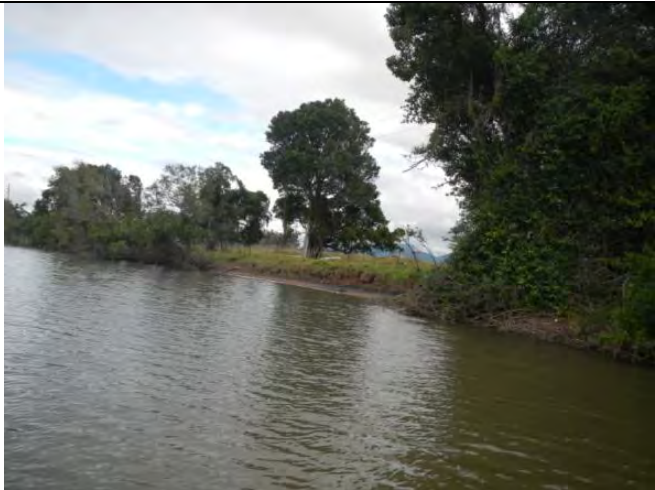
<p>Photo 171– Downstream site J, bank erosion possibly exacerbated by grazing.</p>

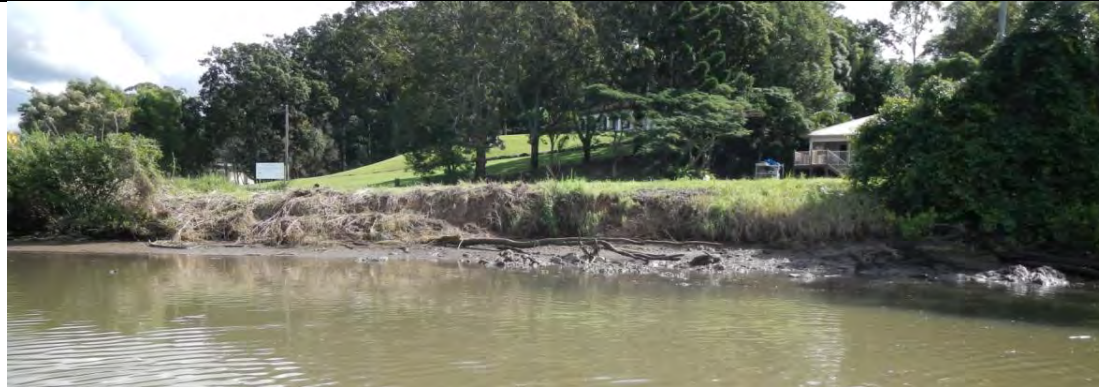
Length (m)	100
Width (m)	7-20
Area m <sup>2</sup>	1013
Bank height (m)	<1-3
Erosion Risk	Bank is fairly stable due to mangrove protection of toe, however recent erosion is occurring in the downstream edge of this area and further along the bank downstream to Tumbulgum Bridge.
Tenure	Road Reserve
Restoration activities and priority	Revegetation Medium-Low priority. Small area.
Constraints/opportunities	<ul style="list-style-type: none"> <li>• Very narrow riparian area between river and road on bank experiencing severe erosion downstream of this site.</li> <li>• Camphor laurels are present along much of this reach, being undercut which may lead to eventual collapse.</li> <li>• Requires discussion with Recreation Services as to status of old boat ramp (fenced off).</li> <li>• Requires consultation with adjacent house owners.</li> <li>• Battering may help stabilise area in photo below. Broad tidal bench would allow rock fillets, bedrock exposed downstream of this site.</li> </ul>

Photo 267– Bank erosion on downstream end of this site.
