# Koala Beach nesting box and Glossy Black-Cockatoo nesting tube monitoring report

Winter 2022

**Tweed Landcare Inc.**

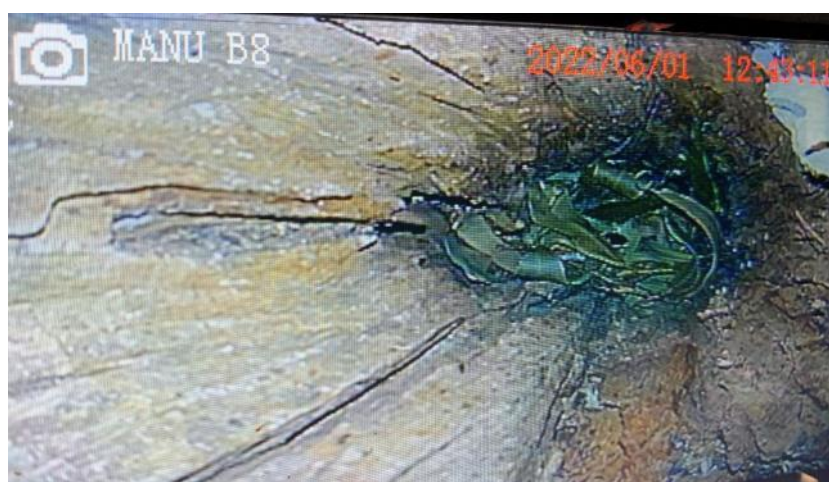
**Occupation:** Of the boxes still present, three contained native bees, and nine contained leaf dens indicative of sugar glider occupation (Figure 2).

**Figure 2.** One of the glider dens with fresh leaves.

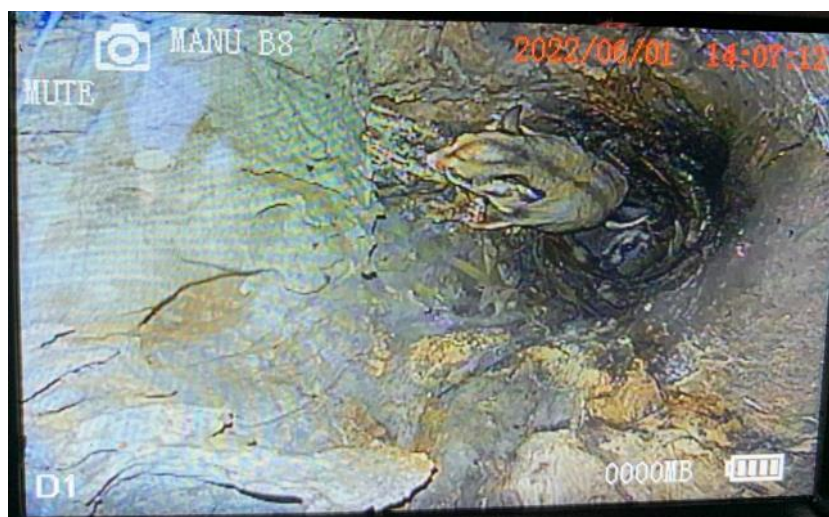
Gliders, most likely sugar gliders, were present at two locations at the time of inspection (see Figure 3). One pair remained in the hollow, whilst the other pair were seen when leaving the hollow. Both pairs of gliders were observed in the salvaged hollow style boxes.

**Figure 3.** Two gliders (*Petaurus spp.*) inside a salvaged hollow known as #16.

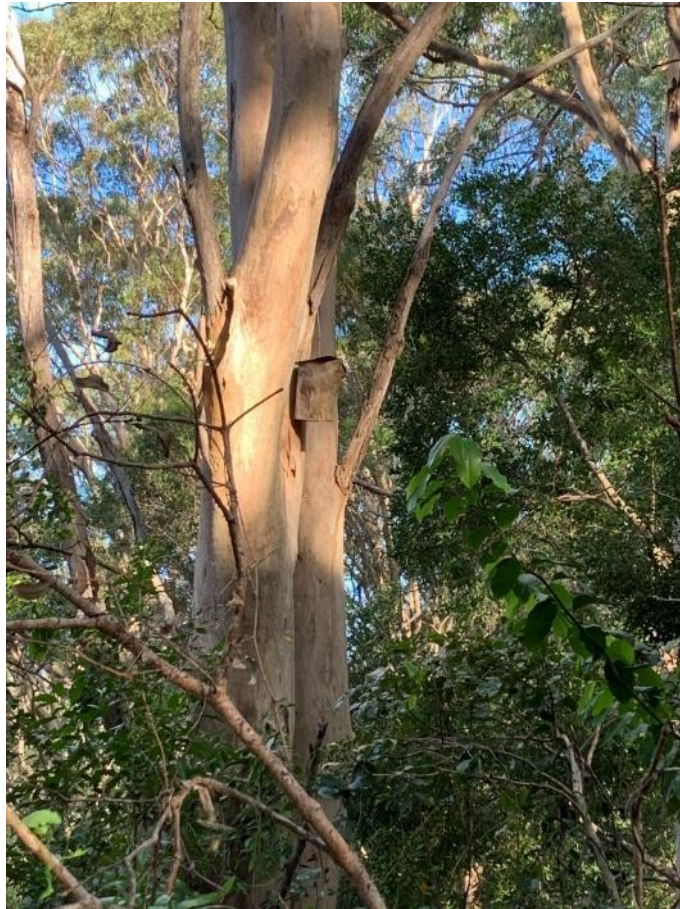
On our approach two gliders fled hollow #15 and climbed and glided away to apparent safety.

**Figure 4.** The salvaged hollow (#15) on a grey gum from which two gliders fled.

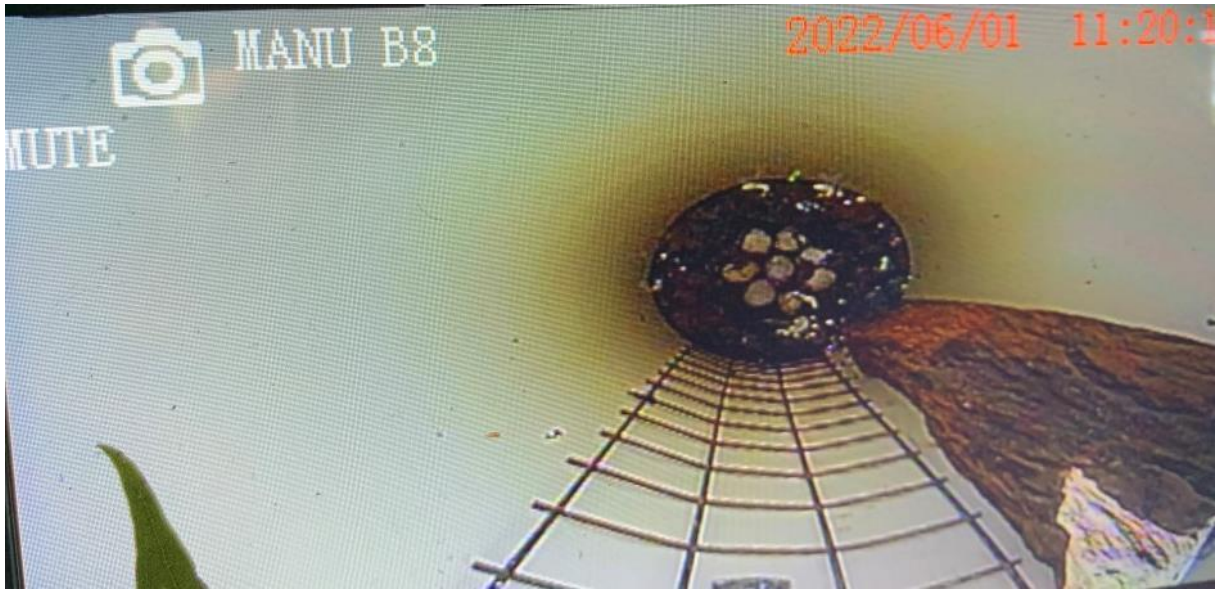
**Occupation:** From the inspections, one tube (#i) had no sign of activity, one tube (#iii) had signs of debris possibly from old wildlife activity and three tubes (#ii, #3, #iv, #vi) contained broken eggs shells and/or down that were presumably the remnants of wood duck (*Chenonetta jubata*) nesting (see Figure 5).

**Figure 5.** A precisely positioned wood duck egg arrangement in the Glossy Black-Cockatoo nesting tube known as #vi.

**Condition:** All of the six PVC nest tubes were considered to be in sound condition. Each of the tree guards around the base of the trees need to be replaced due to problems with the guards growing into trees, or because they were missing or they need to be replaced with a more user friendly material. Large flexible coreflute is recommended.

\* The tree guards on all trees with nesting tubes need to be maintained and/or replaced
