**PLAYGROUND AUDIT
FOR
TWEED SHIRE COUNCIL**

**August 2009
09-060**

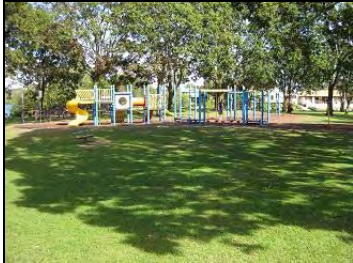
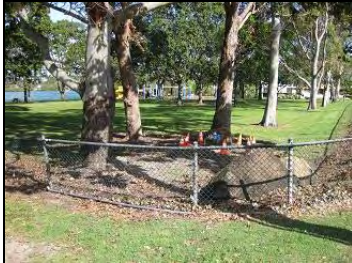
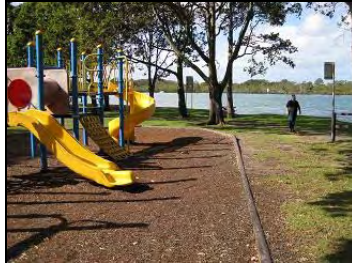
Site Number:	PARK0012	
Site Name:	Ray Pascoe Park, Kennedy Drive, Tweed Heads

Facility Risk Rating Factors	Rating for Site	Score
Table 3A2 – Development (playground equipment, etc)	Playground equipment for regional use (playground generally attracts a wide range of users from beyond the boundaries of the Council area (eg in tourist areas, major sporting facilities and other large gatherings, or where the facility itself is the attraction)), football field, recreational ground, picnic facilities, amenities	4
Table 3A3 - Population using equipment	20 to 50 people at a time	3
Table 3A4 - Frequency of use	Playground used mainly on weekends	2
Table 3A5 – Natural / Drainage hazards in proximity to site	Hazardous features within 30m of playground equipment (may include open drainage facilities permanently holding water, or drop between 1 metre and 3 metres).	4
Table 3A6 – Road hazards in proximity to site	Road within 30m of playground equipment: Sub Arterial	5

FRR = [(3A2 x 3A3) + 3A4] + (3A5 x 3A6)		34
<p>Table 3A7 – Risk Mitigation Measures applying to FRR: Fully fence to separate playground equipment from major hazard, including provision of gate(s); signage warning of all hazards rated HIGH and information indicating importance of parental / carer supervision at all times</p>		
Other matters:	<p>The direct distance to Kennedy Drive is less than 30m, however the existing fence creates a distance in excess of 30m, so the assessment can be revised on the basis of the presence of this fence, making the effective Road Hazard factor of 1, and the effective FRR becomes 18. This suggests appropriate risk mitigation measures to be a barrier between playground equipment and major hazard / screen hazard from playground equipment (type variable, may include dense vegetation or mounding) to increase distance between hazard and playground equipment to be greater than 30m; signage warning of the two highest rated hazards and information indicating importance of parental / carer supervision at all times.</p> <p>It is reasonable to consider the presence of the water bodies on two sides of the reserve as being obvious to users of the park. For Council to fulfill its duty of care as described in the Civil Liability Act 2002 it is appropriate to provide a warning regarding the presence of the hazards, including the water and boat ramp.</p> <p>As a result, further measures to separate the playground equipment from the water are considered discretionary.</p>

Adjusted FRR (allowing for effective Road Hazard Factor)		18
<p>Recommendation: That Council ensures the existing fence is maintained to ensure a distance of 30m between the playground equipment and vehicular traffic is provided, and that signage warning of all hazards rated HIGH and information indicating importance of parental / carer supervision at all times is also provided.</p>

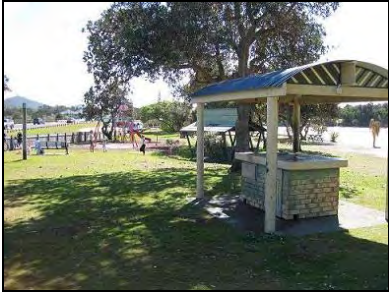
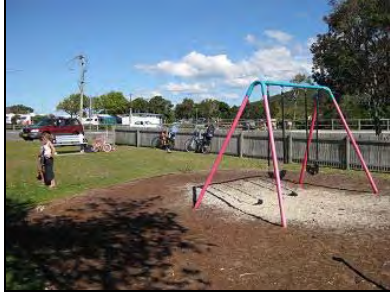
</div>		
Facility Risk Rating Factors	Rating for Site	Score
Table 3A2 – Development (playground equipment, etc)	Playground equipment for regional use (playground generally attracts a wide range of users from beyond the boundaries of the Council area (eg in tourist areas, major sporting facilities and other large gatherings, or where the facility itself is the attraction)), football field, recreational ground, picnic facilities, amenities	4
Table 3A3 - Population using equipment	5 to 20 people at a time	2
Table 3A4 - Frequency of use	Playground used mainly on a daily basis	3
Table 3A5 – Natural / Drainage hazards in proximity to site	Hazardous features within 30m of playground equipment (may include open drainage facilities permanently holding water, or drop between 1 metre and 3 metres).	4

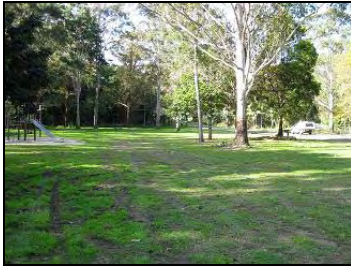
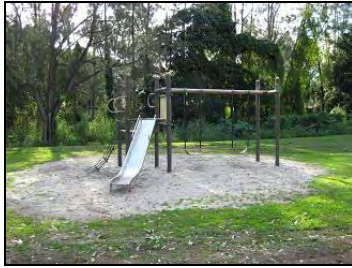
Site Number:	PARK0269		
Site Name:	Gerald Parker Park, Kyogle Road, Uki

Facility Risk Rating Factors	Rating for Site		Score
Table 3A2 – Development (playground equipment, etc)	Playground equipment for district use (the playground is generally used by residents of the local government area (Shire / City / Municipality) when using adjacent facilities for such things as sports for the local sports clubs and schools). Residents travel from other parts of the LGA to use the playground equipment, and other adjacent facilities including sports field(s), leash free dog areas, some picnic tables and chairs, small toilet block. Locations that have a high degree of seasonality in their use		3
Table 3A3 - Population using equipment	5 to 20 people at a time		2
Table 3A4 - Frequency of use	Playground used mainly on weekends		2
Table 3A5 – Natural / Drainage hazards in proximity to site	Hazardous features within 30m of playground equipment include open drainage facilities permanently holding water, or drop between 1 metre and 3 metres).		4

Table 3A6 – Road hazards in proximity to site	Road within 30m of playground equipment: Sub Arterial		5
FRR = [(3A2 x 3A3) + 3A4] + (3A5 x 3A6)			28
Table 3A7 – Risk Mitigation Measures applying to FRR: Provide a densely planted barrier or partial fence separating playground equipment from major hazard / separating hazard from playground equipment to increase distance between hazard and playground equipment to be greater than 30m; signage warning of all hazards rated HIGH and information indicating importance of parental / carer supervision at all times			
Other matters:	<p>The direct distance between the playground equipment and the river is less than 30m. If the existing vegetation is left unmaintained along the river frontage of the reserve it forms a separation between the river and the playground equipment, hence the assessment can be revised making the effective natural / Drainage Hazard factor of 1, and the effective FRR becomes 13. This suggests appropriate risk mitigation measures to be to provide signage relevant to site, depicting top rated hazard and information indicating importance of parental / carer supervision at all times.</p> <p>It is reasonable to consider the presence of the road as being obvious to users of the park. For Council to fulfill its duty of care as described in the Civil Liability Act 2002 it is appropriate to provide a warning regarding the presence of the hazards, including the river and road.</p> <p>As a result, further measures to separate the playground equipment from the water are considered discretionary.</p>

Adjusted FRR (allowing for effective Natural / Drainage Hazard Factor)			13
Recommendation: That Council continues to allow the vegetation along the river frontage of the park to form a dense barrier, and provides signage relevant to site, depicting top rated hazard and information indicating importance of parental / carer supervision at all times.

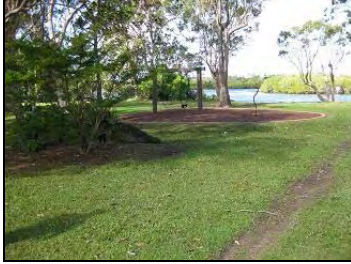
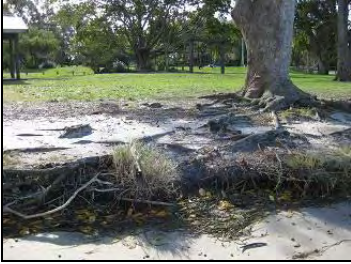
Site Number:	PARK0196	
Site Name:	Pioneer Park, Kennedy Drive, Tweed Heads

<p>View of Park from Kennedy Dr</p>

<p>View from water's edge</p>
Facility Risk Rating Factors	Rating for Site	Score
Table 3A2 – Development (playground equipment, etc)	Playground equipment for immediate local catchment only (the playground is generally located in a small neighbourhood park and is used by the residents nearby), few seats, no picnic facilities, minor landscaping	2
Table 3A3 - Population using equipment	5 to 20 people at a time	2
Table 3A4 - Frequency of use	Playground used mainly on weekends	2
Table 3A5 – Natural / Drainage hazards in proximity to site	Hazardous features within 30m of playground equipment (may include open drainage facilities permanently holding water, or drop between 1 metre and 3 metres).	4
Table 3A6 – Road hazards in proximity to site	Road within 30m of playground equipment: Sub Arterial	5

FRR = [(3A2 x 3A3) + 3A4] + (3A5 x 3A6)		26
<p>Table 3A7 – Risk Mitigation Measures applying to FRR: Densely planted barrier or partial fence separating playground equipment from major hazard / separating hazard from playground equipment to increase distance between hazard and playground equipment to be greater than 30m; signage warning of all hazards rated HIGH and information indicating importance of parental / carer supervision at all times</p>		
Other matters:	<p>The direct distance between the playground equipment and the road is less than 30m, although it is reasonable to consider the presence of the road as being obvious to users of the park. The vegetation and mounding creates a sense of boundary to the playground area, but this would not prevent a child from running towards the road if not supervised. Increasing the effectiveness and extent of this barrier is recommended to increase the distance of travel between the playground equipment and the road to at least 30m. If this is carried out the assessment can be revised, making the effective Road Hazard factor of 1, and the effective FRR becomes 10.</p> <p>The direct distance between the playground equipment and the water is less than 30m, yet it is reasonable to consider the presence of the waterway as being obvious to users of the park.</p> <p>For Council to fulfill its duty of care as described in the Civil Liability Act 2002 it is appropriate to provide a warning regarding the presence of the hazards, including the river and road.</p> <p>As a result, further measures to separate the playground equipment from the water are considered discretionary.</p>

Adjusted FRR (allowing for effective Road Hazard Factor)		10
<p>Recommendation: That Council extends and upgrades the existing mounding and vegetation between Kennedy Drive and the playground equipment to increase the distance of travel between the playground equipment and the road to at least 30m, and to provide signage relevant to site, depicting top rated hazard and information indicating importance of parental / carer supervision at all times.</p>

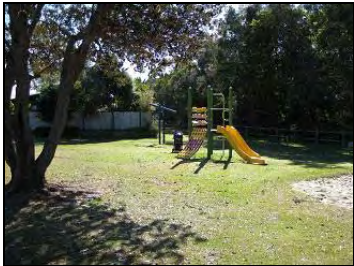
Site Number:	PARK0022	
Site Name:	Hardy Park, Overall Drive, Pottsville

<p style="text-align: center;">Hardy Park taken from road</p>		
Facility Risk Rating Factors	Rating for Site	Score
Table 3A2 – Development (playground equipment, etc)	Playground equipment for immediate local catchment only (the playground is generally located in a small neighbourhood park and is used by the residents nearby), few seats, no picnic facilities, minor landscaping	2
Table 3A3 - Population using equipment	5 to 20 people at a time	2
Table 3A4 - Frequency of use	Playground used mainly on a daily basis	3
Table 3A5 – Natural / Drainage hazards in proximity to site	Hazardous features within 30m of playground equipment (may include open drainage facilities permanently holding water, or drop between 1 metre and 3 metres).	4
Table 3A6 – Road hazards in proximity to site	Road within 30m of playground equipment: Distributor	4

FRR = [(3A2 x 3A3) + 3A4] + (3A5 x 3A6)		23
<p>Table 3A7 – Risk Mitigation Measures applying to FRR: Densely planted barrier or partial fence separating playground equipment from major hazard / separating hazard from playground equipment to increase distance between hazard and playground equipment to be greater than 30m; signage warning of all hazards rated HIGH and information indicating importance of parental / carer supervision at all times.</p>		
Other matters:	<p>There is an existing post-and-rail fence and vegetation between the playground equipment and the creek, although this does not prevent passage by small children. It is considered appropriate that either the fencing or the vegetation be enhanced to restrict access to the water for at least a distance of 30m from the playground equipment. If this was carried out the effective natural / Drainage factor would decrease to 1, and the effective FRR becomes 11. This suggests appropriate risk mitigation measures to be to provide signage relevant to site, depicting top rated hazard and information indicating importance of parental / carer supervision at all times.</p> <p>It is reasonable to consider the presence of the road as being obvious to users of the park. For Council to fulfill its duty of care as described in the Civil Liability Act 2002 it is appropriate to provide a warning regarding the presence of the hazards, including the creek and road.</p> <p>As a result, further measures to separate the playground equipment from the road are considered discretionary.</p>

Adjusted FRR (allowing for effective Natural / Drainage Hazard Factor)		11
<p>Recommendation: That Council upgrades the existing fencing and vegetation between the creek and the playground equipment to restrict access to the creek for a distance of at least 30m from the playground equipment, and to provide signage relevant to site, warning of all hazards rated HIGH and information indicating importance of parental / carer supervision at all times.</p>

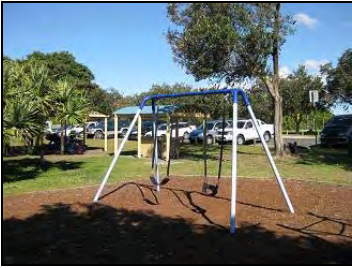
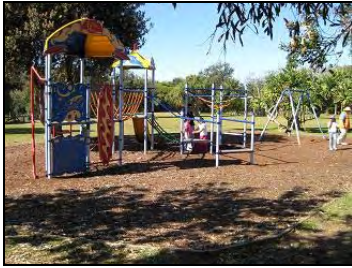
Site Number:	PARK0242	
Site Name:	Lions Park, Cabarita

Facility Risk Rating Factor	Rating for Site	Score
Table 3A2 – Development (playground equipment, etc)	Playground equipment for regional use (the playground generally attracts a wide range of users from beyond the boundaries of the Council area (eg in tourist areas, major sporting facilities and other large gatherings, or where the facility itself is the attraction)), football field, recreational ground, picnic facilities, amenities	4
Table 3A3 - Population using equipment	20 to 50 people at a time	3
Table 3A4 - Frequency of use	Playground used mainly on a daily basis	3
Table 3A5 – Natural / Drainage hazards in proximity to site	Hazardous features within 30m of playground equipment (may include open drainage facilities permanently holding water, or drop between 1 metre and 3 metres).	4
Table 3A6 – Road hazards in proximity to site	Road within 30m of playground equipment: Local Access / Car Park	2

FRR = [(3A2 x 3A3) + 3A4] + (3A5 x 3A6)		23
<p>Table 3A7 – Risk Mitigation Measures applying to FRR: Provide a densely planted barrier or partial fence separating playground equipment from major hazard / separating hazard from playground equipment to increase distance between hazard and playground equipment to be greater than 30m; signage warning of all hazards rated HIGH and information indicating importance of parental / carer supervision at all times</p>		
Other matters:	<p>The existing fencing at the ocean side of the reserve and the vegetation behind the fence forms a separation between the ocean and the playground, hence the assessment can be revised making the effective Natural / Drainage Hazard factor of 1, and the effective FRR becomes 17, The existing timber bollards between the playground equipment and the car park do not prevent access for small children, so this “fence” should be enhanced, or some other form of fencing / screening be provided to the car park frontage of the playground to prevent access from the playground equipment towards the car park for a distance of at least 30m.</p>

Adjusted FRR (allowing for effective Natural / Drainage Hazard Factor)		17
<p>Recommendation: That Council provides a barrier between playground equipment and the car park (type variable, may include dense vegetation or mounding) to increase distance between the car park and playground equipment to greater than 30m; and signage warning of the two highest rated hazards and information indicating importance of parental / carer supervision at all times.</p>

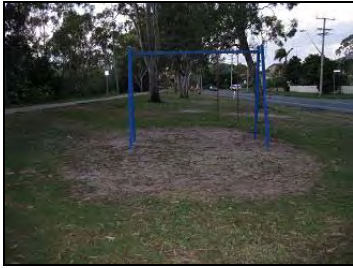
Site Number:	PARK0092	
Site Name:	Dry Dock Road Reserve, Dry Dock Rd, Tweed Heads South

Facility Risk Rating Factors	Rating for Site	Score
Table 3A2 – Development (playground equipment, etc)	Site with basic playground equipment, no picnic facilities	1
Table 3A3 - Population using equipment	Less than 5 people at a time	1
Table 3A4 - Frequency of use	Playground rarely used	1
Table 3A5 – Natural / Drainage hazards in proximity to site	Hazardous features within 30m of playground equipment (may include open drainage facilities permanently holding water, or drop between 1 metre and 3 metres).	4
Table 3A6 – Road hazards in proximity to site	Road within 30m of playground equipment: Sub Arterial	5
FRR = [(3A2 x 3A3) + 3A4] + (3A5 x 3A6)		22
<p>Table 3A7 – Risk Mitigation Measures applying to FRR: Densely planted barrier or partial fence separating playground equipment from major hazard / separating hazard from playground equipment to increase distance between hazard and playground equipment to be greater than 30m; signage warning of all hazards rated HIGH and information indicating importance of parental / carer supervision at all times</p>

Other matters:	The raised pathway and vegetation between the waterway and the playground equipment provides some restriction of access to the water, however the proximity of the playground equipment to the road, and especially considering the road category, places the playground equipment in a highly exposed location. Fencing on the road side would appropriately take the form of guard rail, even though the road is considered an obvious hazard. Unless there are strong and valid reasons to provide playground equipment at this location, it is considered more practical to remove the existing playground equipment and that it not be replaced at this site.	
Recommendation: That Council consider removal of the existing playground equipment and that it not be replaced at this site.

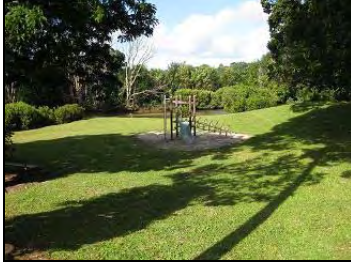
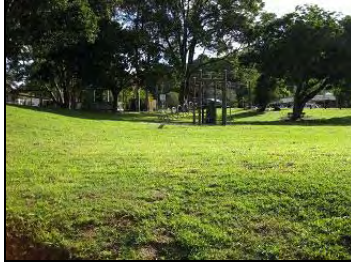
Site Number:	PARK0178	
Site Name:	Prindable Park, Bilambil Rd, Bilambil Heights

<p>Park looking towards the creek</p>

<p>View from the creek bank</p>
Facility Risk Rating Factors	Rating for Site	Score
Table 3A2 – Development (playground equipment, etc)	Playground equipment for immediate local catchment only (the playground is generally located in a small neighbourhood park and is used by the residents nearby), few seats, no picnic facilities, minor landscaping	2
Table 3A3 - Population using equipment	5 to 20 people at a time	2
Table 3A4 - Frequency of use	Playground used mainly on weekends	2
Table 3A5 – Natural / Drainage hazards in proximity to site	Hazardous features within 30m of playground equipment (may include open drainage facilities permanently holding water, or drop between 1 metre and 3 metres).	4
Table 3A6 – Road hazards in proximity to site	Road within 30m of playground equipment: Distributor	4

FRR = [(3A2 x 3A3) + 3A4] + (3A5 x 3A6)		22
<p>Table 3A7 – Risk Mitigation Measures applying to FRR:</p> <p>Densely planted barrier or partial fence separating playground equipment from major hazard / separating hazard from playground equipment to increase distance between hazard and playground equipment to be greater than 30m; signage warning of all hazards rated HIGH and information indicating importance of parental / carer supervision at all times</p>		
Other matters:	<p>The park has drop-offs of over 1m into water on two sides. The grass is currently maintained enabling easy access to the edges of these drop-offs, creating the likelihood of someone falling into water. Even though the edges are obvious from the park, if someone was over one of the edges, they could then be hidden from the park. Reducing the risk of inadvertent access to the water would be most effectively managed by allowing the grass to grow densely around the water frontages to the reserve, or planting with a dense-growing species to form an effective barrier. Alternatively, installation of fencing nearer the playground equipment to increase the separation distance to greater than 30m would be appropriate.</p> <p>It is reasonable to consider the presence of the road as being obvious to users of the park.</p>

<p>Recommendation: That Council provide physical barrier along the water frontages of the reserve to prevent inadvertent access to the water, or provide a form of separation between the playground equipment and the water that increases the travel distance between the two to greater than 30m.</p>

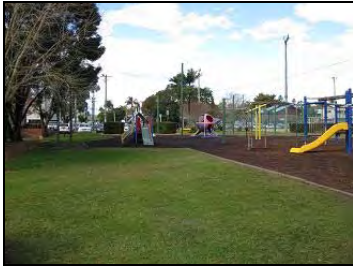
Site Number:	PARK0009	
Site Name:	Knox Park, Nullum Street, Murwillumbah

Facility Risk Rating Factors	Rating for Site	Score
Table 3A2 – Development (playground equipment, etc)	Playground equipment for regional use (playground generally attracts a wide range of users from beyond the boundaries of the Council area (eg in tourist areas, major sporting facilities and other large gatherings, or where the facility itself is the attraction)), football field, recreational ground, picnic facilities, amenities, and with highly sophisticated playground equipment and supporting infrastructure	5
Table 3A3 - Population using equipment	20 to 50 people at a time	3
Table 3A4 - Frequency of use	Playground used mainly on a daily basis	3
Table 3A5 – Natural / Drainage hazards in proximity to site	No hazardous features within 30m of playground equipment (direct line of sight, any form of hazard)	1
Table 3A6 – Road hazards in proximity to site	Road within 30m of playground equipment: Local Access / Car Park	2

FRR = [(3A2 x 3A3) + 3A4] + (3A5 x 3A6)		20
<p>Table 3A7 – Risk Mitigation Measures applying to FRR: Provide a barrier between playground equipment and major hazard / screen hazard from playground equipment (type variable, may include dense vegetation or mounding) to increase distance between hazard and playground equipment to be greater than 30m; signage warning of the two highest rated hazards and information indicating importance of parental / carer supervision at all times</p>		
Other matters:	This FRR has arisen primarily from the sophistication of the playground equipment and its resulting usage level. It would be appropriate to extend to existing hedges (or other form of delineation) between the playground and the car park, in addition to provision of suitable signage.	
<p>Recommendation: That Council extends the existing hedges (or other form of delineation) between the playground and the car park, in addition to provision of signage warning of the two highest rated hazards and information indicating importance of parental / carer supervision at all times.</p>

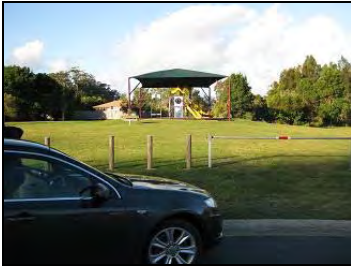
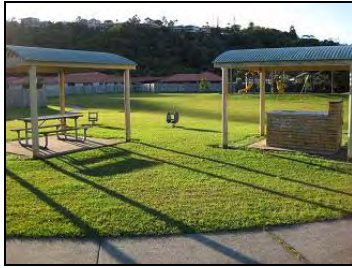
Site Number:	PARK0192	
Site Name:	Medoc Place Park, Medoc PI, Vintage Lakes, Banora Point

Facility Risk Rating Factors	Rating for Site	Score
Table 3A2 – Development (playground equipment, etc)	Playground equipment for district use (the playground is generally used by residents of the local government area (Shire / City / Municipality) when using adjacent facilities for such things as sports for the local sports clubs and schools). Residents travel from other parts of the LGA to use the playground equipment, and other adjacent facilities including sports field(s), leash free dog areas, some picnic tables and chairs, small toilet block. Locations that have a high degree of seasonality in their use	3
Table 3A3 - Population using equipment	20 to 50 people at a time	3
Table 3A4 - Frequency of use	Playground used mainly on weekends	2
Table 3A5 – Natural / Drainage hazards in proximity to site	Hazardous features within 30m of playground equipment include open drainage facilities permanently holding water, or drop between 1 metre and 3 metres).	4

Table 3A6 – Road hazards in proximity to site	Road within 30m of playground equipment: Local Access / Car Park	2
FRR = [(3A2 x 3A3) + 3A4] + (3A5 x 3A6)		19
<p>Table 3A7 – Risk Mitigation Measures applying to FRR:</p> <p>Provide a barrier between playground equipment and major hazard / screen hazard from playground equipment (type variable, may include dense vegetation or mounding) to increase distance between hazard and playground equipment to be greater than 30m; signage warning of the two highest rated hazards and information indicating importance of parental / carer supervision at all times</p>		
Other matters:	<p>It is reasonable to consider the presence of the water as an obvious hazard, although if someone fell on some of the slopes leading to the water it may not be noticed from the other areas of the Park. It is appropriate to increase the vegetation barrier at the water's edge within 30m of the playground equipment, by planting of species that will prevent passage and / or creating a buffer by not mowing to the water's edge in this zone. Incorporation of vegetation planting and / or mounding between the playground equipment and the road frontage will also reduce the potential for small children to inadvertently reach the road.</p>

<p>Recommendation: That Council increase the vegetation barrier at the water's edge within 30m of the playground equipment, by planting of species that will prevent passage and / or creating a buffer by not mowing to the water's edge in this zone; incorporate a screen of vegetation planting and / or mounding between the playground equipment and the road frontage; erect signage warning of the two highest rated hazards and information indicating importance of parental / carer supervision at all times.</p>

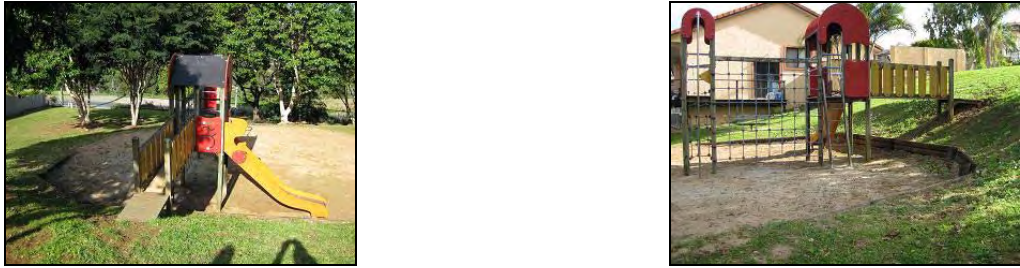
Facility Risk Rating Factors	Rating for Site	Score
Table 3A2 – Development (playground equipment, etc)	Playground equipment for immediate local catchment only (the playground is generally located in a small neighbourhood park and is used by the residents nearby), few seats, no picnic facilities, minor landscaping	2
Table 3A3 - Population using equipment	Less than 5 people at a time	1
Table 3A4 - Frequency of use	Playground rarely used	1
Table 3A5 – Natural / Drainage hazards in proximity to site	Hazardous features within 30m of playground equipment include open drainage facilities permanently holding water, or drop between 1 metre and 3 metres).	4
Table 3A6 – Road hazards in proximity to site	Road within 30m of playground equipment: Distributor	4
FRR = [(3A2 x 3A3) + 3A4] + (3A5 x 3A6)		19
<p>Table 3A7 – Risk Mitigation Measures applying to FRR: Provide a barrier between playground equipment and major hazard / screen hazard from playground equipment (type variable, may include dense vegetation or mounding) to increase distance between hazard and playground equipment to be greater than 30m; signage warning of the two highest rated hazards and information indicating importance of parental / carer supervision at all times</p>

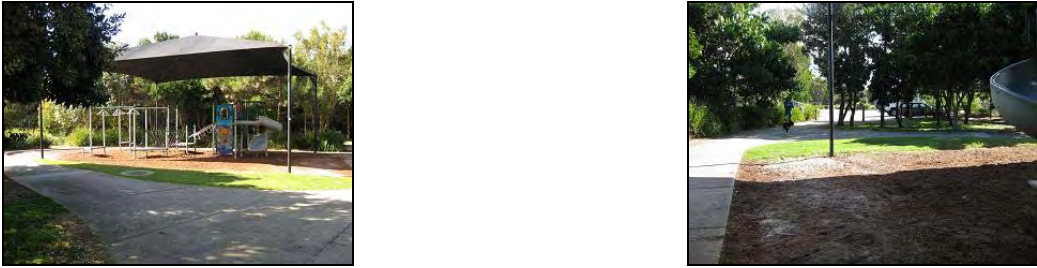
Facility Risk Rating Factors	Rating for Site	Score
Table 3A2 – Development (playground equipment, etc)	Playground equipment for district use (the playground is generally used by residents of the local government area (Shire / City / Municipality) when using adjacent facilities for such things as sports for the local sports clubs and schools). Residents travel from other parts of the LGA to use the playground equipment, and other adjacent facilities including sports field(s), leash free dog areas, some picnic tables and chairs, small toilet block. Locations that have a high degree of seasonality in their use	3
Table 3A3 - Population using equipment	20 to 50 people at a time	3
Table 3A4 - Frequency of use	Playground used mainly on a daily basis	3
Table 3A5 – Natural / Drainage hazards in proximity to site	Hazardous features within 30m of playground equipment (may include open drainage facility that runs during wet weather, or drops less than 1 metre)	3

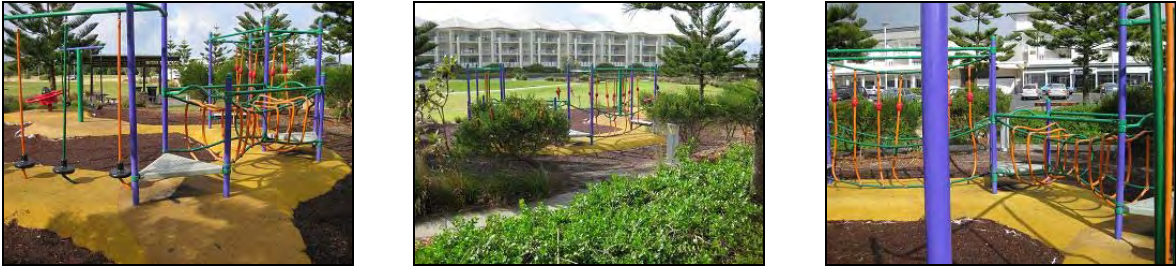
Facility Risk Rating Factors	Rating for Site	Score
Table 3A2 – Development (playground equipment, etc)	Playground equipment for district use (the playground is generally used by residents of the local government area (Shire / City / Municipality) when using adjacent facilities for such things as sports for the local sports clubs and schools). Residents travel from other parts of the LGA to use the playground equipment, and other adjacent facilities including sports field(s), leash free dog areas, some picnic tables and chairs, small toilet block. Locations that have a high degree of seasonality in their use	3
Table 3A3 - Population using equipment	20 to 50 people at a time	3
Table 3A4 - Frequency of use	Playground used mainly on a daily basis	3
Table 3A5 – Natural / Drainage hazards in proximity to site	Hazardous features within 30m of playground equipment (may include open drainage facility that runs during wet weather, or drops less than 1 metre)	3

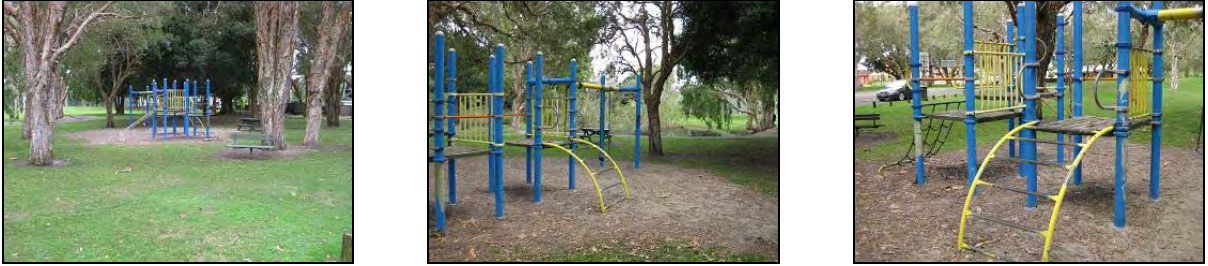
Facility Risk Rating Factors	Rating for Site	Score
Table 3A2 – Development (playground equipment, etc)	Playground equipment for district use (the playground is generally used by residents of the local government area (Shire / City / Municipality) when using adjacent facilities for such things as sports for the local sports clubs and schools). Residents travel from other parts of the LGA to use the playground equipment, and other adjacent facilities including sports field(s), leash free dog areas, some picnic tables and chairs, small toilet block. Locations that have a high degree of seasonality in their use	3
Table 3A3 - Population using equipment	5 to 20 people at a time	2
Table 3A4 - Frequency of use	Playground used mainly on a daily basis	3
Table 3A5 – Natural / Drainage hazards in proximity to site	Hazardous features within 30m of playground equipment (may include open drainage facilities permanently holding water, or drop between 1 metre and 3 metres).	4

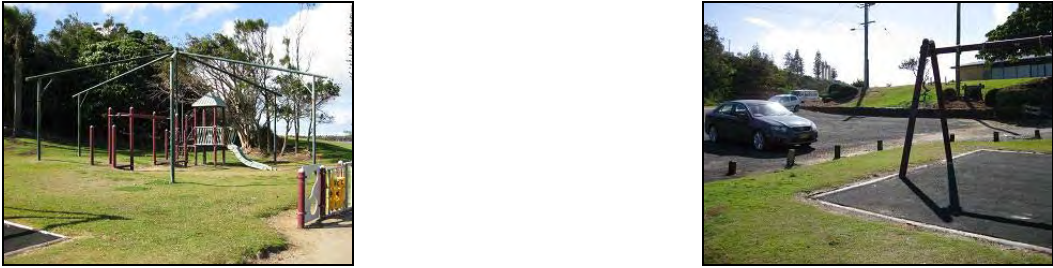
Facility Risk Rating Factors	Rating for Site	Score
Table 3A2 – Development (playground equipment, etc)	Playground equipment for district use (the playground is generally used by residents of the local government area (Shire / City / Municipality) when using adjacent facilities for such things as sports for the local sports clubs and schools). Residents travel from other parts of the LGA to use the playground equipment, and other adjacent facilities including sports field(s), leash free dog areas, some picnic tables and chairs, small toilet block. Locations that have a high degree of seasonality in their use	3
Table 3A3 - Population using equipment	5 to 20 people at a time	2
Table 3A4 - Frequency of use	Playground used mainly on weekends	2
Table 3A5 – Natural / Drainage hazards in proximity to site	Hazardous features within 30m of playground equipment (may include open drainage facility that runs during wet weather, or drops less than 1 metre).	3

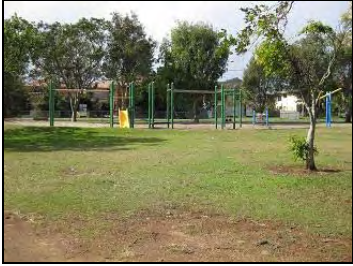
Site Number:	PARK0021	
Site Name:	Reg Dalton Oval, Wommin Bay Rd, Kingscliff

Facility Risk Rating Factors	Rating for Site	Score
Table 3A2 – Development (playground equipment, etc)	Playground equipment for district use (the playground is generally used by residents of the local government area (Shire / City / Municipality) when using adjacent facilities for such things as sports for the local sports clubs and schools). Residents travel from other parts of the LGA to use the playground equipment, and other adjacent facilities including sports field(s), leash free dog areas, some picnic tables and chairs, small toilet block. Locations that have a high degree of seasonality in their use	3
Table 3A3 - Population using equipment	20 to 50 people at a time	3
Table 3A4 - Frequency of use	Playground used mainly on weekends	2
Table 3A5 – Natural / Drainage hazards in proximity to site	No hazardous features within 30m of playground equipment (direct line of sight, any form of hazard)	1

Table 3A6 – Road hazards in proximity to site	Road within 30m of playground equipment: Distributor	4
FRR = [(3A2 x 3A3) + 3A4] + (3A5 x 3A6)		15
<p>Table 3A7 – Risk Mitigation Measures applying to FRR: Provide a barrier between playground equipment and major hazard / screen hazard from playground equipment (type variable, may include dense vegetation or mounding) to increase distance between hazard and playground equipment to be greater than 30m; signage warning of the two highest rated hazards and information indicating importance of parental / carer supervision at all times</p>		
Other matters:	<p>The existing fence provides an effective access restriction between the playground equipment and the road, where it is in place. If it is extended to provide this restriction for a minimum distance of 30m from the playground equipment the Road factor can be reduced to 1 and the effective FRR becomes 12, with the corresponding risk mitigation measure being to erect signage as identified below.</p>

Adjusted FRR (allowing for effective Road Hazard Factor)		12
<p>Recommendation: That Council extend the existing fencing to provide a minimum distance of 30m from the playground equipment to the road; erect signage relevant to site, depicting top rated hazard and information indicating importance of parental / carer supervision at all times.</p>

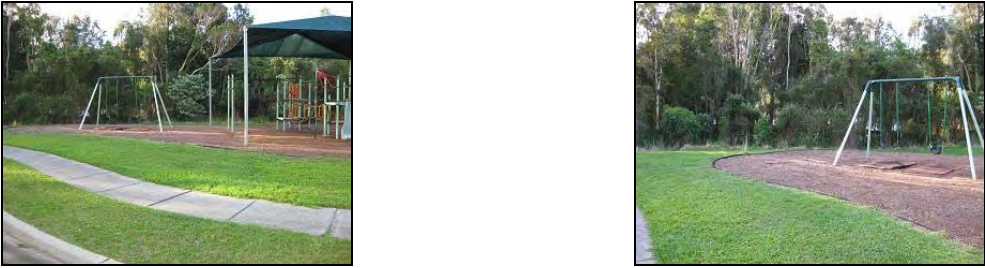
Facility Risk Rating Factors	Rating for Site	Score
Table 3A2 – Development (playground equipment, etc)	Playground equipment for immediate local catchment only (the playground is generally located in a small neighbourhood park and is used by the residents nearby), few seats, no picnic facilities, minor landscaping	2
Table 3A3 - Population using equipment	5 to 20 people at a time	2
Table 3A4 - Frequency of use	Playground used mainly on a daily basis	3
Table 3A5 – Natural / Drainage hazards in proximity to site	Hazardous features within 30m of playground equipment (may include open drainage facilities permanently holding water, or drop between 1 metre and 3 metres).	4
Table 3A6 – Road hazards in proximity to site	Road within 30m of playground equipment: Local Access / Car Park	2
FRR = [(3A2 x 3A3) + 3A4] + (3A5 x 3A6)		15

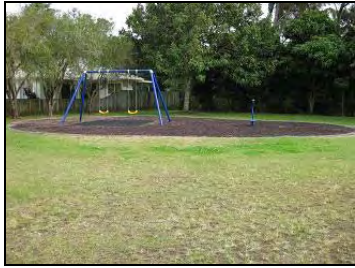
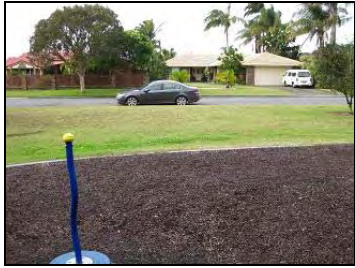
Facility Risk Rating Factors	Rating for Site		Score
Table 3A2 – Development (playground equipment, etc)	Playground equipment for immediate local catchment only (the playground is generally located in a small neighbourhood park and is used by the residents nearby), few seats, no picnic facilities, minor landscaping		2
Table 3A3 - Population using equipment	5 to 20 people at a time		2
Table 3A4 - Frequency of use	Playground used mainly on weekends		2
Table 3A5 – Natural / Drainage hazards in proximity to site	Hazardous features within 30m of playground equipment (may include open drainage facility that runs during wet weather, or drops less than 1 metre).		3
Table 3A6 – Road hazards in proximity to site	Road within 30m of playground equipment: Collector		3
FRR = [(3A2 x 3A3) + 3A4] + (3A5 x 3A6)			15
<p>Table 3A7 – Risk Mitigation Measures applying to FRR: Provide a barrier between playground equipment and major hazard / screen hazard from playground equipment (type variable, may include dense vegetation or mounding) to increase distance between hazard and playground equipment to be greater than 30m; signage warning of the two highest rated hazards and information indicating importance of parental / carer supervision at all times</p>

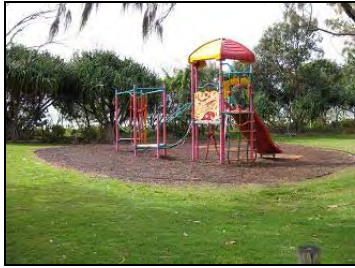
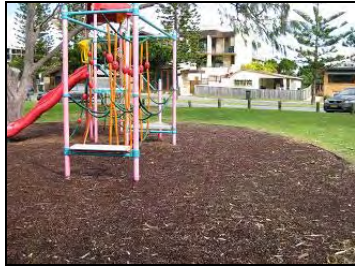
Facility Risk Rating Factors	Rating for Site		Score
Table 3A2 – Development (playground equipment, etc)	Playground equipment for district use (the playground is generally used by residents of the local government area (Shire / City / Municipality) when using adjacent facilities for such things as sports for the local sports clubs and schools). Residents travel from other parts of the LGA to use the playground equipment, and other adjacent facilities including sports field(s), leash free dog areas, some picnic tables and chairs, small toilet block. Locations that have a high degree of seasonality in their use		3
Table 3A3 - Population using equipment	20 to 50 people at a time		3
Table 3A4 - Frequency of use	Playground used mainly on a daily basis		3
Table 3A5 – Natural / Drainage hazards in proximity to site	Hazardous features within 30m of playground equipment (may include open drainage facilities permanently holding water, or drop between 1 metre and 3 metres).		4

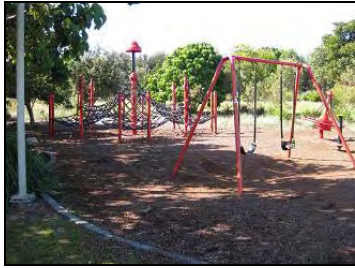
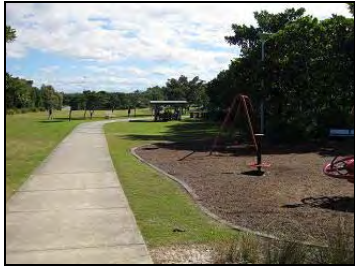
Facility Risk Rating Factors	Rating for Site		Score
Table 3A2 – Development (playground equipment, etc)	Playground equipment for district use (the playground is generally used by residents of the local government area (Shire / City / Municipality) when using adjacent facilities for such things as sports for the local sports clubs and schools). Residents travel from other parts of the LGA to use the playground equipment, and other adjacent facilities including sports field(s), leash free dog areas, some picnic tables and chairs, small toilet block. Locations that have a high degree of seasonality in their use		3
Table 3A3 - Population using equipment	20 to 50 people at a time		3
Table 3A4 - Frequency of use	Playground used mainly on weekends		2
Table 3A5 – Natural / Drainage hazards in proximity to site	Hazardous features within 30m of playground equipment (may include open drainage facility that runs during wet weather, or drops less than 1 metre).		3

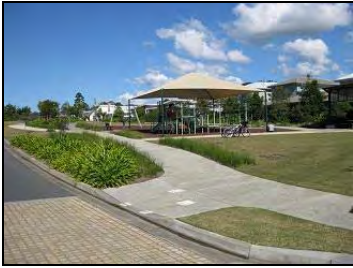
Site Number:	PARK0	
Site Name:	Seabreeze Boulevard and Lennox Circuit, Seabreeze Estate, Pottsville

Facility Risk Rating Factors	Rating for Site	Score
Table 3A2 – Development (playground equipment, etc)	Playground equipment for district use (the playground is generally used by residents of the local government area (Shire / City / Municipality) when using adjacent facilities for such things as sports for the local sports clubs and schools). Residents travel from other parts of the LGA to use the playground equipment, and other adjacent facilities including sports field(s), leash free dog areas, some picnic tables and chairs, small toilet block. Locations that have a high degree of seasonality in their use	3
Table 3A3 - Population using equipment	5 to 20 people at a time	2
Table 3A4 - Frequency of use	Playground used mainly on weekends	3
Table 3A5 – Natural / Drainage hazards in proximity to site	No hazardous features within 30m of playground equipment (direct line of sight, any form of hazard)	1

Table 3A6 – Road hazards in proximity to site	Road within 30m of playground equipment: Distributor	4
FRR = [(3A2 x 3A3) + 3A4] + (3A5 x 3A6)		13
<p>Table 3A7 – Risk Mitigation Measures applying to FRR: Signage relevant to site, depicting top rated hazard and information indicating importance of parental / carer supervision at all times</p>		
Other matters:	It is reasonable that the road be considered an obvious hazard from the playground. It is appropriate that the vegetation zones be enhanced to further reduce the potential for small children to inadvertently reach to road.	
<p>Recommendation: That Council erect signage relevant to site, depicting top rated hazard and information indicating importance of parental / carer supervision at all times and consider providing vegetation zones (or other screening) between the playground equipment and the road to reduce the potential for unrestricted access to the road by small children for a minimum distance of 30m from the playground equipment.</p>

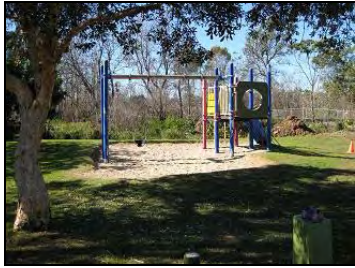
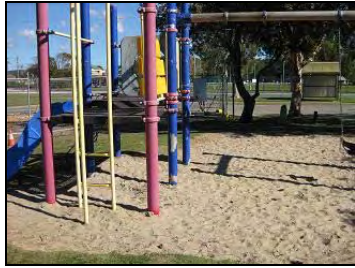
Facility Risk Rating Factors	Rating for Site	Score
Table 3A2 – Development (playground equipment, etc)	Playground equipment for district use (the playground is generally used by residents of the local government area (Shire / City / Municipality) when using adjacent facilities for such things as sports for the local sports clubs and schools). Residents travel from other parts of the LGA to use the playground equipment, and other adjacent facilities including sports field(s), leash free dog areas, some picnic tables and chairs, small toilet block. Locations that have a high degree of seasonality in their use	3
Table 3A3 - Population using equipment	5 to 20 people at a time	2
Table 3A4 - Frequency of use	Playground used mainly on weekends	2
Table 3A5 – Natural / Drainage hazards in proximity to site	No hazardous features within 30m of playground equipment (direct line of sight, any form of hazard)	1

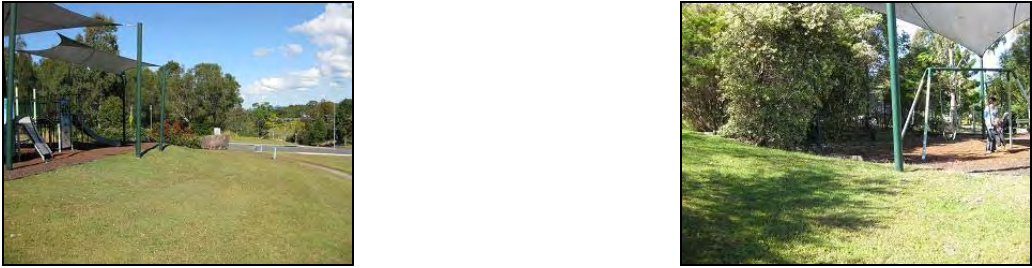
Facility Risk Rating Factors	Rating for Site	Score
Table 3A2 – Development (playground equipment, etc)	Playground equipment for immediate local catchment only (the playground is generally located in a small neighbourhood park and is used by the residents nearby), few seats, no picnic facilities, minor landscaping	2
Table 3A3 - Population using equipment	5 to 20 people at a time	2
Table 3A4 - Frequency of use	Playground used mainly on a daily basis	3
Table 3A5 – Natural / Drainage hazards in proximity to site	Hazardous features within 30m of playground equipment (may include steep sloping ground, walking track around reserve)	2
Table 3A6 – Road hazards in proximity to site	Road within 30m of playground equipment: Collector	3
FRR = [(3A2 x 3A3) + 3A4] + (3A5 x 3A6)		13
<p>Table 3A7 – Risk Mitigation Measures applying to FRR: Signage relevant to site, depicting top rated hazard and information indicating importance of parental / carer supervision at all times</p>

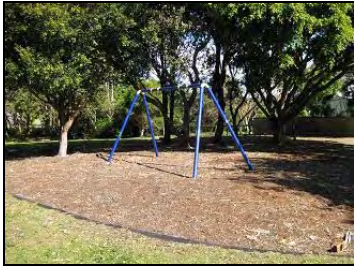
Facility Risk Rating Factors	Rating for Site	Score
Table 3A2 – Development (playground equipment, etc)	Site with basic playground equipment (at present vandalized / out of service), no picnic facilities	1
Table 3A3 - Population using equipment	Less than 5 people at a time	1
Table 3A4 - Frequency of use	Playground used mainly on a daily basis	3
Table 3A5 – Natural / Drainage hazards in proximity to site	Hazardous features within 30m of playground equipment (may include open drainage facility that runs during wet weather, or drops less than 1 metre).	3
Table 3A6 – Road hazards in proximity to site	Road within 30m of playground equipment: Collector	3
FRR = [(3A2 x 3A3) + 3A4] + (3A5 x 3A6)		13
<p>Table 3A7 – Risk Mitigation Measures applying to FRR: Signage relevant to site, depicting top rated hazard and information indicating importance of parental / carer supervision at all times</p>

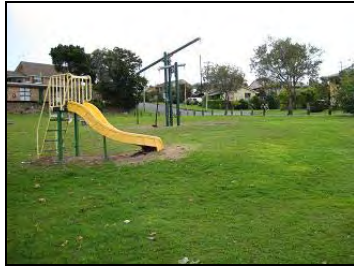
Facility Risk Rating Factors	Rating for Site	Score
Table 3A2 – Development (playground equipment, etc)	Playground equipment for district use (the playground is generally used by residents of the local government area (Shire / City / Municipality) when using adjacent facilities for such things as sports for the local sports clubs and schools). Residents travel from other parts of the LGA to use the playground equipment, and other adjacent facilities including sports field(s), leash free dog areas, some picnic tables and chairs, small toilet block. Locations that have a high degree of seasonality in their use	3
Table 3A3 - Population using equipment	5 to 20 people at a time	2
Table 3A4 - Frequency of use	Playground used mainly on weekends	2
Table 3A5 – Natural / Drainage hazards in proximity to site	Hazardous features within 30m of playground equipment (may include steep sloping ground, walking track around reserve)	2

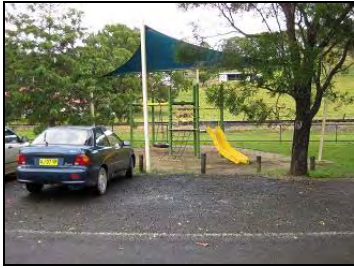
Facility Risk Rating Factors	Rating for Site	Score
Table 3A2 – Development (playground equipment, etc)	Playground equipment for district use (the playground is generally used by residents of the local government area (Shire / City / Municipality) when using adjacent facilities for such things as sports for the local sports clubs and schools). Residents travel from other parts of the LGA to use the playground equipment, and other adjacent facilities including sports field(s), leash free dog areas, some picnic tables and chairs, small toilet block. Locations that have a high degree of seasonality in their use	3
Table 3A3 - Population using equipment	5 to 20 people at a time	2
Table 3A4 - Frequency of use	Playground used mainly on weekends	2
Table 3A5 – Natural / Drainage hazards in proximity to site	No hazardous features within 30m of playground equipment (direct line of sight, any form of hazard).	1

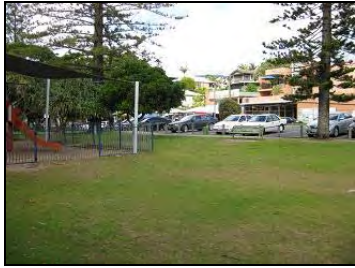
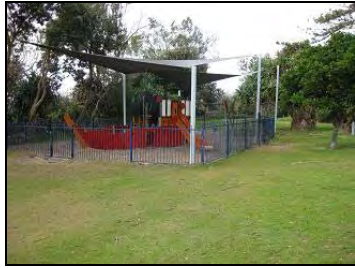
Facility Risk Rating Factors	Rating for Site	Score
Table 3A2 – Development (playground equipment, etc)	Playground equipment for district use (the playground is generally used by residents of the local government area (Shire / City / Municipality) when using adjacent facilities for such things as sports for the local sports clubs and schools). Residents travel from other parts of the LGA to use the playground equipment, and other adjacent facilities including sports field(s), leash free dog areas, some picnic tables and chairs, small toilet block. Locations that have a high degree of seasonality in their use	3
Table 3A3 - Population using equipment	5 to 20 people at a time	2
Table 3A4 - Frequency of use	Playground used mainly on a daily basis	3
Table 3A5 – Natural / Drainage hazards in proximity to site	Hazardous features within 30m of playground equipment (may include open drainage facilities permanently holding water, or drop between 1 metre and 3 metres).	4

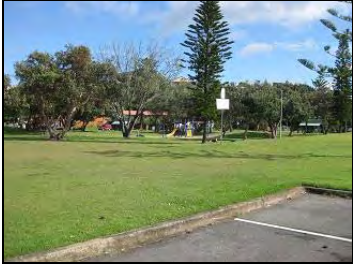
Site Number:	PARK0016	
Site Name:	Faulks Park, Marine Parade, Kingscliff

Facility Risk Rating Factors	Rating for Site	Score
Table 3A2 – Development (playground equipment, etc)	Playground equipment for district use (the playground is generally used by residents of the local government area (Shire / City / Municipality) when using adjacent facilities for such things as sports for the local sports clubs and schools). Residents travel from other parts of the LGA to use the playground equipment, and other adjacent facilities including sports field(s), leash free dog areas, some picnic tables and chairs, small toilet block. Locations that have a high degree of seasonality in their use	3
Table 3A3 - Population using equipment	5 to 20 people at a time	2
Table 3A4 - Frequency of use	Playground used mainly on weekends	2
Table 3A5 – Natural / Drainage hazards in proximity to site	No hazardous features within 30m of playground equipment (direct line of sight, any form of hazard).	1

Table 3A6 – Road hazards in proximity to site	Road within 30m of playground equipment: Collector	3
FRR = [(3A2 x 3A3) + 3A4] + (3A5 x 3A6)		11
Table 3A7 – Risk Mitigation Measures applying to FRR: Signage relevant to site, depicting top rated hazard and information indicating importance of parental / carer supervision at all times		
Other matters:	It is reasonable that the road be considered an obvious hazard from the playground. The existing mounds provide a degree of delineation of the playground area and limitation of free access from the site by small children.	
Recommendation: That Council erect signage relevant to site, depicting top rated hazard and information indicating importance of parental / carer supervision at all times.

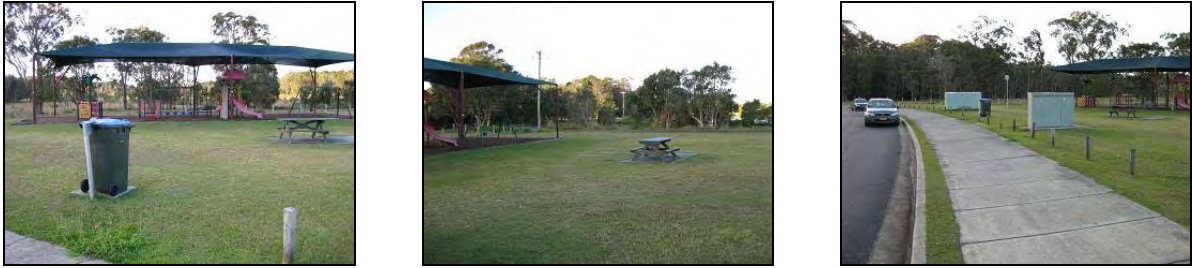
Site Number:	PARK0193	
Site Name:	Russell Way Park, Banora Point

Facility Risk Rating Factors	Rating for Site	Score
Table 3A2 – Development (playground equipment, etc)	Playground equipment for immediate local catchment only (the playground is generally located in a small neighbourhood park and is used by the residents nearby), few seats, no picnic facilities, minor landscaping	2
Table 3A3 - Population using equipment	5 to 20 people at a time	2
Table 3A4 - Frequency of use	Playground used mainly on a daily basis	3
Table 3A5 – Natural / Drainage hazards in proximity to site	Hazardous features within 30m of playground equipment (may include steep sloping ground, walking track around reserve).	2
Table 3A6 – Road hazards in proximity to site	Road within 30m of playground equipment: Local Access / Car Park	2
FRR = [(3A2 x 3A3) + 3A4] + (3A5 x 3A6)		11
Table 3A7 – Risk Mitigation Measures applying to FRR: Signage relevant to site, depicting top rated hazard and information indicating importance of parental / carer supervision at all times

Other matters:	It is reasonable that the road be considered an obvious hazard from the playground equipment. The existing timber bollards provide some delineation between the road and the park. It would reduce the potential for inadvertent access between the two if a barrier was provided in the form of mounds or vegetation screen with suitable species.	
Recommendation: That Council erect signage relevant to site, depicting top rated hazard and information indicating importance of parental / carer supervision at all times.

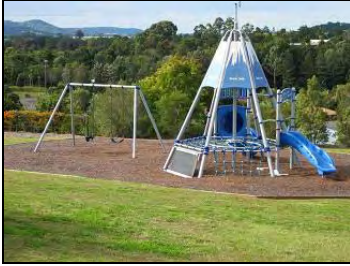
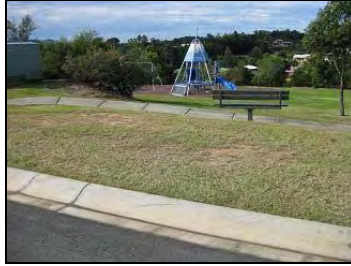
Site Number:	PARK0314		
Site Name:	Saddle Way Park, Bellevue Estate, Murwillumbah

Facility Risk Rating Factors	Rating for Site		Score
Table 3A2 – Development (playground equipment, etc)	Playground equipment for immediate local catchment only (the playground is generally located in a small neighbourhood park and is used by the residents nearby), few seats, no picnic facilities, minor landscaping		2
Table 3A3 - Population using equipment	5 to 20 people at a time		2
Table 3A4 - Frequency of use	Playground used mainly on a daily basis		3
Table 3A5 – Natural / Drainage hazards in proximity to site	Hazardous features within 30m of playground equipment (may include steep sloping ground, walking track around reserve).		2
Table 3A6 – Road hazards in proximity to site	Road within 30m of playground equipment: Local Access / Car Park		2
FRR = [(3A2 x 3A3) + 3A4] + (3A5 x 3A6)			11
Table 3A7 – Risk Mitigation Measures applying to FRR: Signage relevant to site, depicting top rated hazard and information indicating importance of parental / carer supervision at all times

Other matters:	It is reasonable that the road be considered an obvious hazard from the playground equipment. It would reduce the potential for inadvertent access between the two if existing mounding / vegetation was extended to provide a separation of 30m or greater.		
Recommendation: That Council erect signage relevant to site, depicting top rated hazard and information indicating importance of parental / carer supervision at all times; consider extending existing mounding / vegetation to provide a separation of 30m or greater between the road and the playground equipment.

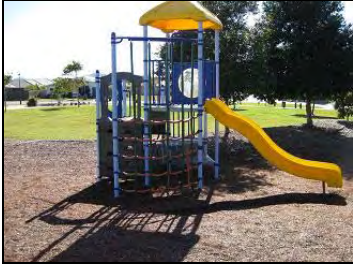
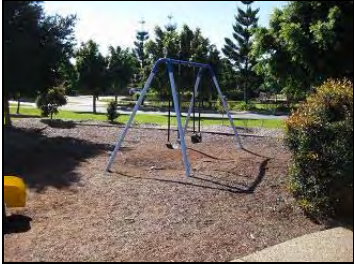
Site Number:	PARK0289	
Site Name:	Seabreeze Boulevard / Taree St Park, Seabreeze Estate, Pottsville

Facility Risk Rating Factors	Rating for Site	Score
Table 3A2 – Development (playground equipment, etc)	Playground equipment for immediate local catchment only (the playground is generally located in a small neighbourhood park and is used by the residents nearby), few seats, no picnic facilities, minor landscaping	2
Table 3A3 - Population using equipment	5 to 20 people at a time	2
Table 3A4 - Frequency of use	Playground used mainly on a daily basis	3
Table 3A5 – Natural / Drainage hazards in proximity to site	No hazardous features within 30m of playground equipment (direct line of sight, any form of hazard)	1
Table 3A6 – Road hazards in proximity to site	Road within 30m of playground equipment: Distributor	4
FRR = [(3A2 x 3A3) + 3A4] + (3A5 x 3A6)		11
Table 3A7 – Risk Mitigation Measures applying to FRR: Signage relevant to site, depicting top rated hazard and information indicating importance of parental / carer supervision at all times

Other matters:	It is reasonable that the road be considered an obvious hazard from the playground. The potential for inadvertent access from the playground equipment to the road by small children would be reduced if separation between the two was enhanced by extending vegetation screens.	
Recommendation: That Council erect signage relevant to site, depicting top rated hazard and information indicating importance of parental / carer supervision at all times; consider extending existing mounding / vegetation to provide a separation of 30m or greater between the road and the playground equipment.

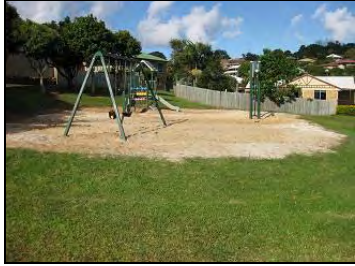
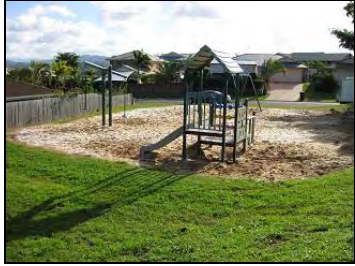
Site Number:	PARK0066	
Site Name:	Bushranger Crescent, Terranora

Facility Risk Rating Factors	Rating for Site	Score
Table 3A2 – Development (playground equipment, etc)	Playground equipment for immediate local catchment only (the playground is generally located in a small neighbourhood park and is used by the residents nearby), few seats, no picnic facilities, minor landscaping	2
Table 3A3 - Population using equipment	5 to 20 people at a time	2
Table 3A4 - Frequency of use	Playground used mainly on a daily basis	3
Table 3A5 – Natural / Drainage hazards in proximity to site	Hazardous features within 30m of playground equipment (may include steep sloping ground, walking track around reserve).	2
Table 3A6 – Road hazards in proximity to site	Road within 30m of playground equipment: Local Access / Car Park	2
FRR = [(3A2 x 3A3) + 3A4] + (3A5 x 3A6)		11
<p>Table 3A7 – Risk Mitigation Measures applying to FRR: Signage relevant to site, depicting top rated hazard and information indicating importance of parental / carer supervision at all times</p>

Other matters:	It is reasonable that the road be considered an obvious hazard from the playground.	
Recommendation: That Council erect signage relevant to site, depicting top rated hazard and information indicating importance of parental / carer supervision at all times.

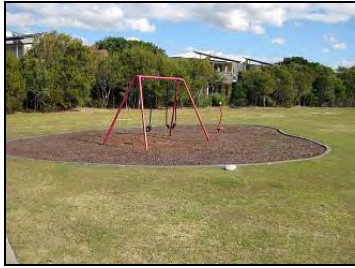
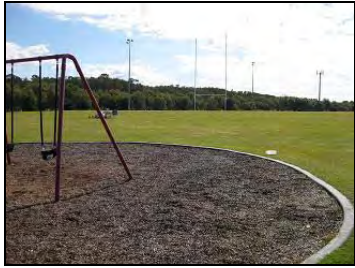
Site Number:	PARK0232	
Site Name:	Casuarina Sportsfields, Barclay Dr, Casuarina

Facility Risk Rating Factors	Rating for Site	Score
Table 3A2 – Development (playground equipment, etc)	Playground equipment for district use (the playground is generally used by residents of the local government area (Shire / City / Municipality) when using adjacent facilities for such things as sports for the local sports clubs and schools). Residents travel from other parts of the LGA to use the playground equipment, and other adjacent facilities including sports field(s), leash free dog areas, some picnic tables and chairs, small toilet block. Locations that have a high degree of seasonality in their use	3
Table 3A3 - Population using equipment	Less than 5 people at a time	1
Table 3A4 - Frequency of use	Playground used mainly on weekends	2
Table 3A5 – Natural / Drainage hazards in proximity to site	Hazardous features within 30m of playground equipment (may include open drainage facility that runs during wet weather, or drops less than 1 metre).	3

Table 3A6 – Road hazards in proximity to site	Road within 30m of playground equipment: Local Access / Car Park	2
FRR = [(3A2 x 3A3) + 3A4] + (3A5 x 3A6)		11
Table 3A7 – Risk Mitigation Measures applying to FRR: Signage relevant to site, depicting top rated hazard and information indicating importance of parental / carer supervision at all times		
Other matters:	It is reasonable that the car park be considered an obvious hazard from the playground.	
Recommendation: That Council erect signage relevant to site, depicting top rated hazard and information indicating importance of parental / carer supervision at all times.
