**PLAYGROUND AUDIT
FOR
TWEED SHIRE COUNCIL**

**August 2009
09-060**

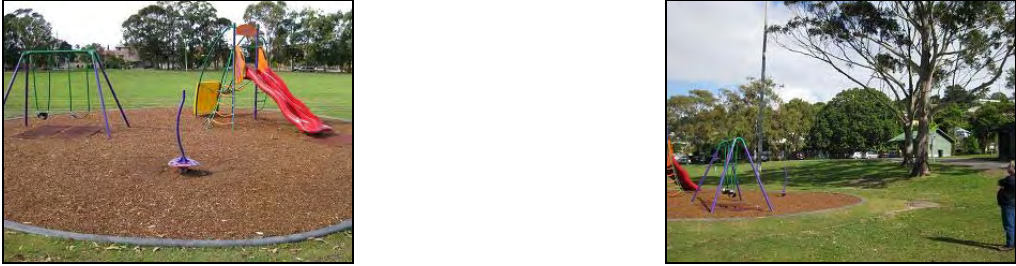
Site Number: PARK0013		
Site Name: Recreation Ground, Recreation St, Tweed Heads

Facility Risk Rating Factors	Rating for Site	Score
Table 3A2 – Development (playground equipment, etc)	Playground equipment for district use (the playground is generally used by residents of the local government area (Shire / City / Municipality) when using adjacent facilities for such things as sports for the local sports clubs and schools). Residents travel from other parts of the LGA to use the playground equipment, and other adjacent facilities including sports field(s), leash free dog areas, some picnic tables and chairs, small toilet block. Locations that have a high degree of seasonality in their use	3
Table 3A3 - Population using equipment	5 to 20 people at a time	2
Table 3A4 - Frequency of use	Playground used mainly on weekends	2
Table 3A5 – Natural / Drainage hazards in proximity to site	No hazardous features within 30m of playground equipment (direct line of sight, any form of hazard)	1

Table 3A6 – Road hazards in proximity to site	Road within 30m of playground equipment: Local Access / Car Park	2
FRR = [(3A2 x 3A3) + 3A4] + (3A5 x 3A6)		10
Table 3A7 – Risk Mitigation Measures applying to FRR: Signage relevant to site, depicting top rated hazard and information indicating importance of parental / carer supervision at all times		
Other matters:	It is reasonable that the road be considered an obvious hazard from the playground.	
Recommendation: That Council erect signage relevant to site, depicting top rated hazard and information indicating importance of parental / carer supervision at all times.

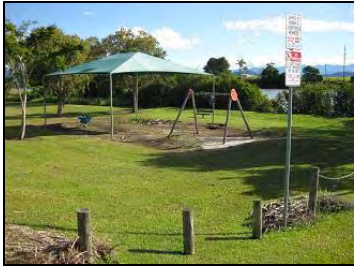
Site Number:	PARK0125	
Site Name:	Lizzio Park, Condong

Facility Risk Rating Factors	Rating for Site	Score
Table 3A2 – Development (playground equipment, etc)	Playground equipment for immediate local catchment only (the playground is generally located in a small neighbourhood park and is used by the residents nearby), few seats, no picnic facilities, minor landscaping	2
Table 3A3 - Population using equipment	5 to 20 people at a time	2
Table 3A4 - Frequency of use	Playground used mainly on weekends	2
Table 3A5 – Natural / Drainage hazards in proximity to site	Hazardous features within 30m of playground equipment (may include open drainage facilities permanently holding water, or drop between 1 metre and 3 metres).	4
Table 3A6 – Road hazards in proximity to site	No road within 30m of playground equipment (direct line of sight, any classification)	1
FRR = [(3A2 x 3A3) + 3A4] + (3A5 x 3A6)		10
Table 3A7 – Risk Mitigation Measures applying to FRR: Signage relevant to site, depicting top rated hazard and information indicating importance of parental / carer supervision at all times

Other matters:	It is reasonable that the river be considered an obvious hazard from the playground, however if someone inadvertently fell over the river bank they may not be seen from the playground. The potential for this to occur would be reduced by providing some form of barrier between the river bank and the playground equipment (vegetation or fencing). It must be noted that this area is flood-prone and subject to debris and water flows at such times, hence a vegetation screen may be most suitable.	
Recommendation: That Council erect signage relevant to site, depicting top rated hazard and information indicating importance of parental / carer supervision at all times; consider establishment of a vegetation barrier providing a minimum 30m separation between the playground equipment and the river.

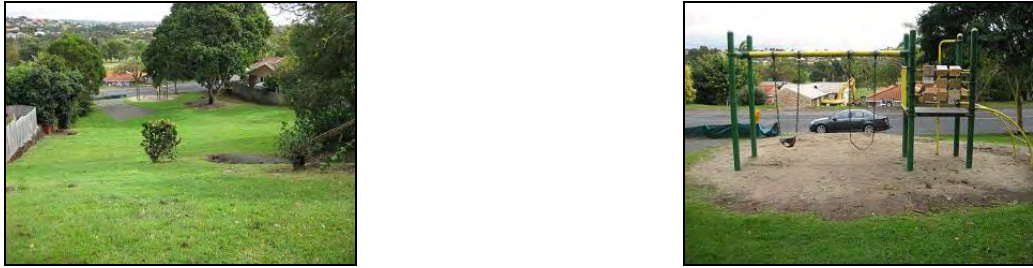
Site Number: PARK0072		
Site Name: Darlington Drive Park, Banora Point

Facility Risk Rating Factors	Rating for Site	Score
Table 3A2 – Development (playground equipment, etc)	Playground equipment for immediate local catchment only (the playground is generally located in a small neighbourhood park and is used by the residents nearby), few seats, no picnic facilities, minor landscaping	2
Table 3A3 - Population using equipment	Less than 5 people at a time	1
Table 3A4 - Frequency of use	Playground used mainly on weekends	2
Table 3A5 – Natural / Drainage hazards in proximity to site	Hazardous features within 30m of playground equipment (may include steep sloping ground, walking track around reserve).	2
Table 3A6 – Road hazards in proximity to site	Road within 30m of playground equipment: Collector	3
FRR = [(3A2 x 3A3) + 3A4] + (3A5 x 3A6)		10
Table 3A7 – Risk Mitigation Measures applying to FRR: Signage relevant to site, depicting top rated hazard and information indicating importance of parental / carer supervision at all times

Other matters:	It is reasonable that the road be considered an obvious hazard from the playground. The potential for a child reaching Darlington Drive would be reduced by the provision of a barrier (vegetation or fencing) to the road frontage of the park.	
Recommendation: That Council erect signage relevant to site, depicting top rated hazard and information indicating importance of parental / carer supervision at all times; consider development of screening the Darlington Drive frontage of the park (vegetation / fence).

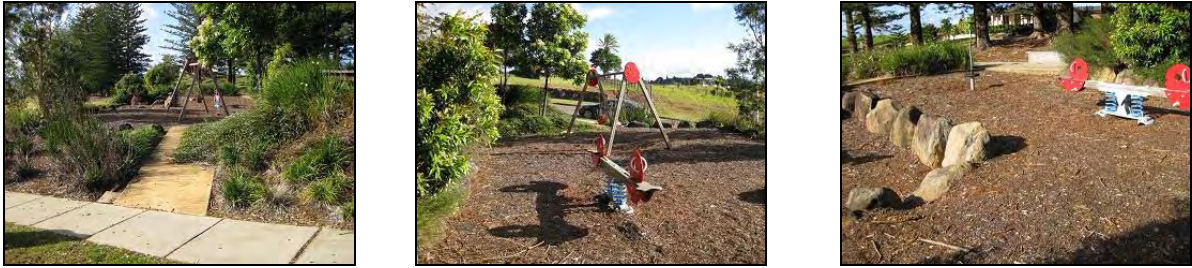
Site Number:	PARK0316	
Site Name:	Sunny Crest Dr Park, Azure Estate, Sunnycrest Dr, Terranora

Facility Risk Rating Factors	Rating for Site	Score
Table 3A2 – Development (playground equipment, etc)	Playground equipment for immediate local catchment only (the playground is generally located in a small neighbourhood park and is used by the residents nearby), few seats, no picnic facilities, minor landscaping	2
Table 3A3 - Population using equipment	Less than 5 people at a time	1
Table 3A4 - Frequency of use	Playground used mainly on weekends	2
Table 3A5 – Natural / Drainage hazards in proximity to site	Hazardous features within 30m of playground equipment (may include open drainage facility that runs during wet weather, or drops less than 1 metre).	3
Table 3A6 – Road hazards in proximity to site	Road within 30m of playground equipment: Local Access / Car Park	2
FRR = [(3A2 x 3A3) + 3A4] + (3A5 x 3A6)		10

<p>Table 3A7 – Risk Mitigation Measures applying to FRR: Signage relevant to site, depicting top rated hazard and information indicating importance of parental / carer supervision at all times</p>		
Other matters:	It is reasonable that the road be considered an obvious hazard from the playground.	
<p>Recommendation: That Council erect signage relevant to site, depicting top rated hazard and information indicating importance of parental / carer supervision at all times.</p>

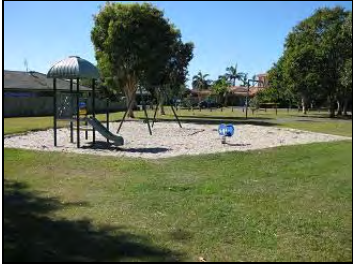
Site Number:	PARK0035	
Site Name:	Grasstree Circuit, Cabarita Beach

Facility Risk Rating Factors	Rating for Site	Score
Table 3A2 – Development (playground equipment, etc)	Playground equipment for immediate local catchment only (the playground is generally located in a small neighbourhood park and is used by the residents nearby), few seats, no picnic facilities, minor landscaping	2
Table 3A3 - Population using equipment	5 to 20 people at a time	2
Table 3A4 - Frequency of use	Playground used mainly on a daily basis	3
Table 3A5 – Natural / Drainage hazards in proximity to site	No hazardous features within 30m of playground equipment (direct line of sight, any form of hazard).	1
Table 3A6 – Road hazards in proximity to site	Road within 30m of playground equipment: Local Access / Car Park	2
FRR = [(3A2 x 3A3) + 3A4] + (3A5 x 3A6)		9
<p>Table 3A7 – Risk Mitigation Measures applying to FRR: Signage relevant to site, depicting top rated hazard and information indicating importance of parental / carer supervision at all times</p>

Other matters:	It is reasonable that the road be considered an obvious hazard from the playground.	
<p>Recommendation: That Council erect signage relevant to site, depicting top rated hazard and information indicating importance of parental / carer supervision at all times.</p>

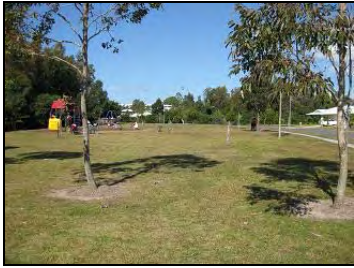
Site Number:	PARK0	
Site Name:	Sugar Glider park, Sugar Glider Drive, Koala Beach, Pottsville

Facility Risk Rating Factors	Rating for Site	Score
Table 3A2 – Development (playground equipment, etc)	Playground equipment for immediate local catchment only (the playground is generally located in a small neighbourhood park and is used by the residents nearby), few seats, no picnic facilities, minor landscaping	2
Table 3A3 - Population using equipment	5 to 20 people at a time	2
Table 3A4 - Frequency of use	Playground used mainly on a daily basis	3
Table 3A5 – Natural / Drainage hazards in proximity to site	No hazardous features within 30m of playground equipment (direct line of sight, any form of hazard).	1
Table 3A6 – Road hazards in proximity to site	Road within 30m of playground equipment: Local Access / Car Park	2
FRR = [(3A2 x 3A3) + 3A4] + (3A5 x 3A6)		9
<p>Table 3A7 – Risk Mitigation Measures applying to FRR: Signage relevant to site, depicting top rated hazard and information indicating importance of parental / carer supervision at all times</p>

Other matters:	It is reasonable that the road be considered an obvious hazard from the playground.	
<p>Recommendation: That Council erect signage relevant to site, depicting top rated hazard and information indicating importance of parental / carer supervision at all times.</p>

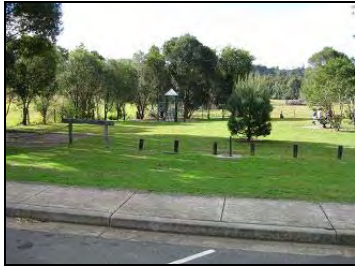
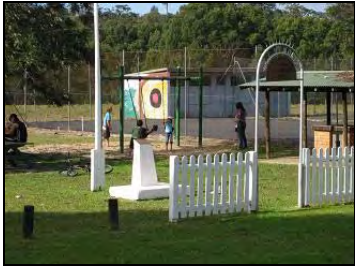
Site Number:	PARK0138	
Site Name:	Tyalgum Memorial Park, Coolman St, Tyalgum

Facility Risk Rating Factors	Rating for Site	Score
Table 3A2 – Development (playground equipment, etc)	Playground equipment for immediate local catchment only (the playground is generally located in a small neighbourhood park and is used by the residents nearby), few seats, no picnic facilities, minor landscaping	2
Table 3A3 - Population using equipment	5 to 20 people at a time	2
Table 3A4 - Frequency of use	Playground used mainly on a daily basis	3
Table 3A5 – Natural / Drainage hazards in proximity to site	No hazardous features within 30m of playground equipment (direct line of sight, any form of hazard).	1
Table 3A6 – Road hazards in proximity to site	Road within 30m of playground equipment: Local Access / Car Park	2
FRR = [(3A2 x 3A3) + 3A4] + (3A5 x 3A6)		9
<p>Table 3A7 – Risk Mitigation Measures applying to FRR: Signage relevant to site, depicting top rated hazard and information indicating importance of parental / carer supervision at all times</p>

Other matters:	It is reasonable that the road be considered an obvious hazard from the playground.	
Recommendation: That Council erect signage relevant to site, depicting top rated hazard and information indicating importance of parental / carer supervision at all times.

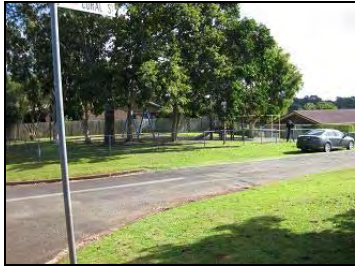
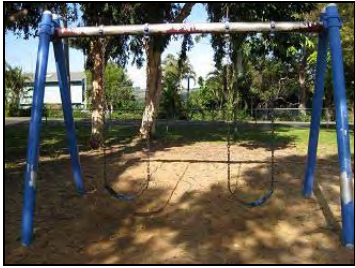
Site Number:	PARK0315	
Site Name:	Coral St Park, Coral St, Bilambil Heights

Facility Risk Rating Factors	Rating for Site	Score
Table 3A2 – Development (playground equipment, etc)	Playground equipment for immediate local catchment only (the playground is generally located in a small neighbourhood park and is used by the residents nearby), few seats, no picnic facilities, minor landscaping	2
Table 3A3 - Population using equipment	5 to 20 people at a time	2
Table 3A4 - Frequency of use	Playground used mainly on weekends	2
Table 3A5 – Natural / Drainage hazards in proximity to site	No hazardous features within 30m of playground equipment (direct line of sight, any form of hazard).	1
Table 3A6 – Road hazards in proximity to site	Road within 30m of playground equipment: Collector	3
FRR = [(3A2 x 3A3) + 3A4] + (3A5 x 3A6)		9
Table 3A7 – Risk Mitigation Measures applying to FRR: Signage relevant to site, depicting top rated hazard and information indicating importance of parental / carer supervision at all times

Other matters:	It is reasonable that the roads be considered obvious hazards from the playground. The existing fencing provides a restriction to free access from the playground to both Coral Street and Simson Drive. It is appropriate that Council maintains the fence to ensure this benefit is retained.	
Recommendation: That Council erect signage relevant to site, depicting top rated hazard and information indicating importance of parental / carer supervision at all times.

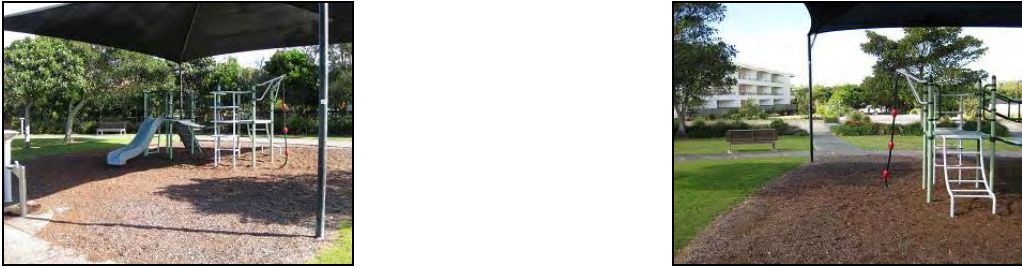
Site Number: PARK0226		
Site Name: Casuarina Way playground, Chatfield Court, Casuarina

Facility Risk Rating Factors	Rating for Site	Score
Table 3A2 – Development (playground equipment, etc)	Playground equipment for immediate local catchment only (the playground is generally located in a small neighbourhood park and is used by the residents nearby), few seats, no picnic facilities, minor landscaping	2
Table 3A3 - Population using equipment	5 to 20 people at a time	2
Table 3A4 - Frequency of use	Playground used mainly on weekends	2
Table 3A5 – Natural / Drainage hazards in proximity to site	No hazardous features within 30m of playground equipment (direct line of sight, any form of hazard).	1
Table 3A6 – Road hazards in proximity to site	Road within 30m of playground equipment: Collector	3
FRR = [(3A2 x 3A3) + 3A4] + (3A5 x 3A6)		9
<p>Table 3A7 – Risk Mitigation Measures applying to FRR: Signage relevant to site, depicting top rated hazard and information indicating importance of parental / carer supervision at all times</p>

Other matters:	It is reasonable that the road be considered an obvious hazard from the playground. The existing vegetation zones provide a restriction to direct access between the playground equipment and the road.	
Recommendation: That Council erect signage relevant to site, depicting top rated hazard and information indicating importance of parental / carer supervision at all times.

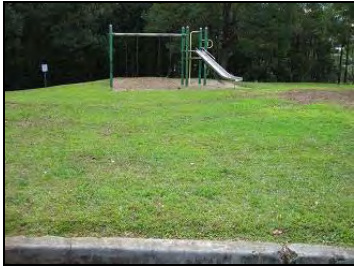
Site Number:	PARK0110	
Site Name:	Arbor Place Park, Arbor PI, Murwillumbah

Facility Risk Rating Factors	Rating for Site	Score
Table 3A2 – Development (playground equipment, etc)	Playground equipment for immediate local catchment only (the playground is generally located in a small neighbourhood park and is used by the residents nearby), few seats, no picnic facilities, minor landscaping	2
Table 3A3 - Population using equipment	Less than 5 people at a time	1
Table 3A4 - Frequency of use	Playground used mainly on a daily basis	3
Table 3A5 – Natural / Drainage hazards in proximity to site	Hazardous features within 30m of playground equipment (may include steep sloping ground, walking track around reserve).	2
Table 3A6 – Road hazards in proximity to site	Road within 30m of playground equipment: Local Access / Car Park	2
FRR = [(3A2 x 3A3) + 3A4] + (3A5 x 3A6)		9
<p>Table 3A7 – Risk Mitigation Measures applying to FRR: Signage relevant to site, depicting top rated hazard and information indicating importance of parental / carer supervision at all times</p>

Other matters:	It is reasonable that the road be considered an obvious hazard from the playground.	
<p>Recommendation: That Council erect signage relevant to site, depicting top rated hazard and information indicating importance of parental / carer supervision at all times.</p>

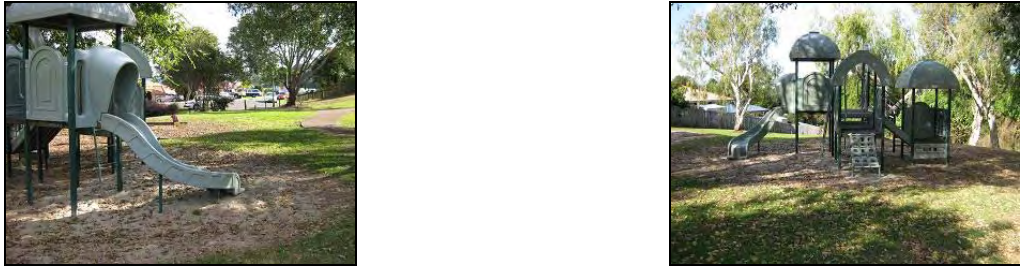
Site Number:	PARK0176	
Site Name:	Sierra Vista Estate Park, Tweed Heads

Facility Risk Rating Factors	Rating for Site	Score
Table 3A2 – Development (playground equipment, etc)	Playground equipment for immediate local catchment only (the playground is generally located in a small neighbourhood park and is used by the residents nearby), few seats, no picnic facilities, minor landscaping	2
Table 3A3 - Population using equipment	5 to 20 people at a time	2
Table 3A4 - Frequency of use	Playground rarely used	1
Table 3A5 – Natural / Drainage hazards in proximity to site	Hazardous features within 30m of playground equipment (may include steep sloping ground, walking track around reserve).	2
Table 3A6 – Road hazards in proximity to site	Road within 30m of playground equipment: Local Access / Car Park	2
FRR = [(3A2 x 3A3) + 3A4] + (3A5 x 3A6)		9
<p>Table 3A7 – Risk Mitigation Measures applying to FRR: Signage relevant to site, depicting top rated hazard and information indicating importance of parental / carer supervision at all times</p>

Other matters:	It is reasonable that the road be considered an obvious hazard from the playground.	
<p>Recommendation: That Council erect signage relevant to site, depicting top rated hazard and information indicating importance of parental / carer supervision at all times.</p>

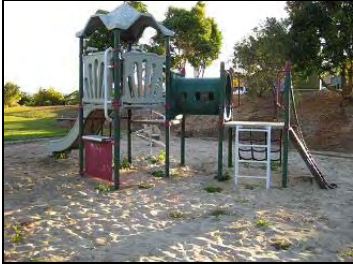
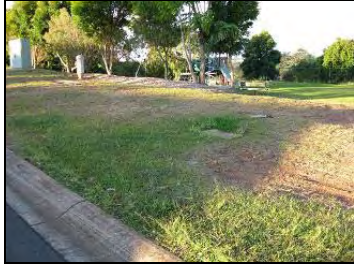
Site Number:	PARK0090	
Site Name:	Vintage Lakes Playground, Champagne Dr, Tweed Heads South

Facility Risk Rating Factors	Rating for Site	Score
Table 3A2 – Development (playground equipment, etc)	Playground equipment for immediate local catchment only (the playground is generally located in a small neighbourhood park and is used by the residents nearby), few seats, no picnic facilities, minor landscaping	2
Table 3A3 - Population using equipment	Less than 5 people at a time	1
Table 3A4 - Frequency of use	Playground rarely used	1
Table 3A5 – Natural / Drainage hazards in proximity to site	Hazardous features within 30m of playground equipment (may include steep sloping ground, walking track around reserve).	2
Table 3A6 – Road hazards in proximity to site	Road within 30m of playground equipment: Collector	3
FRR = [(3A2 x 3A3) + 3A4] + (3A5 x 3A6)		9
<p>Table 3A7 – Risk Mitigation Measures applying to FRR: Signage relevant to site, depicting top rated hazard and information indicating importance of parental / carer supervision at all times</p>

Other matters:	It is reasonable that the road be considered an obvious hazard from the playground. The existing fencing between the playground and the downhill side is extensively vandalized. Since the vegetation below the fence discourages access to the hillside, it would be appropriate to remove what remains of the fence to reduce the risk of injury to users of the site.	
<p>Recommendation: That Council erect signage relevant to site, depicting top rated hazard and information indicating importance of parental / carer supervision at all times; consider removal of the remaining fence on the downhill side of the playground.</p>

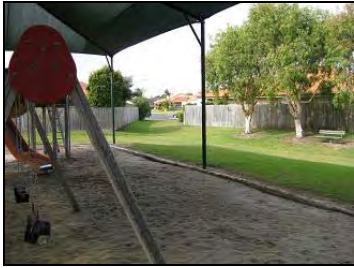
Site Number:	PARK0048	
Site Name:	Shore Place, Kingscliff

Facility Risk Rating Factors	Rating for Site	Score
Table 3A2 – Development (playground equipment, etc)	Playground equipment for immediate local catchment only (the playground is generally located in a small neighbourhood park and is used by the residents nearby), few seats, no picnic facilities, minor landscaping	2
Table 3A3 - Population using equipment	5 to 20 people at a time	2
Table 3A4 - Frequency of use	Playground used mainly on a daily basis	3
Table 3A5 – Natural / Drainage hazards in proximity to site	No hazardous features within 30m of playground equipment (direct line of sight, any form of hazard).	1
Table 3A6 – Road hazards in proximity to site	Road within 30m of playground equipment: Distributor	4
FRR = [(3A2 x 3A3) + 3A4] + (3A5 x 3A6)		11
<p>Table 3A7 – Risk Mitigation Measures applying to FRR: Signage relevant to site, depicting top rated hazard and information indicating importance of parental / carer supervision at all times</p>

Other matters:	The existing fence between the playground and Elrond Drive is an important risk mitigation measure to prevent access to the road. It is important to maintain the fence to maximize the access restriction.	
<p>Recommendation: That Council erect signage relevant to site, depicting top rated hazard and information indicating importance of parental / carer supervision at all times and maintain the existing fence between the playground and Elrond Drive.</p>

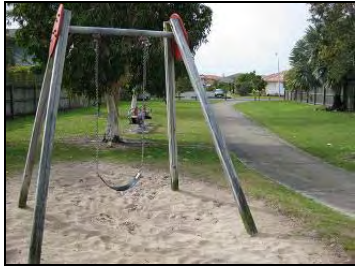
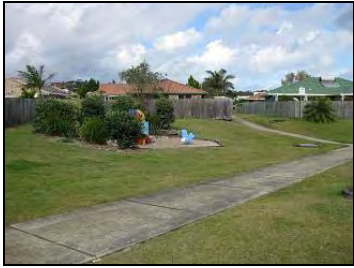
Site Number:	PARK0049	
Site Name:	IbisCourt, Kingscliff

Facility Risk Rating Factors	Rating for Site	Score
Table 3A2 – Development (playground equipment, etc)	Playground equipment for immediate local catchment only (the playground is generally located in a small neighbourhood park and is used by the residents nearby), few seats, no picnic facilities, minor landscaping	2
Table 3A3 - Population using equipment	5 to 20 people at a time	2
Table 3A4 - Frequency of use	Playground used mainly on weekends	2
Table 3A5 – Natural / Drainage hazards in proximity to site	No hazardous features within 30m of playground equipment (direct line of sight, any form of hazard).	1
Table 3A6 – Road hazards in proximity to site	Road within 30m of playground equipment: Local Access / Car Park	2
FRR = [(3A2 x 3A3) + 3A4] + (3A5 x 3A6)		8
<p>Table 3A7 – Risk Mitigation Measures applying to FRR: Signage relevant to site, depicting top rated hazard and information indicating importance of parental / carer supervision at all times</p>

Other matters:	It is reasonable that the car parking area be considered an obvious hazard from the playground.	
<p>Recommendation: That Council erect signage relevant to site, depicting top rated hazard and information indicating importance of parental / carer supervision at all times.</p>

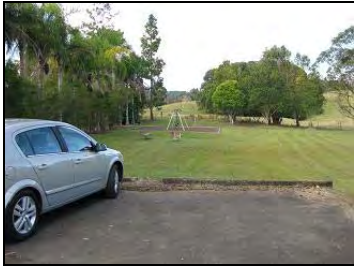
Site Number:	PARK0120	
Site Name:	Amarillo Drive Park, Amarillo Drive, Murwillumbah

Facility Risk Rating Factors	Rating for Site	Score
Table 3A2 – Development (playground equipment, etc)	Playground equipment for immediate local catchment only (the playground is generally located in a small neighbourhood park and is used by the residents nearby), few seats, no picnic facilities, minor landscaping	2
Table 3A3 - Population using equipment	5 to 20 people at a time	2
Table 3A4 - Frequency of use	Playground used mainly on weekends	2
Table 3A5 – Natural / Drainage hazards in proximity to site	No hazardous features within 30m of playground equipment (direct line of sight, any form of hazard).	1
Table 3A6 – Road hazards in proximity to site	Road within 30m of playground equipment: Local Access / Car Park	2
FRR = [(3A2 x 3A3) + 3A4] + (3A5 x 3A6)		8
<p>Table 3A7 – Risk Mitigation Measures applying to FRR: Signage relevant to site, depicting top rated hazard and information indicating importance of parental / carer supervision at all times</p>

Other matters:	It is reasonable that the road be considered an obvious hazard from the playground.	
<p>Recommendation: That Council erect signage relevant to site, depicting top rated hazard and information indicating importance of parental / carer supervision at all times.</p>

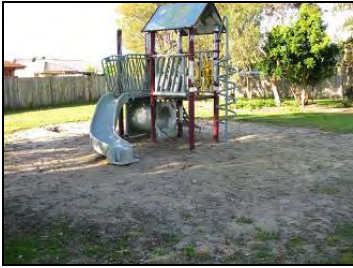
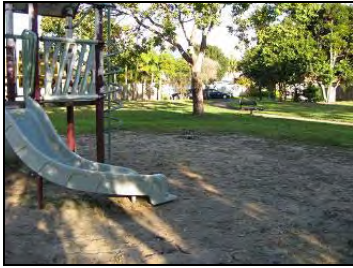
Site Number:	PARK0070	
Site Name:	Covent Garden Way Park, Terranora

Facility Risk Rating Factors	Rating for Site	Score
Table 3A2 – Development (playground equipment, etc)	Site with basic playground equipment, no picnic facilities	1
Table 3A3 - Population using equipment	5 to 20 people at a time	2
Table 3A4 - Frequency of use	Playground used mainly on a daily basis	3
Table 3A5 – Natural / Drainage hazards in proximity to site	No hazardous features within 30m of playground equipment (direct line of sight, any form of hazard).	1
Table 3A6 – Road hazards in proximity to site	Road within 30m of playground equipment: Collector	3
FRR = [(3A2 x 3A3) + 3A4] + (3A5 x 3A6)		8
<p>Table 3A7 – Risk Mitigation Measures applying to FRR: Signage relevant to site, depicting top rated hazard and information indicating importance of parental / carer supervision at all times</p>		
Other matters:	It is reasonable that the roads be considered obvious hazards from the playground. The existing fence on the park's frontage to Covent Gardens Way provides a restriction to access from the playground equipment to the road. It is desirable that the fence be maintained.

Recommendation: That Council erect signage relevant to site, depicting top rated hazard and information indicating importance of parental / carer supervision at all times.

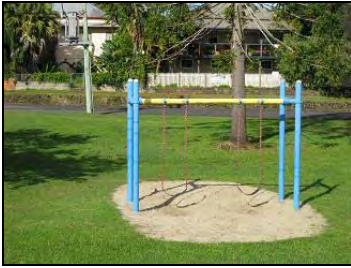
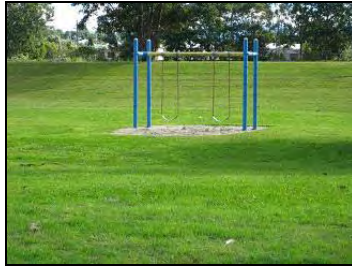
Site Number:	PARK0117	
Site Name:	Hartman Park, River St, Murwillumbah

Facility Risk Rating Factors	Rating for Site	Score
Table 3A2 – Development (playground equipment, etc)	Site with basic playground equipment, no picnic facilities	1
Table 3A3 - Population using equipment	Less than 5 people at a time	1
Table 3A4 - Frequency of use	Playground used mainly on a daily basis	3
Table 3A5 – Natural / Drainage hazards in proximity to site	Hazardous features within 30m of playground equipment (may include open drainage facilities permanently holding water, or drop between 1 metre and 3 metres).	4
Table 3A6 – Road hazards in proximity to site	No road within 30m of playground equipment (direct line of sight, any classification)	1
	FRR = [(3A2 x 3A3) + 3A4] + (3A5 x 3A6)	8
<p>Table 3A7 – Risk Mitigation Measures applying to FRR: Signage relevant to site, depicting top rated hazard and information indicating importance of parental / carer supervision at all times</p>

Other matters:	It is reasonable that the road be considered an obvious hazard from the playground. The Tweed River is not obvious from the playground due to the levee bank.	
<p>Recommendation: That Council erect signage relevant to site, depicting top rated hazard and information indicating importance of parental / carer supervision at all times.</p>

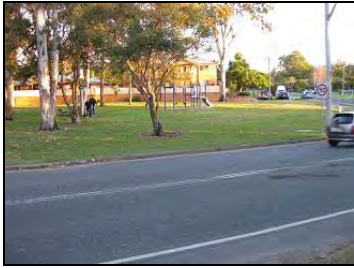
Site Number:	PARK0088	
Site Name:	Suter Park, Dry Dock Rd, Tweed Heads South

Facility Risk Rating Factors	Rating for Site	Score
Table 3A2 – Development (playground equipment, etc)	Site with basic playground equipment, no picnic facilities	1
Table 3A3 - Population using equipment	Less than 5 people at a time	1
Table 3A4 - Frequency of use	Playground used mainly on weekends	2
Table 3A5 – Natural / Drainage hazards in proximity to site	No hazardous features within 30m of playground equipment (direct line of sight, any form of hazard)	1
Table 3A6 – Road hazards in proximity to site	Road within 30m of playground equipment: Sub Arterial	5
FRR = [(3A2 x 3A3) + 3A4] + (3A5 x 3A6)		8
<p>Table 3A7 – Risk Mitigation Measures applying to FRR: Signage relevant to site, depicting top rated hazard and information indicating importance of parental / carer supervision at all times</p>		
Other matters:	It is reasonable that the roads be considered obvious hazards from the playground.

<p>Recommendation: That Council erect signage relevant to site, depicting top rated hazard and information indicating importance of parental / carer supervision at all times.</p>

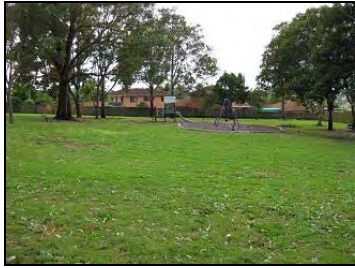
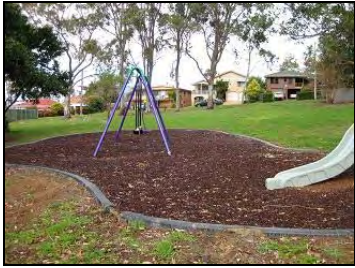
Site Number:	PARK0059	
Site Name:	Peter Solomon Park, Peter Street, Banora Point

Facility Risk Rating Factors	Rating for Site	Score
Table 3A2 – Development (playground equipment, etc)	Playground equipment for immediate local catchment only (the playground is generally located in a small neighbourhood park and is used by the residents nearby), few seats, no picnic facilities, minor landscaping	2
Table 3A3 - Population using equipment	5 to 20 people at a time	2
Table 3A4 - Frequency of use	Playground used mainly on weekends	2
Table 3A5 – Natural / Drainage hazards in proximity to site	No hazardous features within 30m of playground equipment (direct line of sight, any form of hazard).	1
Table 3A6 – Road hazards in proximity to site	No road within 30m of playground equipment (direct line of sight, any classification)	1
	FRR = [(3A2 x 3A3) + 3A4] + (3A5 x 3A6)	7
<p>Table 3A7 – Risk Mitigation Measures applying to FRR: Signage relevant to site, depicting top rated hazard and information indicating importance of parental / carer supervision at all times</p>

Other matters:	These playground equipment are situated well clear of the road.	
Recommendation: That Council erect signage relevant to site, depicting top rated hazard and information indicating importance of parental / carer supervision at all times.

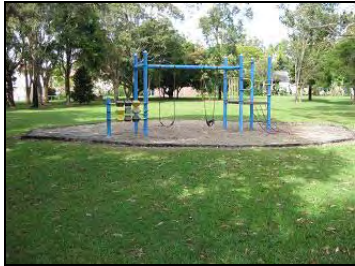
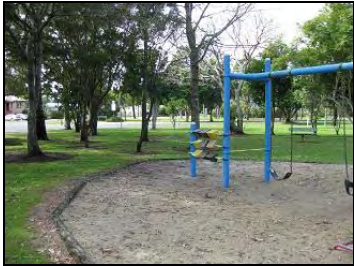
Site Number:	PARK0051	
Site Name:	Turnock Park, Chinderah Rd, Chinderah

Facility Risk Rating Factors	Rating for Site	Score
Table 3A2 – Development (playground equipment, etc)	Playground equipment for immediate local catchment only (the playground is generally located in a small neighbourhood park and is used by the residents nearby), few seats, no picnic facilities, minor landscaping	2
Table 3A3 - Population using equipment	5 to 20 people at a time	2
Table 3A4 - Frequency of use	Playground used mainly on weekends	2
Table 3A5 – Natural / Drainage hazards in proximity to site	No hazardous features within 30m of playground equipment (direct line of sight, any form of hazard).	1
Table 3A6 – Road hazards in proximity to site	No road within 30m of playground equipment (direct line of sight, any classification)	1
	FRR = [(3A2 x 3A3) + 3A4] + (3A5 x 3A6)	7
<p>Table 3A7 – Risk Mitigation Measures applying to FRR: Signage relevant to site, depicting top rated hazard and information indicating importance of parental / carer supervision at all times</p>

Other matters:		
<p>Recommendation: That Council erect signage relevant to site, depicting top rated hazard and information indicating importance of parental / carer supervision at all times.</p>

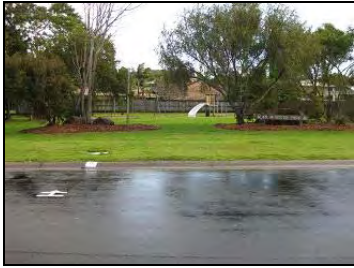
Site Number:	PARK0045	
Site Name:	Alan McIntosh Park, Guilfoyle PI, Cudgen

Facility Risk Rating Factors	Rating for Site	Score
Table 3A2 – Development (playground equipment, etc)	Playground equipment for immediate local catchment only (the playground is generally located in a small neighbourhood park and is used by the residents nearby), few seats, no picnic facilities, minor landscaping	2
Table 3A3 - Population using equipment	5 to 20 people at a time	2
Table 3A4 - Frequency of use	Playground used mainly on weekends	2
Table 3A5 – Natural / Drainage hazards in proximity to site	No hazardous features within 30m of playground equipment (direct line of sight, any form of hazard).	1
Table 3A6 – Road hazards in proximity to site	No road within 30m of playground equipment (direct line of sight, any classification)	1
FRR = [(3A2 x 3A3) + 3A4] + (3A5 x 3A6)		7
<p>Table 3A7 – Risk Mitigation Measures applying to FRR: Signage relevant to site, depicting top rated hazard and information indicating importance of parental / carer supervision at all times</p>

Other matters:	It is reasonable that the road be considered an obvious hazard from the playground.	
<p>Recommendation: That Council erect signage relevant to site, depicting top rated hazard and information indicating importance of parental / carer supervision at all times.</p>

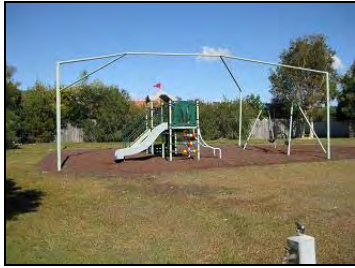
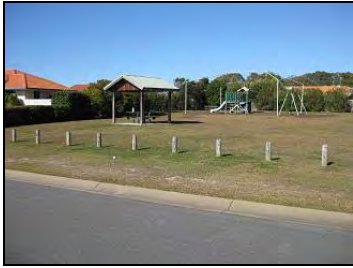
Site Number:	PARK0223	
Site Name:	Border Crescent Park, Black Rocks Estate, Pottsville

Facility Risk Rating Factors	Rating for Site	Score
Table 3A2 – Development (playground equipment, etc)	Playground equipment for immediate local catchment only (the playground is generally located in a small neighbourhood park and is used by the residents nearby), few seats, no picnic facilities, minor landscaping	2
Table 3A3 - Population using equipment	5 to 20 people at a time	2
Table 3A4 - Frequency of use	Playground used mainly on weekends	2
Table 3A5 – Natural / Drainage hazards in proximity to site	No hazardous features within 30m of playground equipment (direct line of sight, any form of hazard).	1
Table 3A6 – Road hazards in proximity to site	No road within 30m of playground equipment (direct line of sight, any classification)	1
FRR = [(3A2 x 3A3) + 3A4] + (3A5 x 3A6)		7
<p>Table 3A7 – Risk Mitigation Measures applying to FRR: Signage relevant to site, depicting top rated hazard and information indicating importance of parental / carer supervision at all times</p>

Other matters:	It is reasonable that the road be considered an obvious hazard from the playground.	
<p>Recommendation: That Council erect signage relevant to site, depicting top rated hazard and information indicating importance of parental / carer supervision at all times.</p>

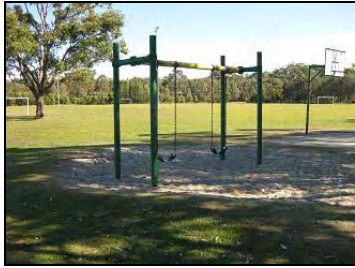
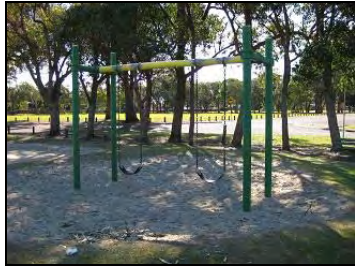
Site Number:	PARK0011	
Site Name:	Arkinstall Park, Cunningham St, Tweed Heads South

Facility Risk Rating Factors	Rating for Site	Score
Table 3A2 – Development (playground equipment, etc)	Playground equipment for district use (the playground is generally used by residents of the local government area (Shire / City / Municipality) when using adjacent facilities for such things as sports for the local sports clubs and schools). Residents travel from other parts of the LGA to use the playground equipment, and other adjacent facilities including sports field(s), leash free dog areas, some picnic tables and chairs, small toilet block. Locations that have a high degree of seasonality in their use	3
Table 3A3 - Population using equipment	Less than 5 people at a time	1
Table 3A4 - Frequency of use	Playground used mainly on weekends	2
Table 3A5 – Natural / Drainage hazards in proximity to site	No hazardous features within 30m of playground equipment (direct line of sight, any form of hazard).	1

Table 3A6 – Road hazards in proximity to site	Road within 30m of playground equipment: Local Access / Car Park	2
FRR = [(3A2 x 3A3) + 3A4] + (3A5 x 3A6)		7
Table 3A7 – Risk Mitigation Measures applying to FRR: Signage relevant to site, depicting top rated hazard and information indicating importance of parental / carer supervision at all times		
Other matters:	It is reasonable that the car park be considered an obvious hazard from the playground. The existing timber bollards provide some delineation of the park, although they do not restrict direct access from the playground equipment to the roadway. Enhancement of the “fence” would reduce the potential for inadvertent access from the playground equipment to the car park.	
Recommendation: That Council erect signage relevant to site, depicting top rated hazard and information indicating importance of parental / carer supervision at all times.

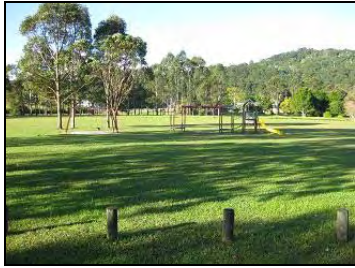
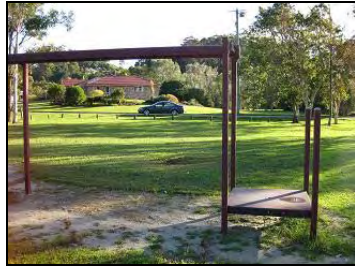
Site Number:	PARK0126	
Site Name:	Elva North Park, North Lane, Nunderi

Facility Risk Rating Factors	Rating for Site	Score
Table 3A2 – Development (playground equipment, etc)	Site with basic playground equipment, no picnic facilities	1
Table 3A3 - Population using equipment	5 to 20 people at a time	2
Table 3A4 - Frequency of use	Playground used mainly on weekends	2
Table 3A5 – Natural / Drainage hazards in proximity to site	No hazardous features within 30m of playground equipment (direct line of sight, any form of hazard).	1
Table 3A6 – Road hazards in proximity to site	Road within 30m of playground equipment: Collector	3
FRR = [(3A2 x 3A3) + 3A4] + (3A5 x 3A6)		7
<p>Table 3A7 – Risk Mitigation Measures applying to FRR: Signage relevant to site, depicting top rated hazard and information indicating importance of parental / carer supervision at all times</p>		
Other matters:	It is reasonable that the road be considered an obvious hazard from the playground.

Recommendation: That Council erect signage relevant to site, depicting top rated hazard and information indicating importance of parental / carer supervision at all times.

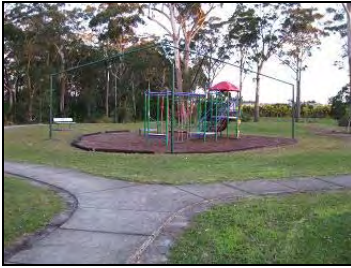
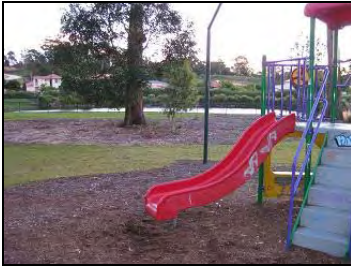
Site Number:	PARK0253	
Site Name:	Harold Pearce Park, Falcon Way, Tweed Heads South

Facility Risk Rating Factors	Rating for Site	Score
Table 3A2 – Development (playground equipment, etc)	Playground equipment for immediate local catchment only (the playground is generally located in a small neighbourhood park and is used by the residents nearby), few seats, no picnic facilities, minor landscaping	2
Table 3A3 - Population using equipment	Less than 5 people at a time	1
Table 3A4 - Frequency of use	Playground used mainly on weekends	2
Table 3A5 – Natural / Drainage hazards in proximity to site	Hazardous features within 30m of playground equipment (may include open drainage facility that runs during wet weather, or drops less than 1 metre)	3
Table 3A6 – Road hazards in proximity to site	No road within 30m of playground equipment (direct line of sight, any classification)	1
FRR = [(3A2 x 3A3) + 3A4] + (3A5 x 3A6)		7

<p>Table 3A7 – Risk Mitigation Measures applying to FRR: Signage relevant to site, depicting top rated hazard and information indicating importance of parental / carer supervision at all times</p>		
Other matters:	The existing fences at the drainage facilities are an important risk mitigation measure, and should be inspected and maintained systematically.	
Recommendation: That Council erect signage relevant to site, depicting top rated hazard and information indicating importance of parental / carer supervision at all times.

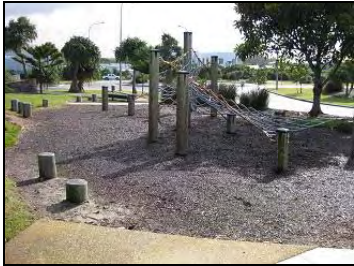
Site Number:	PARK0	
Site Name:	Norfolk Park, Euston St/ Saltwater Cres, Salt

Facility Risk Rating Factors	Rating for Site	Score
Table 3A2 – Development (playground equipment, etc)	Site with basic playground equipment, no picnic facilities	1
Table 3A3 - Population using equipment	5 to 20 people at a time	2
Table 3A4 - Frequency of use	Playground used mainly on weekends	2
Table 3A5 – Natural / Drainage hazards in proximity to site	No hazardous features within 30m of playground equipment (direct line of sight, any form of hazard).	1
Table 3A6 – Road hazards in proximity to site	Road within 30m of playground equipment: Collector	3
FRR = [(3A2 x 3A3) + 3A4] + (3A5 x 3A6)		7
<p>Table 3A7 – Risk Mitigation Measures applying to FRR: Signage relevant to site, depicting top rated hazard and information indicating importance of parental / carer supervision at all times</p>		
Other matters:	It is reasonable that the roads be considered obvious hazards from the playground. The nature of this item of playground equipment reduces the likelihood of its use by small children.

Recommendation: That Council erect signage relevant to site, depicting top rated hazard and information indicating importance of parental / carer supervision at all times.

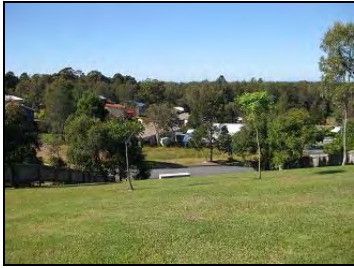
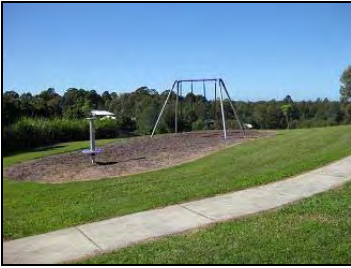
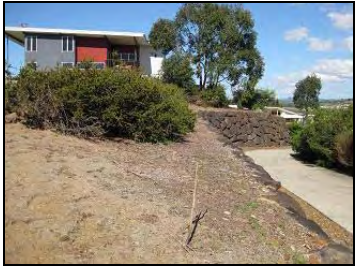
Site Number:	PARK0280	
Site Name:	Euodia Ave Park, Koala Beach, Pottsville

Facility Risk Rating Factors	Rating for Site	Score
Table 3A2 – Development (playground equipment, etc)	Site with basic playground equipment, no picnic facilities	1
Table 3A3 - Population using equipment	Less than 5 people at a time	1
Table 3A4 - Frequency of use	Playground used mainly on weekends	2
Table 3A5 – Natural / Drainage hazards in proximity to site	Hazardous features within 30m of playground equipment (may include open drainage facilities permanently holding water, or drop between 1 metre and 3 metres).	4
Table 3A6 – Road hazards in proximity to site	No road within 30m of playground equipment (direct line of sight, any classification)	1
FRR = [(3A2 x 3A3) + 3A4] + (3A5 x 3A6)		7
<p>Table 3A7 – Risk Mitigation Measures applying to FRR: Signage relevant to site, depicting top rated hazard and information indicating importance of parental / carer supervision at all times</p>

Other matters:	The vegetation screening at the top of the retaining walls is an important risk mitigation measure. This vegetation should be maintained and replaced if individual plants die or are otherwise removed.	
<p>Recommendation: That Council erect signage relevant to site, depicting top rated hazard and information indicating importance of parental / carer supervision at all times; Inspect, maintain and replace vegetation screen at top of retaining walls.</p>

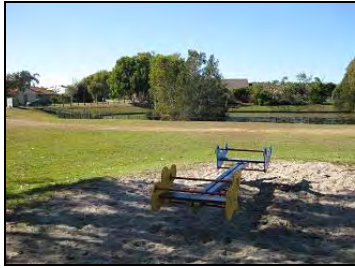
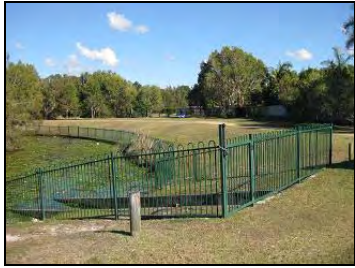
Site Number:	PARK0023	
Site Name:	McKenzie Avenue Park, Black Rocks Estate, Pottsville

Facility Risk Rating Factors	Rating for Site	Score
Table 3A2 – Development (playground equipment, etc)	Site with basic playground equipment, no picnic facilities	1
Table 3A3 - Population using equipment	Less than 5 people at a time	1
Table 3A4 - Frequency of use	Playground used mainly on weekends	2
Table 3A5 – Natural / Drainage hazards in proximity to site	Hazardous features within 30m of playground equipment (may include open drainage facilities permanently holding water, or drop between 1 metre and 3 metres).	4
Table 3A6 – Road hazards in proximity to site	No road within 30m of playground equipment (direct line of sight, any classification)	1
	FRR = [(3A2 x 3A3) + 3A4] + (3A5 x 3A6)	7
<p>Table 3A7 – Risk Mitigation Measures applying to FRR: Signage relevant to site, depicting top rated hazard and information indicating importance of parental / carer supervision at all times</p>

Other matters:	The existing fences to the drainage facilities are a significant risk management measure and should be inspected and maintained in a systematic manner.	
Recommendation: That Council erect signage relevant to site, depicting top rated hazard and information indicating importance of parental / carer supervision at all times; inspect and maintain drainage facility fences.

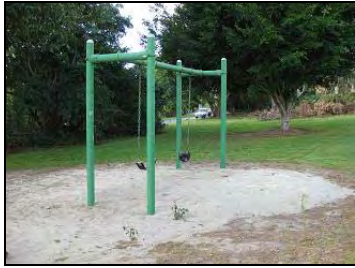
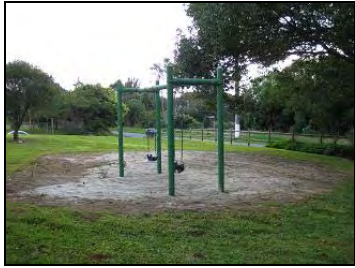
Site Number:	PARK0063	
Site Name:	Windley Park, Terranora Rd, Terranora

Facility Risk Rating Factors	Rating for Site	Score
Table 3A2 – Development (playground equipment, etc)	Site with basic playground equipment, no picnic facilities	1
Table 3A3 - Population using equipment	Less than 5 people at a time	1
Table 3A4 - Frequency of use	Playground rarely used	1
Table 3A5 – Natural / Drainage hazards in proximity to site	No hazardous features within 30m of playground equipment (direct line of sight, any form of hazard)	1
Table 3A6 – Road hazards in proximity to site	Road within 30m of playground equipment: Sub Arterial	5
FRR = [(3A2 x 3A3) + 3A4] + (3A5 x 3A6)		7
<p>Table 3A7 – Risk Mitigation Measures applying to FRR: Signage relevant to site, depicting top rated hazard and information indicating importance of parental / carer supervision at all times</p>		
Other matters:	It is reasonable that the road be considered an obvious hazard from the playground.

Recommendation: That Council erect signage relevant to site, depicting top rated hazard and information indicating importance of parental / carer supervision at all times.

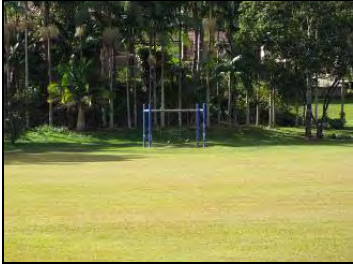
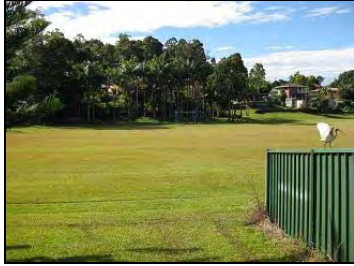
Site Number:	PARK0106	
Site Name:	Countryside Park, Countryside Drive, Murwillumbah

Facility Risk Rating Factors	Rating for Site	Score
Table 3A2 – Development (playground equipment, etc)	Site with basic playground equipment, no picnic facilities	1
Table 3A3 - Population using equipment	5 to 20 people at a time	2
Table 3A4 - Frequency of use	Playground used mainly on a daily basis	3
Table 3A5 – Natural / Drainage hazards in proximity to site	No hazardous features within 30m of playground equipment (direct line of sight, any form of hazard)	1
Table 3A6 – Road hazards in proximity to site	No road within 30m of playground equipment (direct line of sight, any classification)	1
	FRR = [(3A2 x 3A3) + 3A4] + (3A5 x 3A6)	6
Table 3A7 – Risk Mitigation Measures applying to FRR: Provide signage relevant to site, indicating importance of parental / carer supervision at all times		
Other matters:		
Recommendation: That Council erect signage relevant to site, indicating importance of parental / carer supervision at all times.

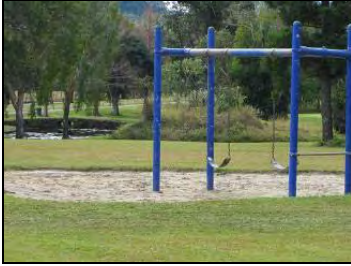
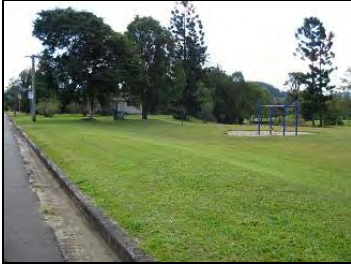
Site Number:	PARK0108	
Site Name:	Tamarisk Avenue Park, Tamarisk Avenue, Murwillumbah

Facility Risk Rating Factors	Rating for Site	Score
Table 3A2 – Development (playground equipment, etc)	Site with basic playground equipment, no picnic facilities	1
Table 3A3 - Population using equipment	Less than 5 people at a time	1
Table 3A4 - Frequency of use	Playground used mainly on a daily basis	3
Table 3A5 – Natural / Drainage hazards in proximity to site	No hazardous features within 30m of playground equipment (direct line of sight, any form of hazard)	1
Table 3A6 – Road hazards in proximity to site	Road within 30m of playground equipment: Local Access / Car Park	2
	FRR = [(3A2 x 3A3) + 3A4] + (3A5 x 3A6)	6
Table 3A7 – Risk Mitigation Measures applying to FRR: Provide signage relevant to site, indicating importance of parental / carer supervision at all times		
Other matters:	It is reasonable that the road be considered an obvious hazard from the playground.

Recommendation: That Council erect signage relevant to site, indicating importance of parental / carer supervision at all times.

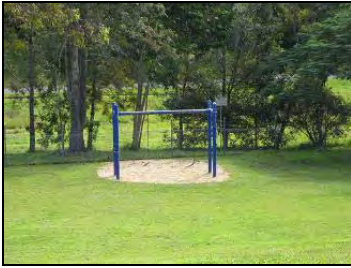
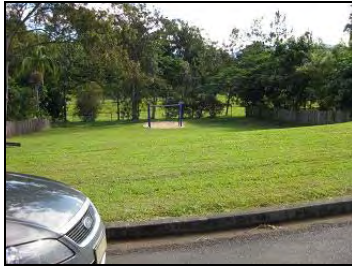
Site Number:	PARK0107	
Site Name:	Hall Drive Park, Hall Drive, Murwillumbah

Facility Risk Rating Factors	Rating for Site	Score
Table 3A2 – Development (playground equipment, etc)	Site with basic playground equipment, no picnic facilities	1
Table 3A3 - Population using equipment	Less than 5 people at a time	1
Table 3A4 - Frequency of use	Playground used mainly on a daily basis	3
Table 3A5 – Natural / Drainage hazards in proximity to site	Hazardous features within 30m of playground equipment (may include steep sloping ground, walking track around reserve)	2
Table 3A6 – Road hazards in proximity to site	No road within 30m of playground equipment (direct line of sight, any classification)	1
	FRR = [(3A2 x 3A3) + 3A4] + (3A5 x 3A6)	6
Table 3A7 – Risk Mitigation Measures applying to FRR: Provide signage relevant to site, indicating importance of parental / carer supervision at all times		
Other matters:	It is reasonable that the road be considered an obvious hazard from the playground.

Recommendation: That Council erect signage relevant to site, indicating importance of parental / carer supervision at all times.

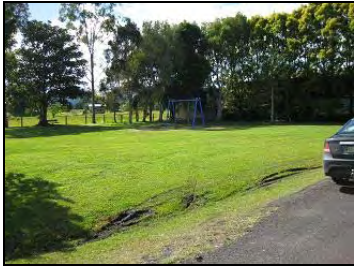
Site Number:	PARK0096	
Site Name:	Martin Watt Park, Reynolds / Charles Sts, Murwillumbah

Facility Risk Rating Factors	Rating for Site	Score
Table 3A2 – Development (playground equipment, etc)	Site with basic playground equipment, no picnic facilities	1
Table 3A3 - Population using equipment	Less than 5 people at a time	1
Table 3A4 - Frequency of use	Playground used mainly on a daily basis	3
Table 3A5 – Natural / Drainage hazards in proximity to site	No hazardous features within 30m of playground equipment (direct line of sight, any form of hazard)	1
Table 3A6 – Road hazards in proximity to site	Road within 30m of playground equipment: Local Access / Car Park	2
FRR = [(3A2 x 3A3) + 3A4] + (3A5 x 3A6)		6
Table 3A7 – Risk Mitigation Measures applying to FRR: Provide signage relevant to site, indicating importance of parental / carer supervision at all times		
Other matters:	It is reasonable that the road be considered an obvious hazard from the playground.

Recommendation: That Council erect signage relevant to site, indicating importance of parental / carer supervision at all times.

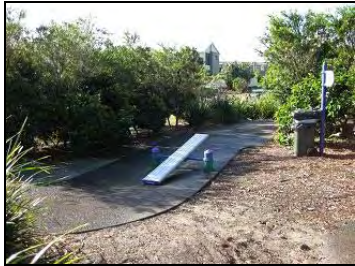
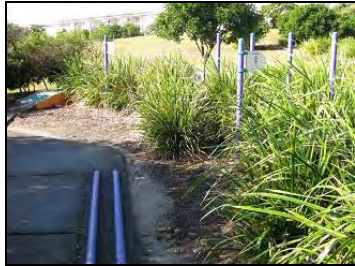
Site Number:	PARK0243	
Site Name:	Saltwater Park, Gunnamatta Ave, Salt

Facility Risk Rating Factors	Rating for Site	Score
Table 3A2 – Development (playground equipment, etc)	Playground equipment for immediate local catchment only (the playground is generally located in a small neighbourhood park and is used by the residents nearby), few seats, no picnic facilities, minor landscaping	2
Table 3A3 - Population using equipment	Less than 5 people at a time	1
Table 3A4 - Frequency of use	Playground used mainly on weekends	2
Table 3A5 – Natural / Drainage hazards in proximity to site	Hazardous features within 30m of playground equipment (may include steep sloping ground, walking track around reserve)	2
Table 3A6 – Road hazards in proximity to site	No road within 30m of playground equipment (direct line of sight, any classification)	1
FRR = [(3A2 x 3A3) + 3A4] + (3A5 x 3A6)		6
Table 3A7 – Risk Mitigation Measures applying to FRR: Provide signage relevant to site, indicating importance of parental / carer supervision at all times

Other matters:		
Recommendation: That Council erect signage relevant to site, indicating importance of parental / carer supervision at all times.

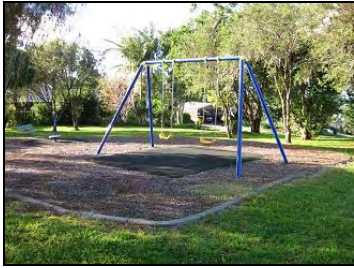
Site Number:	PARK0069	
Site Name:	Peppermint Place Park, Peppermint Pl, Terranora

Facility Risk Rating Factors	Rating for Site	Score
Table 3A2 – Development (playground equipment, etc)	Site with basic playground equipment, no picnic facilities	1
Table 3A3 - Population using equipment	Less than 5 people at a time	1
Table 3A4 - Frequency of use	Playground used mainly on a daily basis	3
Table 3A5 – Natural / Drainage hazards in proximity to site	No hazardous features within 30m of playground equipment (direct line of sight, any form of hazard)	1
Table 3A6 – Road hazards in proximity to site	Road within 30m of playground equipment: Local Access / Car Park	2
FRR = [(3A2 x 3A3) + 3A4] + (3A5 x 3A6)		6
Table 3A7 – Risk Mitigation Measures applying to FRR: Provide signage relevant to site, indicating importance of parental / carer supervision at all times		
Other matters:		
Recommendation: That Council erect signage relevant to site, indicating importance of parental / carer supervision at all times.

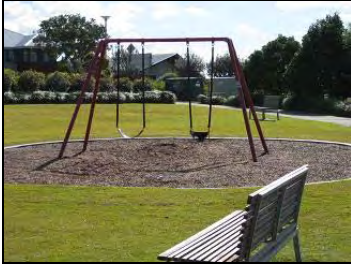
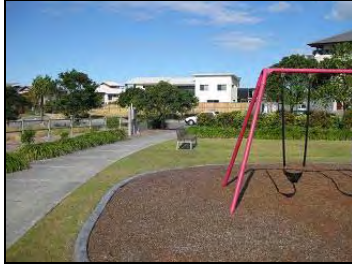
Site Number:	PARK0233	
Site Name:	Casuarina Park, Dianella Drive, Casuarina

Facility Risk Rating Factors	Rating for Site	Score
Table 3A2 – Development (playground equipment, etc)	Site with basic playground equipment, no picnic facilities	1
Table 3A3 - Population using equipment	Less than 5 people at a time	1
Table 3A4 - Frequency of use	Playground used mainly on weekends	2
Table 3A5 – Natural / Drainage hazards in proximity to site	No hazardous features within 30m of playground equipment (direct line of sight, any form of hazard)	1
Table 3A6 – Road hazards in proximity to site	Road within 30m of playground equipment: Collector	3
	FRR = [(3A2 x 3A3) + 3A4] + (3A5 x 3A6)	6
Table 3A7 – Risk Mitigation Measures applying to FRR: Provide signage relevant to site, indicating importance of parental / carer supervision at all times		
Other matters:	The existing vegetation reduces the potential for inadvertent access to either of the adjoining roads.

Recommendation: That Council erect signage relevant to site, indicating importance of parental / carer supervision at all times.

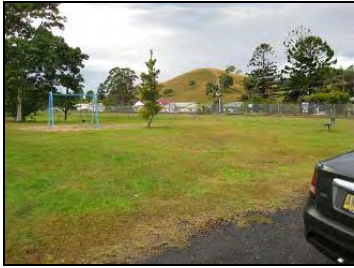
Site Number:	PARK0198	
Site Name:	Mooball Reserve, Pottsville Rd, Mooball

Facility Risk Rating Factors	Rating for Site	Score
Table 3A2 – Development (playground equipment, etc)	Site with basic playground equipment, no picnic facilities	1
Table 3A3 - Population using equipment	Less than 5 people at a time	1
Table 3A4 - Frequency of use	Playground used mainly on weekends	2
Table 3A5 – Natural / Drainage hazards in proximity to site	No hazardous features within 30m of playground equipment (direct line of sight, any form of hazard)	1
Table 3A6 – Road hazards in proximity to site	Road within 30m of playground equipment: Collector	3
FRR = [(3A2 x 3A3) + 3A4] + (3A5 x 3A6)		6
Table 3A7 – Risk Mitigation Measures applying to FRR: Provide signage relevant to site, indicating importance of parental / carer supervision at all times		
Other matters:	It is reasonable that the road be considered an obvious hazard from the playground.

Recommendation: That Council erect signage relevant to site, indicating importance of parental / carer supervision at all times.

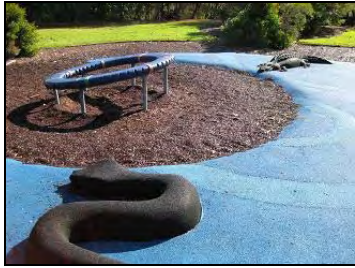
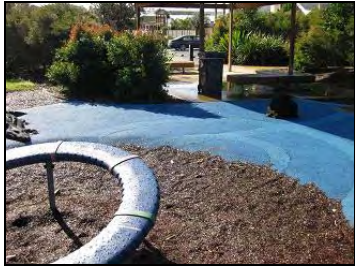
Site Number:	PARK0247	
Site Name:	Plomer Park, Snapper Ave, Salt

Facility Risk Rating Factors	Rating for Site	Score
Table 3A2 – Development (playground equipment, etc)	Site with basic playground equipment, no picnic facilities	1
Table 3A3 - Population using equipment	Less than 5 people at a time	1
Table 3A4 - Frequency of use	Playground rarely used	1
Table 3A5 – Natural / Drainage hazards in proximity to site	Hazardous features within 30m of playground equipment (may include steep sloping ground, walking track around reserve)	2
Table 3A6 – Road hazards in proximity to site	Road within 30m of playground equipment: Local Access / Car Park	2
FRR = [(3A2 x 3A3) + 3A4] + (3A5 x 3A6)		6
Table 3A7 – Risk Mitigation Measures applying to FRR: Provide signage relevant to site, indicating importance of parental / carer supervision at all times		
Other matters:	nil	
Recommendation: That Council erect signage relevant to site, indicating importance of parental / carer supervision at all times.

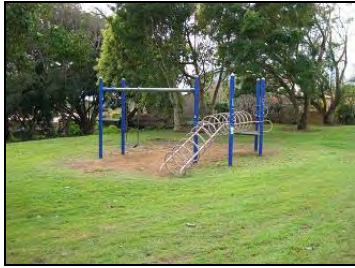
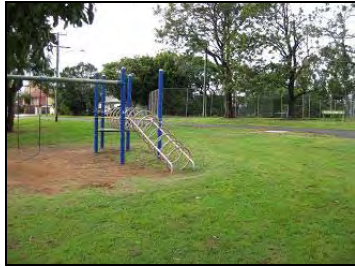
Site Number:	PARK0085	
Site Name:	Wilson Park, Oyster Point Rd, Banora Point

Facility Risk Rating Factors	Rating for Site	Score
Table 3A2 – Development (playground equipment, etc)	Playground equipment for immediate local catchment only (the playground is generally located in a small neighbourhood park and is used by the residents nearby), few seats, no picnic facilities, minor landscaping	2
Table 3A3 - Population using equipment	Less than 5 people at a time	1
Table 3A4 - Frequency of use	Playground rarely used	1
Table 3A5 – Natural / Drainage hazards in proximity to site	No hazardous features within 30m of playground equipment (direct line of sight, any form of hazard)	1
Table 3A6 – Road hazards in proximity to site	Road within 30m of playground equipment: Local Access / Car Park	2
	FRR = [(3A2 x 3A3) + 3A4] + (3A5 x 3A6)	5
Table 3A7 – Risk Mitigation Measures applying to FRR: Provide signage relevant to site, indicating importance of parental / carer supervision at all times

Other matters:	It is reasonable that the road be considered an obvious hazard from the playground.	
Recommendation: That Council erect signage relevant to site, indicating importance of parental / carer supervision at all times.

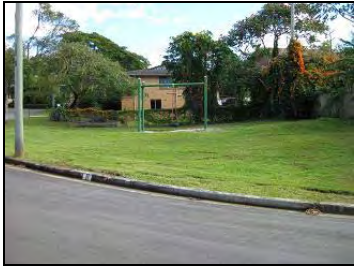
Site Number:	PARK0109	
Site Name:	Amethyst Place Park, Murwillumbah

Facility Risk Rating Factors	Rating for Site	Score
Table 3A2 – Development (playground equipment, etc)	Site with basic playground equipment, no picnic facilities	1
Table 3A3 - Population using equipment	Less than 5 people at a time	1
Table 3A4 - Frequency of use	Playground used mainly on weekends	2
Table 3A5 – Natural / Drainage hazards in proximity to site	No hazardous features within 30m of playground equipment (direct line of sight, any form of hazard)	1
Table 3A6 – Road hazards in proximity to site	Road within 30m of playground equipment: Local Access / Car Park	2
FRR = [(3A2 x 3A3) + 3A4] + (3A5 x 3A6)		5
Table 3A7 – Risk Mitigation Measures applying to FRR: Provide signage relevant to site, indicating importance of parental / carer supervision at all times		
Other matters:	It is reasonable that the road be considered an obvious hazard from the playground.

Recommendation: That Council erect signage relevant to site, indicating importance of parental / carer supervision at all times.
