**PLAYGROUND AUDIT
FOR
TWEED SHIRE COUNCIL**

**August 2009
09-060**

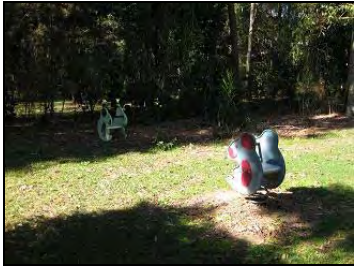
Site Number:	PARK0279	
Site Name:	Koala Beach Park, Cudgera Ave, Koala Beach, Pottsville

Facility Risk Rating Factors	Rating for Site	Score
Table 3A2 – Development (playground equipment, etc)	Site with basic playground equipment, no picnic facilities	1
Table 3A3 - Population using equipment	Less than 5 people at a time	1
Table 3A4 - Frequency of use	Playground used mainly on weekends	2
Table 3A5 – Natural / Drainage hazards in proximity to site	Hazardous features within 30m of playground equipment (may include steep sloping ground, walking track around reserve)	2
Table 3A6 – Road hazards in proximity to site	No road within 30m of playground equipment (direct line of sight, any classification)	1
FRR = [(3A2 x 3A3) + 3A4] + (3A5 x 3A6)		5
Table 3A7 – Risk Mitigation Measures applying to FRR: Provide signage relevant to site, indicating importance of parental / carer supervision at all times

Other matters:	nil	
Recommendation: That Council erect signage relevant to site, indicating importance of parental / carer supervision at all times.

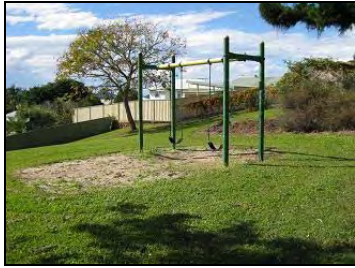
Site Number:	PARK0104	
Site Name:	Amwill Park, Almac Ave, Murwillumbah

Facility Risk Rating Factors	Rating for Site	Score
Table 3A2 – Development (playground equipment, etc)	Site with basic playground equipment, no picnic facilities	1
Table 3A3 - Population using equipment	Less than 5 people at a time	1
Table 3A4 - Frequency of use	Playground used mainly on weekends	2
Table 3A5 – Natural / Drainage hazards in proximity to site	Hazardous features within 30m of playground equipment (may include steep sloping ground, walking track around reserve)	2
Table 3A6 – Road hazards in proximity to site	No road within 30m of playground equipment (direct line of sight, any classification)	1
	FRR = [(3A2 x 3A3) + 3A4] + (3A5 x 3A6)	5
Table 3A7 – Risk Mitigation Measures applying to FRR: Provide signage relevant to site, indicating importance of parental / carer supervision at all times		
Other matters:	nil

Recommendation: That Council erect signage relevant to site, indicating importance of parental / carer supervision at all times at each access to the Park.

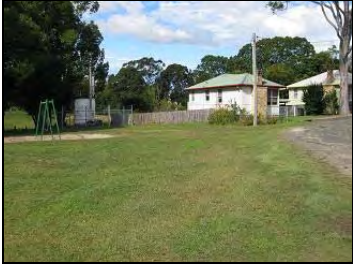
Site Number:	PARK0102	
Site Name:	Willward Park, Harwood St, Murwillumbah

Facility Risk Rating Factors	Rating for Site	Score
Table 3A2 – Development (playground equipment, etc)	Site with basic playground equipment, no picnic facilities	1
Table 3A3 - Population using equipment	Less than 5 people at a time	1
Table 3A4 - Frequency of use	Playground used mainly on weekends	2
Table 3A5 – Natural / Drainage hazards in proximity to site	No hazardous features within 30m of playground equipment (direct line of sight, any form of hazard)	1
Table 3A6 – Road hazards in proximity to site	Road within 30m of playground equipment: Local Access / Car Park	2
FRR = [(3A2 x 3A3) + 3A4] + (3A5 x 3A6)		5
Table 3A7 – Risk Mitigation Measures applying to FRR: Provide signage relevant to site, indicating importance of parental / carer supervision at all times		
Other matters:	It is reasonable that the road be considered an obvious hazard from the playground.

Recommendation: That Council erect signage relevant to site, indicating importance of parental / carer supervision at all times.

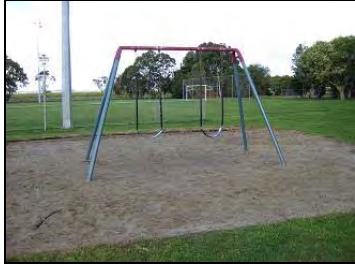
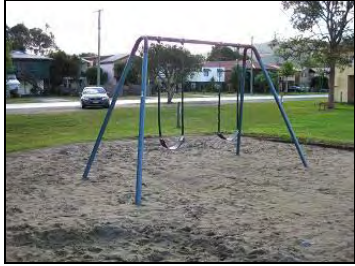
Site Number:	PARK0130	
Site Name:	Brian Breckenridge Sportsground, Bawden St, Tumbulgum

Facility Risk Rating Factors	Rating for Site	Score
Table 3A2 – Development (playground equipment, etc)	Site with basic playground equipment, no picnic facilities	1
Table 3A3 - Population using equipment	Less than 5 people at a time	1
Table 3A4 - Frequency of use	Playground used mainly on weekends	2
Table 3A5 – Natural / Drainage hazards in proximity to site	No hazardous features within 30m of playground equipment (direct line of sight, any form of hazard)	1
Table 3A6 – Road hazards in proximity to site	Road within 30m of playground equipment: Local Access / Car Park	2
	FRR = [(3A2 x 3A3) + 3A4] + (3A5 x 3A6)	5
Table 3A7 – Risk Mitigation Measures applying to FRR: Provide signage relevant to site, indicating importance of parental / carer supervision at all times		
Other matters:	It is reasonable that the road be considered an obvious hazard from the playground.

Recommendation: That Council erect signage relevant to site, indicating importance of parental / carer supervision at all times.

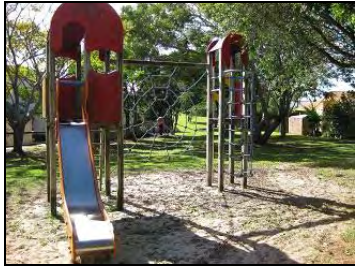
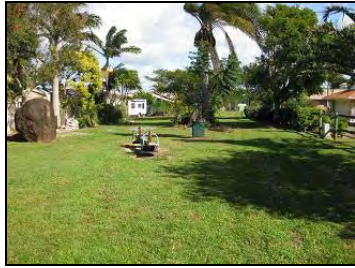
Site Number:	PARK0172	
Site Name:	Karringal / Warringa Easement, Karringal Ave, Bilambil Heights

Facility Risk Rating Factors	Rating for Site	Score
Table 3A2 – Development (playground equipment, etc)	Playground equipment for immediate local catchment only (the playground is generally located in a small neighbourhood park and is used by the residents nearby), few seats, no picnic facilities, minor landscaping	2
Table 3A3 - Population using equipment	Less than 5 people at a time	1
Table 3A4 - Frequency of use	Playground rarely used	1
Table 3A5 – Natural / Drainage hazards in proximity to site	No hazardous features within 30m of playground equipment (direct line of sight, any form of hazard)	1
Table 3A6 – Road hazards in proximity to site	No road within 30m of playground equipment (direct line of sight, any classification)	1
	FRR = [(3A2 x 3A3) + 3A4] + (3A5 x 3A6)	4
Table 3A7 – Risk Mitigation Measures applying to FRR: Provide signage relevant to site, indicating importance of parental / carer supervision at all times

Other matters:	nil	
Recommendation: That Council erect signage relevant to site, indicating importance of parental / carer supervision at all times.

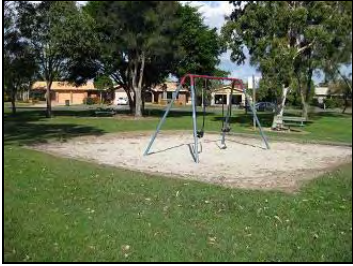
Site Number:	PARK0183	
Site Name:	Quota Park, Caloola Dr, Tweed Heads

Facility Risk Rating Factors	Rating for Site	Score
Table 3A2 – Development (playground equipment, etc)	Site with basic playground equipment, no picnic facilities	1
Table 3A3 - Population using equipment	5 to 20 people at a time	2
Table 3A4 - Frequency of use	Playground rarely used	1
Table 3A5 – Natural / Drainage hazards in proximity to site	No hazardous features within 30m of playground equipment (direct line of sight, any form of hazard)	1
Table 3A6 – Road hazards in proximity to site	No road within 30m of playground equipment (direct line of sight, any classification)	1
FRR = [(3A2 x 3A3) + 3A4] + (3A5 x 3A6)		4
Table 3A7 – Risk Mitigation Measures applying to FRR: Provide signage relevant to site, indicating importance of parental / carer supervision at all times		
Other matters:	nil	
Recommendation: That Council erect signage relevant to site, indicating importance of parental / carer supervision at all times.

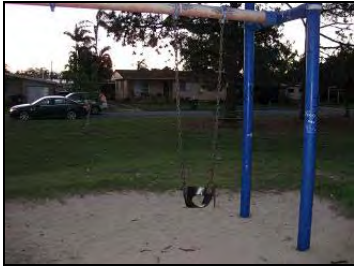
Site Number:	PARK0171	
Site Name:	Eunga Street Park, Eunga St, Tweed Heads South

Facility Risk Rating Factors	Rating for Site	Score
Table 3A2 – Development (playground equipment, etc)	Site with basic playground equipment, no picnic facilities	1
Table 3A3 - Population using equipment	Less than 5 people at a time	1
Table 3A4 - Frequency of use	Playground rarely used	1
Table 3A5 – Natural / Drainage hazards in proximity to site	No hazardous features within 30m of playground equipment (direct line of sight, any form of hazard)	1
Table 3A6 – Road hazards in proximity to site	Road within 30m of playground equipment: Local Access / Car Park	2
FRR = [(3A2 x 3A3) + 3A4] + (3A5 x 3A6)		4
Table 3A7 – Risk Mitigation Measures applying to FRR: Provide signage relevant to site, indicating importance of parental / carer supervision at all times		
Other matters:	It is reasonable that the road be considered an obvious hazard from the playground.

Recommendation: That Council erect signage relevant to site, indicating importance of parental / carer supervision at all times.

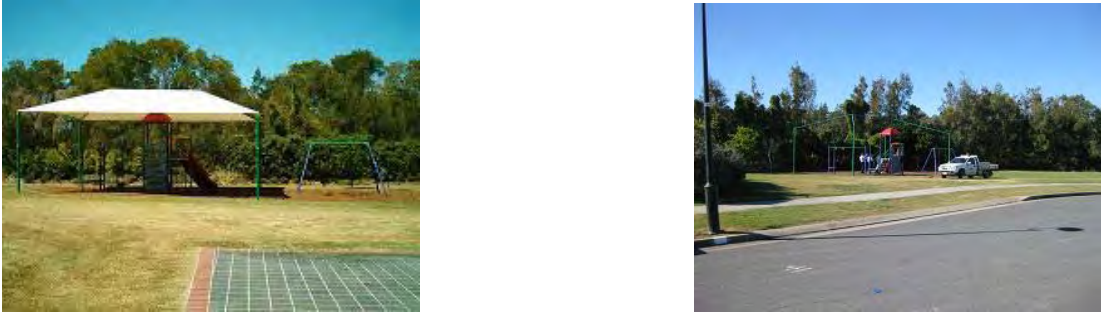
Site Number:	PARK0309	
Site Name:	Trigonie Drive Park, Trigonie Dr, Tweed Heads South

Facility Risk Rating Factors	Rating for Site	Score
Table 3A2 – Development (playground equipment, etc)	Playground equipment for immediate local catchment only (the playground is generally located in a small neighbourhood park and is used by the residents nearby), few seats, no picnic facilities, minor landscaping	2
Table 3A3 - Population using equipment	5 to 20 people at a time	2
Table 3A4 - Frequency of use	Playground used mainly on a daily basis	3
Table 3A5 – Natural / Drainage hazards in proximity to site	Hazardous features within 30m of playground equipment (may include open drainage facilities permanently holding water, or drop between 1 metre and 3 metres).	4
Table 3A6 – Road hazards in proximity to site	Road within 30m of play facilities: Local Access	2
FRR = [(3A2 x 3A3) + 3A4] + (3A5 x 3A6)		15
Table 3A7 – Risk Mitigation Measures applying to FRR: Provide a barrier between playground equipment and major hazard / screen hazard from playground equipment (type variable, may include dense vegetation or mounding) to increase distance between hazard and playground equipment to be greater than 30m; signage warning of the two highest rated hazards and information indicating importance of parental / carer supervision at all times

Other matters:	It is reasonable that the road be considered an obvious hazard from the playground. The vegetation at the rear of the park creates an extensive barrier to access to the Shallow Bay area, enabling the Natural / Drainage hazard factor to be reduced to 1, and the effective FRR becomes 9.	
Adjusted FRR (allowing for effective Natural / Drainage Hazard Factor)		9
Recommendation: That Council erect signage relevant to site, depicting top rated hazard and information indicating importance of parental / carer supervision at all times.

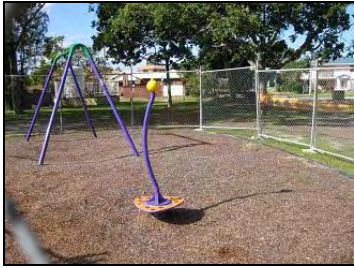
Site Number:	PARK0150	
Site Name:	Clarrie Englert Park, Gollan Dr, Tweed Heads West

Facility Risk Rating Factors	Rating for Site	Score
Table 3A2 – Development (playground equipment, etc)	Site with basic playground equipment, no picnic facilities	1
Table 3A3 - Population using equipment	Less than 5 people at a time	1
Table 3A4 - Frequency of use	Playground rarely used	1
Table 3A5 – Natural / Drainage hazards in proximity to site	No hazardous features within 30m of playground equipment (direct line of sight, any form of hazard)	1
Table 3A6 – Road hazards in proximity to site	No road within 30m of playground equipment (direct line of sight, any classification)	1
FRR = [(3A2 x 3A3) + 3A4] + (3A5 x 3A6)		3
Table 3A7 – Risk Mitigation Measures applying to FRR: Provide signage relevant to site, indicating importance of parental / carer supervision at all times		
Other matters:	nil	
Recommendation: That Council erect signage relevant to site, indicating importance of parental / carer supervision at all times.

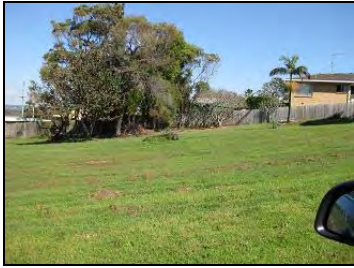
Site Number:	PARK0076	
Site Name:	Seaview / Hibiscus Park, Seaview St, Banora Point

Facility Risk Rating Factors	Rating for Site	Score
Table 3A2 – Development (playground equipment, etc)	No playground equipment, no picnic facilities	0
Table 3A3 - Population using equipment	Less than 5 people at a time	1
Table 3A4 - Frequency of use	Playground rarely used	1
Table 3A5 – Natural / Drainage hazards in proximity to site	No hazardous features within 30m of playground equipment (direct line of sight, any form of hazard)	1
Table 3A6 – Road hazards in proximity to site	Road within 30m of playground equipment: Local Access / Car Park	2
FRR = [(3A2 x 3A3) + 3A4] + (3A5 x 3A6)		3
Table 3A7 – Risk Mitigation Measures applying to FRR: Provide signage relevant to site, indicating importance of parental / carer supervision at all times		
Other matters:	nil	
Recommendation: That Council erect signage relevant to site, indicating importance of parental / carer supervision at all times.
