Queen Street Toilet Block, Murwillumbah

Heritage Assessment & Options Report

March 2011

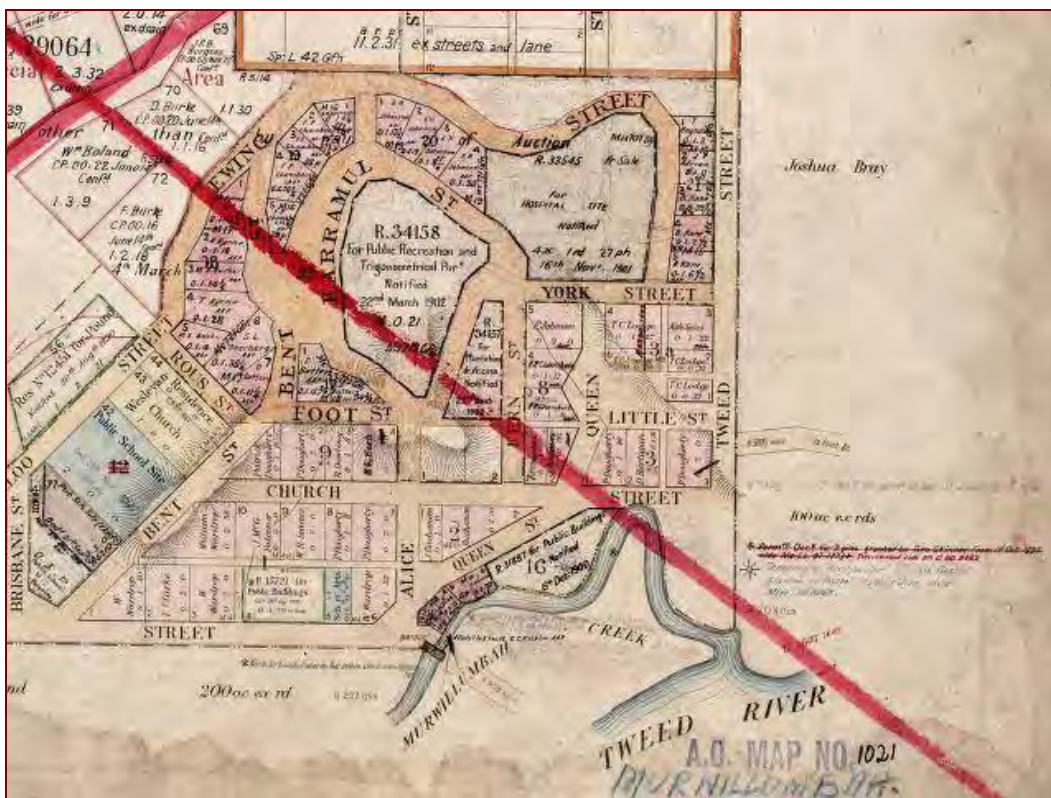
Figure 2.2: Parish Map of the Town Murwillumbah, 1893. (Parish Map Preservation Project).

The earliest parish maps of the Murwillumbah area (which are pre-1900) show the settlements of Byangum and Murwillumbah, as well as much of the land that is now part of the town that was once owned by Joshua Bray. The earliest town map (1893), following the auctioning of sites in the newly proclaimed town in 1881, shows that the area where the Toilet Block is situated was in the Alice/Queen Streets intersection road reserve, next to the allotment taken up by J. Buchanan. Buchanan went on to build the two story Queensland style Australian Hotel, which sat immediately to the east of the later site of the Toilet Block. In 1917, the Hotel was demolished by the photographer Angus McNeil, who built the existing shops that now sit to the east of the toilet block.

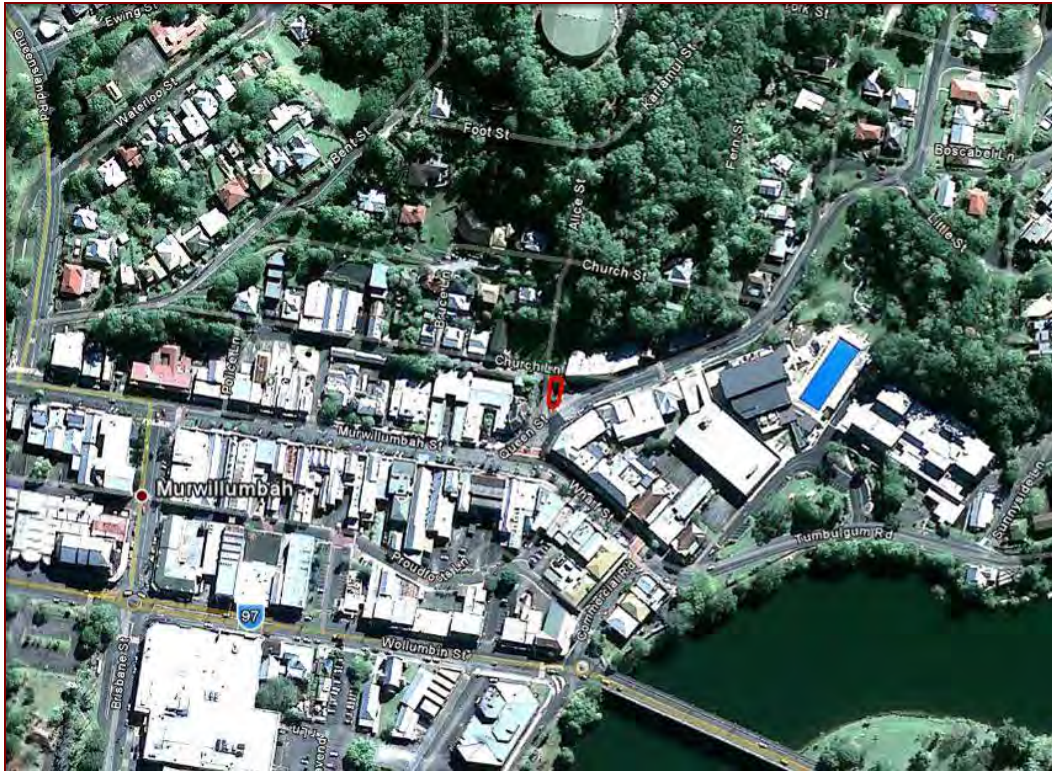
Figure 3.2: Current aerial image of Murwillumbah, with the site outlined in red.

The site is rectangle shaped (approximately 9 meters by 4.5 meters), with the long axis running north/south. A semicircular bay fronts Queen Street and dominates the façade of the Toilet Block. The site contains the Toilet block building and its associated access points. Most of the Toilet Block sits on the hill or on footings, all combined to provide a level surface.

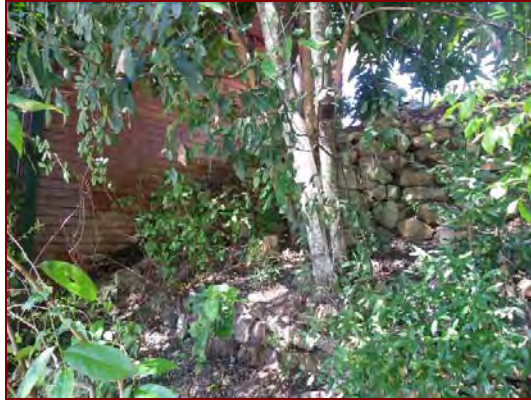
A small rubble retaining wall forms part of the slope, which joins the ridge spur coming down from Hospital Hill. Photos across the roof from the north, looking south, also show some of the cracking in the roof slab, which is causing significant ingress of waters and degradation of the block.

Figure 3.7: North elevation, showing the retaining wall.

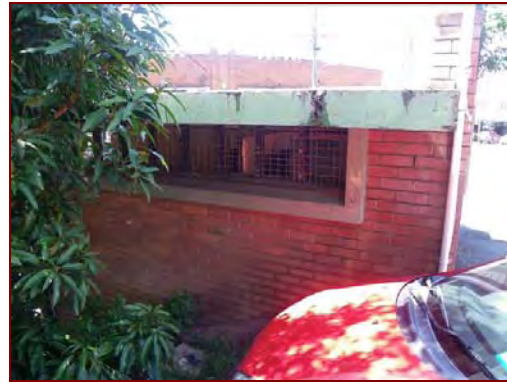
Figure 3.8: North elevation showing the rear window and roof overhang.

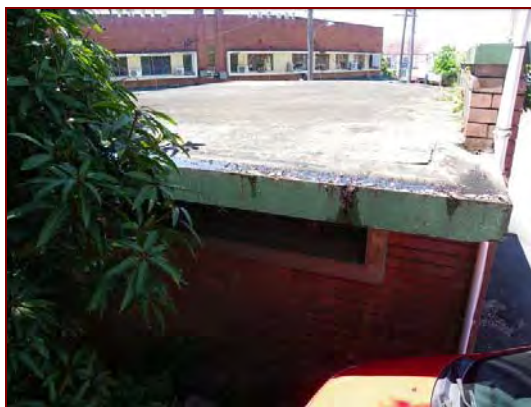
Figure 3.9: North elevation showing cracking of roof slab.

Due to the cracking evident within the roof slab and the deterioration of some of the brickwork, both externally and internally, Council's building inspector should undertake a full inspection of the Toilet Block to determine its structural condition and any works required for future stabilisation. This step will be critical in determining the future use of the Toilet Block.

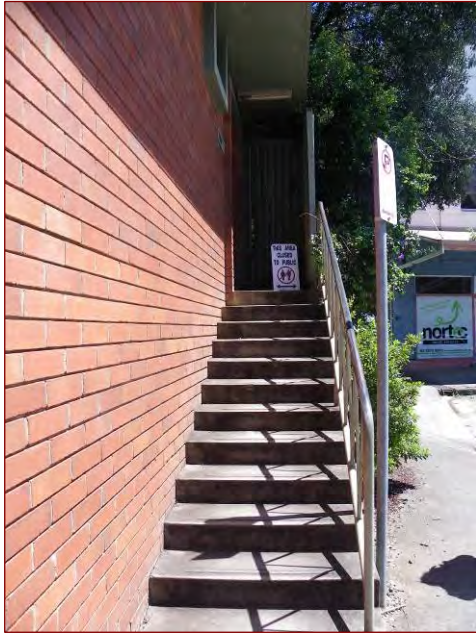
Figure 3.10: Stairs on the east elevation.

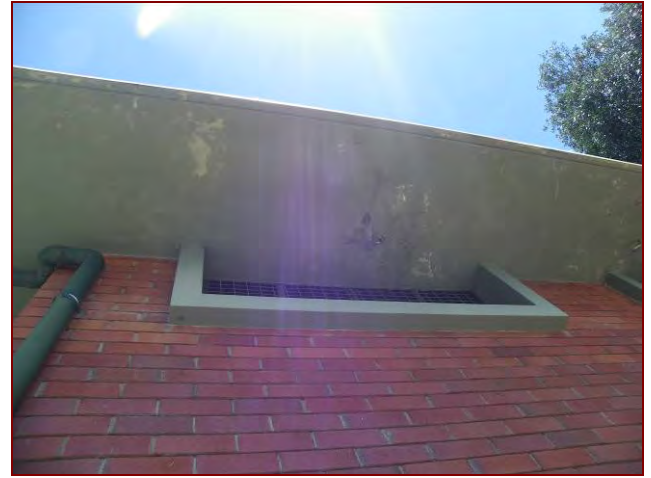
There is some evidence of cracking in the eaves of the east elevation with water damage present around the cracking and underneath the stairs.

Figure 3.11: Cracking and water damage under the eaves of the east elevation.

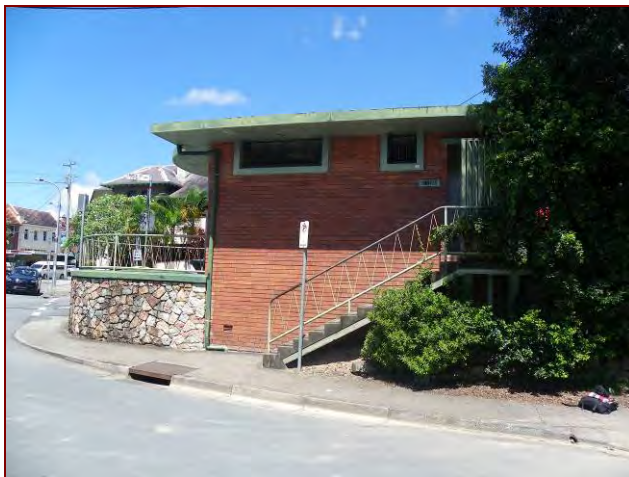
Figure 3.12: The east elevation from looking south west.

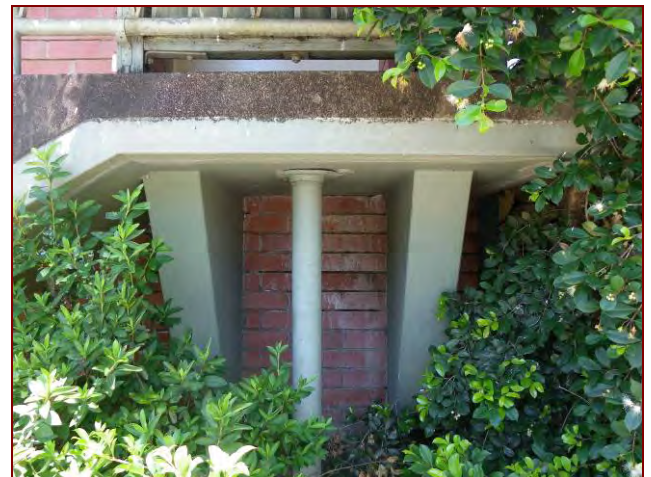
Figure 3.13: The stair supports, with later steel support. Water damage can be seen on the bricks behind.

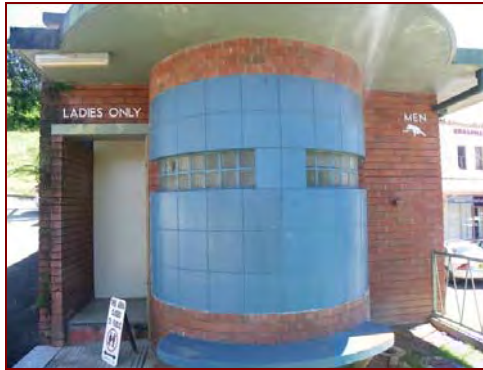
The south elevation is dominated by the semicircular bay, which has been rendered and painted to mimic decorative terracotta. This rendered façade is further detailed by a split twin row of glass bricks, some of which have been broken on the western side. The front of the semi-circle has a small blue painted bench, which is 30cm deep and faces to the south.

Figure 3.14: Southern elevation, dominated by the semi-circular bay.

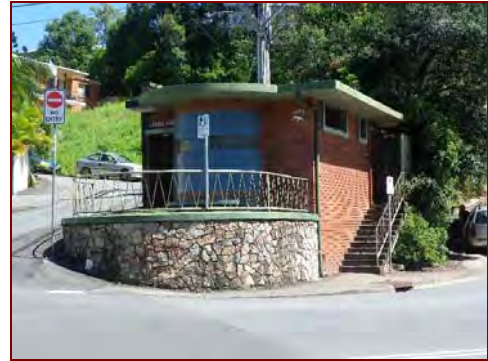
The elevation shows some decay, with mortar missing from between some brick, especially closer to the door, with vegetation growing from the wall around the door and some bricks having begun to crumble from damp issues.

Figure 3.15: Southern elevation showing the retaining wall

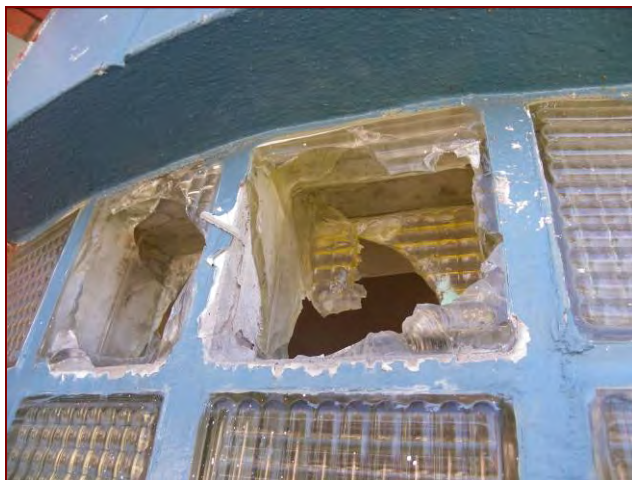
Figure 3.16: Broken glass bricks on the south elevation.

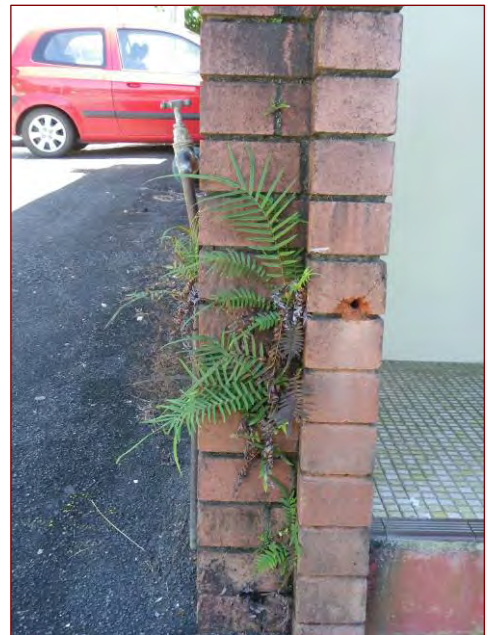
Figure 3.17: Damaged bricks and vegetation on the south elevation.

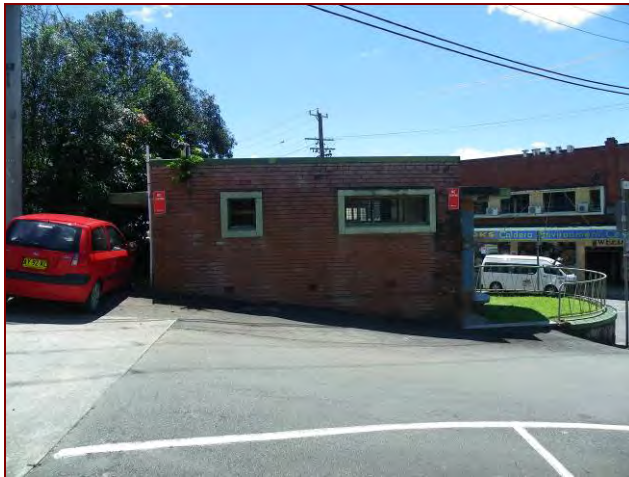
The Western elevation consists of a brick wall, with a small rectangular window on its north which lights the Men’s bathroom and a longer rectangular window that faces into the Women’s bathroom. The wall of the west elevation extends approximately half a meter higher than the roof line, creating a parapet, likely designed to prevent easy access to the Toilet Block’s roof. The carpark in Alice Street abuts the side of the Toilet Block along this elevation. There is some

evidence of water damage along this elevation and further vegetation has gained a foothold along the roof line.

Figure 3.18: Western elevation.

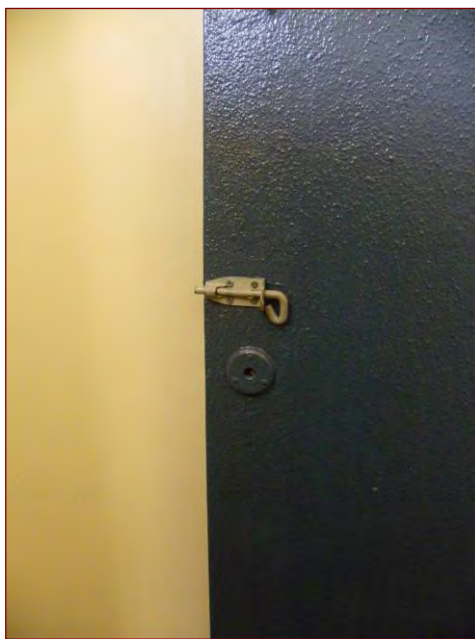
Figure 3.21: Original stall door with circular latch and later bolt.

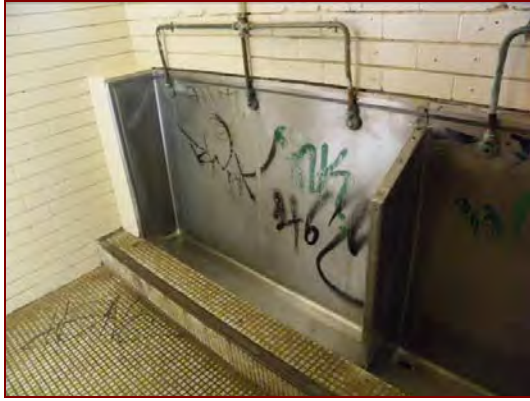
Figure 2.42: Men's urinal, note the original water spouts

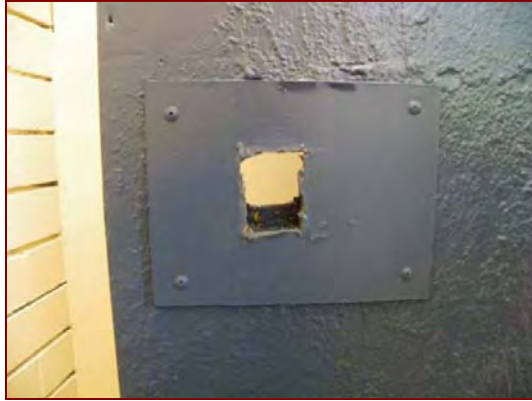
Figure 2.43: Coin slot in original door.

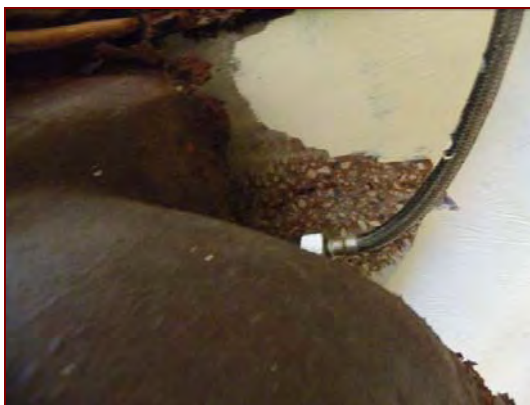
Figure 2.44: some of the original terrazzo visible behind the basin in the men's toilets.

- k) Original terrazzo should be removed and surface ground to restore finish. These may then be used as internal linings. Paint stripper or other chemical paint removal system would remove the gout faster than the stone chips resulting in an exposed aggregate finish, with possible aggregate loss.

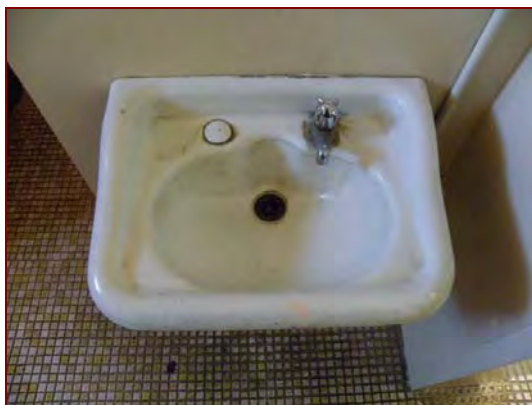
Figure 2.45: Men's toilets basin and tiling.

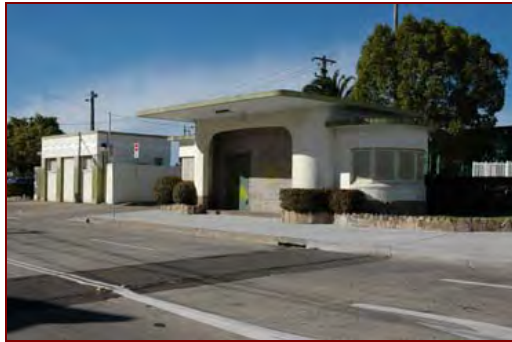
Figure 2.47: Punchbowl Bus Station, showing some similar design elements to the Toilet Block. The station is now a store room for the local park (Photo courtesy of Chris Betteridge).

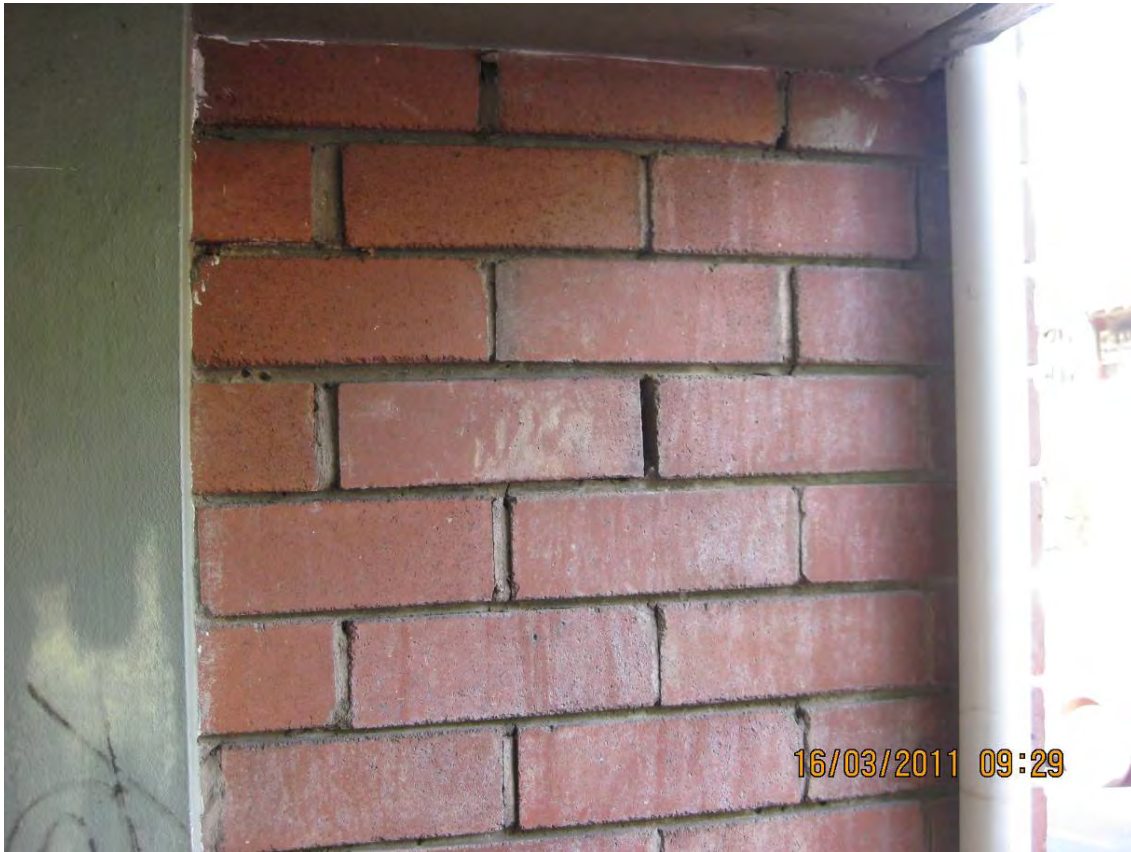
Figure 3 – Northern wall crack

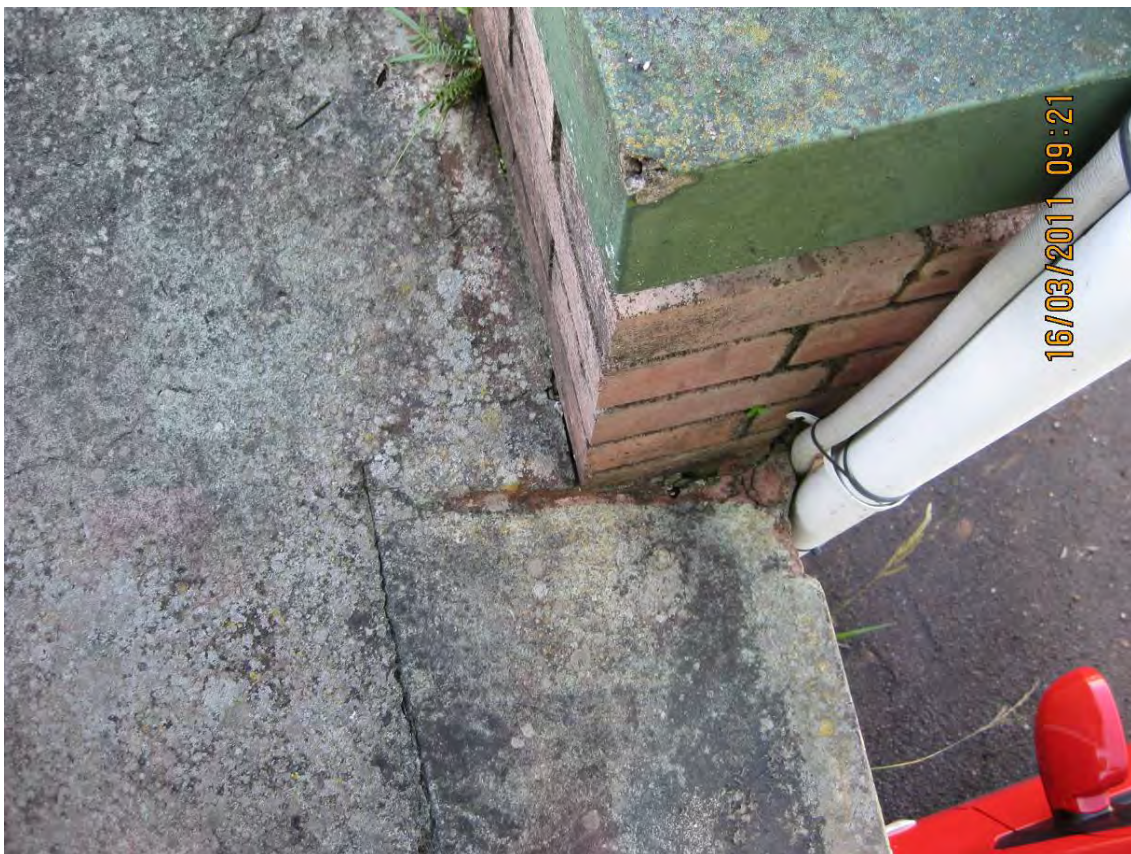
Figure 4 – Grouted roof gutter and parapet

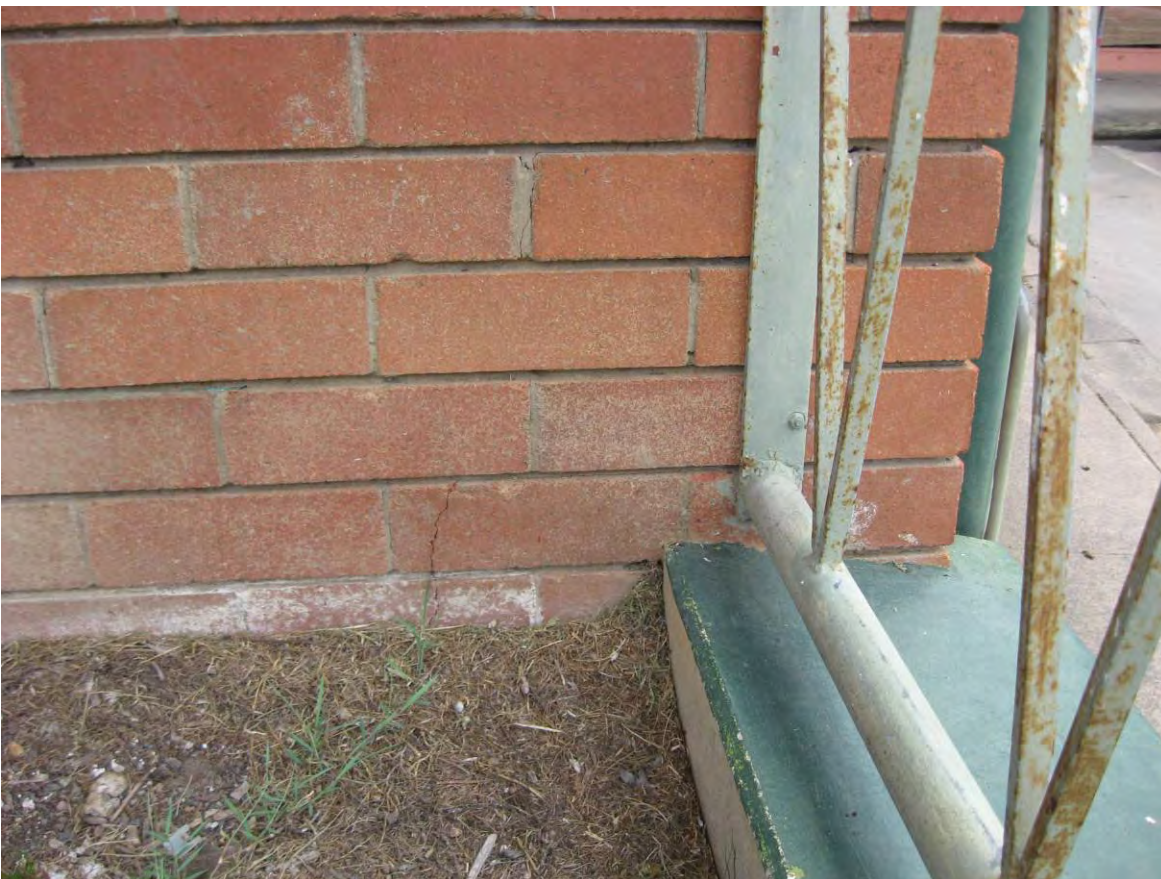
Two cracks are visible at this junction. Firstly a splitting of the lower bricks 300mm along the southern wall from the corner. Retained fill earth pressures are pushing the eastern wall outwards at the junction (Figure 6). Secondly the inclined crack, commencing behind the downpipe and inclined down to the right (north) is accordingly the result of earth pressures at this retaining wall junction.

Figure 6 – South east corner

- g) Rectify damage to masonry doorways if possible. Remove protruding bolts.
- h) Repair broken steel pipe handrail above retaining wall.
- i) Confirm retaining wall backfill has method of surface runoff and ground-water egress (agriculture pipe) outlet, or weep holes.

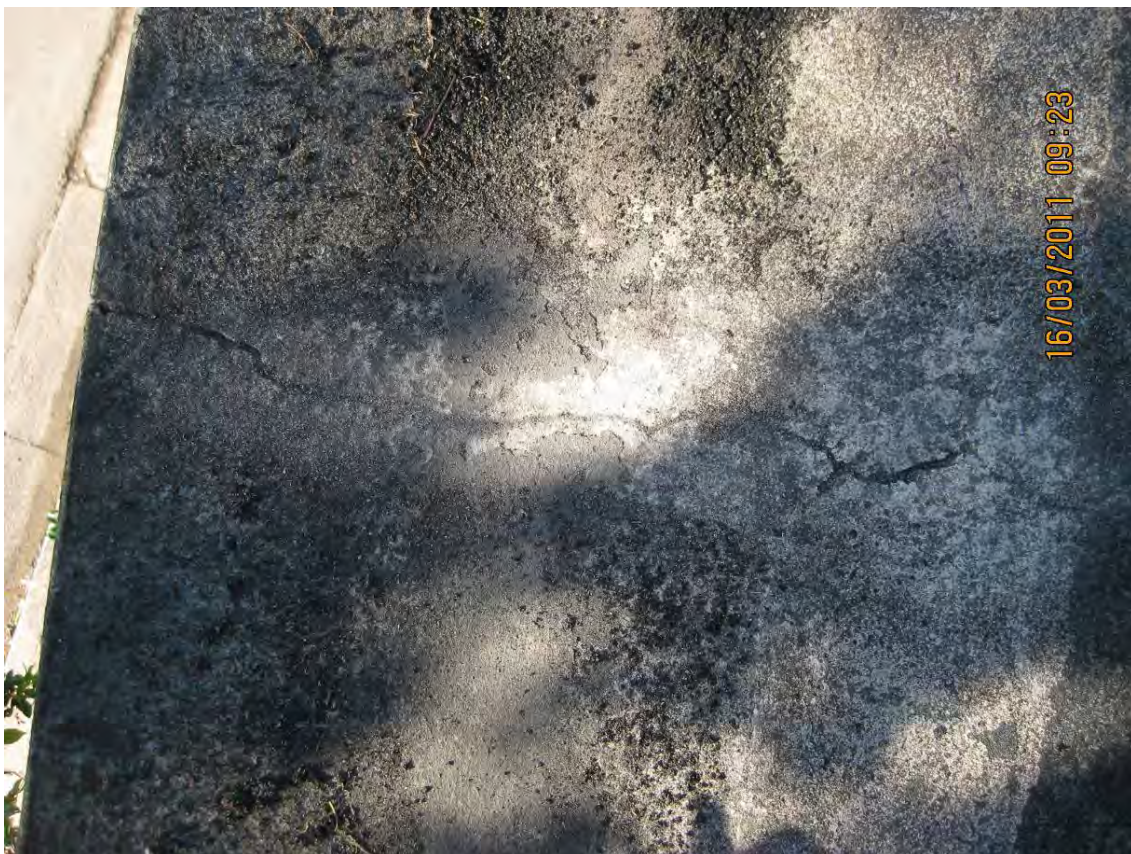
Figure 8 – Cracks over soffit water damage

- e) Water damaged ceilings, soffits to be cleaned and panted with a permeable paint to allow moisture to escape through roof slab.
- f) Pave outside ladies toilet to reduce step height to acceptable limit. Do not glue, or concrete bed pavers but rather open joint paver will enable future removal without damage to the existing.

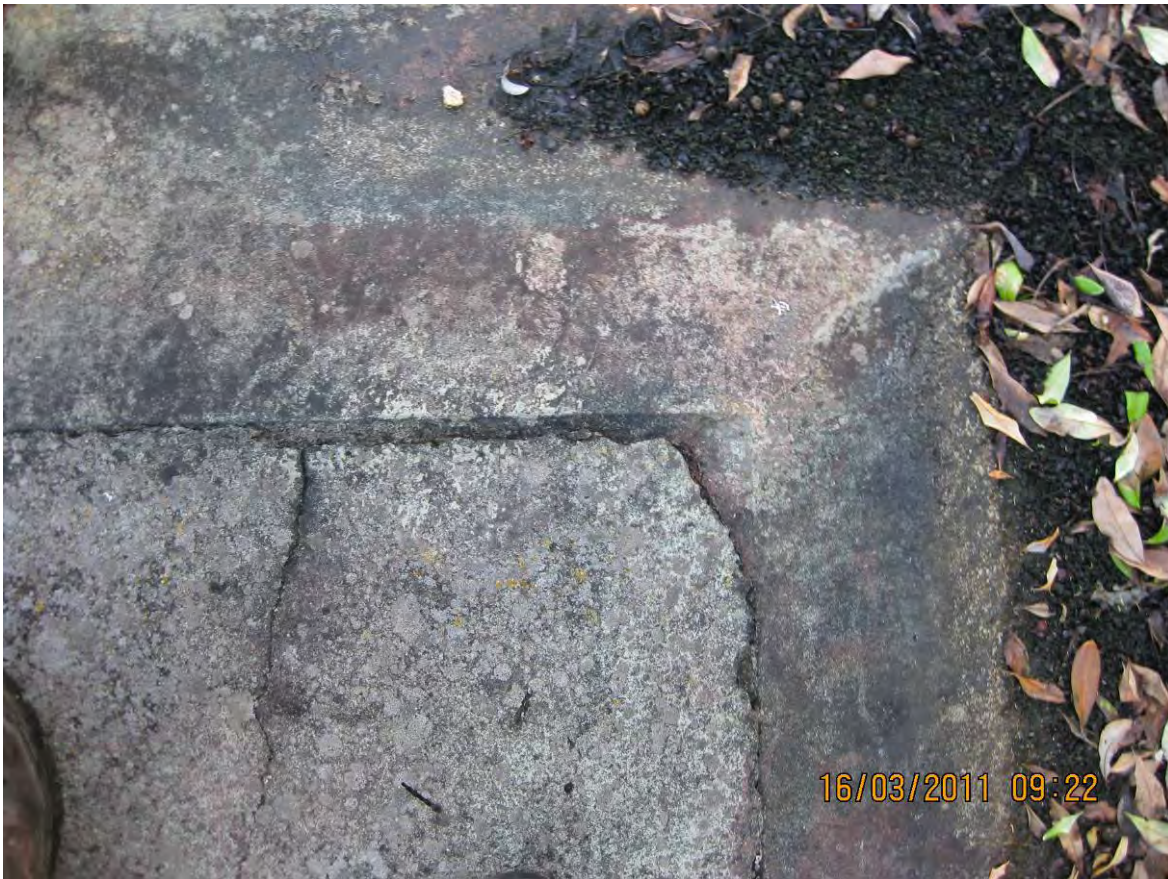
Figure 9 – Cantilever cracking and gutter debris

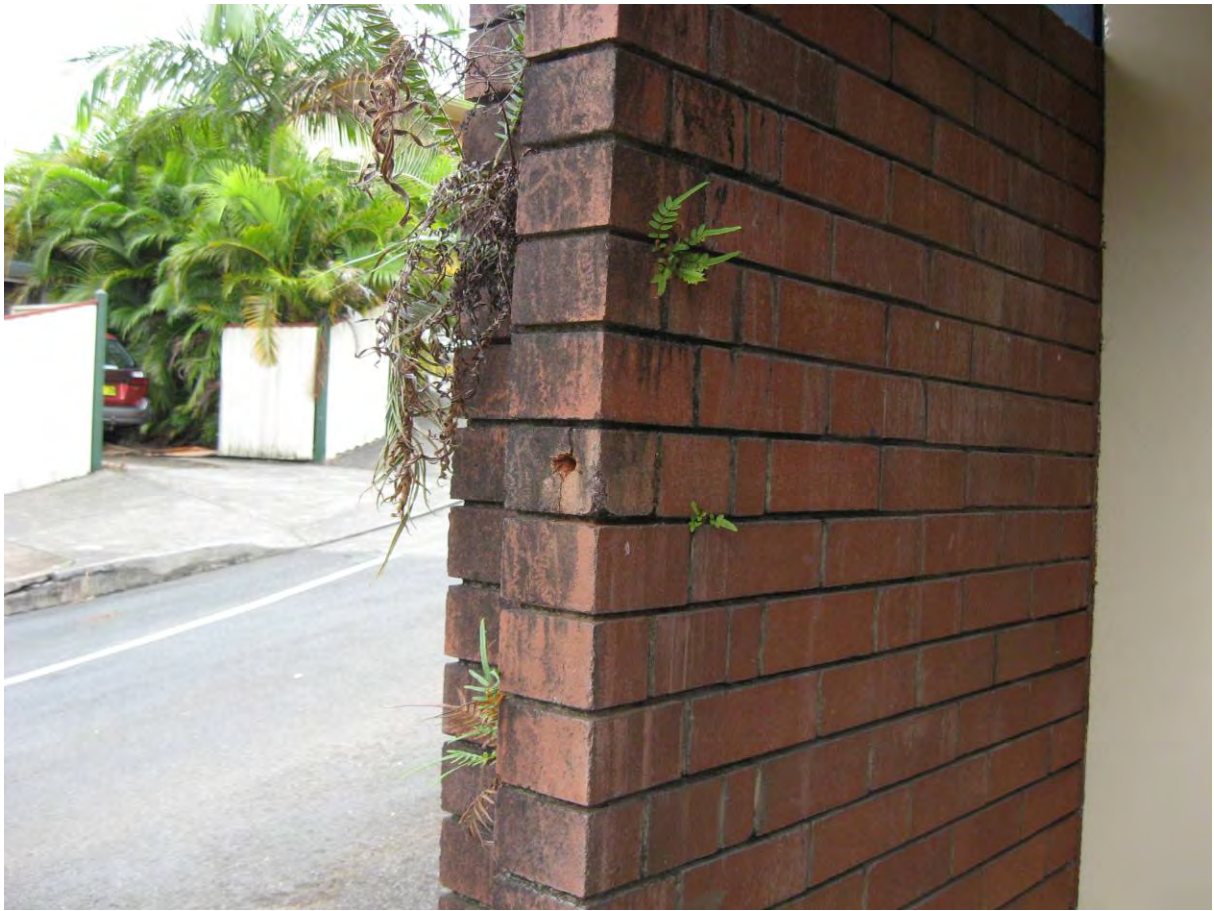
The toilet was recently closed to the public and maintenance staff fitted ply formboard sheets to the doorways. Significant damage to feature masonry doorway trims occurred from poorly positioned dyna-bolts, one of which expanded when tightened to split the brick (Figure 10). The maintenance staff should have used smaller sized (non-expanding) masonry screw anchors into the mortar beds leaving a simple repair utilising matching coloured mortar. The damage is disastrous and some bolts remain protruding from brickwork doorways at present. A professional repair and possible brick replacement will be required if the building is given historic significance. Further assessment of the repair is needed given the buildings possible heritage value.

Figure 11 – Bolt Damage splitting brick
