**LATE ADDENDUM REPORT**

**2 [EM-TCHP] Kingscliff Foreshore Erosion Emergency Works**

**FILE REFERENCE: GC3/8/2**

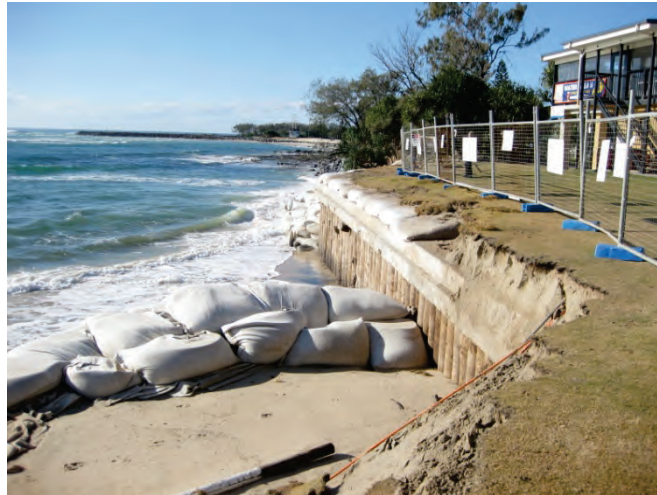
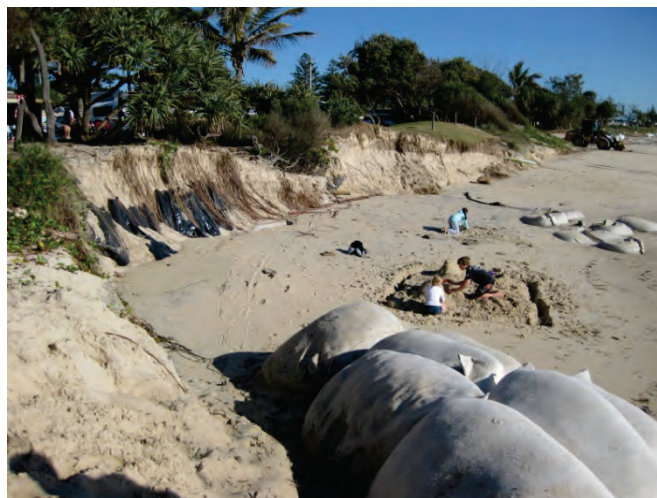
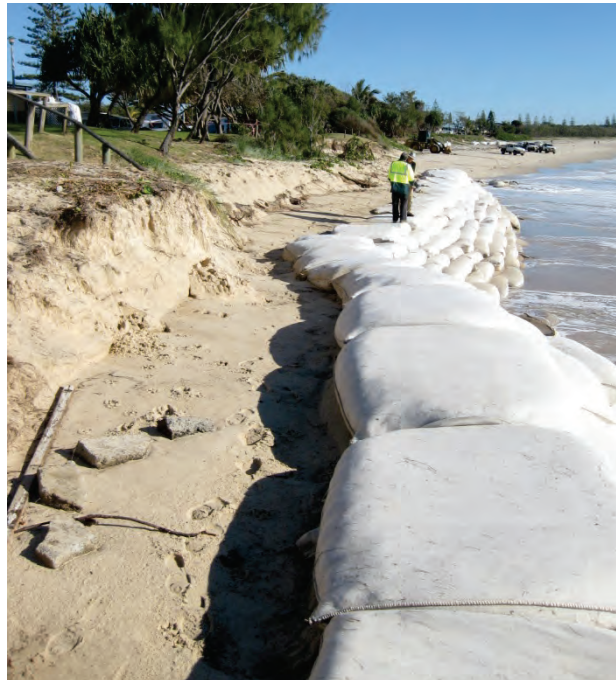
Unfortunately, erosion has reoccurred at the southern end of Kingscliff Beach and the nourished sand has moved out of this section of the beach, most likely to the north and offshore. This has exposed the rock wall and deepened the near-shore area between the Cudgen Creek Training Wall and the Cudgen Headland Surf Club.

In the last week, a combination of spring high tides, high swell and the deepened near-shore conditions has led to partial failure of the sandbag walls constructed in front of the Cudgen Headland Surf Club and Kingscliff Beach Holiday Park. To maintain the foreshore area, these sandbag walls need to be rebuilt and strengthened.

It should be noted that the rock retaining wall constructed between the Cudgen Headland Surf Club and the north training wall of Cudgen Creek would appear to be maintaining the current alignment however as this is not designed as a full sea wall it may be subject to failure if a large storm event occurs.

The original works were constructed in an attempt to minimise costs and a more robust design is required for the repairs due to the length of time that the foreshore is likely to be subject to erosion and length of time anticipated for recovery of the beach. Further works are required to reduce erosion impacts on Cudgen Headland Surf Club and Kingscliff Beach Holiday Park.

The estimated cost for the repair and strengthening of the sandbag walls is \$140,000. Approximately 60% of this is construction of a wall in front of the Kingscliff Beach Holiday Park and the remainder at the Cudgen Headland Surf Club.
