# Environmental assessment of an unnamed creek adjacent Harrys Road, Crystal Creek

July 2013

This report has been prepared in response to a notice of motion of council at its meeting of 18 April 2013, to bring forward a report on the state of the unnamed creek at Harrys Road, Crystal Creek including recommendations for remediation as soon as possible.

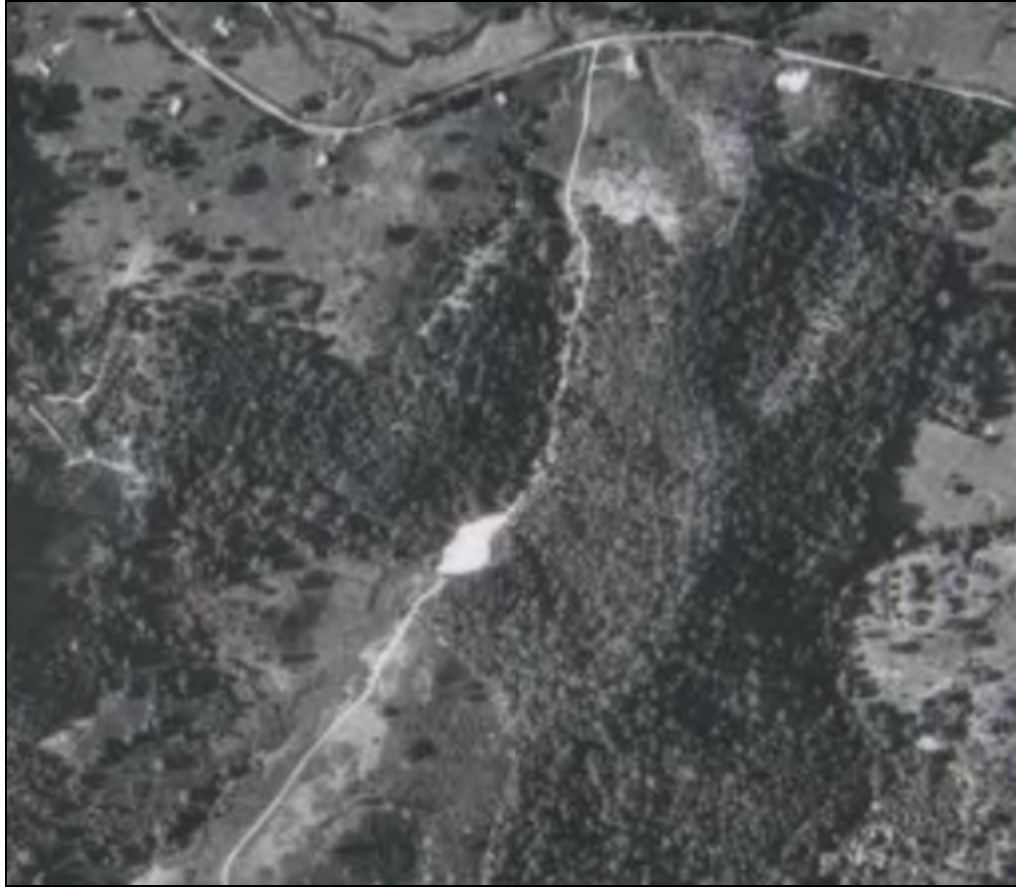
**Figure 3: 1970 aerial photograph noting commencement of quarry operations at Harrys Road** (note that the Harrys Road entrance was moved further west along north arm road by 1991)

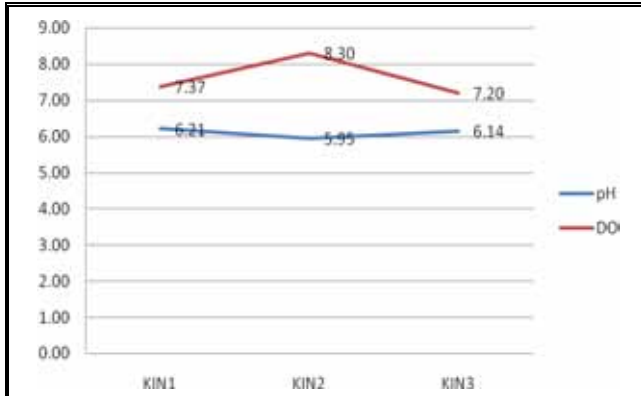
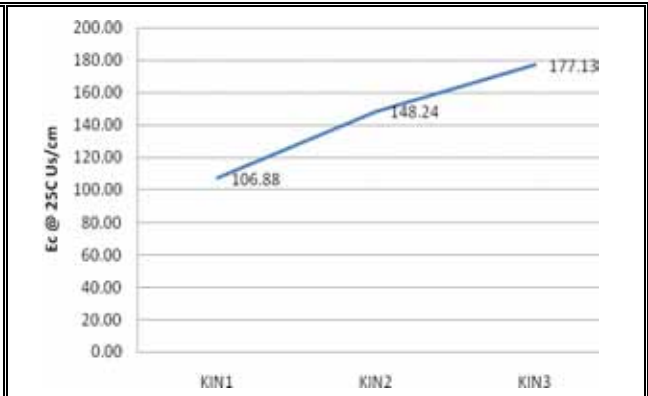
Figure 6a-6d: Results for water quality parameters at upstream and downstream sampling locations (KIN1,2,3) since construction of ARD treatment basins at Kinnears Quarry

Figure 6a. Results for pH and Dissolved Oxygen since treatment ponds established at Kinnears Quarry

Figure 6b: Results for Conductivity since treatment ponds established at Kinnears Quarry

Figure 6c: Aluminium levels post establishment of treatment ponds at Kinnears Quarry

Figure 6d: Iron (Total) levels post establishment of treatment ponds at Kinnears Quarry

As required under licence, the ARD contaminated water produced on the Kinnears Quarry site is contained within ponds and corrected for pH (6-8), Dissolved Oxygen (>5 mg/L) and Total Suspended Solids (TSS <20 mg/L) prior to discharge to the adjacent subject creek. A water sample is collected at the time of discharge and tested for a range of parameters and is summarised in Table 5. Results show that water quality discharged from the Kinnears site is within EPA licence requirements for pH, DO and Turbidity. These results have remained within licence conditions since December 2011.

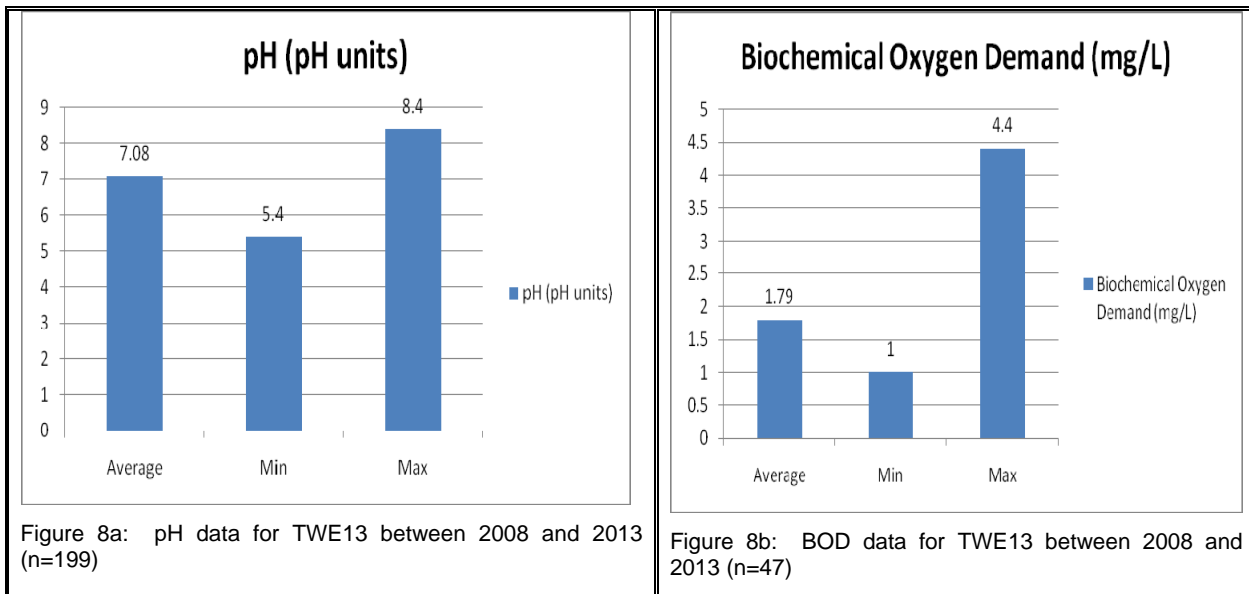
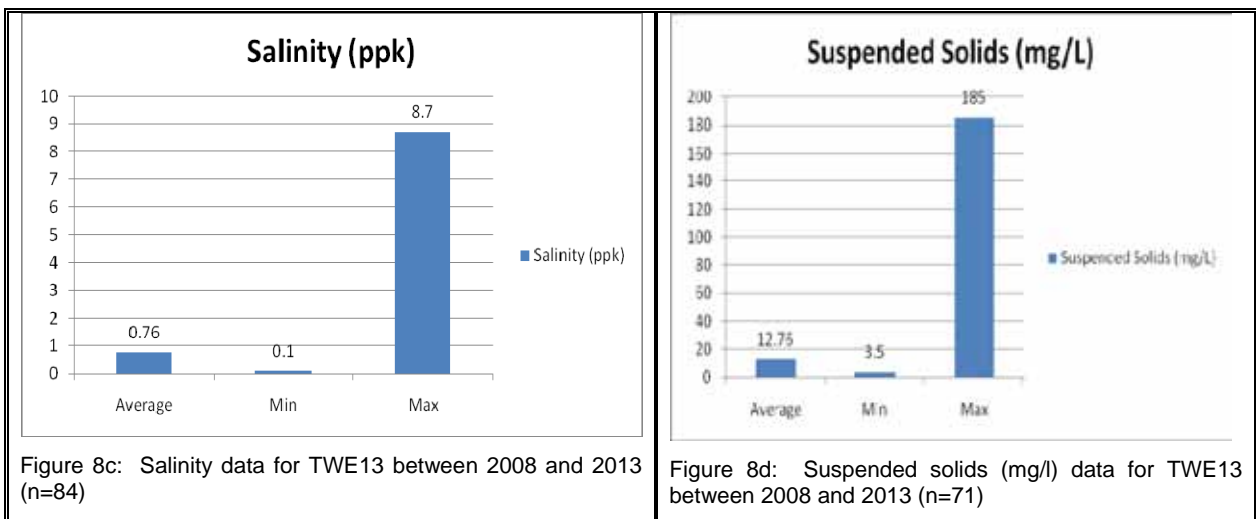
Figure 8a-8d: Water quality parameters for Rous River monitoring location TWE13 between 2008 and 2013.

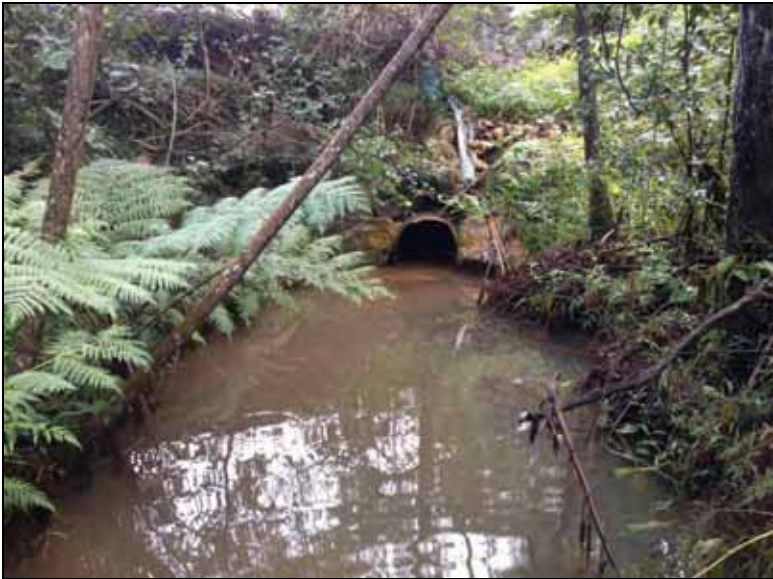
Significant manmade features observed within the subject creek included a piped section across the floor of Sanderoocks Quarry (PLATE 1), a weir located midway between the Kinnears Quarry outlet and the culverts at Harrys Road (PLATE 2) and large pools directly upstream and downstream of the Harrys Road crossing (PLATE 3).

Plate 1: Outlet of piped section of the subject creek.

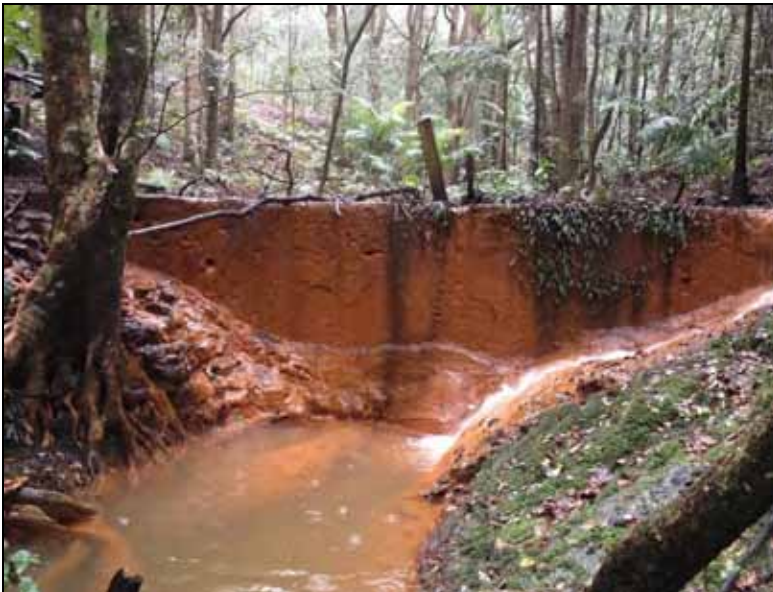
Plate 2: Constructed weir located midway between the culverts at Harrys Road and Kinnears Quarry (note iron staining on concrete surfaces; Fish and crustaceans were observed in the pools directly below the weir)

One fish species was observed during sampling within the Subject Creek, the Striped Gudgeon (*Gobiomorphus australis*) (refer PLATE 4). The striped Gudgeon occurs in coastal streams of southern Queensland, New South Wales and eastern Victoria (Australian Museum website <http://australianmuseum.net.au/Striped-Gudgeon-Gobiomorphus-australis-Krefft-1864/>). The Striped Gudgeon is an inhabitant of fresh water streams with adults recorded to feed on Eastern Gambusia and aquatic insects. Within the Subject Creek, ten individuals were recorded in a 30m section below the weir. In this section of the stream, numerous small pools had formed in the slower flatter gradient areas below the weir. Pools averaged about 2m wide and 0.5m deep. No fish were observed above the weir confirming the significant obstruction of the weir to fish passage.

<b>Rehabilitation Options</b>	<p>Remove weir and reinstate original creek grade</p> <p>Provide scour protection for localised erosion within dam upstream of Harry's Road</p> <p>Rehabilitate regenerating lowland rainforest, targeting Camphor and Lantana as a priority</p> <p>Establishing macrophytes within the creek line is not likely to be successful due to heavy shade, acidic soil conditions and coarse bed material</p> <p>Remove accumulated organic matter (and sediment) from the dam to reinstate the storage capacity. Additionally the weed species Parrots Feather (<i>Myriophyllum aquaticum</i>) could be removed in the process.</p>
-------------------------------	---

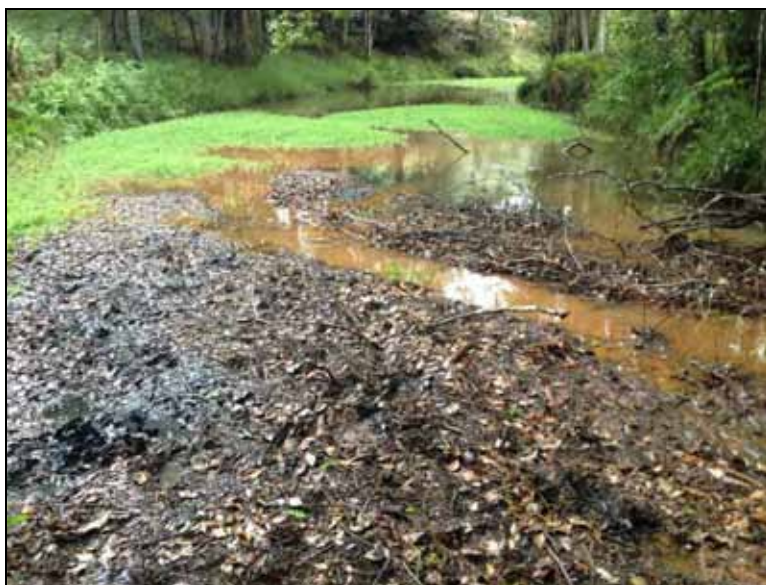
Plate 3: Pond located above culverts at Harrys Road – view looking downstream towards culverts (note dominance of the aquatic weed Parrots Feather *Myriophyllum aquaticum*)
