Safewater 7
Tweed Kenya Mentoring Programme
Tinga Dam, Siaya, March 2017

The intent of this report is to provide an overview of the specifics of the Safewater 7 project undertaken in 2017.

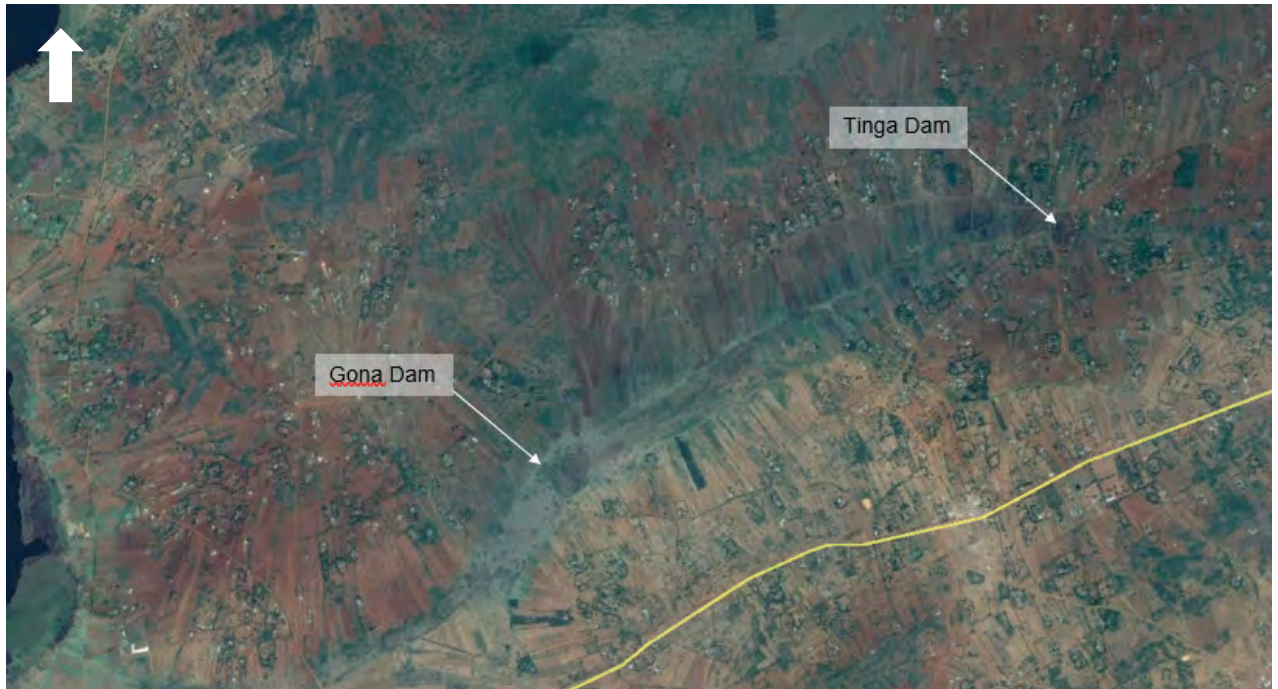
Figure 6: Location of Gona and Tinga Dams within the valley floor. Lake Kanyabola is located to the west or LHS of image.

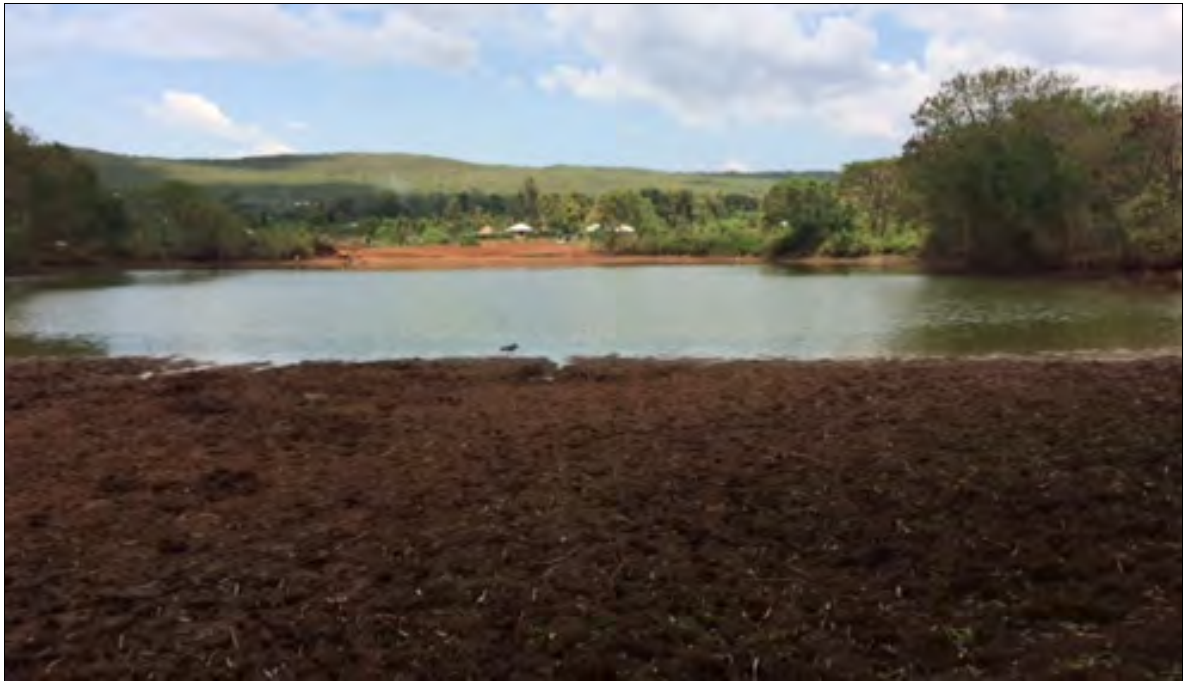
Figure 8: Low water Levels within Tinga Dam. View north from the southern shore, August 2016.

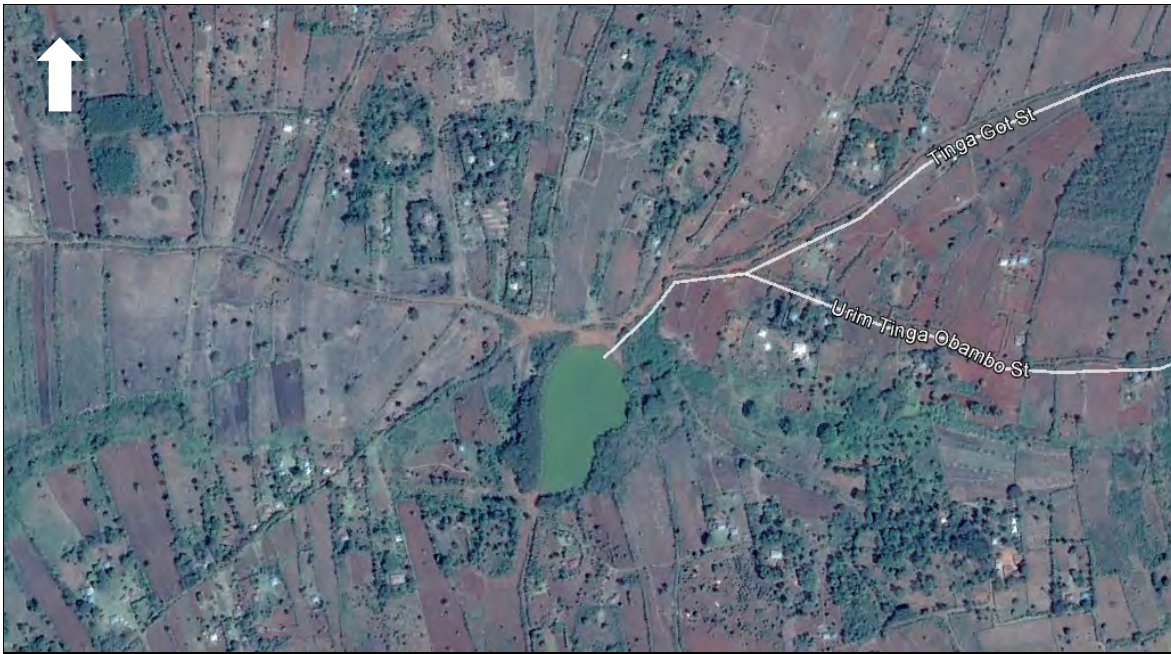
From a water storage perspective Tinga Dam is approximately oval in shape and approximately 100m in length and 70m in width at its widest point. In 2016 the maximum depth of the dam was approximately one metre in depth at its maximum depth. Refer to Figure 9 for aerial image of Tinga Dam.

Figure 9: 2015 aerial view of Tinga Dam. (Source: Google Maps)

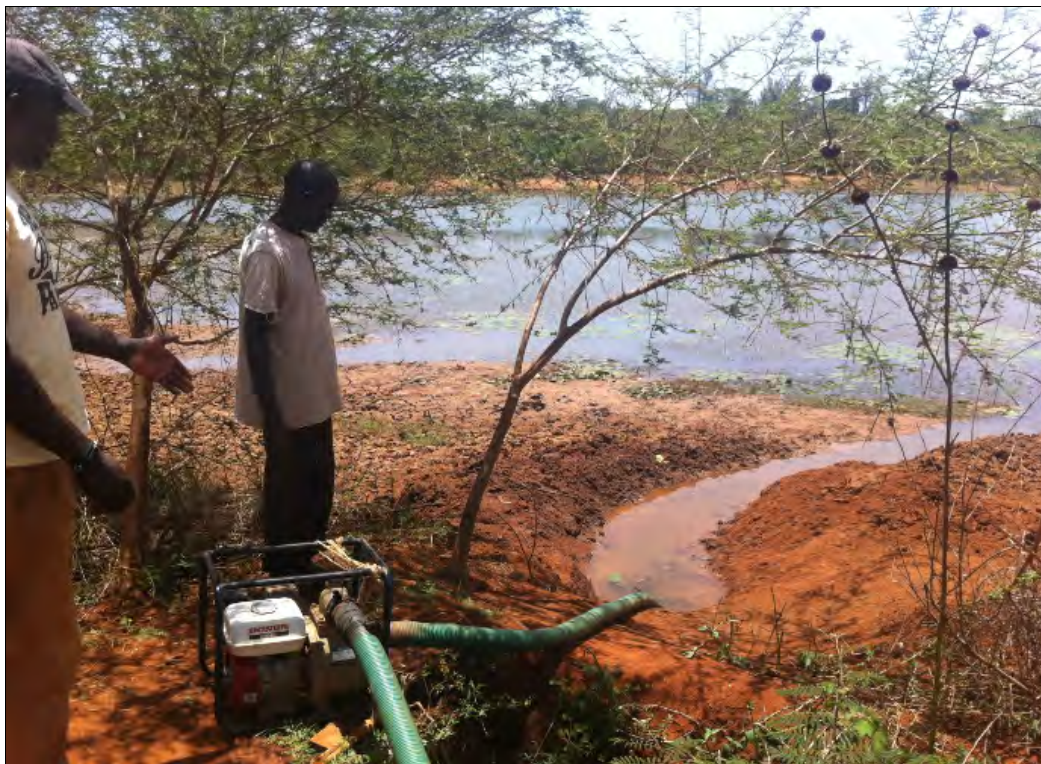
Manyasi Dam – Low water but still operational (daily digging of trench to maintain draw off point for pump) with a heavy daily load due to being only clean water supply in area. Due to drought stock are drinking direct from dam. Manyasi Dam is a long narrow dam that has natural pre-treatment of water via upstream reeds instream vegetation. The next dam downstream of Manyasi (before Tinga Dam) is Nyalnawe Dam and it also has a dense area of instream vegetation that acts as pre-treatment for inflows to the dam (eg. filters out sediment to reduce the deposition of sediment within the main dam basin)

Figure 10: Pumping water at Manyasi Dam.

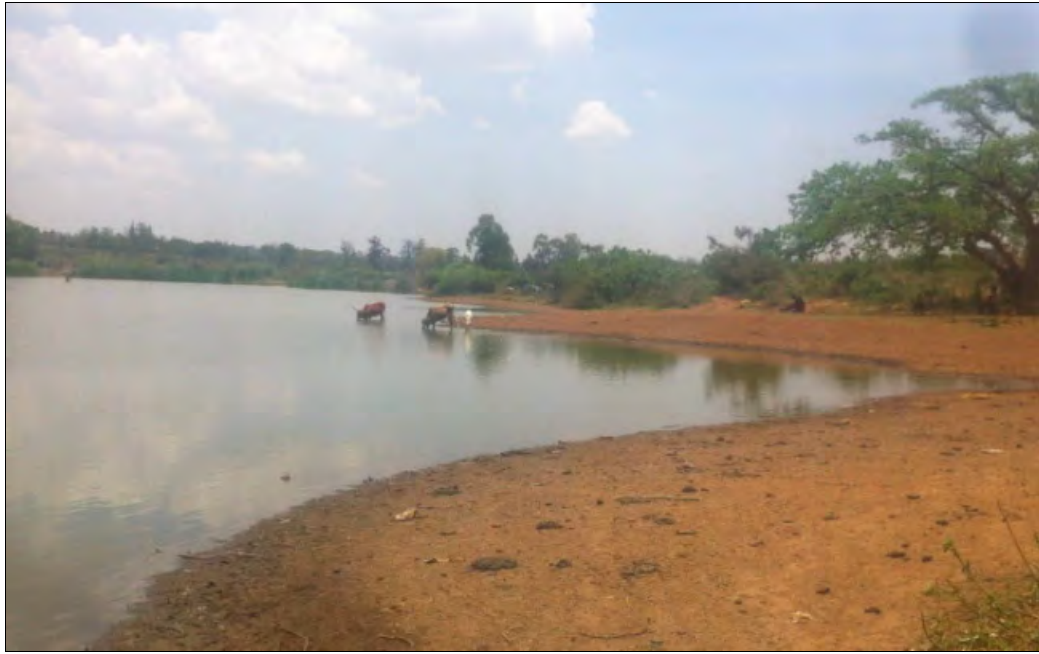
Ochillo School – Low but still plentiful, water quality within dam now green and odorous, people collecting raw water and stock drinking direct from dam. Ochillo Dam is a large water body that is stated to be spring fed and has never run dry.

Figure 11: Low water levels at t Ochillo Dam.

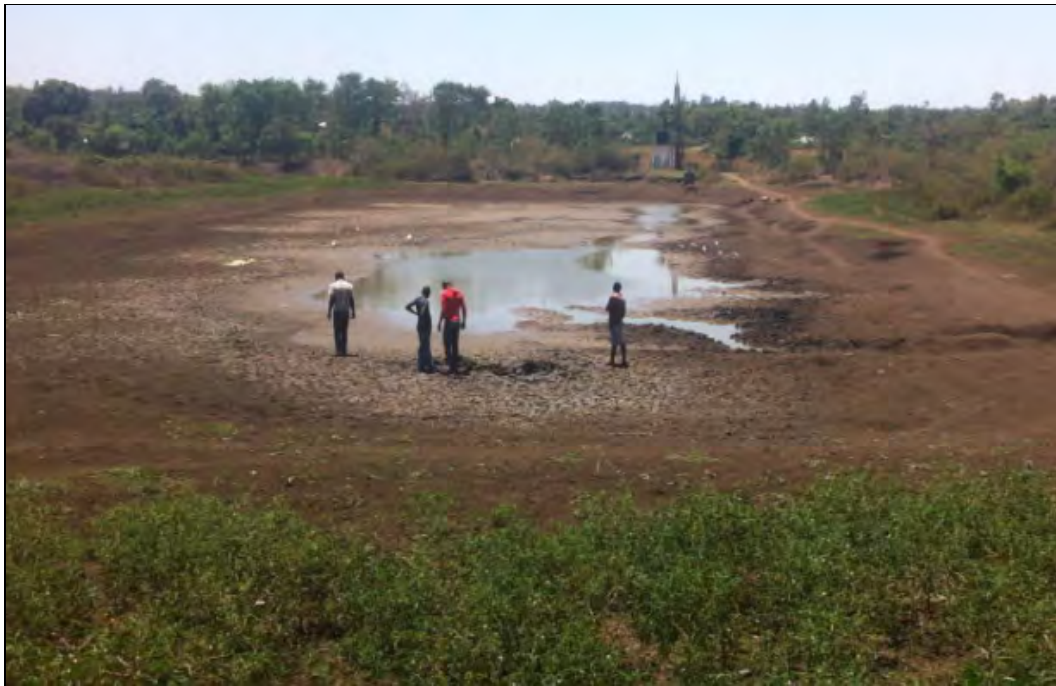
Gona Dam – closed due to lack of water. Stock accessing what little water there is left. Previous fencing to exclude stock gone, fence posts pushed down or eaten by termites etc. Gona Dam is located low in the landscape and is the last in the valley to receive water. Soils are black clays compared to the orange red clays in the upstream elevated areas of the valley. The upstream soils are very erodible compared to the black clays.

Figure 12: Gona Dam basically dry

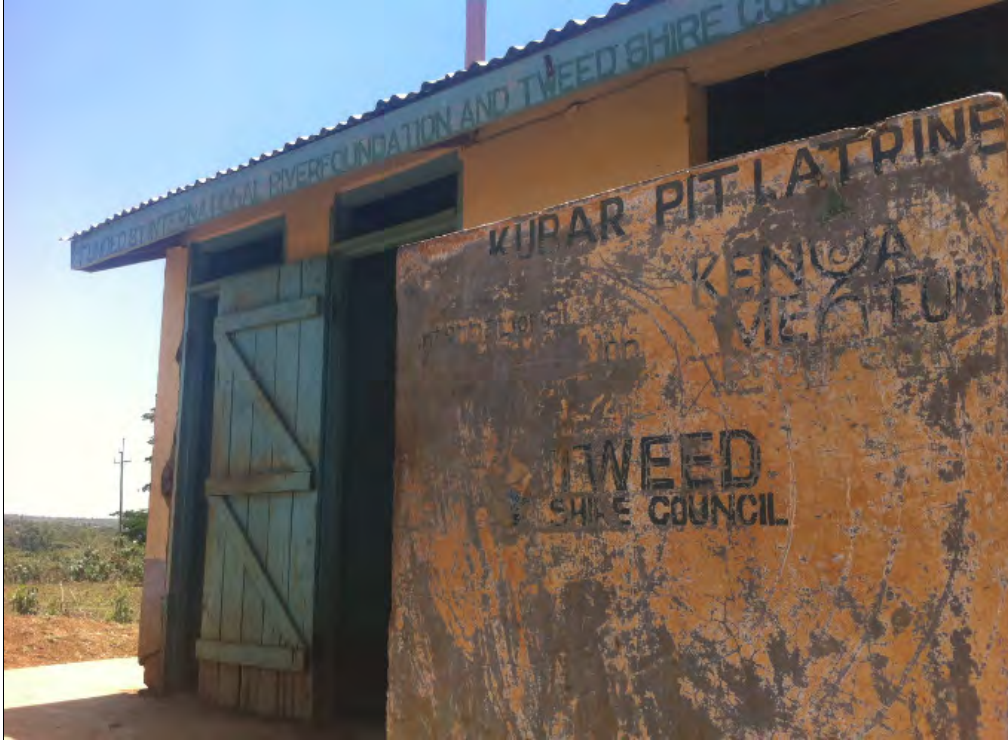
Kubar School- toilets operational but very odorous, many flies. Capacity of pit toilets approximately 1 to 1.2 m from top. One water tank within school vandalized and destroyed other vandalized and now no water due to drought. Children would typically rely on Tinga Dam for water, however as this is out of action for Safewater 7, water is being sourced from Manyasi Dam.

Figure 13: The toilet block at Kubar School located west of Tinga Dam.

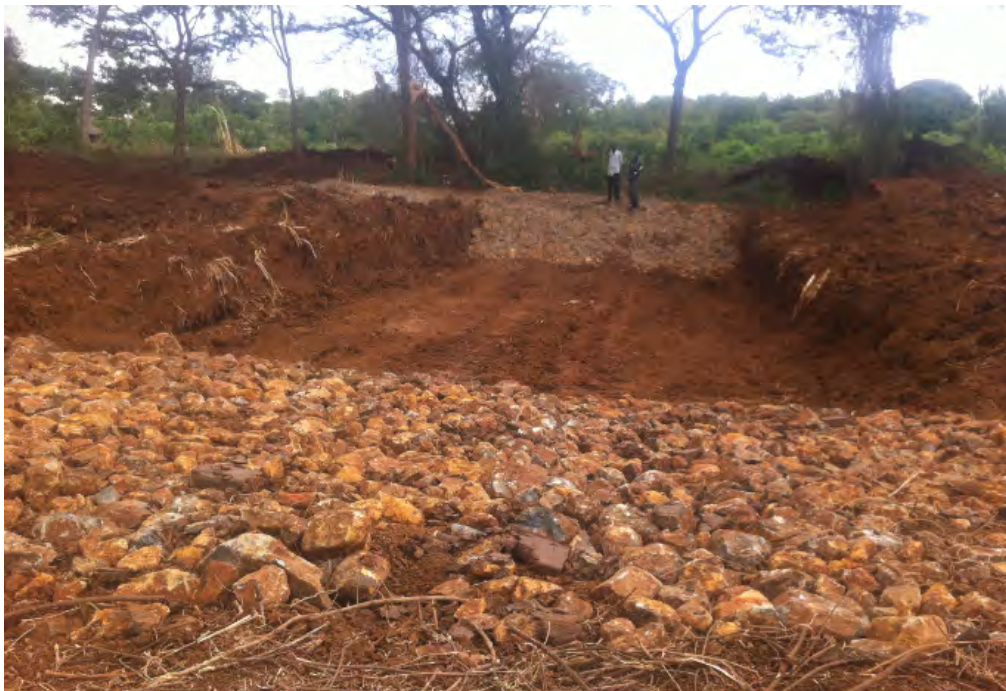
On the north eastern side of the dam two linear collection trenches were excavated approximately in a vee arrangement, to direct upstream flows into the dam via a new excavated silt trap, which is located within the bund walls of the former silt trap. The orientation of the new silt trap is square to the dam wall, however, when the collection trenches were excavated (with advice from the dam committee) they are oriented at an angle to the new silt trap. The resulting flows have the capacity to short cut the silt trap under high flow conditions.

Figure 17: The newly constructed sediment trap located on the eastern side of dam

The dimensions of the silt trap basin are approximately 9m in width by 12m in length by 1.5m in depth. The inlet ramp to the excavated silt trap was stabilized via a rock lined and cemented riprap, however the discharge point is rock lined but rocks/cobbles are not cemented/stabilized in place.

Disturbance around the collection trenches and silt trap were cause for concern based on loose spoil from excavations (small indiscriminate stockpiles), directional low in height earth bunds not compacted or stabilised, all in the direct flow path to the silt trap and dam. Although this was not completed satisfactorily by the use of dozer or excavator, the contractor agreed to pay members of the community (local boys) to relocated loose material from within the main flow path, to other side of bund walls out of the flow path.

One of the main criticisms of the works was the final state and disturbance of the silt trap and collection trenches. As previously discussed the site was not left in a satisfactory state and required the additional contracting of local community workers to remove and relocate stockpiled and loose material out of the drainage line flow path.

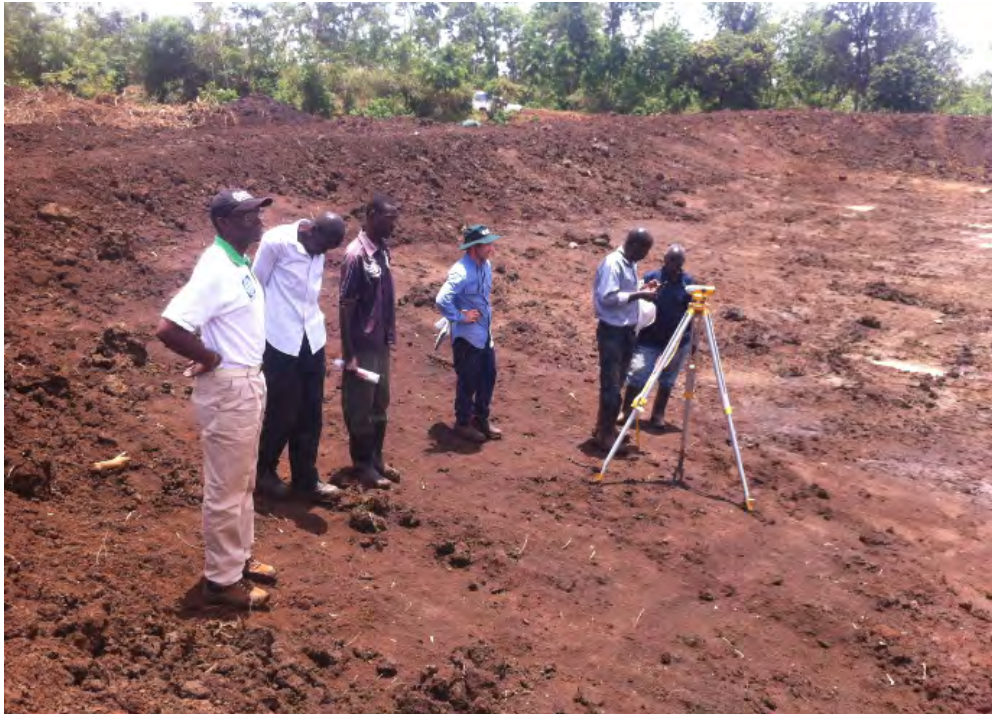
Based on the post works survey, undertaken on Friday 17 March and the previous survey of the dam undertaken by PlumTech on 22 December, 2016 prior to desilting works, the findings are as follows:

Figure 19: Survey works to determine volume of material excavated.
