HEAVY VEHICLE ROUTE ASSESSMENT  
- DULGUIGAN ROAD  
ADDENDUM 1  
TUMBULGUM, NSW

## Document Control Sheet

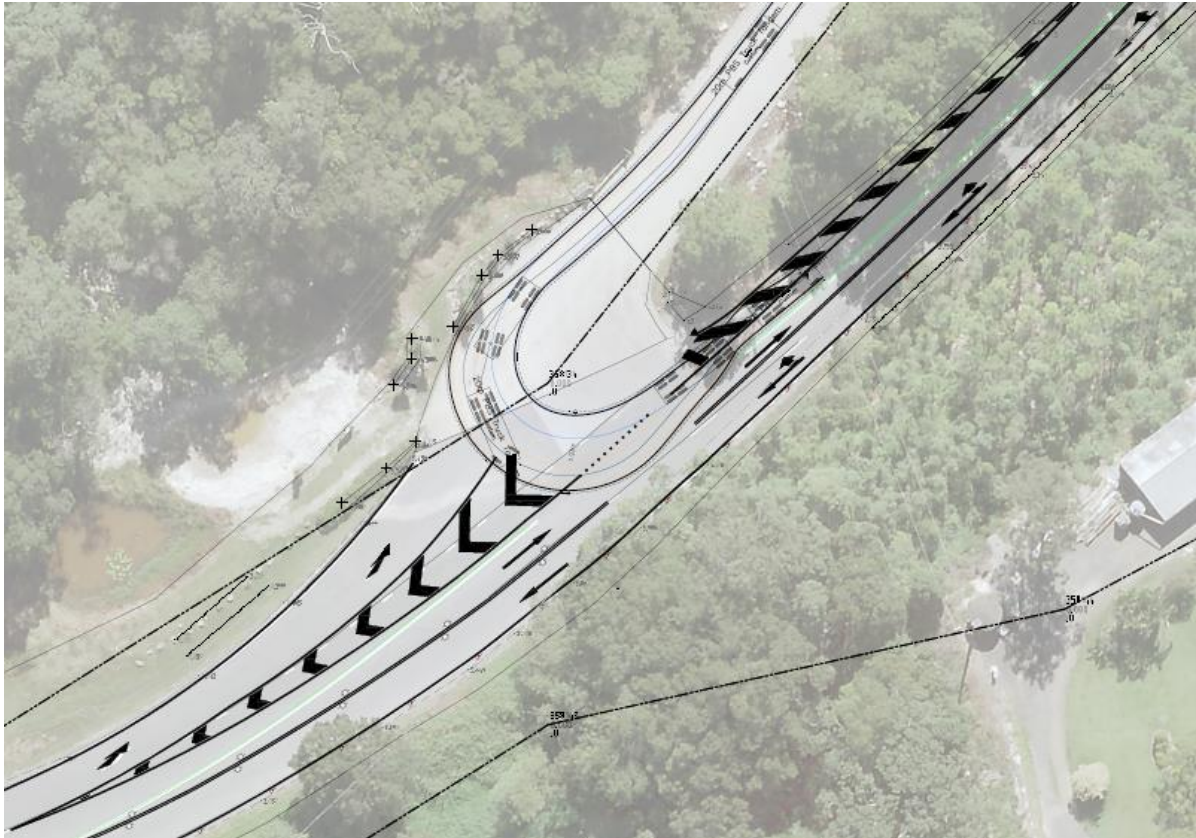
Figure 3.1: Portion of Preliminary Sketch titled "Turns - 20m PBS Vehicle, Quarry Entrance"

Note: The vehicle swept path shown in *Figure 3.1* is for a 20m PBS vehicle. It shows the vehicle entering the middle lane when turning left out of the quarry. With reference to *Control Measure No.1: On-site Assessment of Vehicle Swept Path* a 19.6m PBS vehicle was able to just remain within the single eastbound lane (ie: not enter the middle lane) when turning left out of the quarry, hence the 20m PBS vehicle turn path template may be considered conservative.

- Eastbound - single eastbound lane
- Westbound - single westbound lane with combined straight-through arrow and right-turn arrow for vehicles turning right into the quarry
- Westbound - wide road shoulder for westbound vehicles to pass stationary vehicle waiting to turn right into the quarry

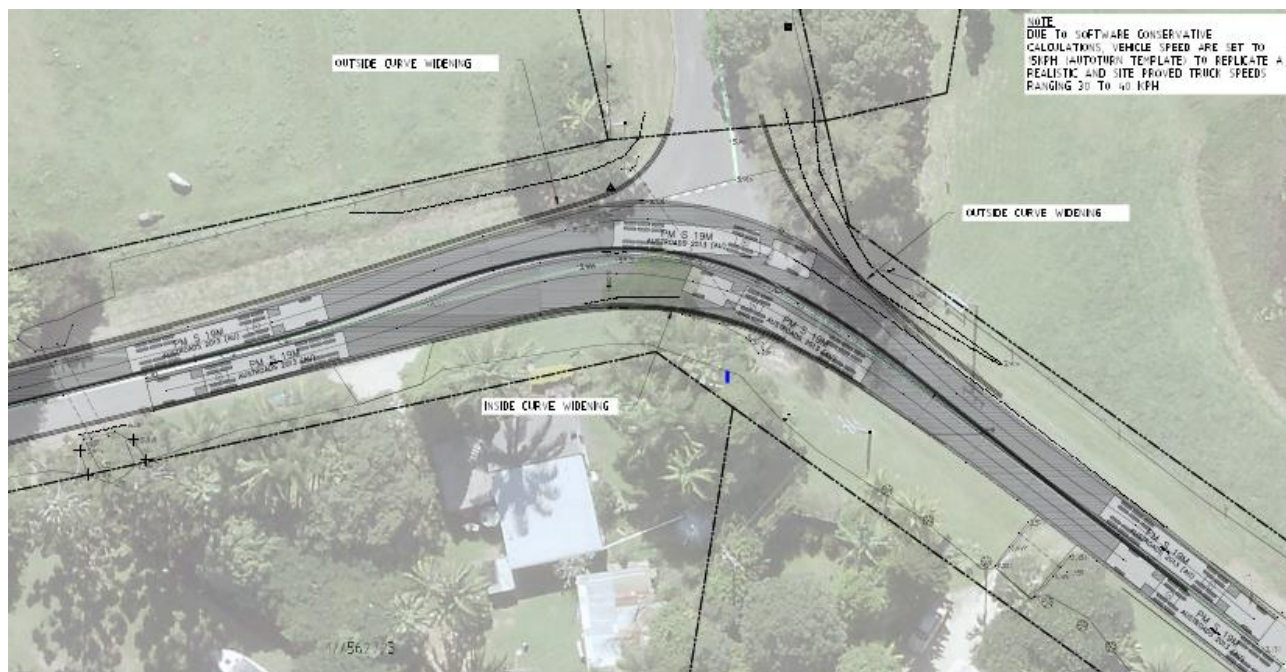
Figure 3.2: Portion of Preliminary Sketch titled "Turns - 19m Semi, Hogans Road Intersection"

Tweed Shire Council is presently preparing a design that widens the road formation and the road seal at three (3) locations around the curve. The proposed road widening works will cater for a 19m semi-trailer and a 20m PBS vehicle. With reference to *Section 2.1: Control Measure No.1* the 19.6m PBS vehicle travelling at 30-40km/h closely replicates TSC's swept path analysis for a 19m semi-trailer travelling at 15km/h. Therefore, the proposed road widening works at the Dulguigan Road / Hogans Road intersection is based on a 19m semi-trailer travelling at 15km/h as shown in *Figure 3.2* below (Refer *Appendix G: Proposed Road Widening at Hogans Road*).

Road widening works will assist all road users in safely negotiating the curve on Dulguigan Road in either direction, as well as assist all road users when undertaking the various traffic manoeuvres at the Dulguigan Road / Hogans Road intersection.

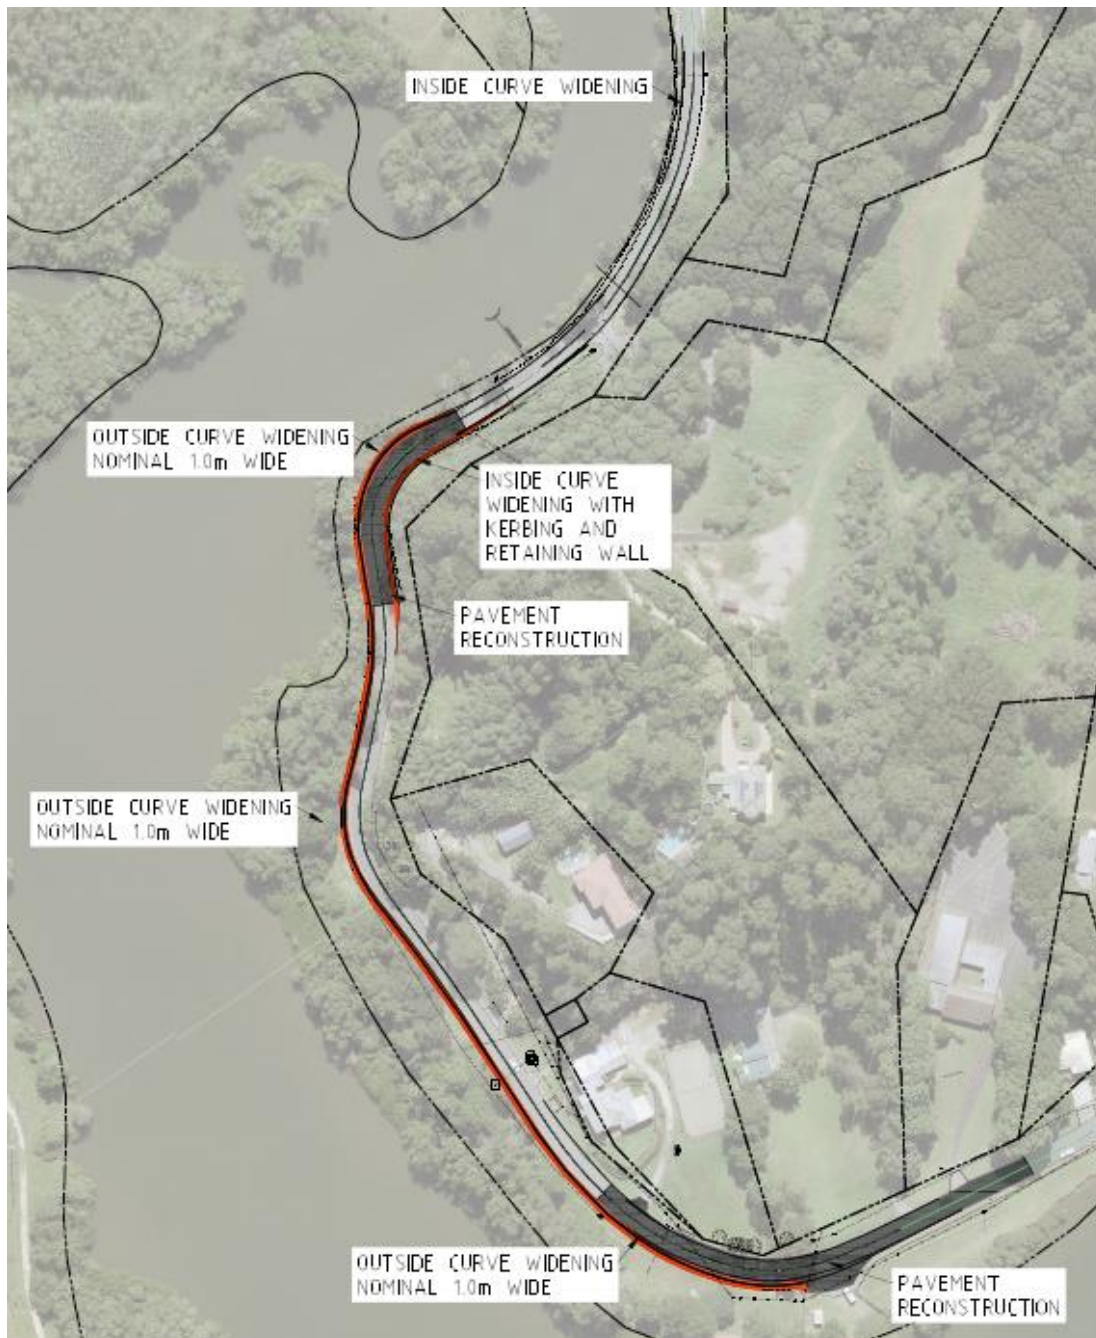
Figure 3.3: Portion of Preliminary Sketch titled "Turns - 19m Semi, Tumbulgum Section"

With reference to *Section 2.1: Control Measure No.1* the 19.6m PBS vehicle travelling at 30-40km/h closely replicates TSC's swept path analysis for a 19m semi-trailer travelling at 15km/h. Therefore, the proposed road widening works on the curves east of Mayes Hill Road is based on a 19m semi-trailer travelling at 15km/h as shown in *Figure 3.3* below (Refer *Appendix H: Proposed Road Widening East of Mayes Hill Road*).

Tweed Shire Council is presently preparing a design that widens the road formation around the series of curves located east of Mayes Hill Road. The design also includes pavement reconstruction at two (2) of the curves.

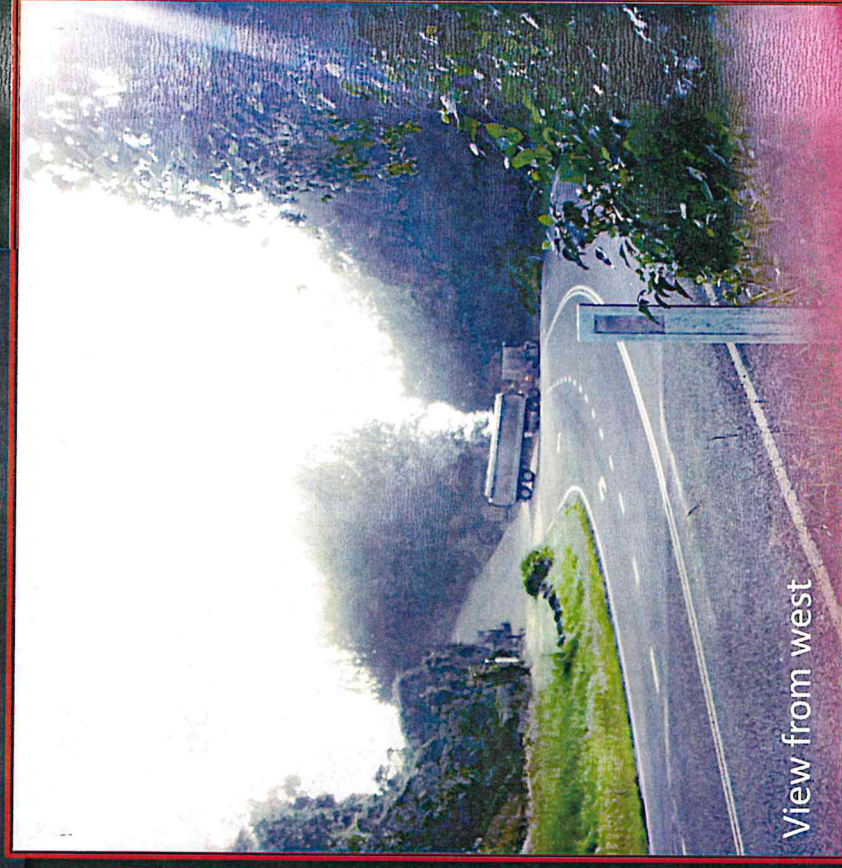
# Quarry Entrance (Cont.)

View from west

Entrance designed for max 40 x 20m<sup>3</sup> trucks on any given day and 10,000 p.a. as condition - 2004 Quarry DA04/0162

**Risk Control Measure**  
relies on behaviour change  
**lowest order safety control**

Note: Unless entrance is redesigned, safer for traffic to enter from and leave the quarry to the west, where it is easier for trucks to stay in correct lane.

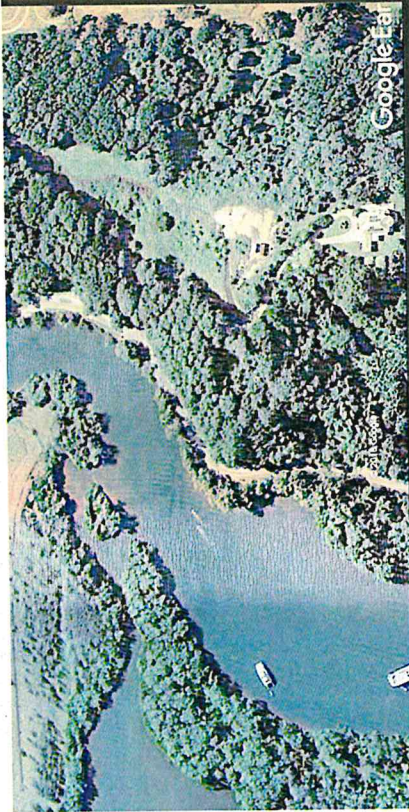
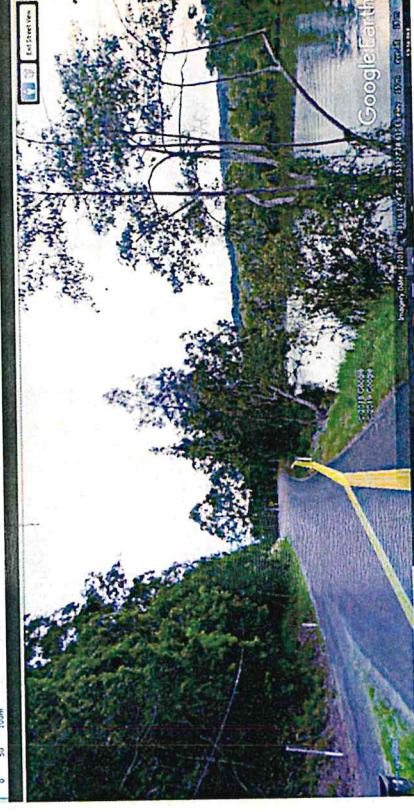
# 4. Mayes Hill Curves High Risk

Truck rollover on approach from west c. 2011

To reduce the risk to medium requires major work - acquisition of properties and redesign of curves.

Topography and proximity of river

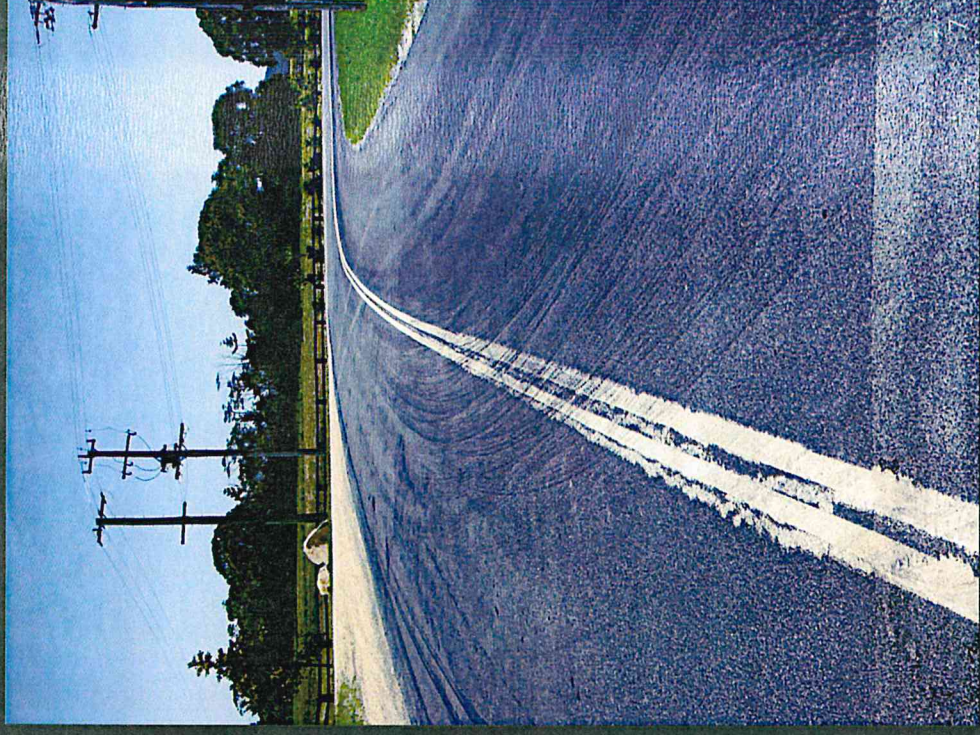
## 5. Terranora Rd Intersection

Proposed right turning lane in Dulguigan Rd does NOT address the community concern of cars travelling north east along Terranora Rd being run off the road by trucks turning left on Terranora Rd from Dulguigan Rd **NO Verge**

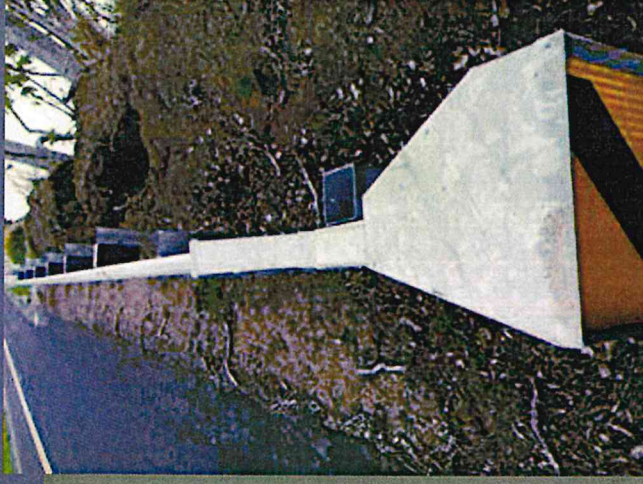
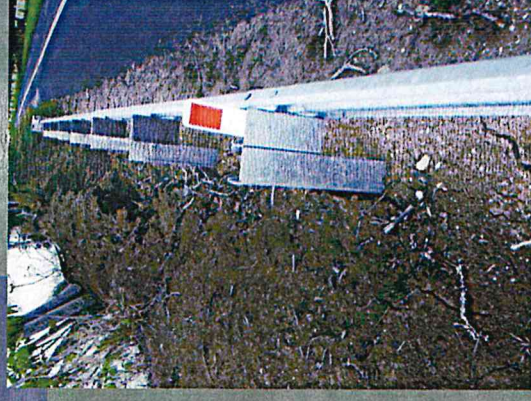
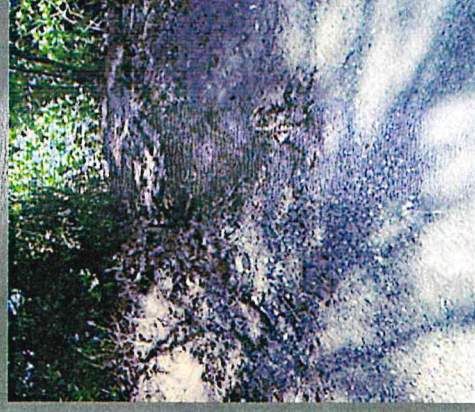
**Medium Risk**

Vegetation

Current carriageway width  
not spelt out (requires 2.4m  
i.e 2 x1.2 m of sealed  
shoulder

NO Verge NO Shoulder + Topography

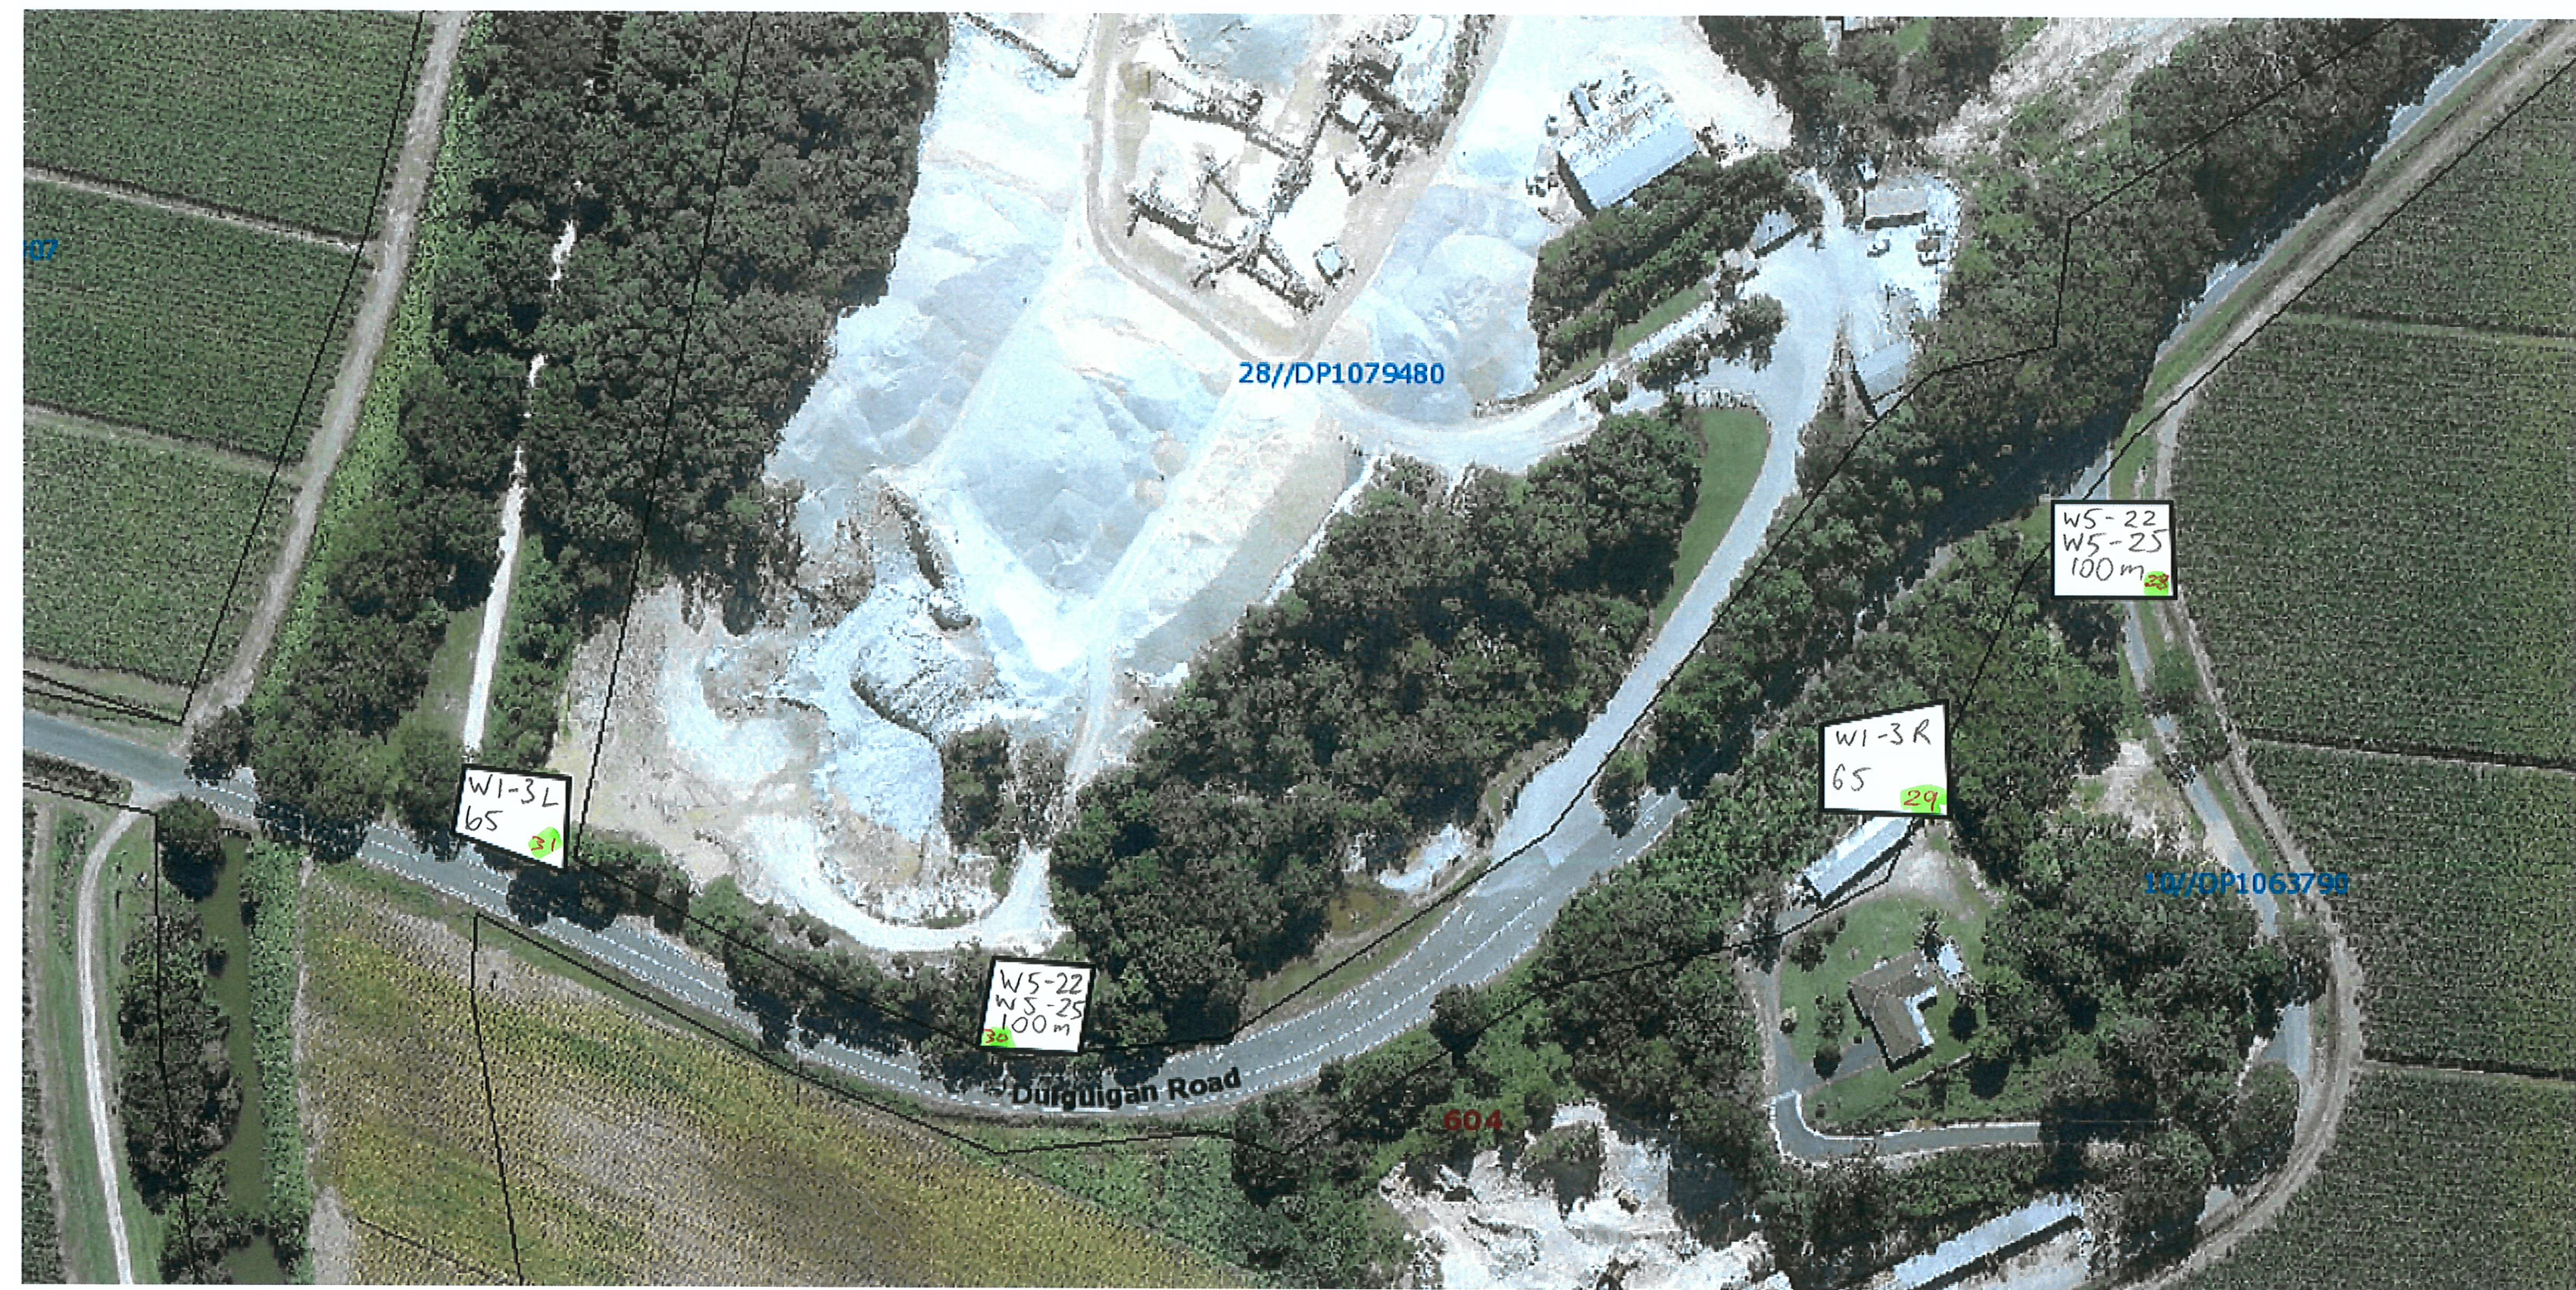
**PROPOSED SIGN LAYOUT**

SIGN NUMBER	SIGN CODE	SPEED km	LENGTH m
1	W1-3R	45	0
2	W1-3R	25	0
3	W1-3L	45	0
4	W8-237	35	400
5	W1-3L	35	0
6	W8-237	35	400
7	W1-3R	75	0
8	W1-3R	65	0
9	W1-3R	45	0
10	W1-3L	65	0
11	W8-237	35	300
12	W1-3L	45	0
13	W1-3L	55	0
14	W8-237	35	300
15	W1-4L	45	0
16	W1-3R	55	0
17	W1-4R	45	0
18	W1-4L	65	0
19	W1-4L	65	0
20	W1-3L	75	0
21	W1-4L	65	0
22	W1-3R	65	0
23	W1-3R	55	0
24	W8-237	55	600
25	W8-237	55	600
26	W8-237	55	600
27	W8-237	55	600
28	W5-22 W5-25	0	100
29	W1-3R	65	0
30	W5-22 W5-25	0	100
31	W1-3L	65	0
32	G9-348	0	0
33	A. W1-1L+	25	0
34	B. W1-1R +	25	0
35	G9-348	0	0
36	CAM's Hogans Rd	0	0
37	CAM's 987 Dul	0	0

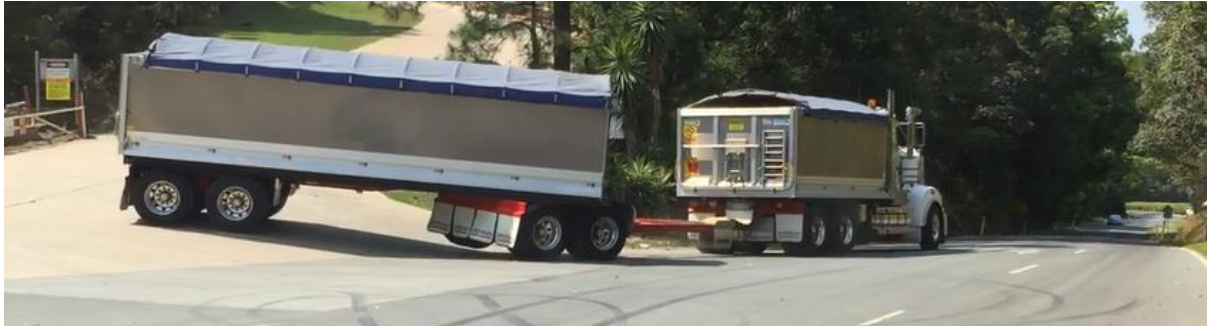
Site 1 Quarry entrance: PBS vehicle exiting quarry and turning left (eastbound) onto Dulguigan Road - Wheels just remained within the eastbound travel lane

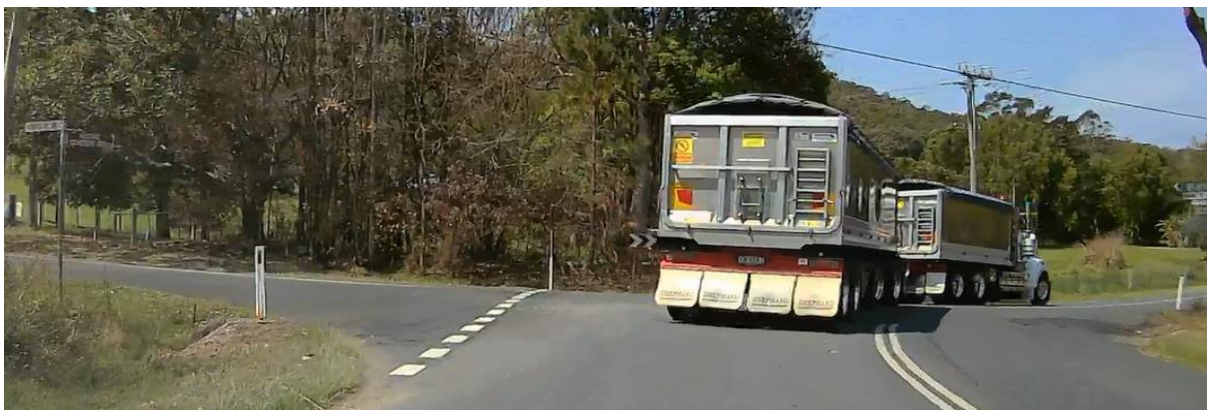
Site 2 Hogan Road Intersection: PBS vehicle travelling eastbound on Dulguigan Road - Wheels remained within the eastbound travel lane when negotiating the right hand curve

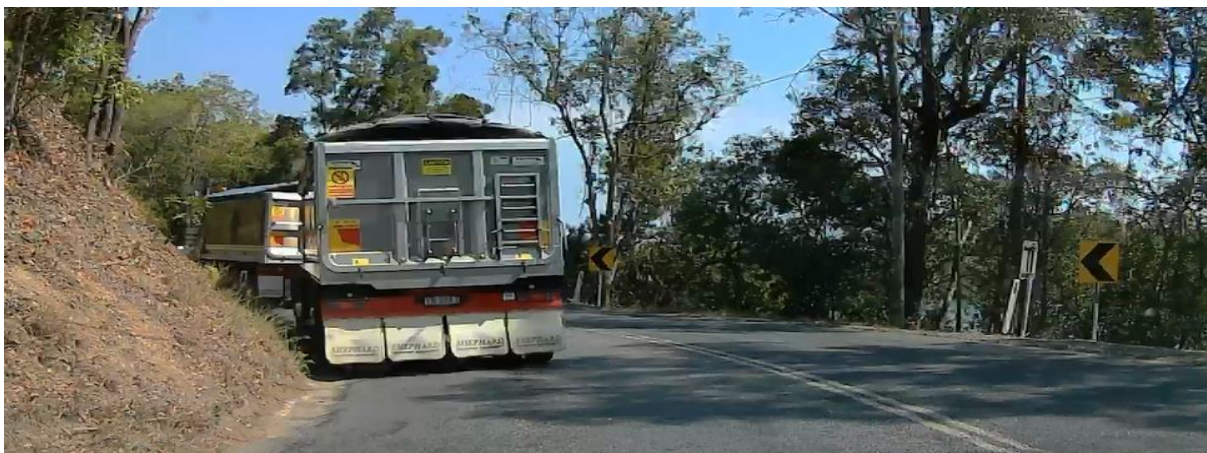
Site 3 First Curve East of Mayes Hill Road: PBS vehicle travelling eastbound on Dulguigan Road - Rear wheels travelled slightly off the sealed road surface when negotiating the left hand curve

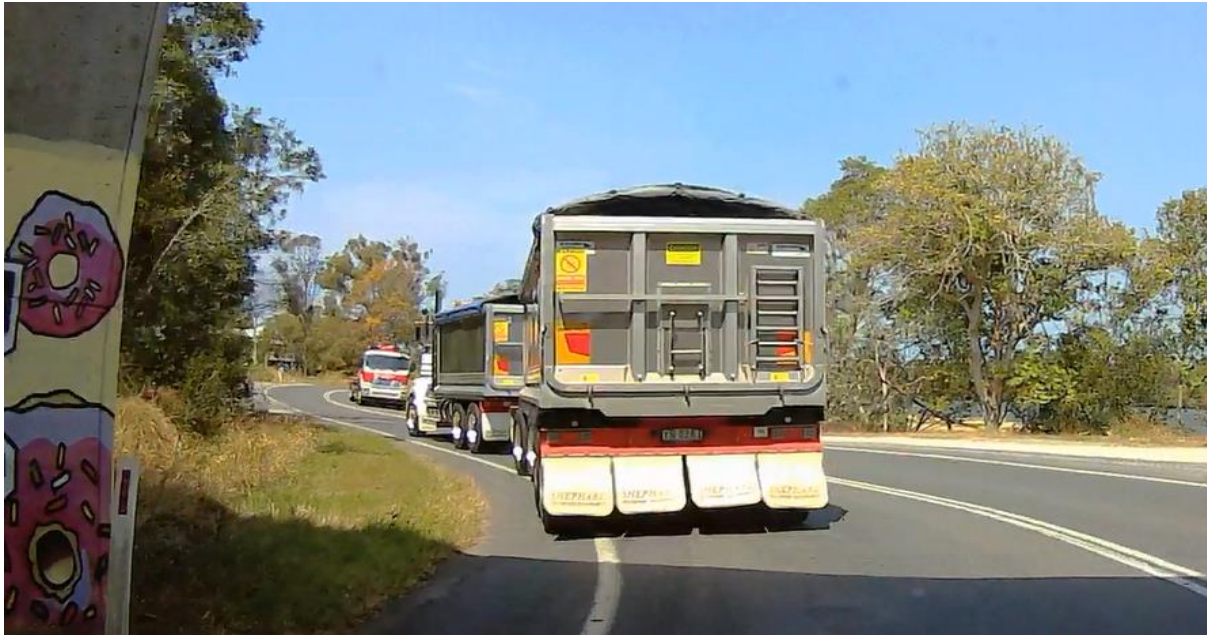
Site 4 Under Terranora Road Structure: PBS vehicle travelling eastbound on Dulguigan Road - Two sets of rear wheels travelled outside of road edge line when negotiating the left hand curve, however wheels remained on the sealed road surface

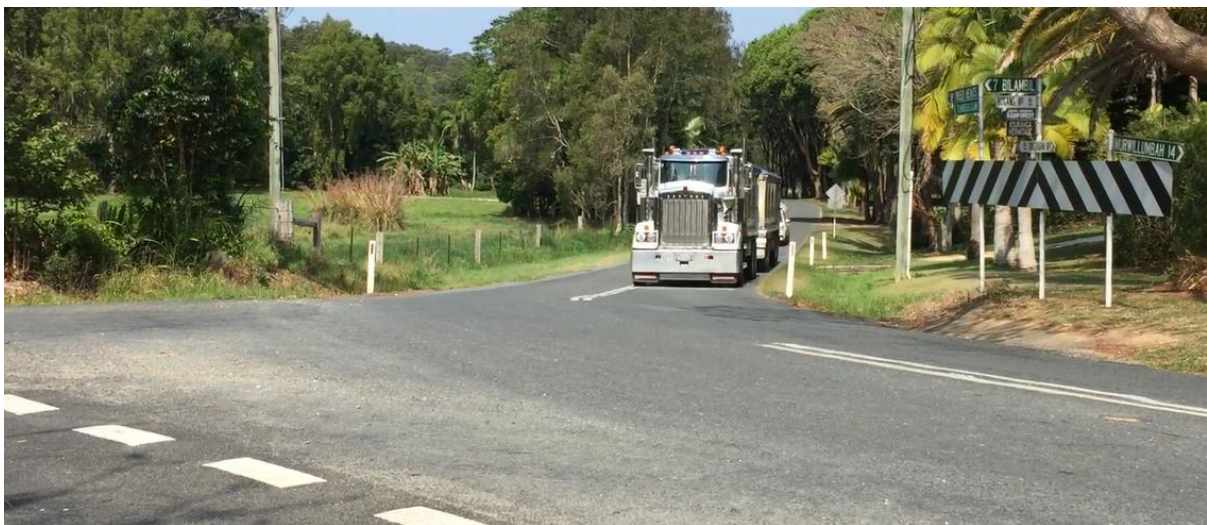
Site 5 Hogan Road Intersection: PBS vehicle travelling westbound on Dulguigan Road - Wheels just remained within the westbound travel lane when negotiating the left hand curve

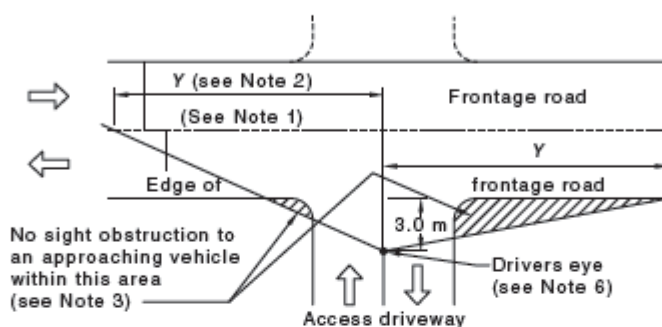
Figure 3.3 — Sight distance requirements at access driveway exits

- (a) *Sight distance to oncoming traffic on the public roadway* — Sight distance requirements to enable a commercial vehicle to find a safe gap in oncoming traffic when leaving an access driveway are specified in [Figure 3.3](#).

Frontage road speed (see Note 4) km/h	Distance (Y) along frontage road (see Note 5) m	
	5 s gap	8 s gap
40	55	89
50	69	111
60	83	133
70	97	156
80	111	178
90	125	200
100	139	222
110	153	244

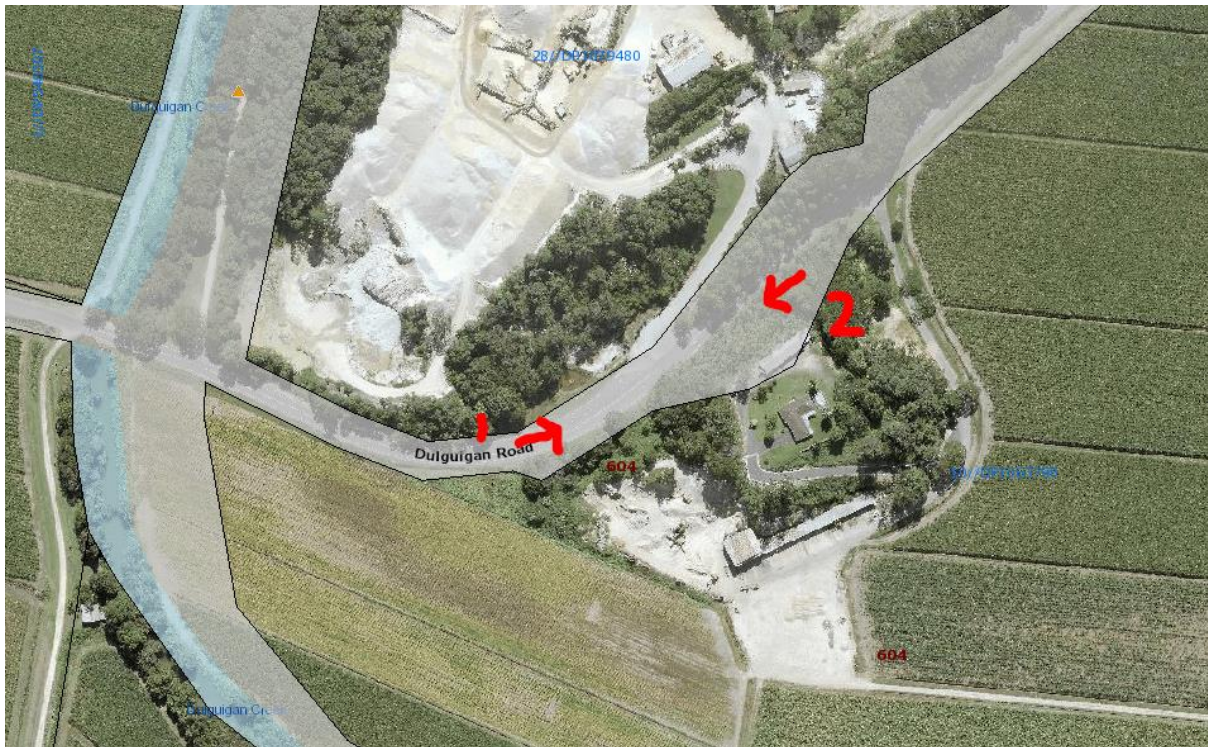
Figure 1. Traffic volumes approaching the quarry access. Site 1 eastbound traffic only and Site 2 westbound traffic only

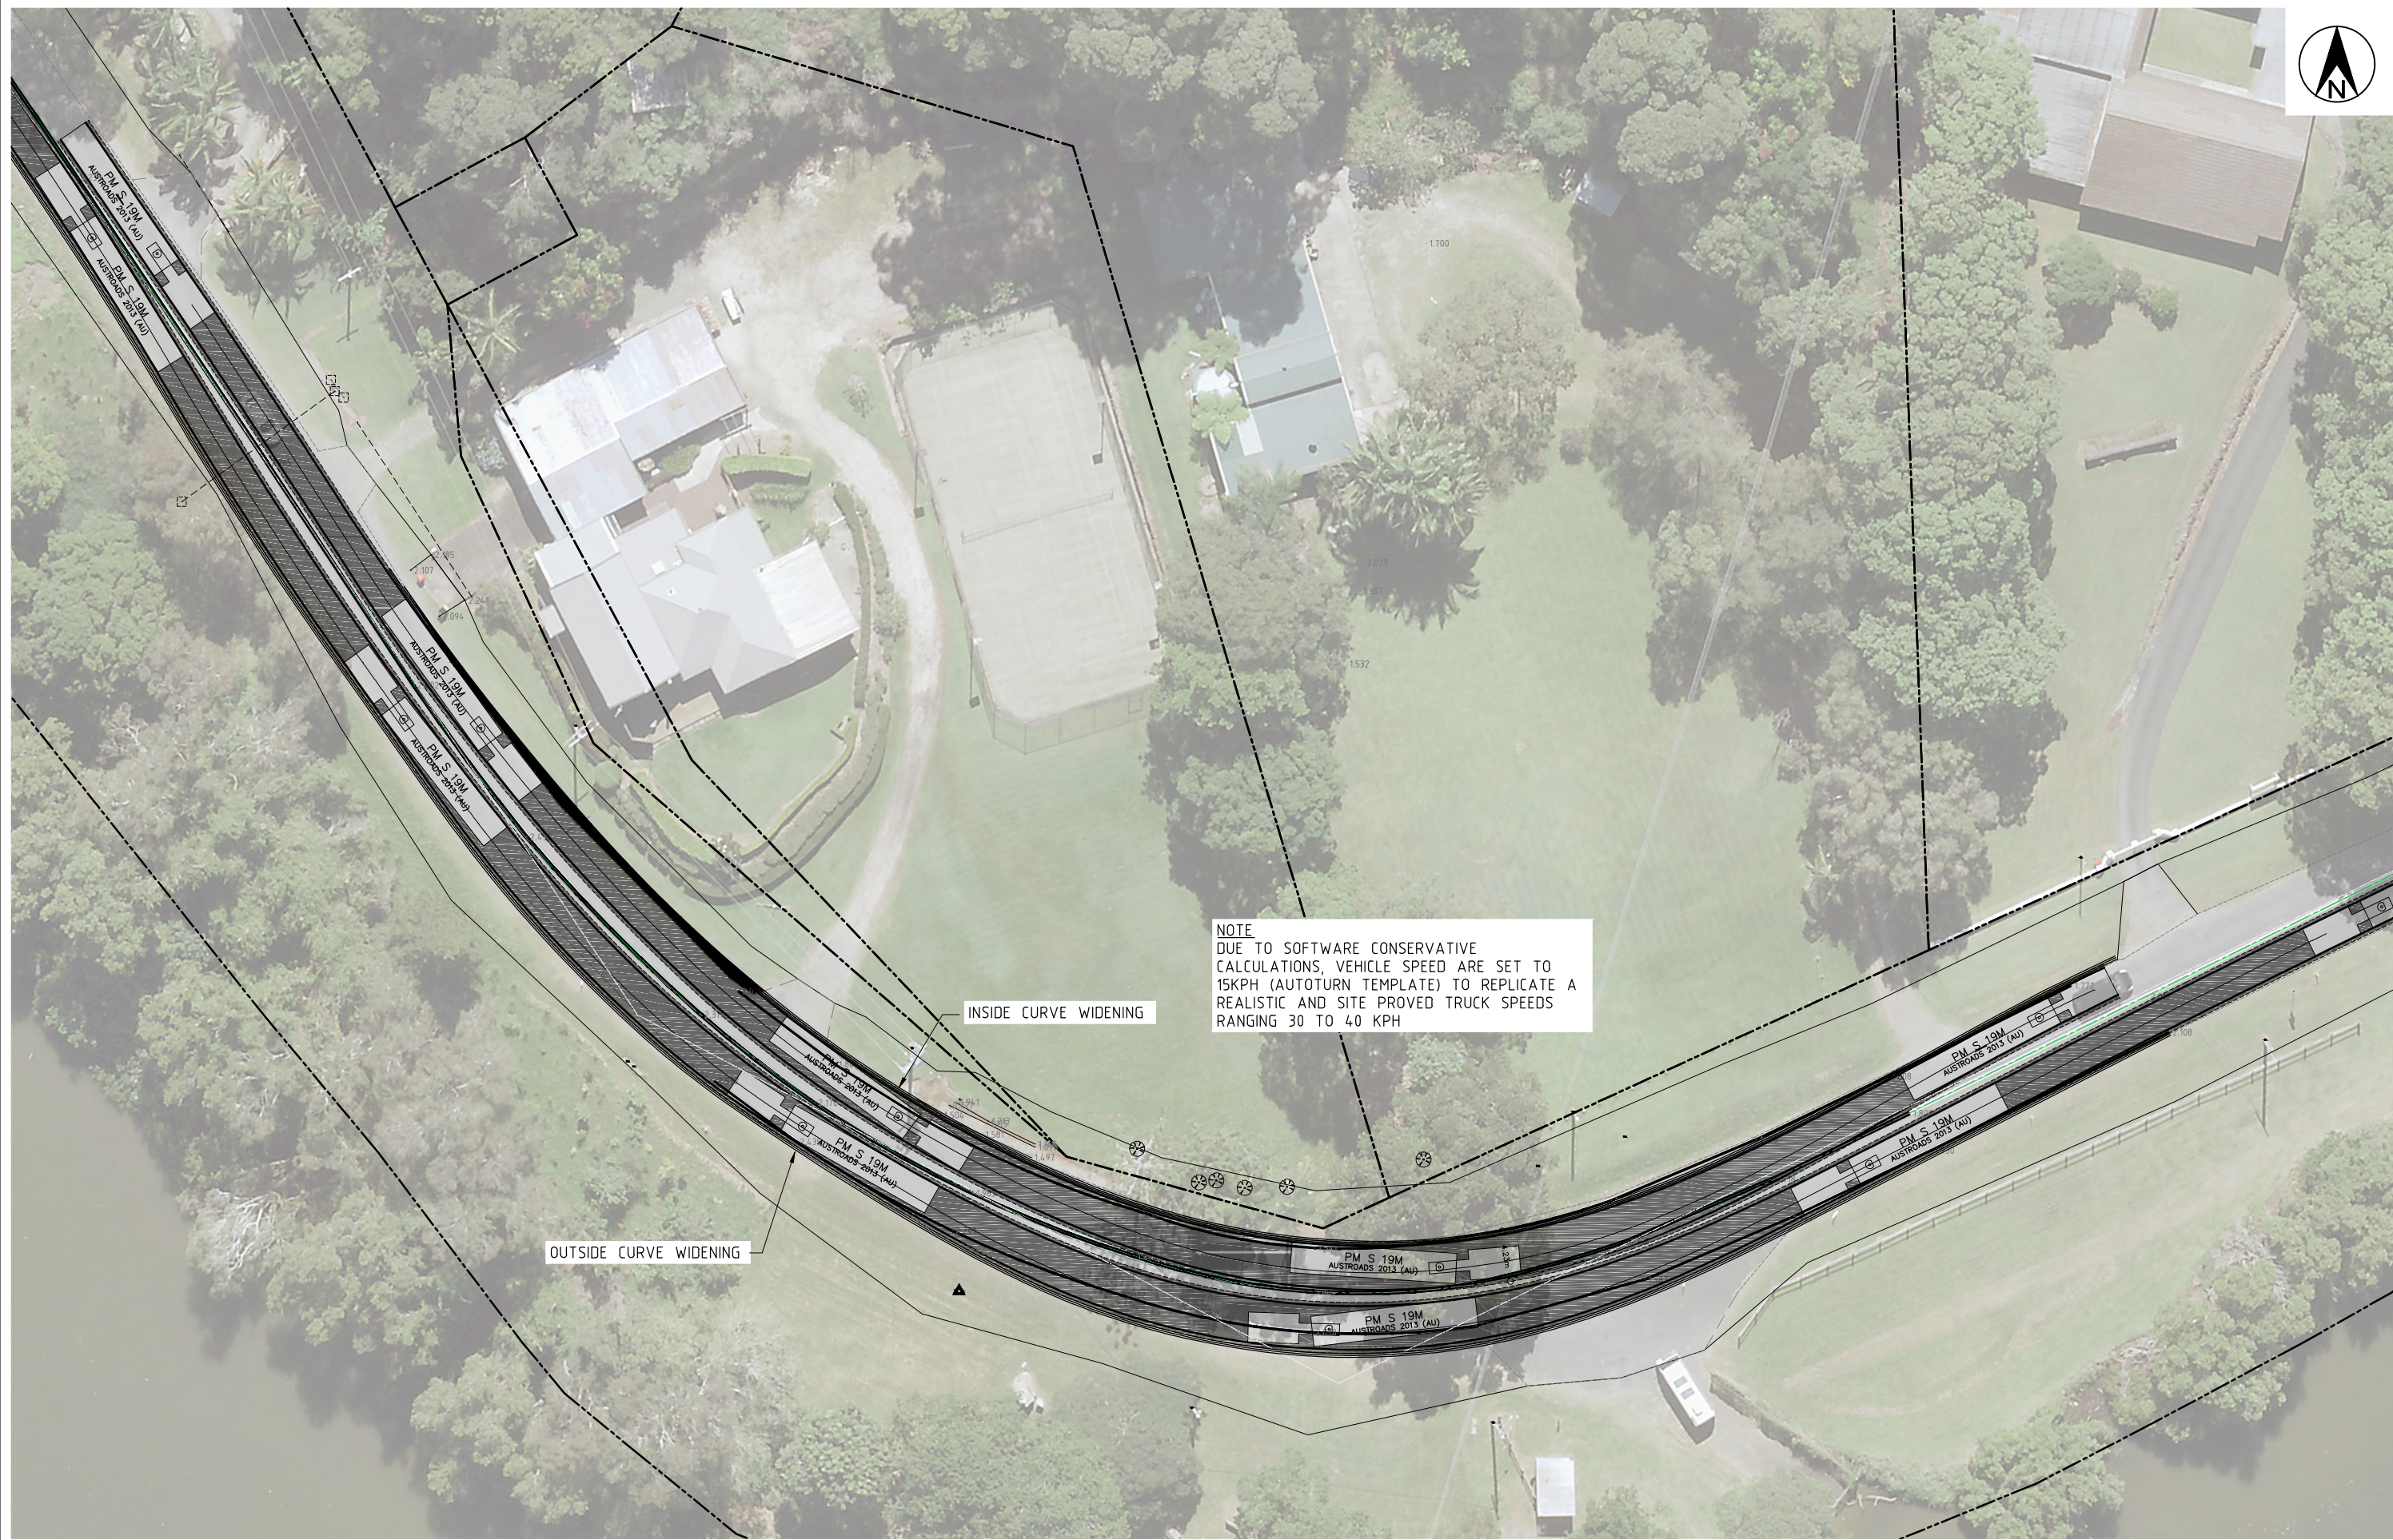
**NOTE**  
 DUE TO SOFTWARE CONSERVATIVE CALCULATIONS, VEHICLE SPEED ARE SET TO 15KPH (AUTOTURN TEMPLATE) TO REPLICATE A REALISTIC AND SITE PROVED TRUCK SPEEDS RANGING 30 TO 40 KPH

INSIDE CURVE WIDENING

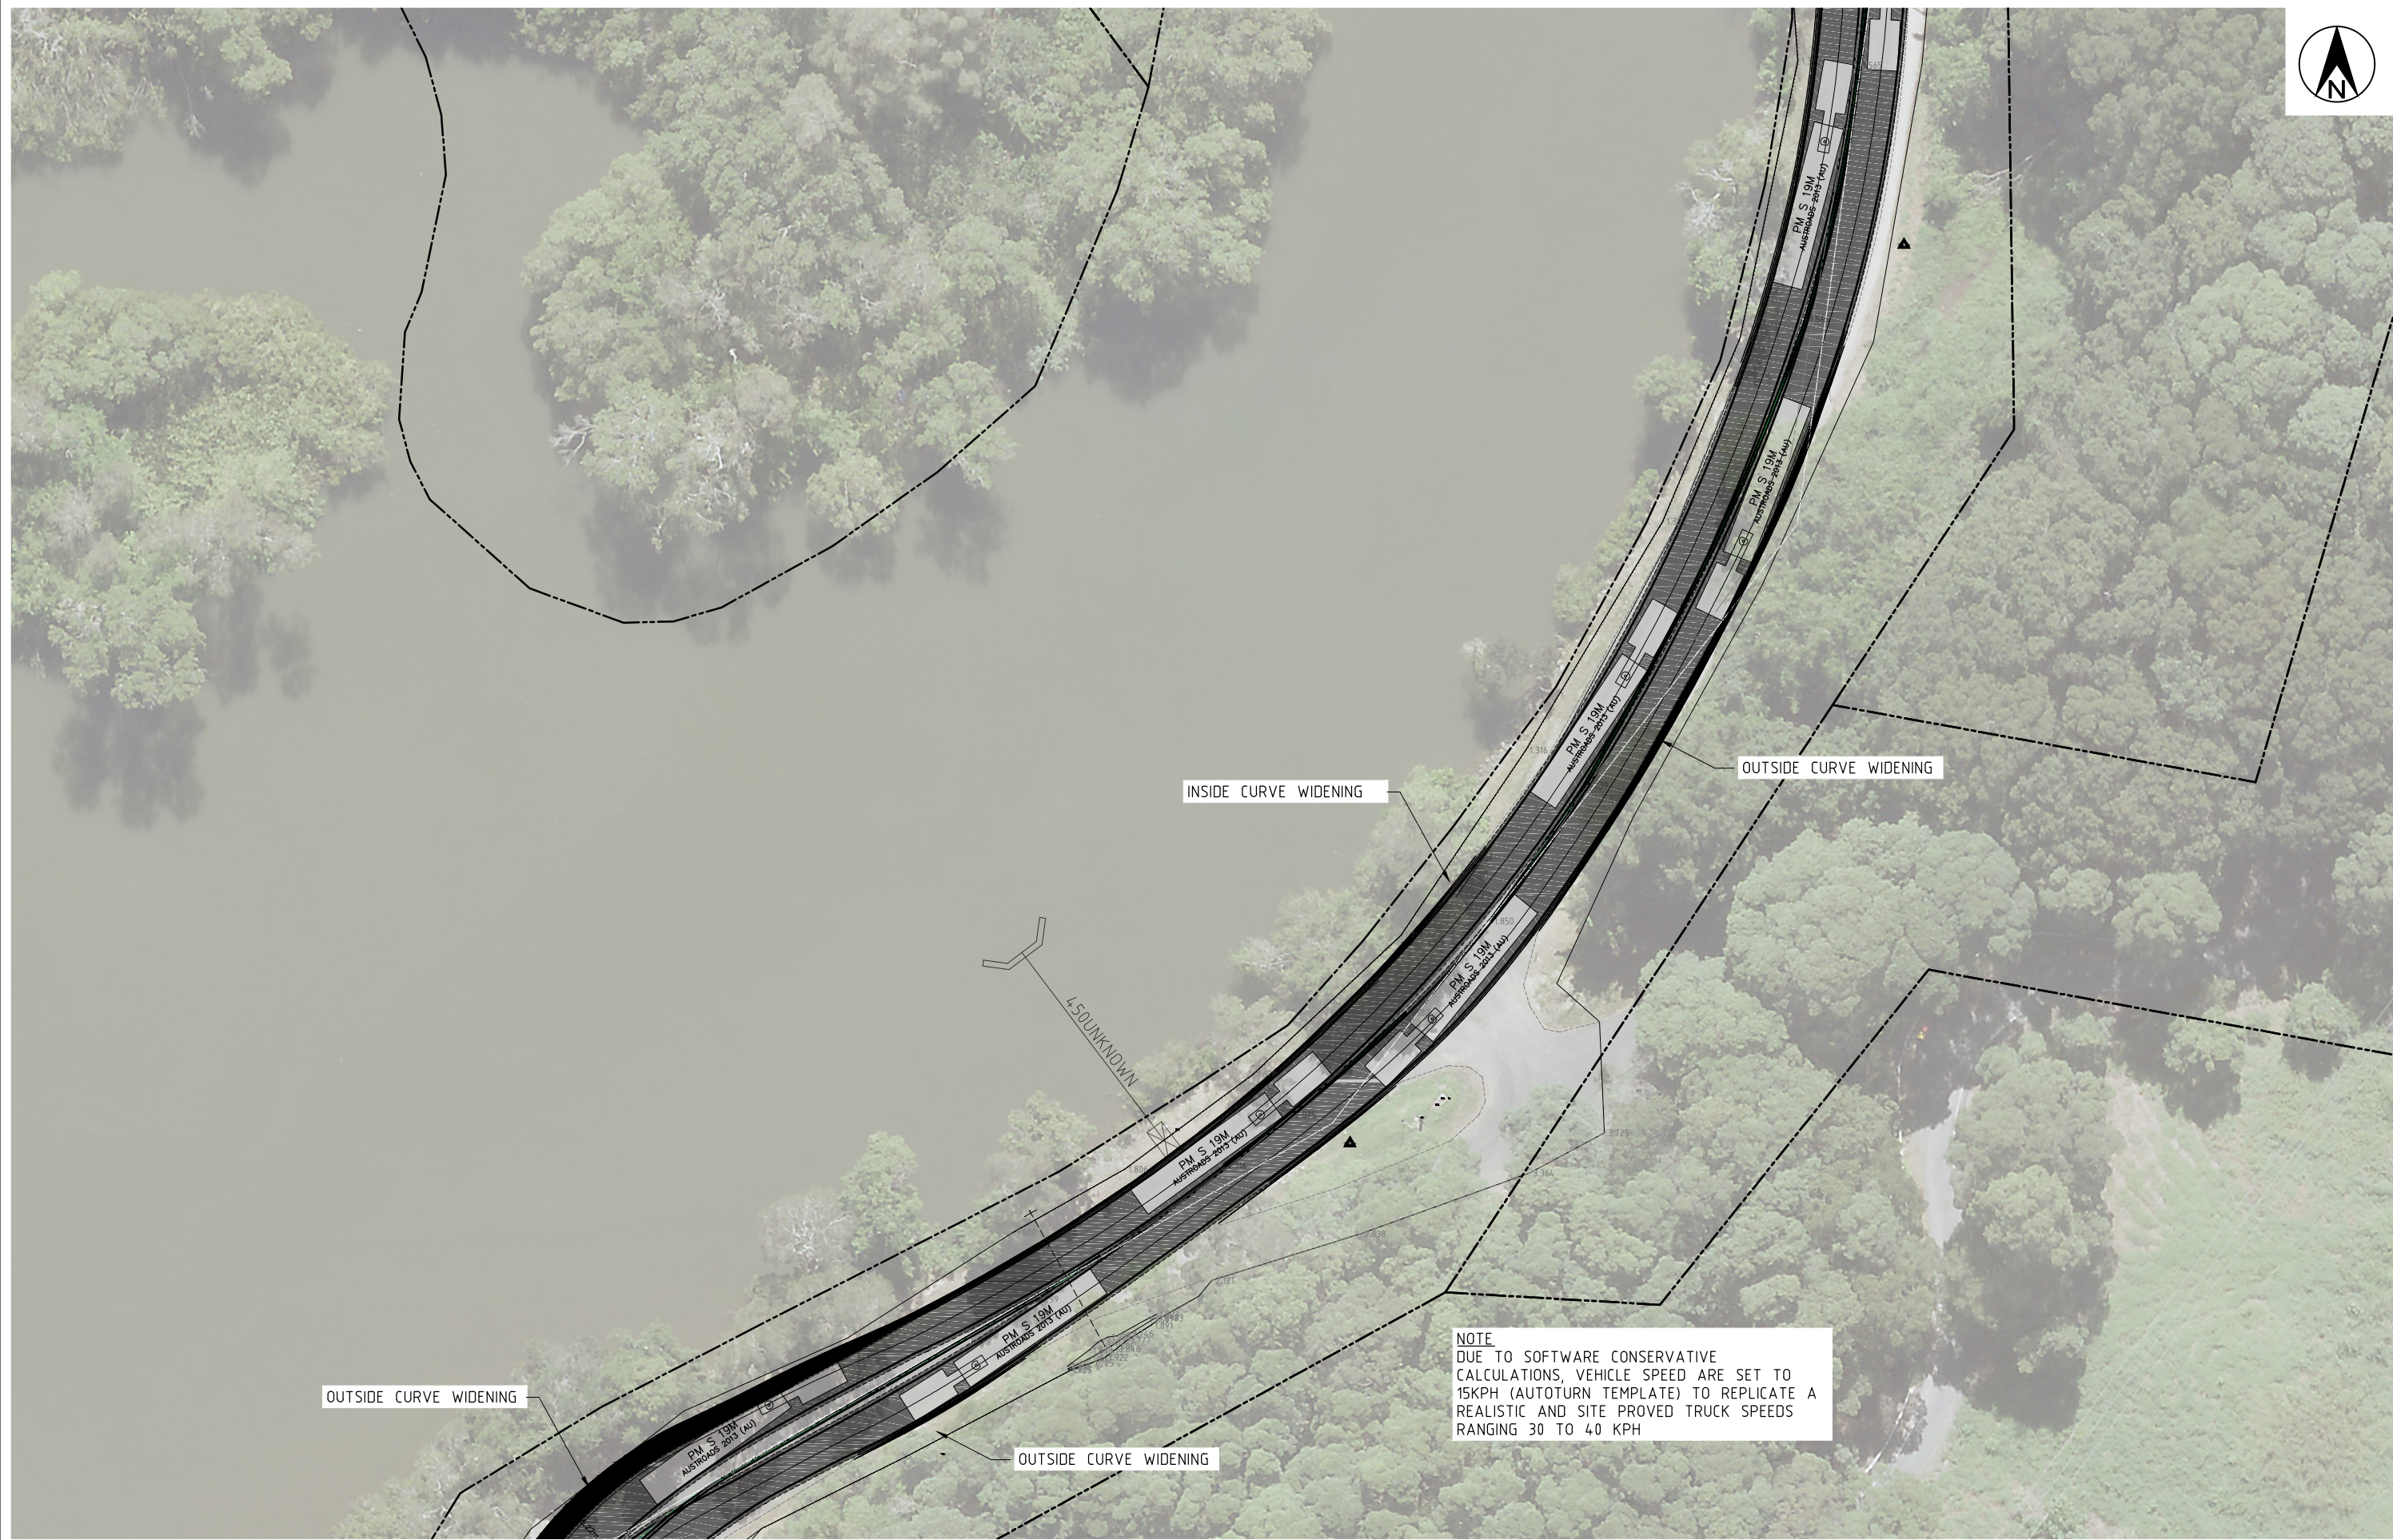
**NOTE**  
 DUE TO SOFTWARE CONSERVATIVE CALCULATIONS, VEHICLE SPEED ARE SET TO 15KPH (AUTOTURN TEMPLATE) TO REPLICATE A REALISTIC AND SITE PROVED TRUCK SPEEDS RANGING 30 TO 40 KPH
