HEAVY VEHICLE ROUTE ASSESSMENT  
- DULGUIGAN ROAD  
TUMBULGUM, NSW

RoadNet Pty Ltd (RoadNet) has been commissioned by Tweed Shire Council (TSC) to undertake a Heavy Vehicle Route Assessment of the roads between the Dulguigan Quarry and the Tweed Valley Way in Tumbulgum (refer *Figure 1.1* below).

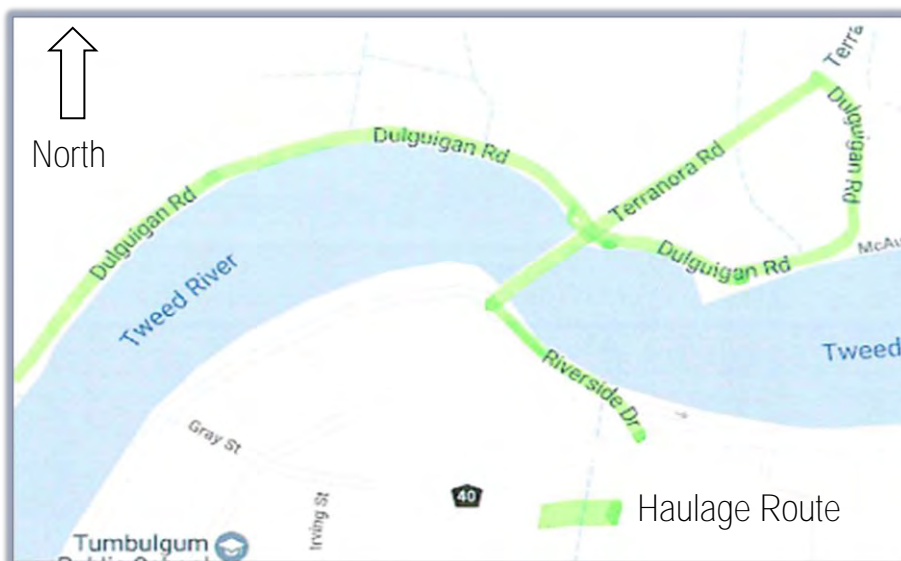
Figure 7.1: Haulage Route - eastern end

The majority of the haulage route is on Dulguigan Road, however the eastern end of the haulage route includes short sections on Terranora Road (incl. bridge over the Tweed River) and Riverside Drive (refer *Figure 7.1*).

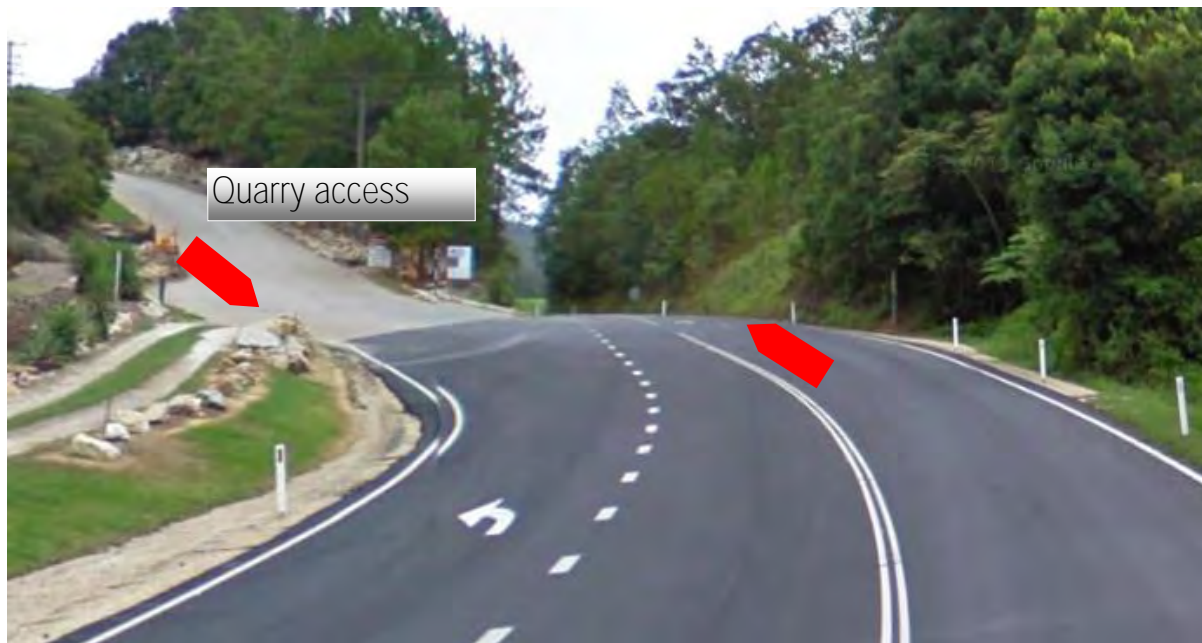
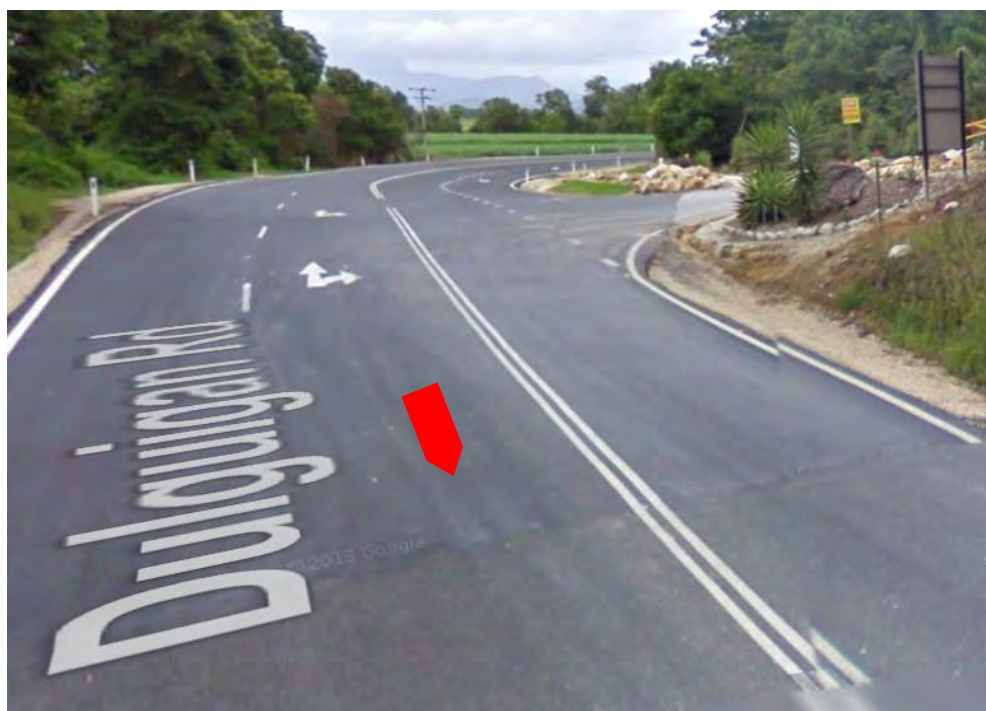
Vehicles turning left out of Dulguigan Quarry cross to the side of the quarry access and the other side of Dulguigan Road when undertaking this manoeuvre.

Photo 7.1 Dulguigan Road - looking north-east

Photo 7.2 Dulguigan Road - looking south-west

Undertake onsite trial of heavy vehicles exiting the Dulguigan Quarry to assess risk associated with traffic conflict both within the quarry access and on Dulguigan Road.

Confirm quarry owners have internal protocol(s) in relation to vehicles entering and exiting the quarry and assess associated risks.

Review the present linemarking and signage layout at the quarry entrance and undertake modifications, if required.

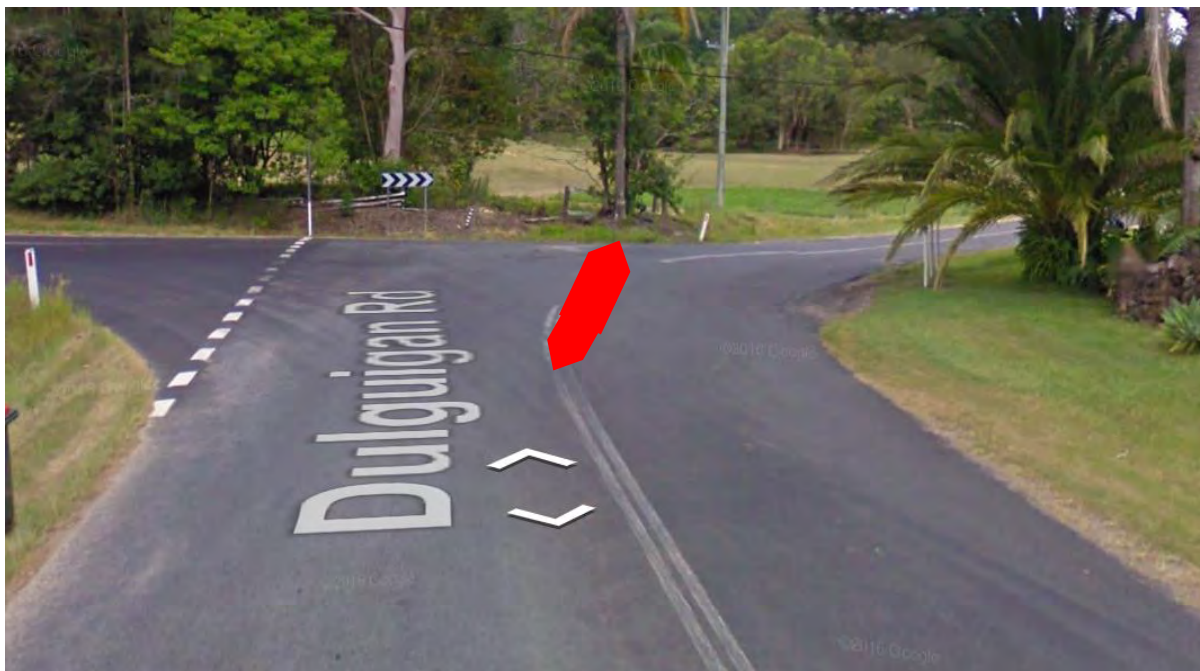
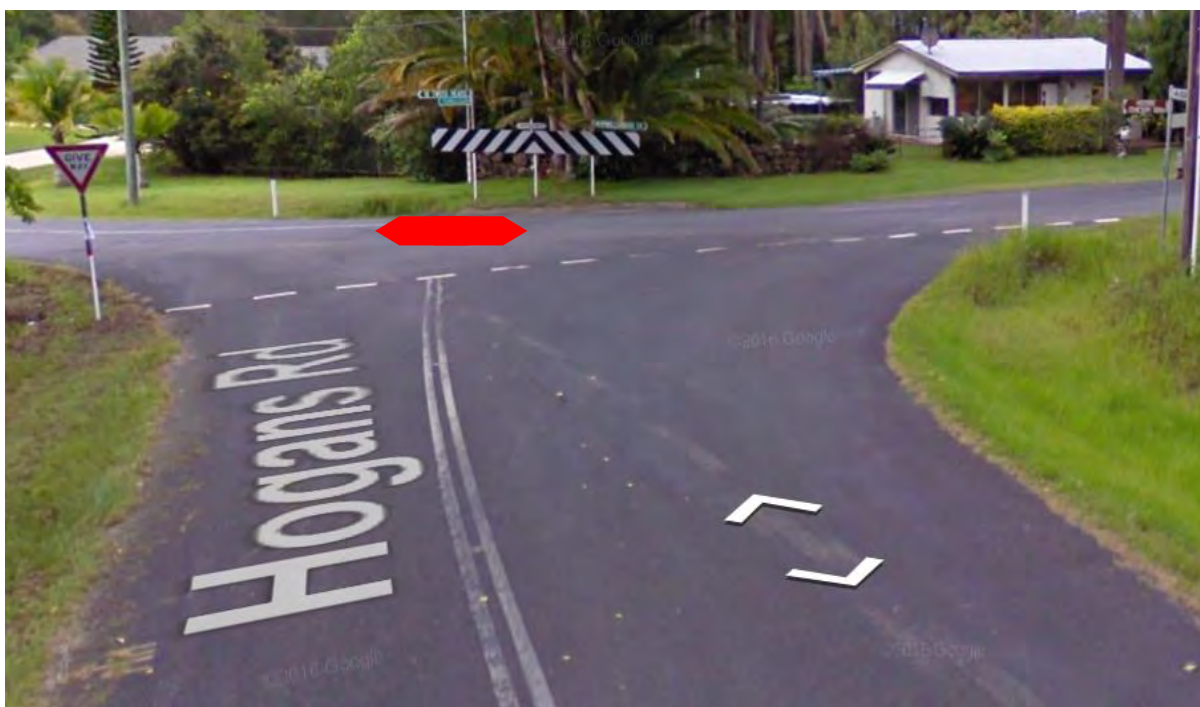
Even at slow speed vehicles are tracking onto the other side of the road when negotiating this curve.

Photo 7.3 Dulguigan Road - looking east

Photo 7.4 Hogans Road - looking south

| Ref No. | Specific Activity | Hazard | Risk | Frequency | Severity | Risk Level | Control measures | Recommended Actions | Action by Whom | Frequency | Severity | Risk Level |
|--|---|--|---|---|---|---|--|--|--|---|---|---|
| <b>Dulguigan Road / Hogans Road Intersection (Ch 2500)</b> - Vehicle swept paths (Drawing No. 18029G-TP-1002 Rev 02) and on-site observation showed the travel path for a number of heavy and light vehicles travelling eastbound on Dulguigan Road was close to the road centreline or partly within the opposing travel lane when negotiating the curve. Observed travel speeds appeared to exceed the posted 25km/h advisory speed. Driver behaviour altered with high level of compliance (ie: remaining in travel lane) when other vehicles were present. | | | | | | | | | | | | |

Install more prominent signage highlighting the advisory speed.

Improve sight distance by clearing vegetation on the inside of the curve.

Prepare a concept design (higher design speed) to determine intersection layout modifications required to ensure heavy vehicles remain in their travel lane when negotiating the curve and implement the works.

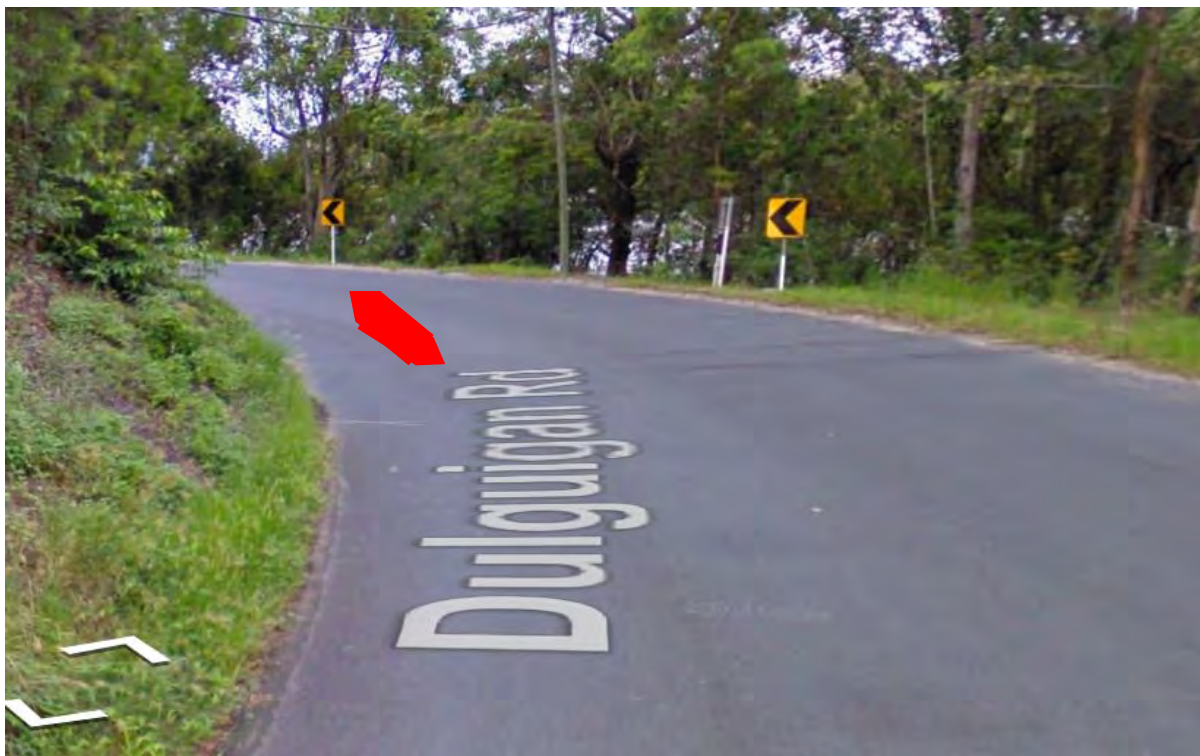
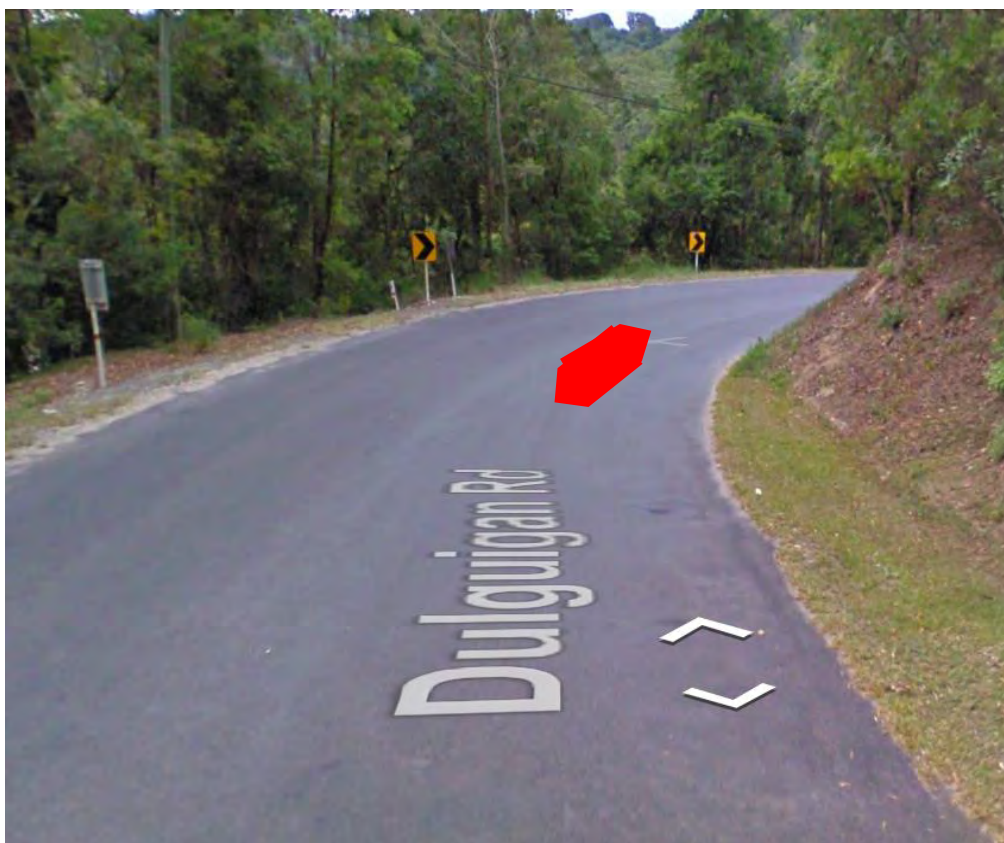
Even at slow speed haulage vehicles are tracking onto the other side of the road when negotiating this curve

Photo 7.5 Dulguigan Road - looking south-west

Photo 7.6 Dulguigan Road - looking north

Prepare a concept design to determine curve modifications (including curve widening requirements) required to ensure heavy vehicles are able to remain in their travel lane when negotiating the series of curves, with sufficient width to accommodate a double barrier centreline and possibly edge lines, and implement the works.

Ongoing monitoring of road conditions (refer 6 below).

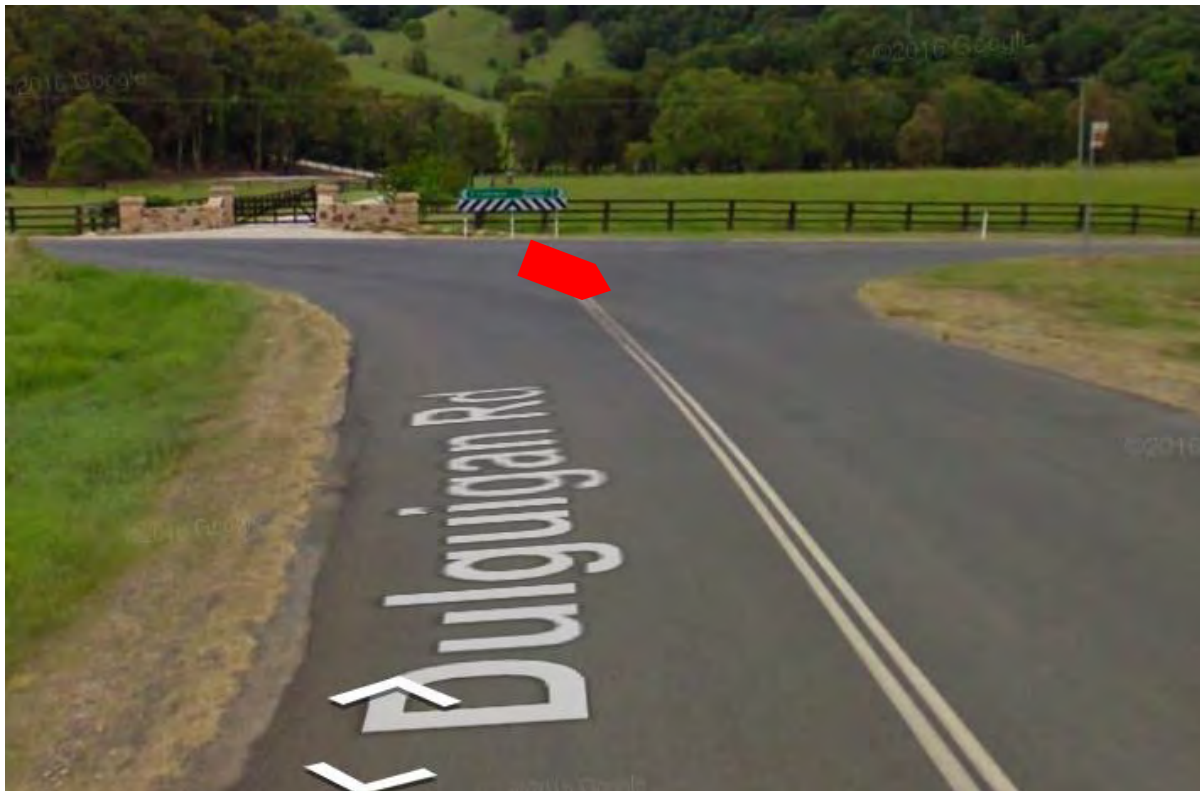
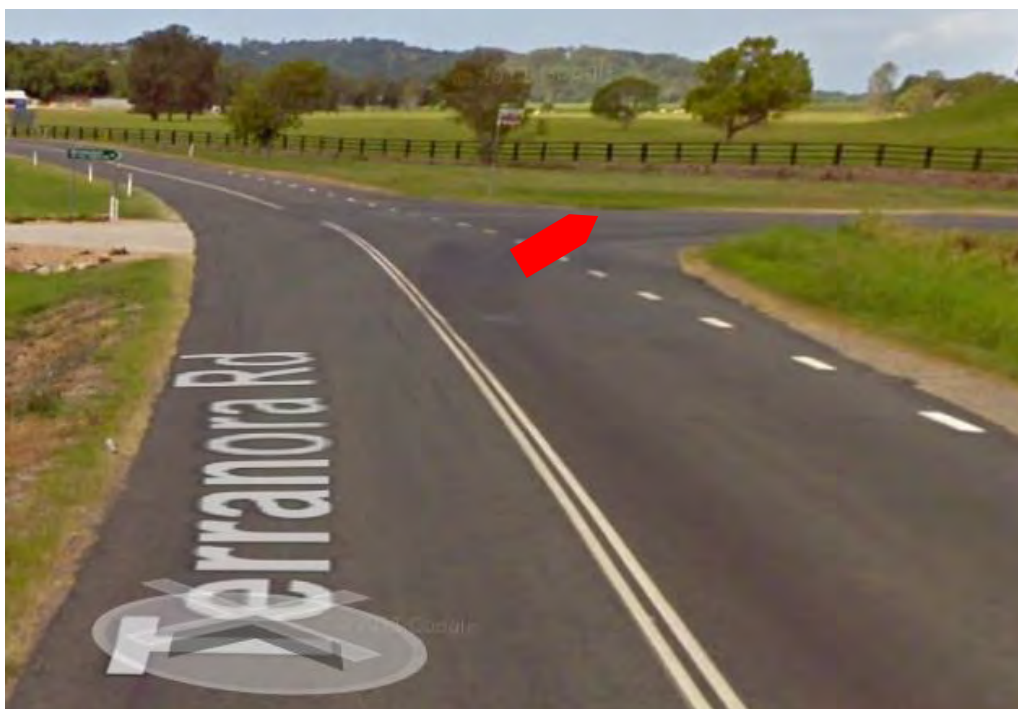
Vehicles travelling on Terranora Road and turning right into Dulguigan Road will track into the opposing travel lane.

Photo 7.7 Dulguigan Road - looking north-west

Photo 7.8 Terranora Road - looking north-east

Assess intersection traffic data to determine the potential for conflict between vehicles turning right from Dulguigan Road into Terranora Road and vehicles turning right from Terranora Road into Dulguigan Rd. Review linemarking layout with consideration to the position of a vehicle in Dulguigan Road waiting to turn right into Terranora Road. Implement the works.

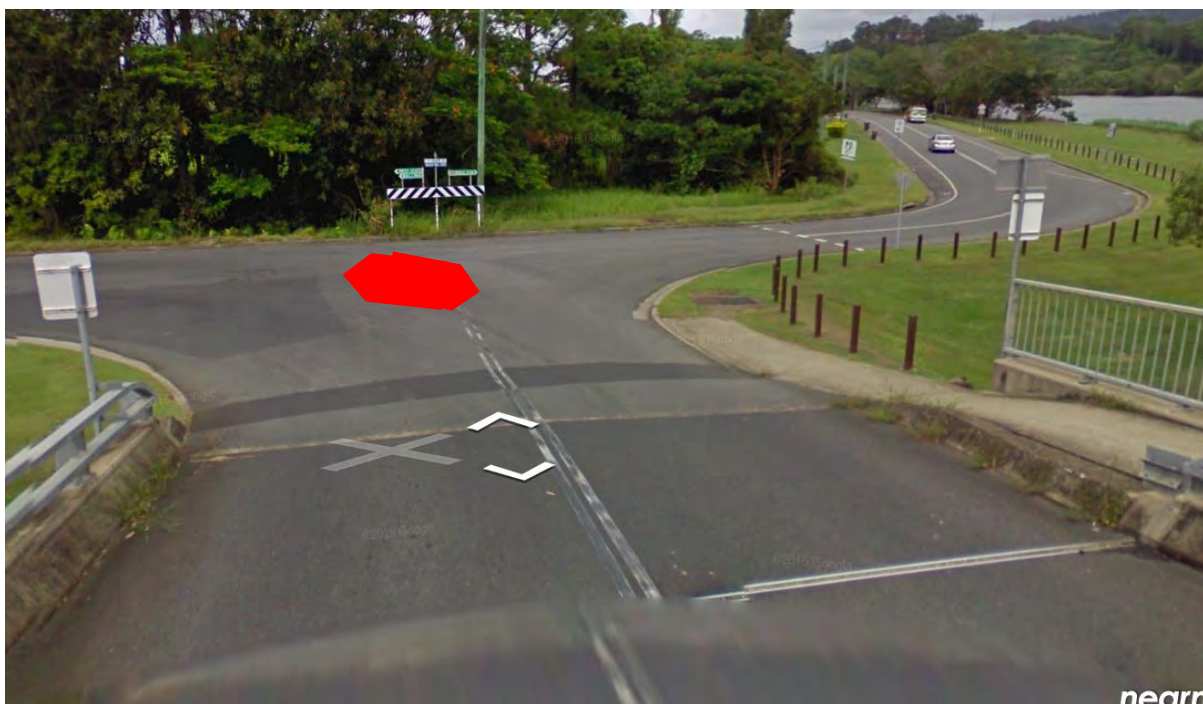
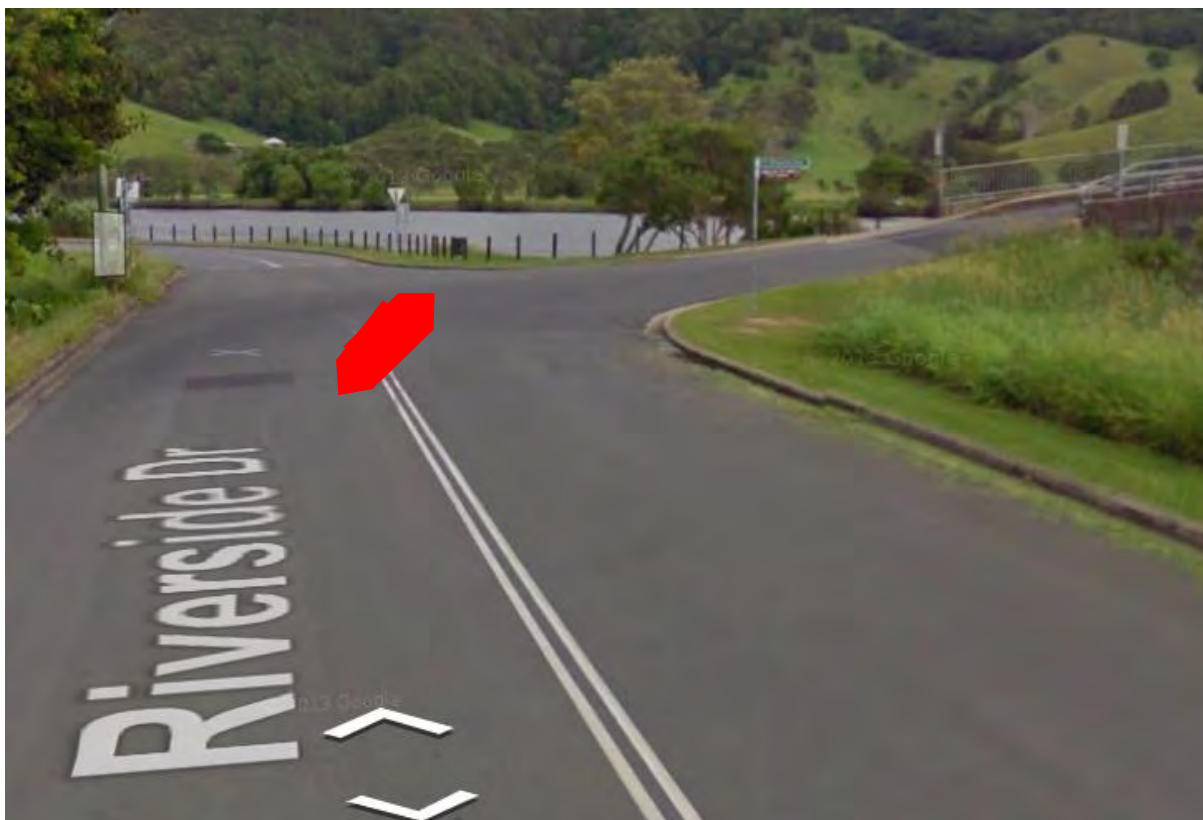
Vehicles travelling on Riverside Drive and turning right into Terranora Road cross into the opposing traffic lane. Similarly, vehicles travelling on Terranora Road and turning left into Riverside Drive will also cross into the oncoming traffic lane. There is a conflict point at this location.

Photo 7.9 Terranora Road - looking south-west

Photo 7.10 Riverside Drive - looking north-west

Ongoing monitoring of road condition including linemarking and signage with maintenance regime to maintain appropriate level of delineation.

Prepare a concept design with the potential to realign Riverside Drive to better accommodate all traffic movements at this intersection and encourage traffic not to cross into the opposing traffic lane.

Concept design to give consideration to the extension of the existing bridge safety barriers. Implement the works.

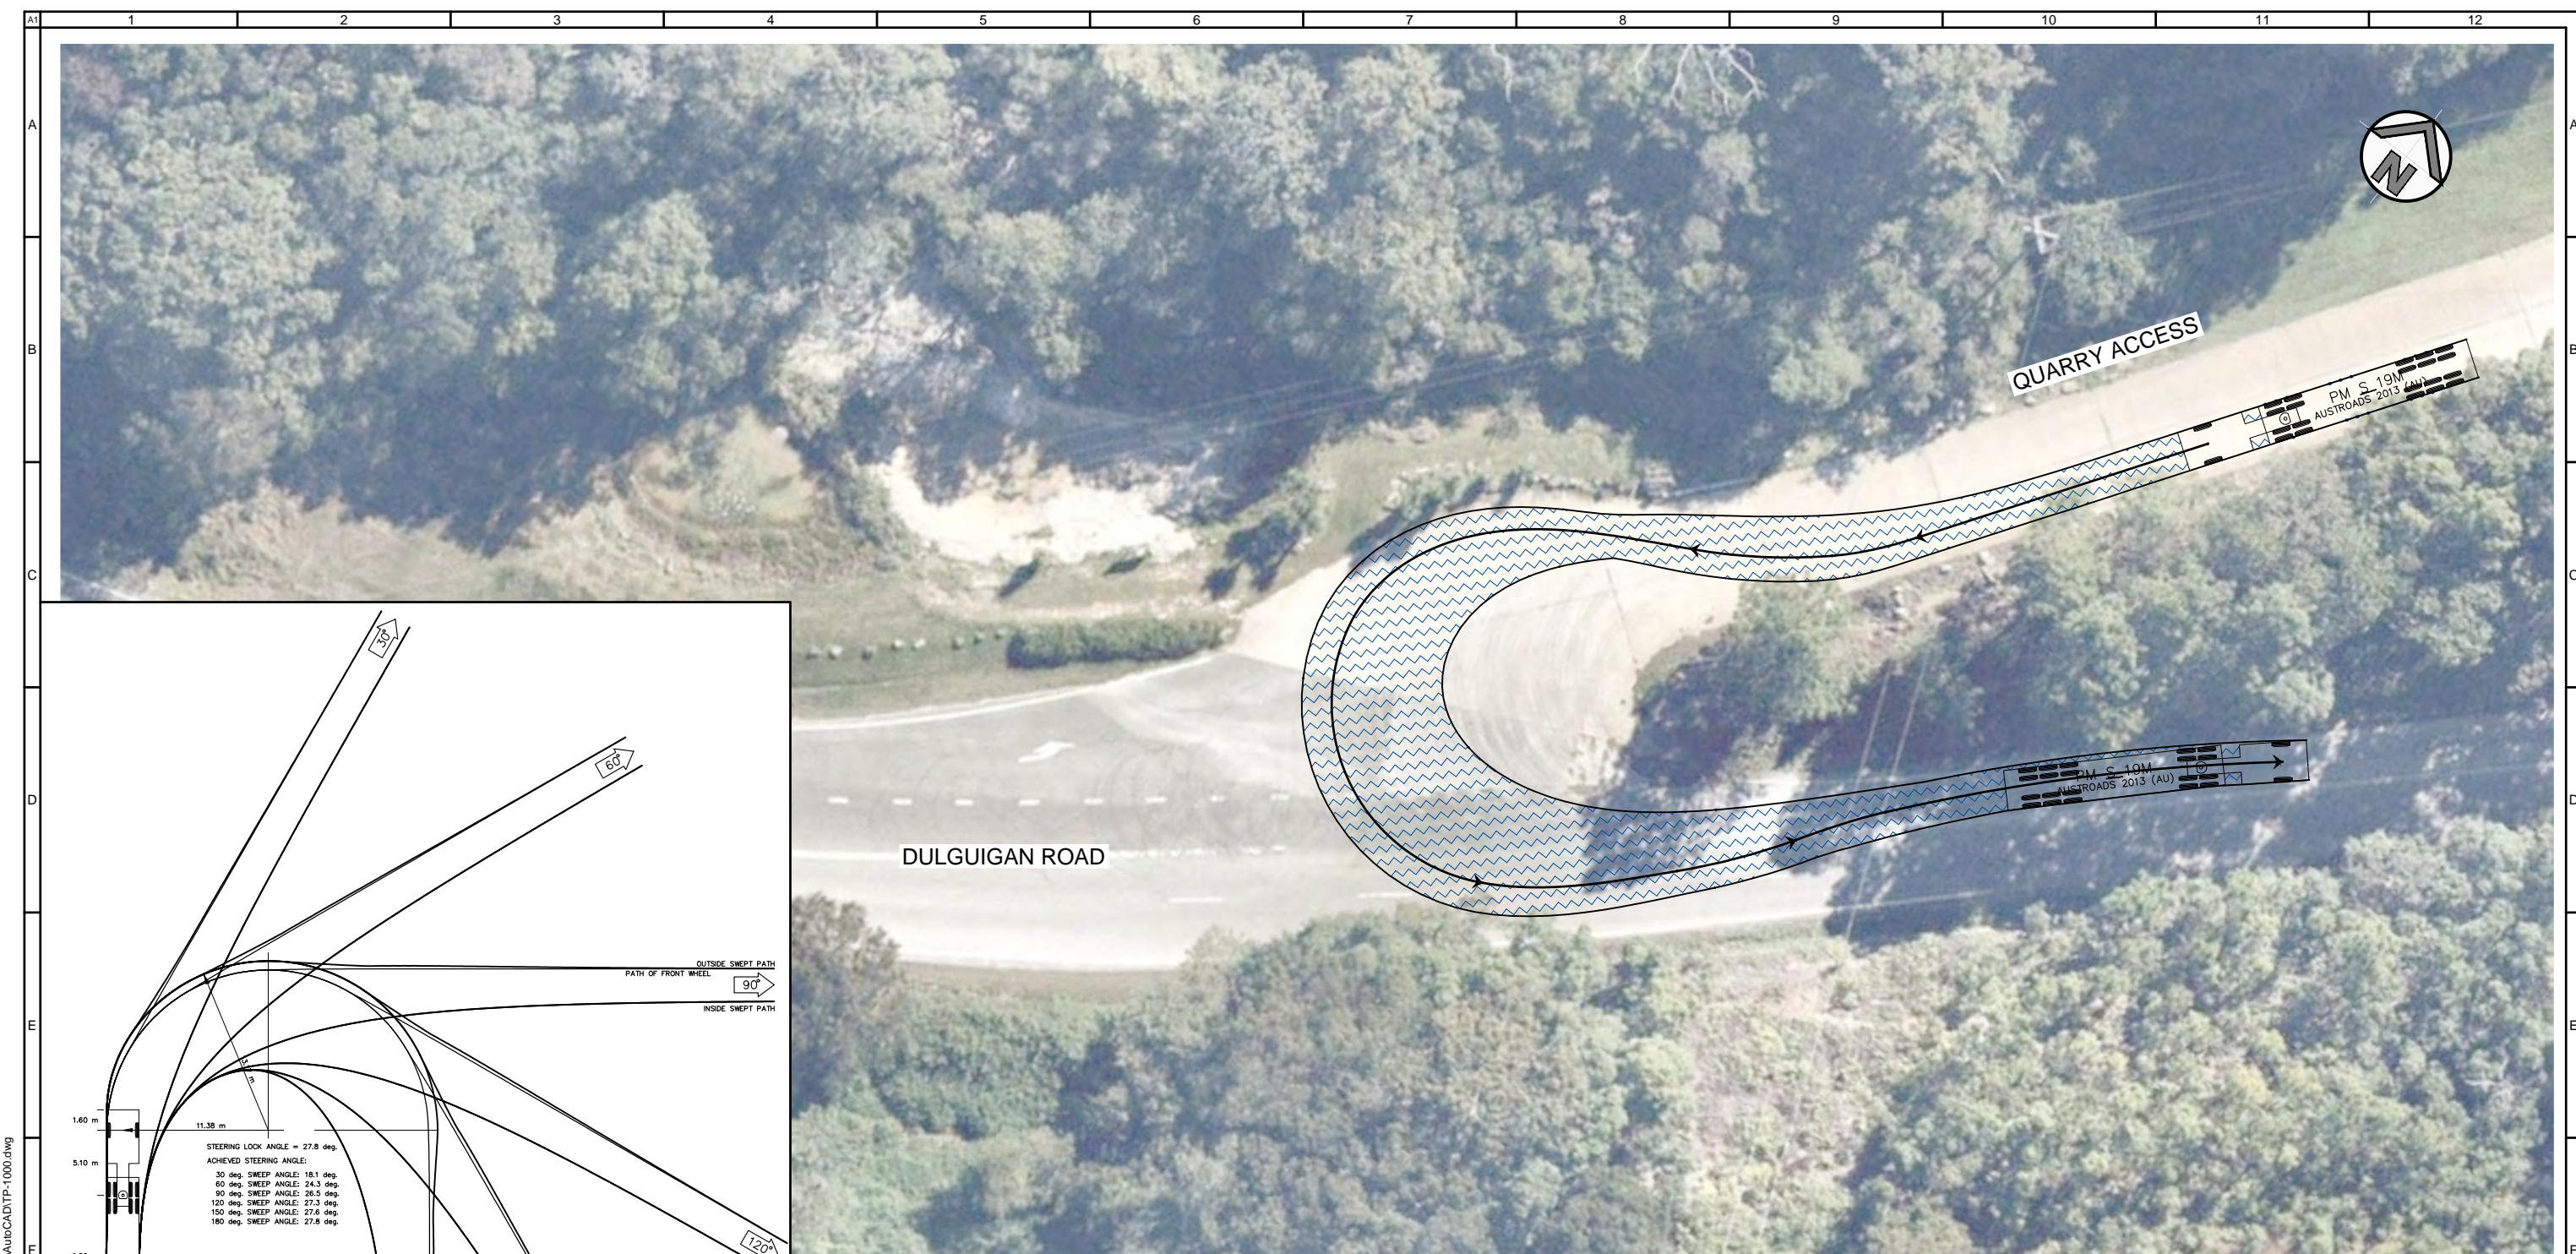
| Drawing No.<br>18029G-TP-1001 | | Revision<br>02 |

TWEED SHIRE COUNCIL  
 DULGUIGAN QUARRY TO TUMBULGUM  
 TURNING PATH ANALYSIS  
 DULGUIGAN QUARRY ACCESS  
 19m SEMI TRAILER

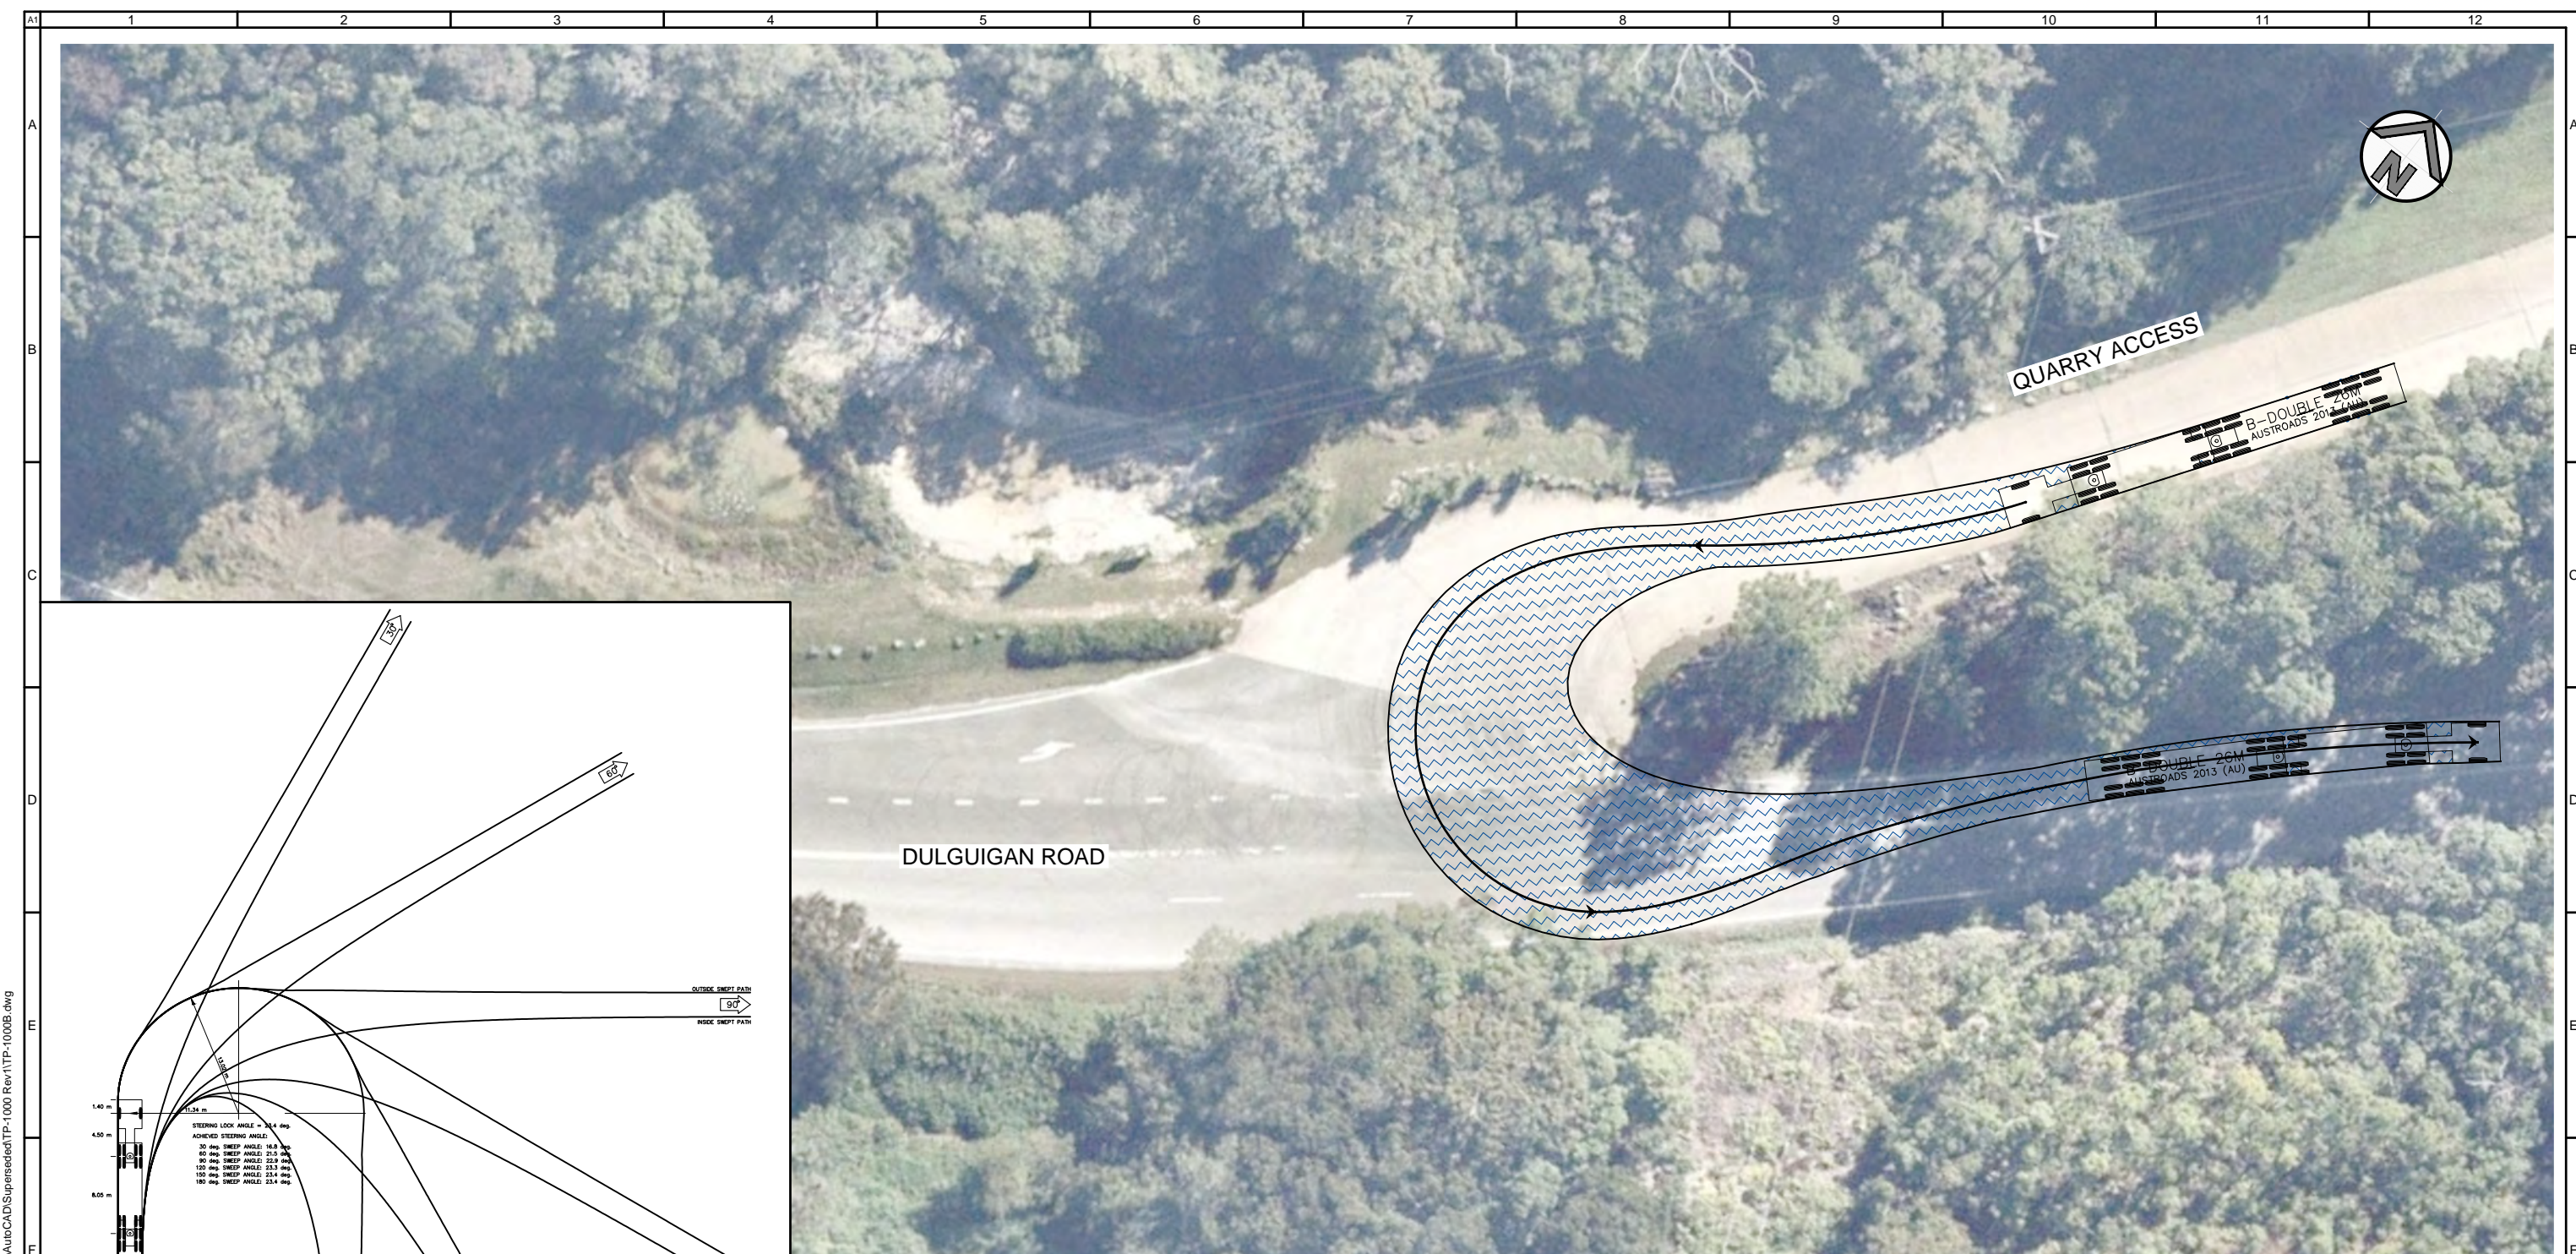
| Drawing No.<br>18029G-TP-1006 | | Revision<br>02 |

DULGUIGAN ROAD

QUARRY ACCESS

B-DOUBLE 26M  
AUSTROADS 2013 (AU)
