Tweed Valley Flood Study Update and Expansion – Technical Sub Committee

Update

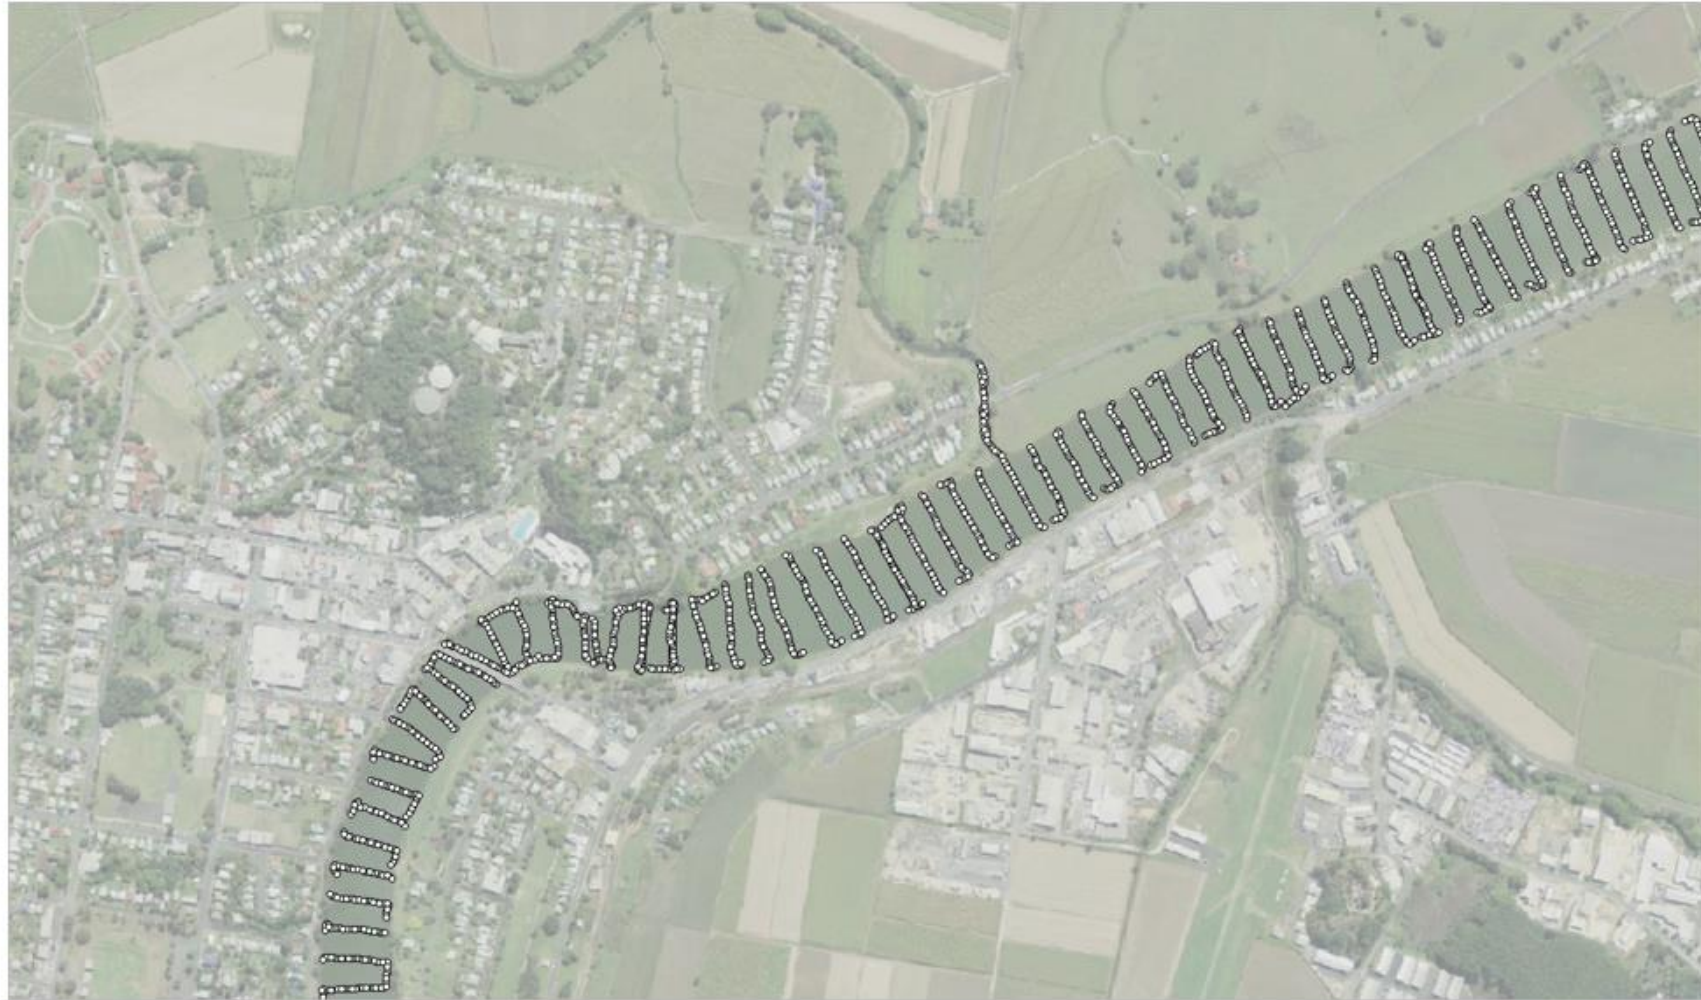
Bathymetry – Raw Dataset

Image 1. 2018 Bathymetry Survey (Raw Data)

- Prior to the study detailed bathymetry of the Tweed River was undertaken
- This information provides a much higher resolution dataset compared to previous assessments and enables more accurate representation of flow characteristics in the channel

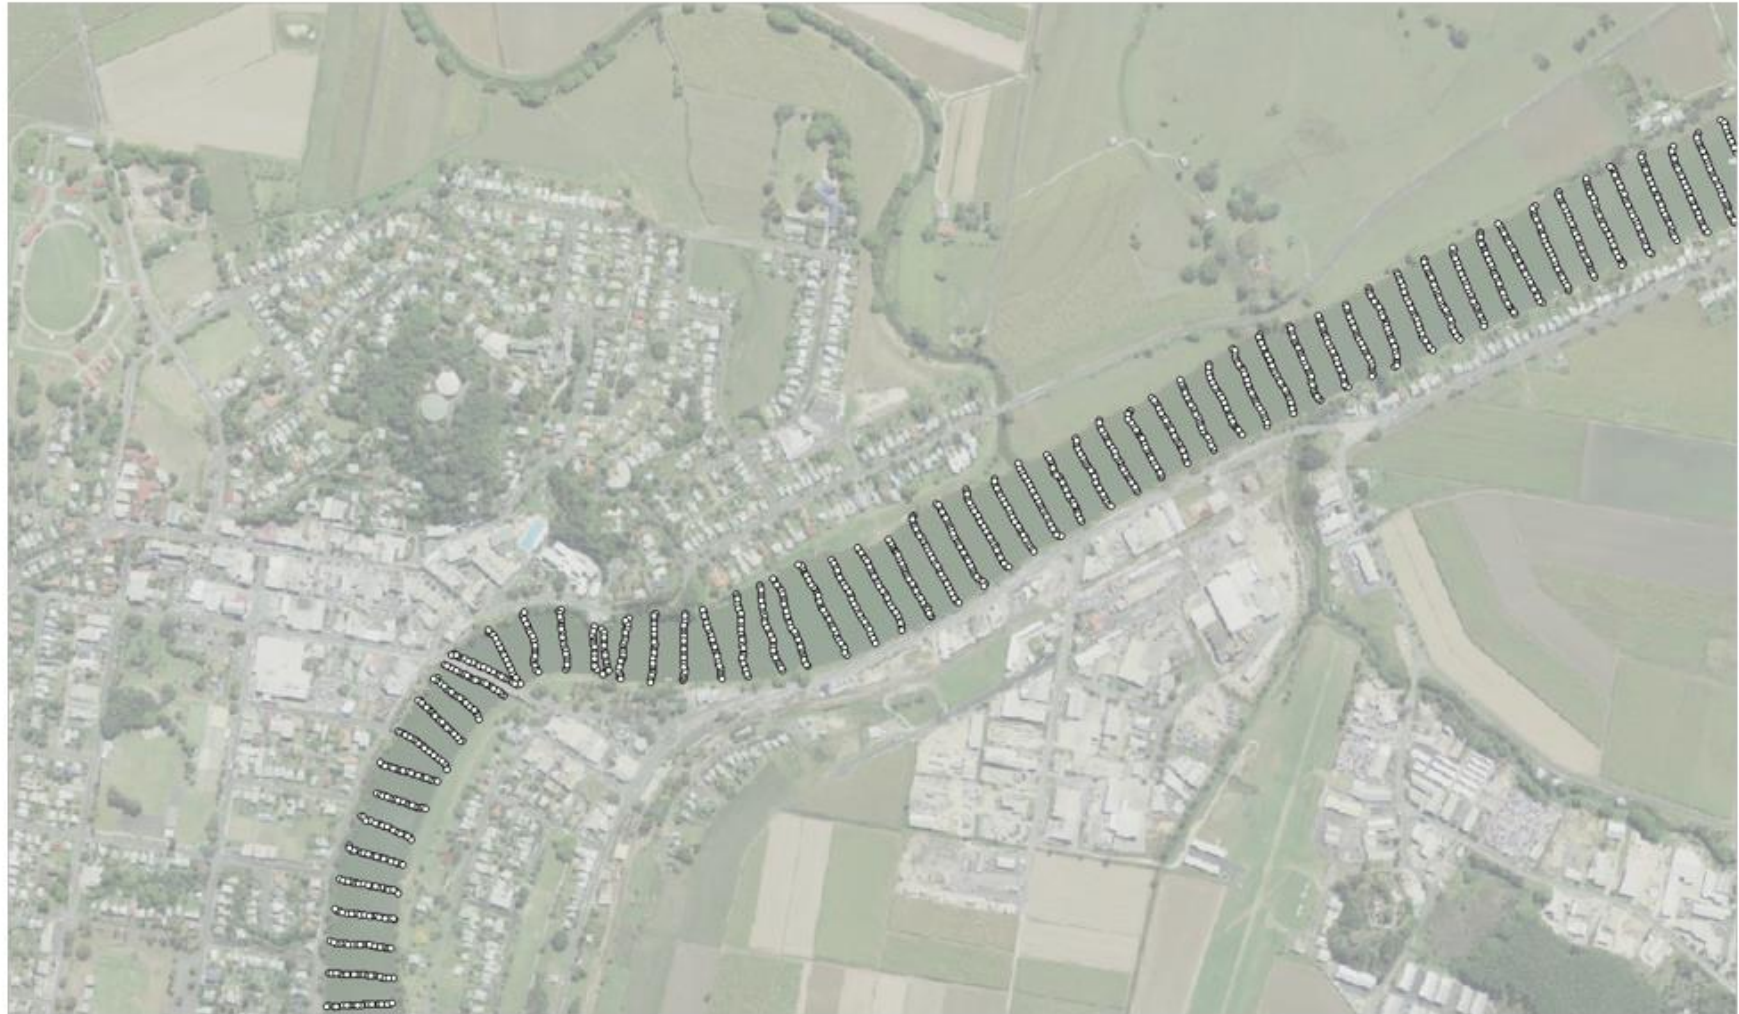
Bathymetry – Trimmed for Model

Image 2. 2018 Bathymetry Survey (Filtered Data)

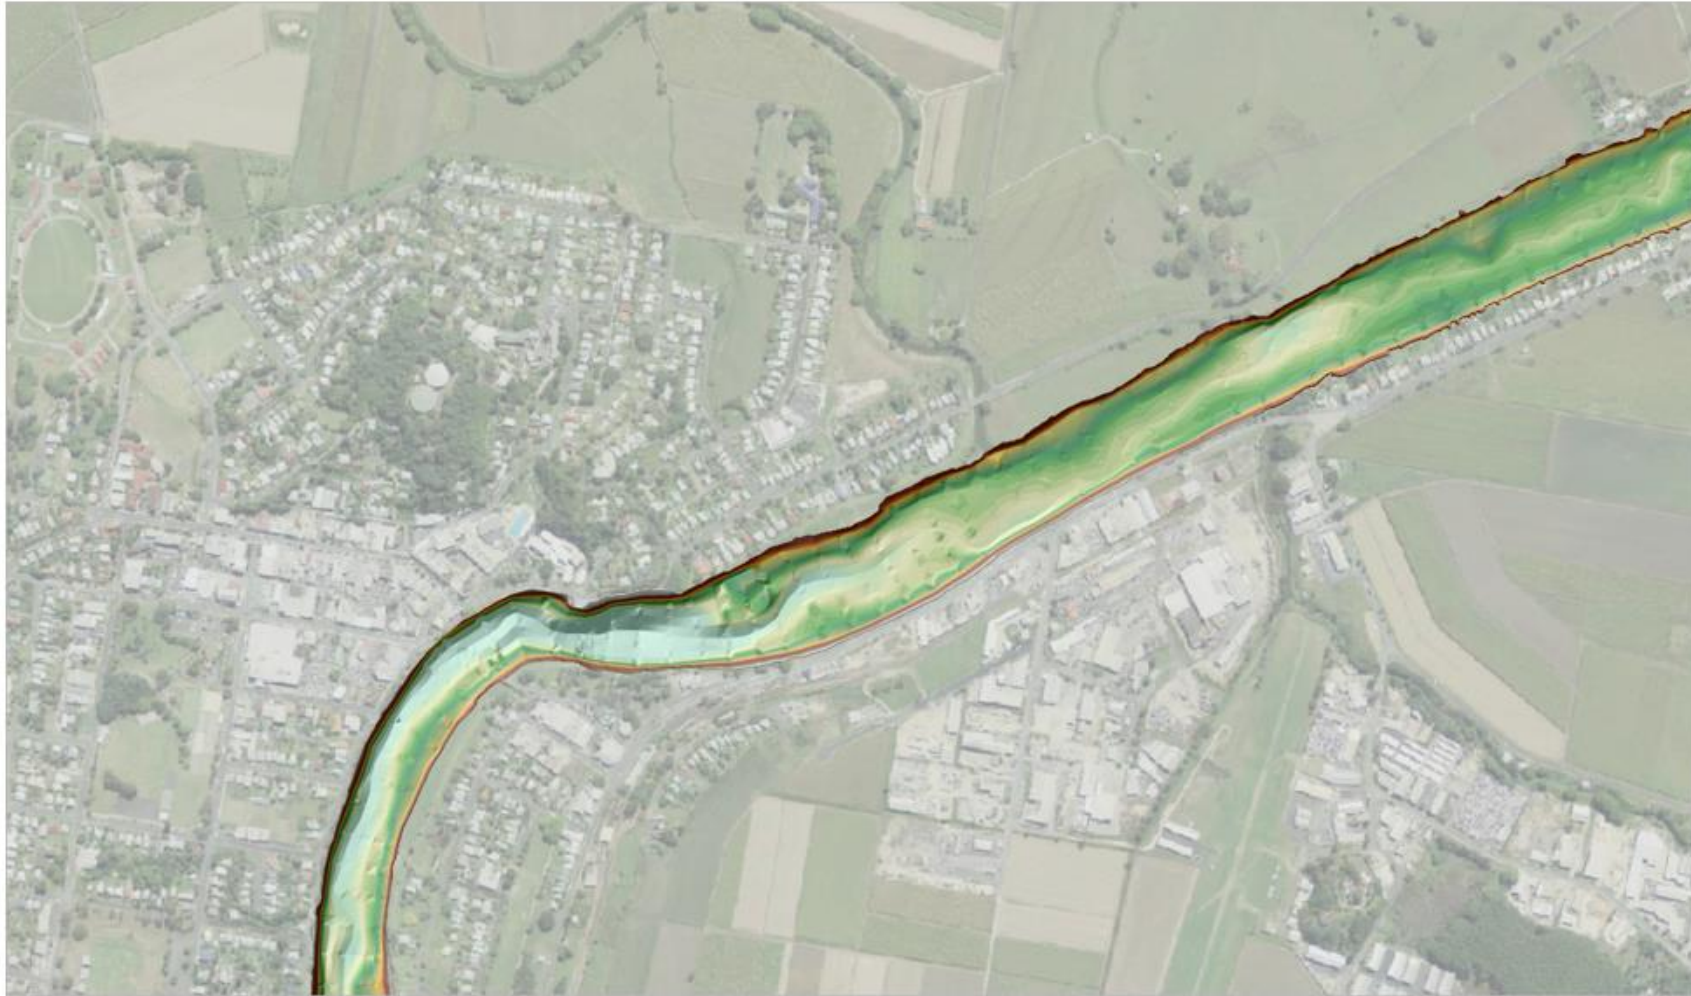
Image 4. Tweed River Bathymetry Model (After Tinning)

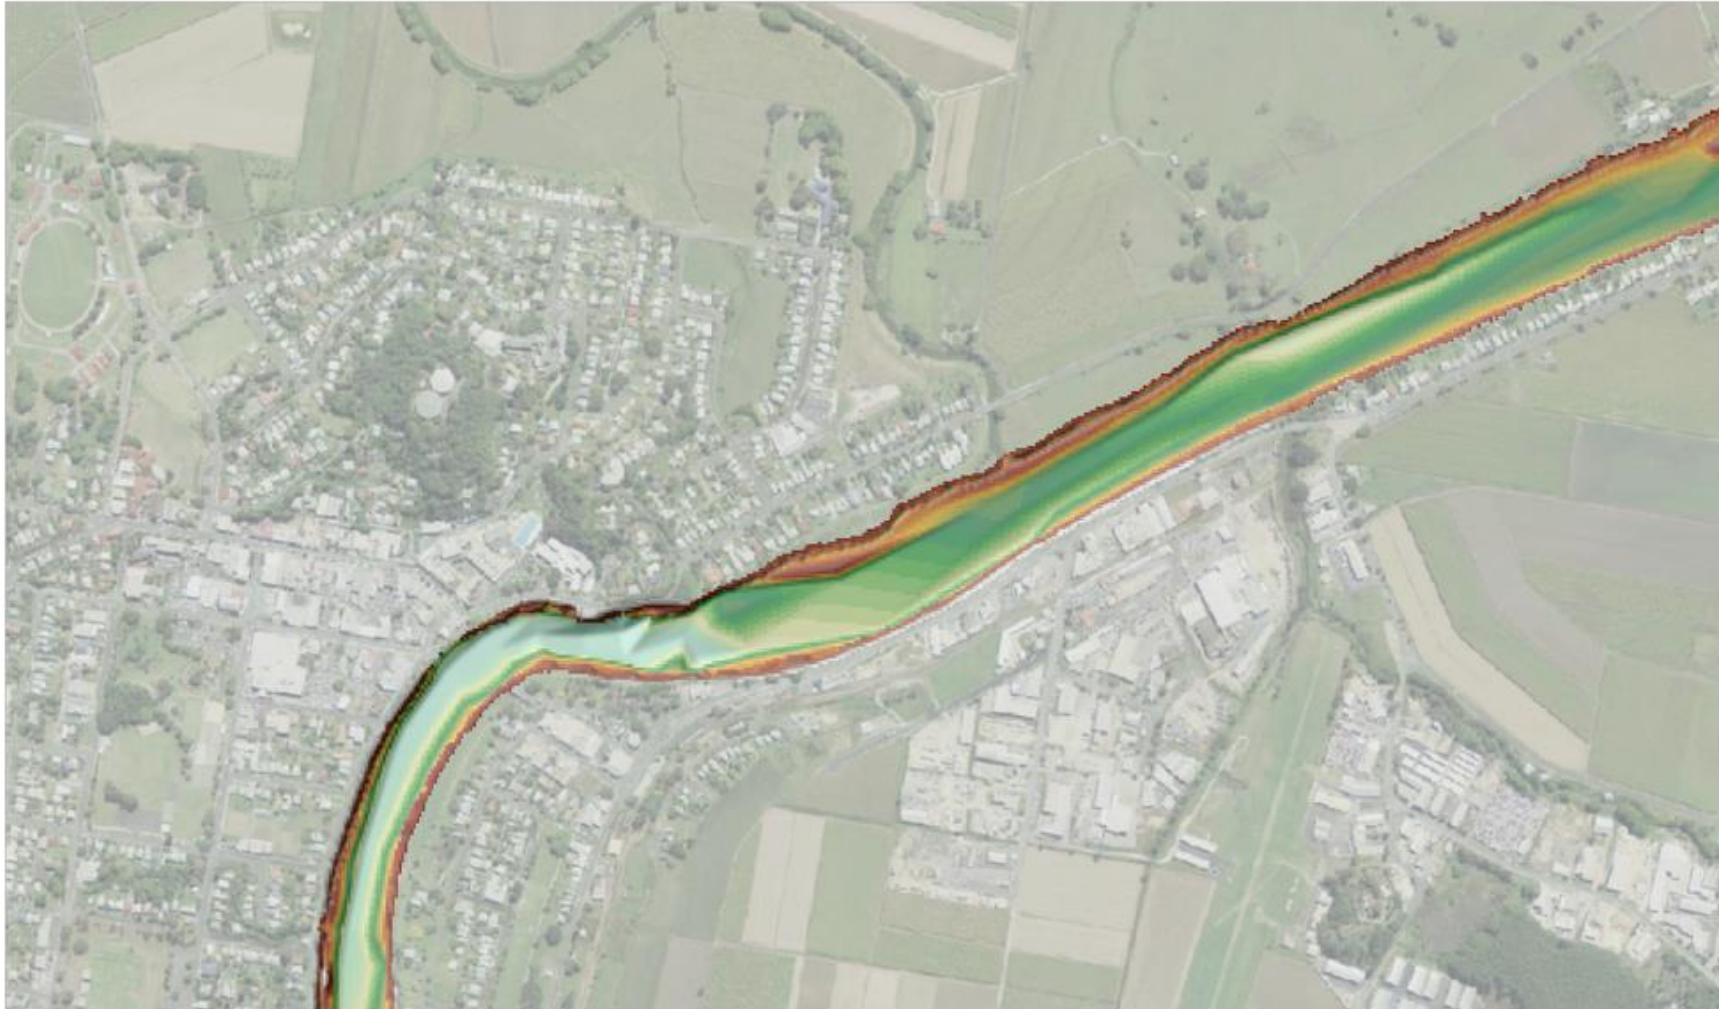
Image 5. Original Tweed River Bathymetry Model

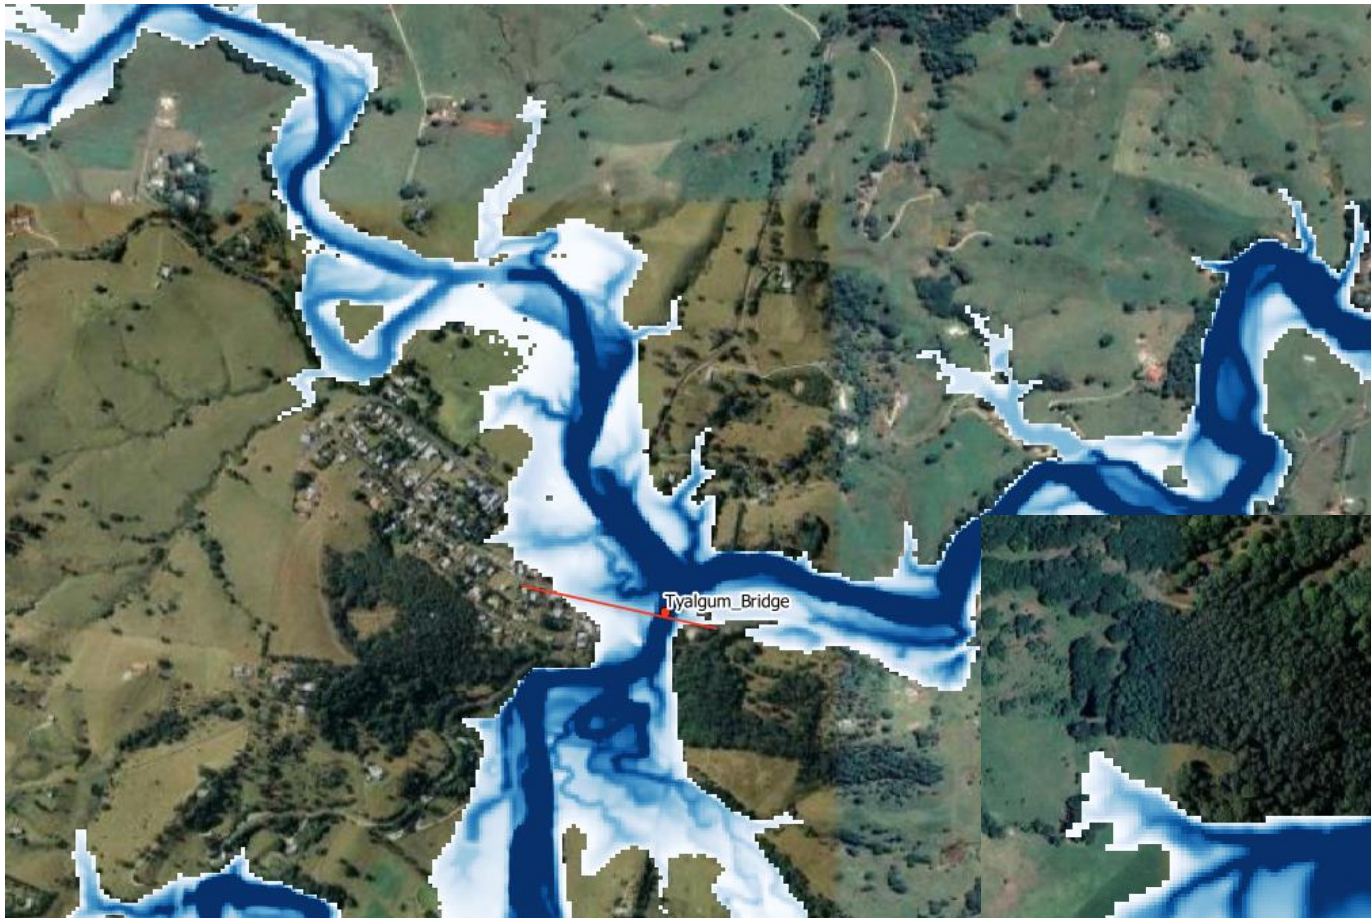
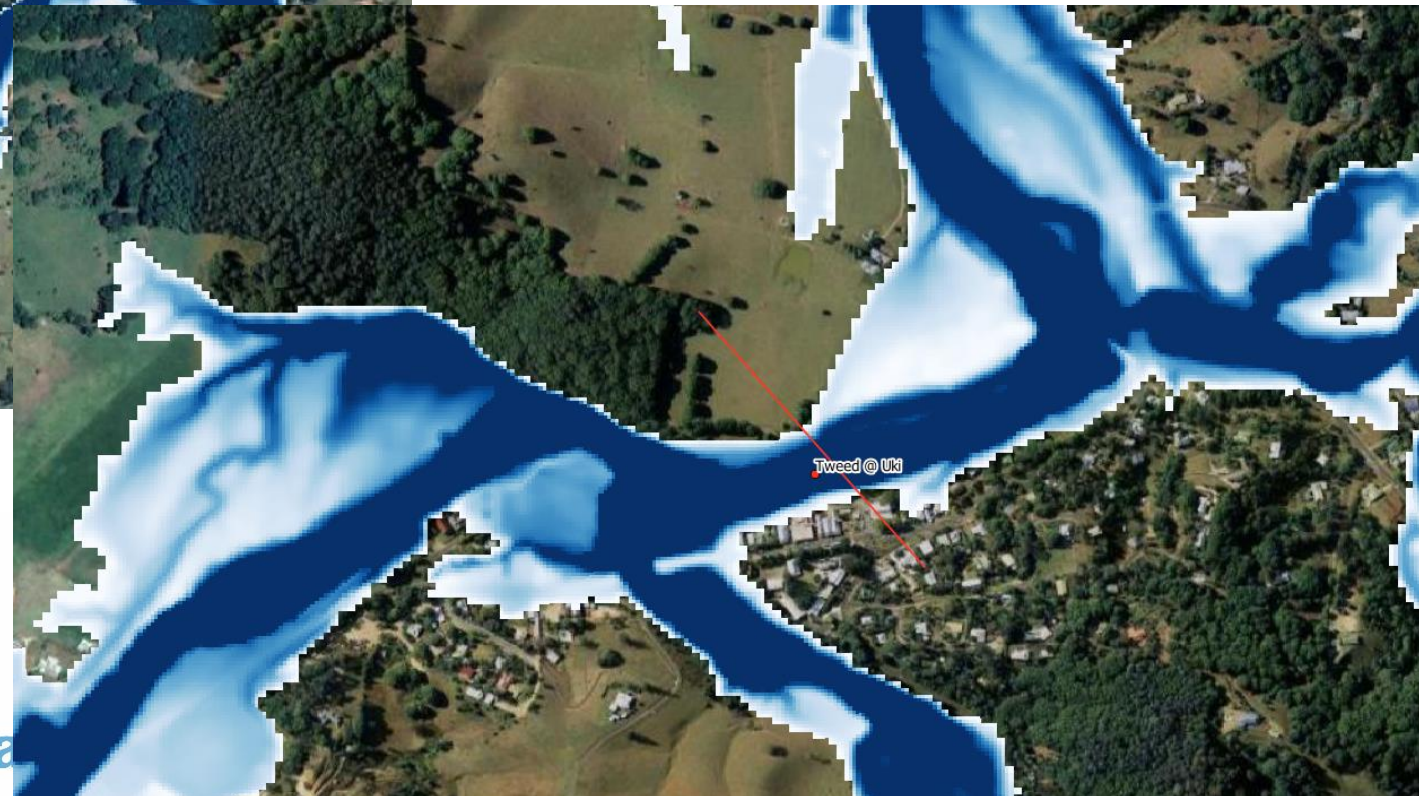
2017 Model Results (First Run)

- Response looking good in the upper areas, obviously areas to improve but first pass indicates reasonable replication
- Currently in the process of refining downstream, gridding issues joining datasets affected model

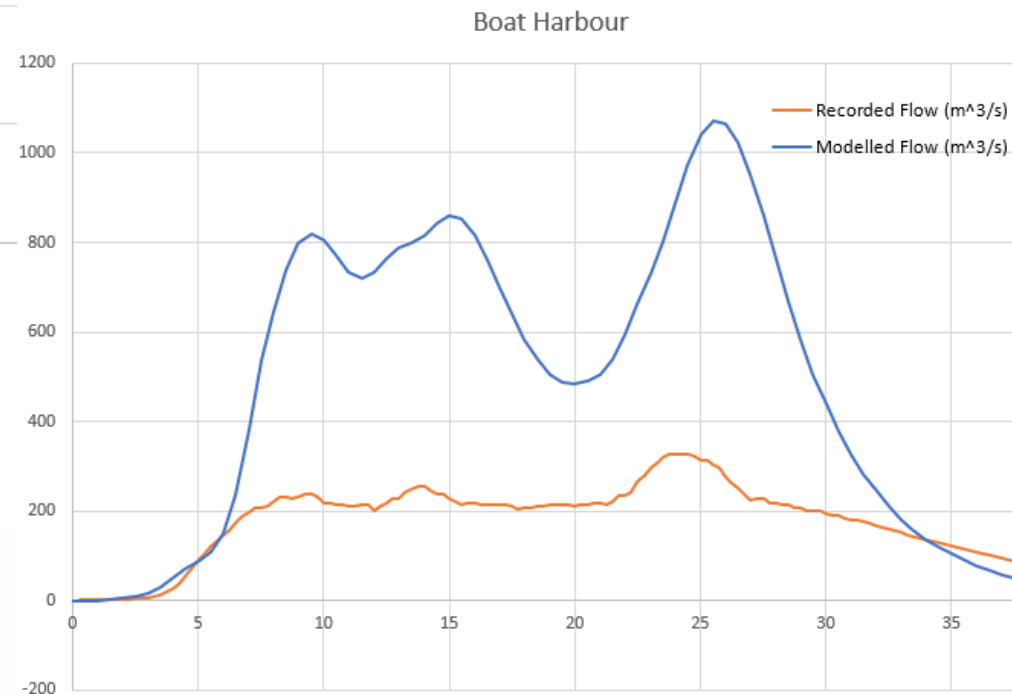
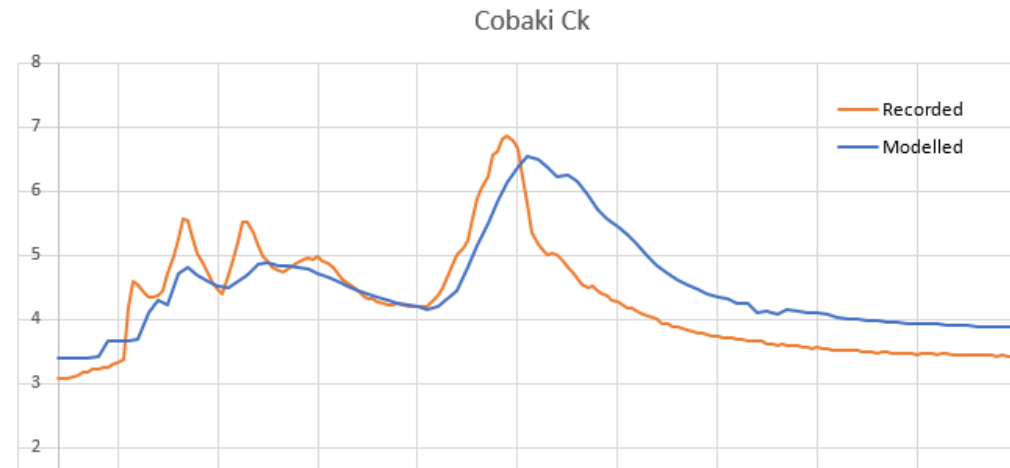
Generally good match to level and flow however general response is delayed

This is not unexpected given the regional parameters of the hydrology

Local validation will improve this result
