## **Coastal Hazards Line (2014)**

Update of Tweed Shire Coastal Hazard Lines

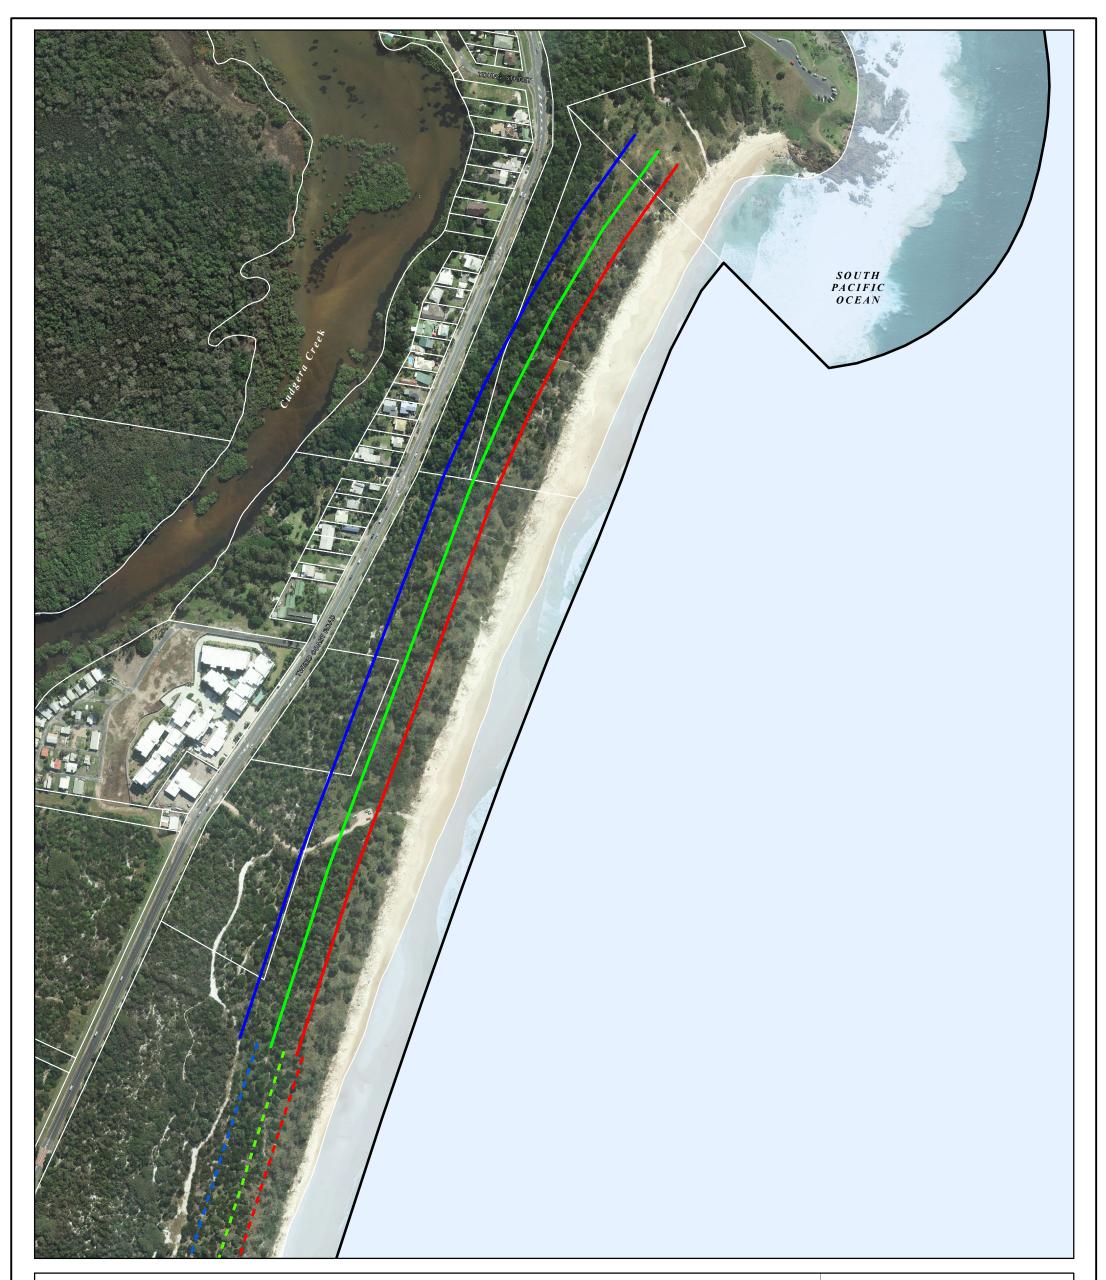
Notes: A zone of reduced bearing capacity will exist landward of a receding erosion scarp. Definition of the extent of the zone of reduced bearing capacity will require professional assessment on a site by site basis. An additional allowance in this regard should be included in considering the immediate hazard zone.

The accuracy of predicting these hazard lines is subject to many uncertainties. The existence of bedrock, indurated sands and/or structures may impact on the realisation of the hazards.

Coastal features and structures have been observed and digitally plotted using photogrammetric techniques. Hazard lines have been determined and plotted relative to the photogrammetry data. Cadastral boundaries as shown may not have been survey corrected and are presented for guidance.

## **Coastal Hazards Line (2010)** Immediate Hazard Line 2050 Hazard Line 2100 Hazard Line

- Immediate Hazard Line - - - -
- Maximum 2050 Hazard Line - - - -
- Maximum 2100 Hazard Line - - - -
