## **Coastal Hazards Line (2014)**

Update of Tweed Shire Coastal Hazard Lines

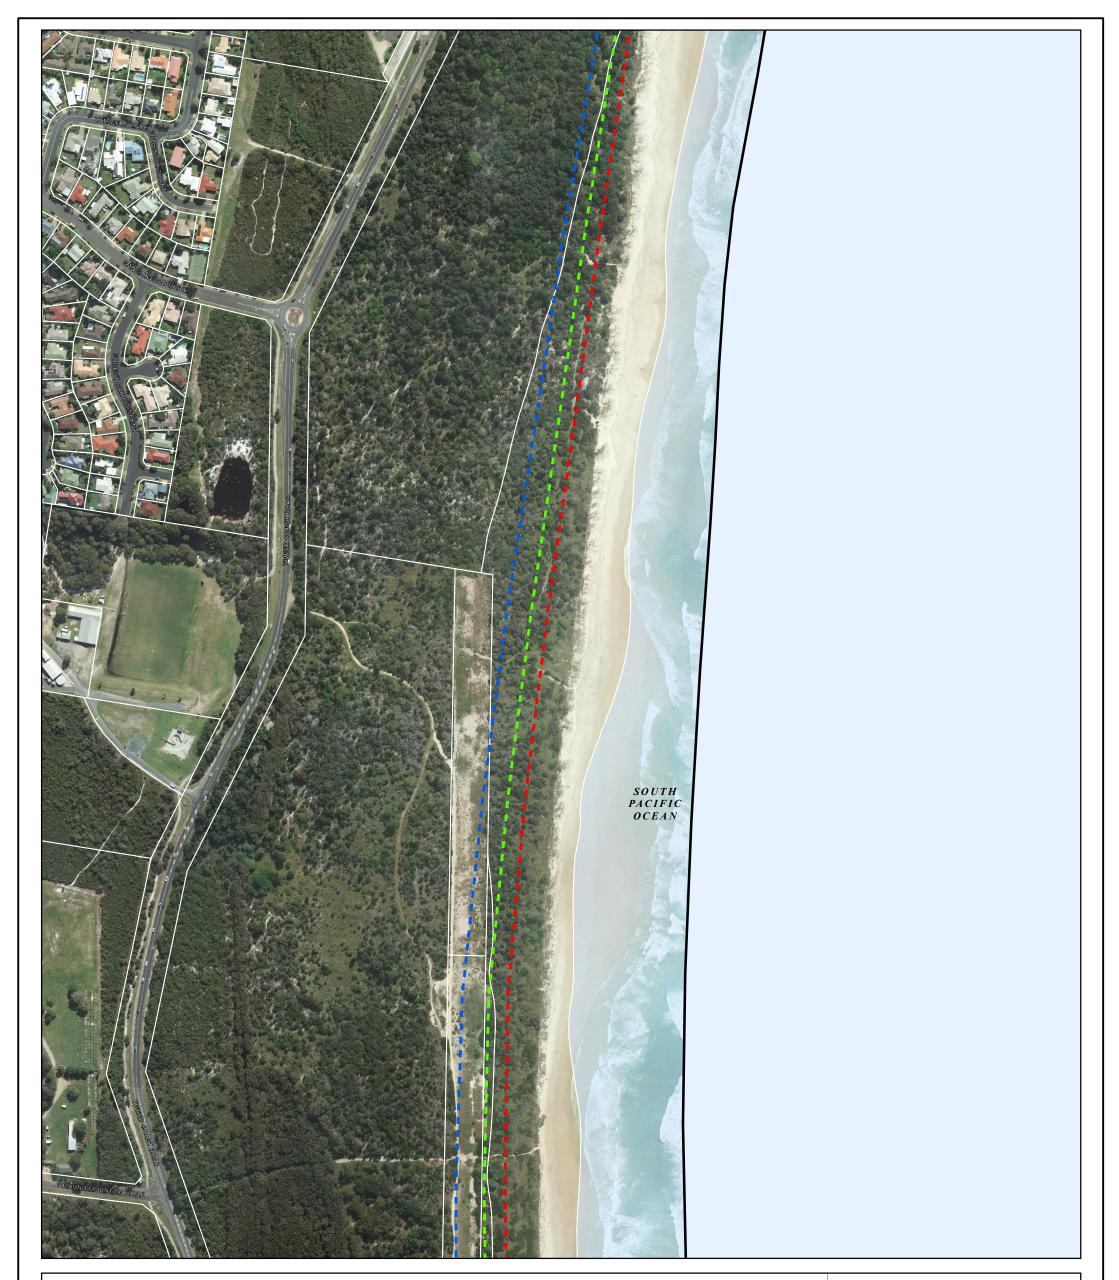
Notes: A zone of reduced bearing capacity will exist landward of a receding erosion scarp. Definition of the extent of the zone of reduced bearing capacity will require professional assessment on a site by site basis. An additional allowance in this regard should be included in considering the immediate hazard zone.

The accuracy of predicting these hazard lines is subject to many uncertainties. The existence of bedrock, indurated sands and/or structures may impact on the realisation of the hazards.

Coastal features and structures have been observed and digitally plotted using photogrammetric techniques. Hazard lines have been determined and plotted relative to the photogrammetry data. Cadastral boundaries as shown may not have been survey corrected and are presented for guidance.

- Immediate Hazard Line - - - -
- Maximum 2050 Hazard Line - - - -
- Maximum 2100 Hazard Line - - - -
