Tweed Shire Coastal Hazards

#### TWEED DEVELOPMENT **CONTROL PLAN**

Section B25 **Coastal Hazards**

Coastal Hazard Lines Map

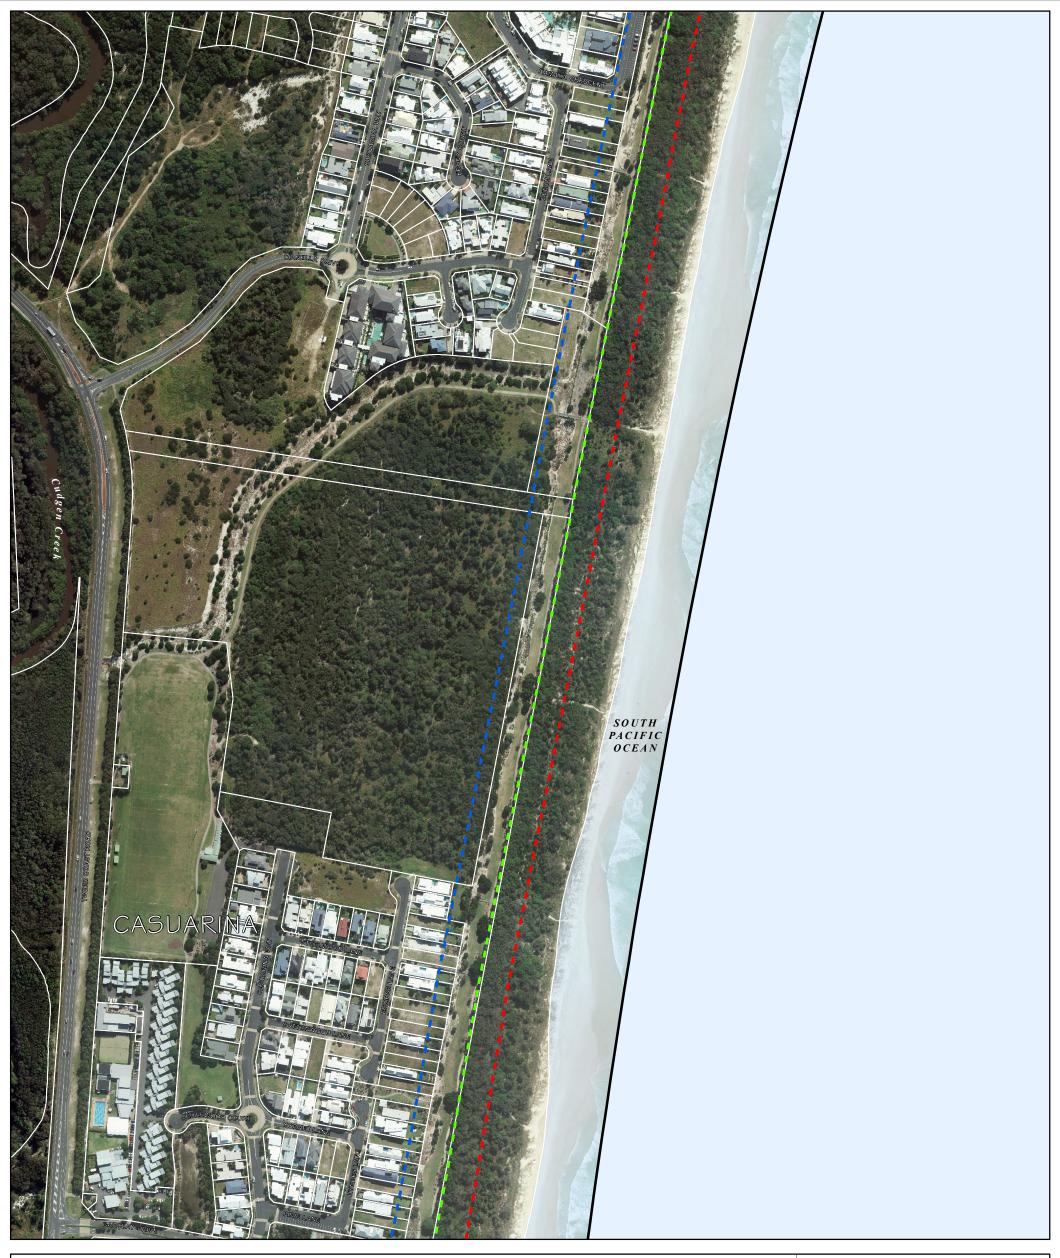
Figure 1.16

A zone of reduced bearing capacity will exist landward of a receding erosion scarp. Definition of the extent of the zone of reduced bearing capacity will require professional assessment on a site by site basis. An additional allowance in this regard should be included in considering the immediate hazard zone.

The accuracy of predicting these hazard lines is subject to many uncertainties. The existence of bedrock, indurated sands and/or structures may impact on the realisation of the hazards.

Coastal features and structures have been observed and digitally plotted using photogrammetric techniques. Hazard lines have been determined and plotted relative to the photogrammetry data. Cadastral boundaries as shown may not have been survey corrected and are presented for guidance.
