Coastal Hazard Lines Map Figure 1.22 Sheet 22 of 26

TWEED DEVELOPMENT **CONTROL PLAN**

Section B25 **Coastal Hazards**

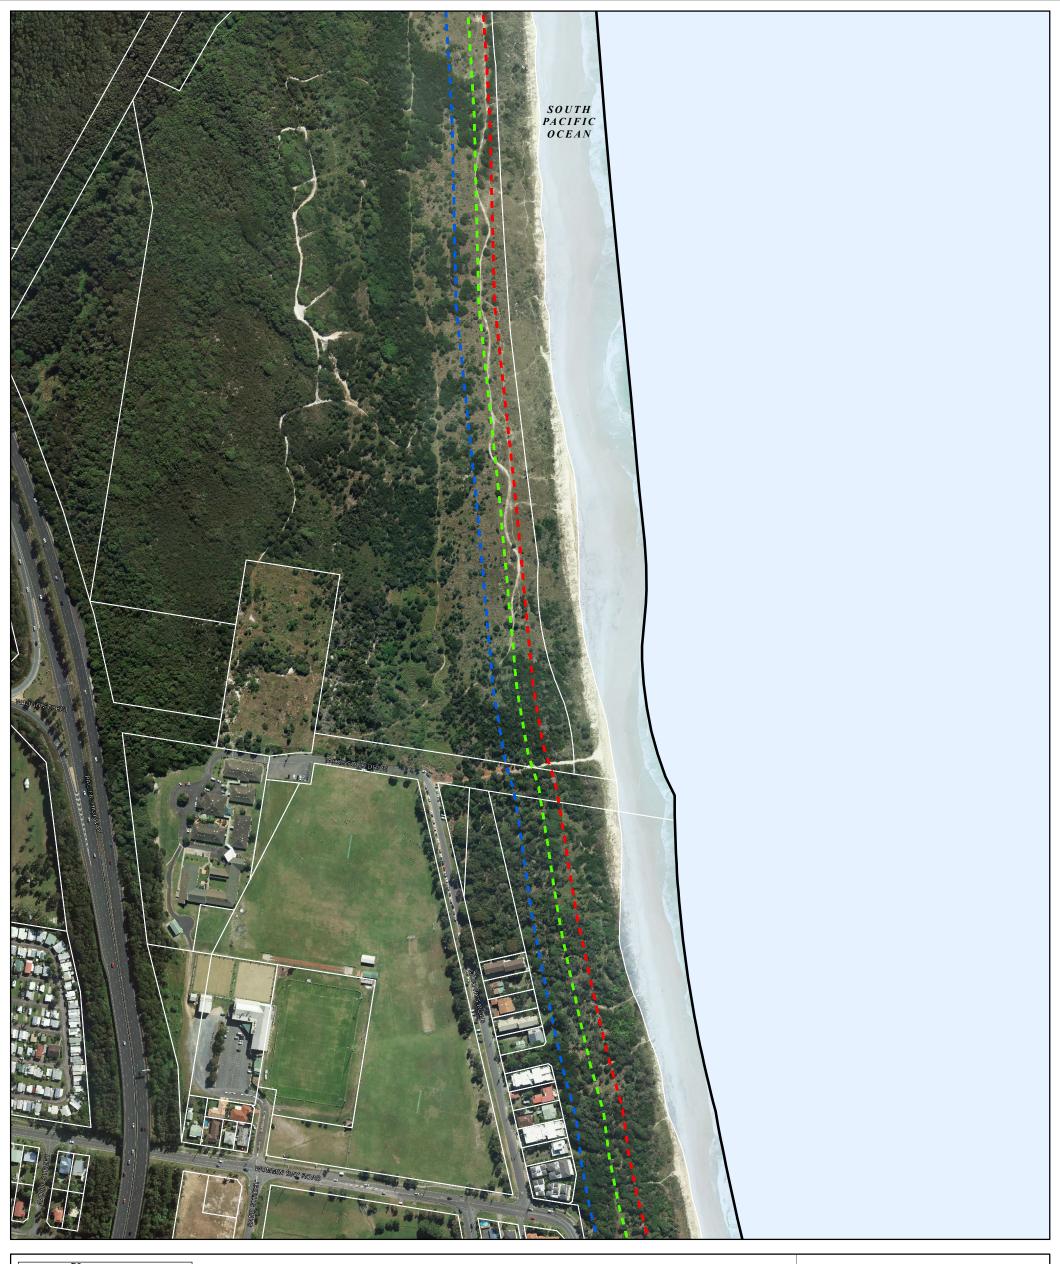
Coastal features and structures have been observed and digitally plotted using photogrammetric techniques. Hazard lines have been determined and plotted relative to the photogrammetry data. Cadastral boundaries as shown may not have been survey corrected and are presented for guidance.

Coastal Hazards Line (2010)

Immediate Hazard Line 2050 Hazard Line

2100 Hazard Line

Coastal Hazards Line (2014)

Immediate Hazard Line

Maximum 2100 Hazard Line

Maximum 2050 Hazard Line

A zone of reduced bearing capacity will exist landward of a receding erosion scarp. Definition of the extent of the zone of reduced bearing capacity will require professional assessment on a site by site basis. An additional allowance in this regard should be included in considering the immediate hazard zone.

The accuracy of predicting these hazard lines is subject to many uncertainties. The existence of bedrock, indurated sands and/or structures may impact on the realisation of the hazards.
