## **Coastal Hazards Line (2014)**

Update of Tweed Shire Coastal Hazard Lines

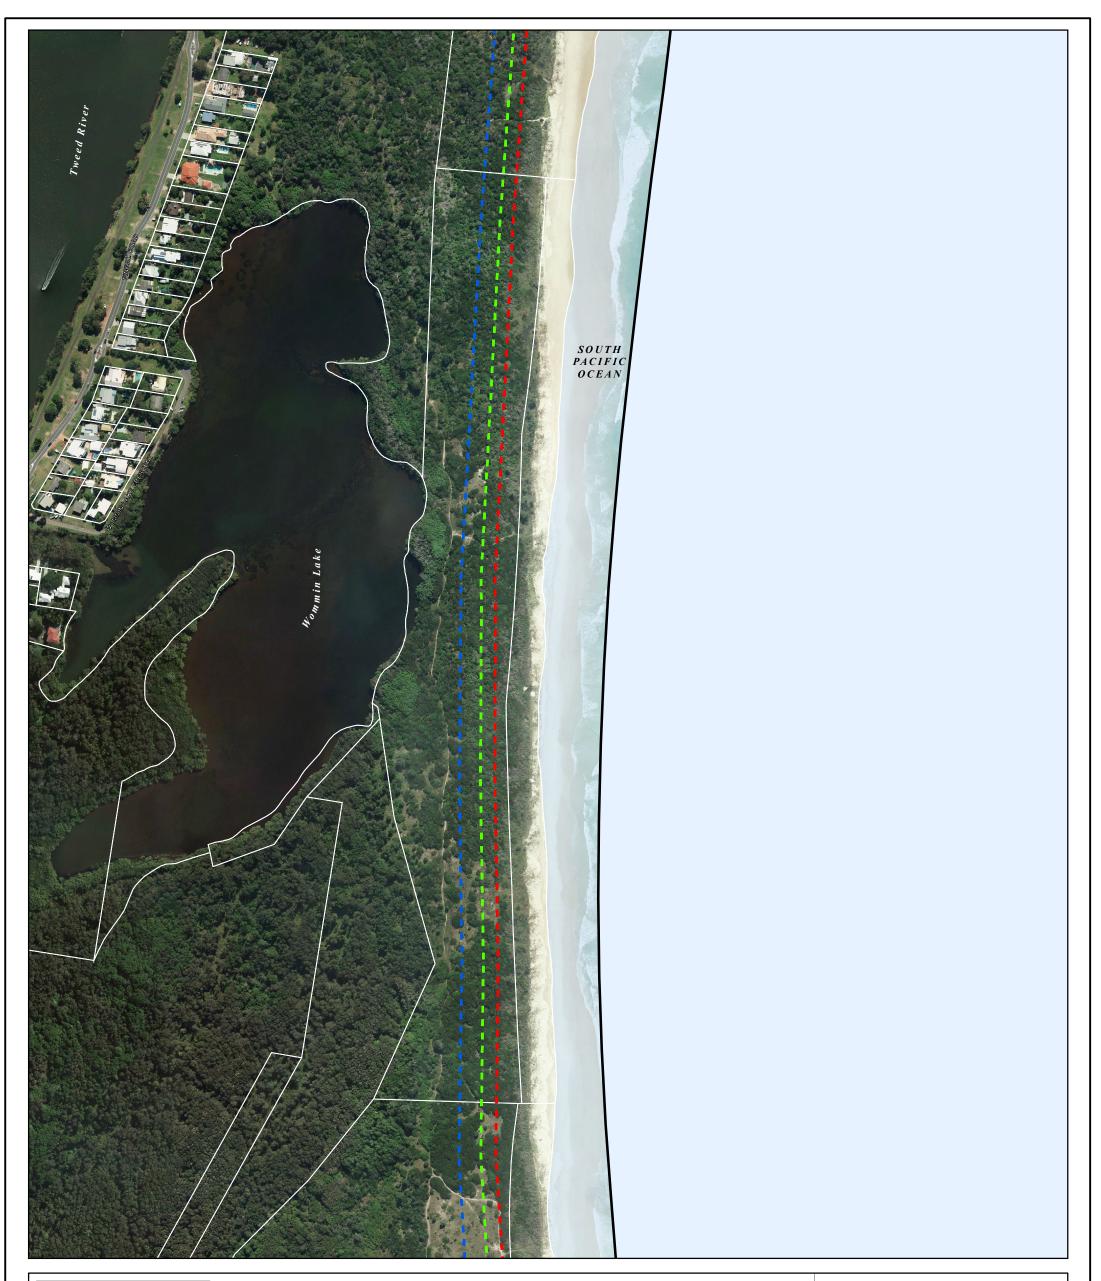
A zone of reduced bearing capacity will exist landward of a receding erosion scarp. Definition of the extent of the zone of reduced bearing capacity will require professional assessment on a site by site basis. An additional allowance in this regard should be included in considering the immediate hazard zone.

The accuracy of predicting these hazard lines is subject to many uncertainties. The existence of bedrock, indurated sands and/or structures may impact on the realisation of the hazards.

Coastal features and structures have been observed and digitally plotted using photogrammetric techniques. Hazard lines have been determined and plotted relative to the photogrammetry data. Cadastral boundaries as shown may not have been survey corrected and are presented for guidance.
