## **Coastal Hazards Line (2014)**

Update of Tweed Shire Coastal Hazard Lines

August 2010 Prepared By: The University of New South Wales Water Research Laboratory

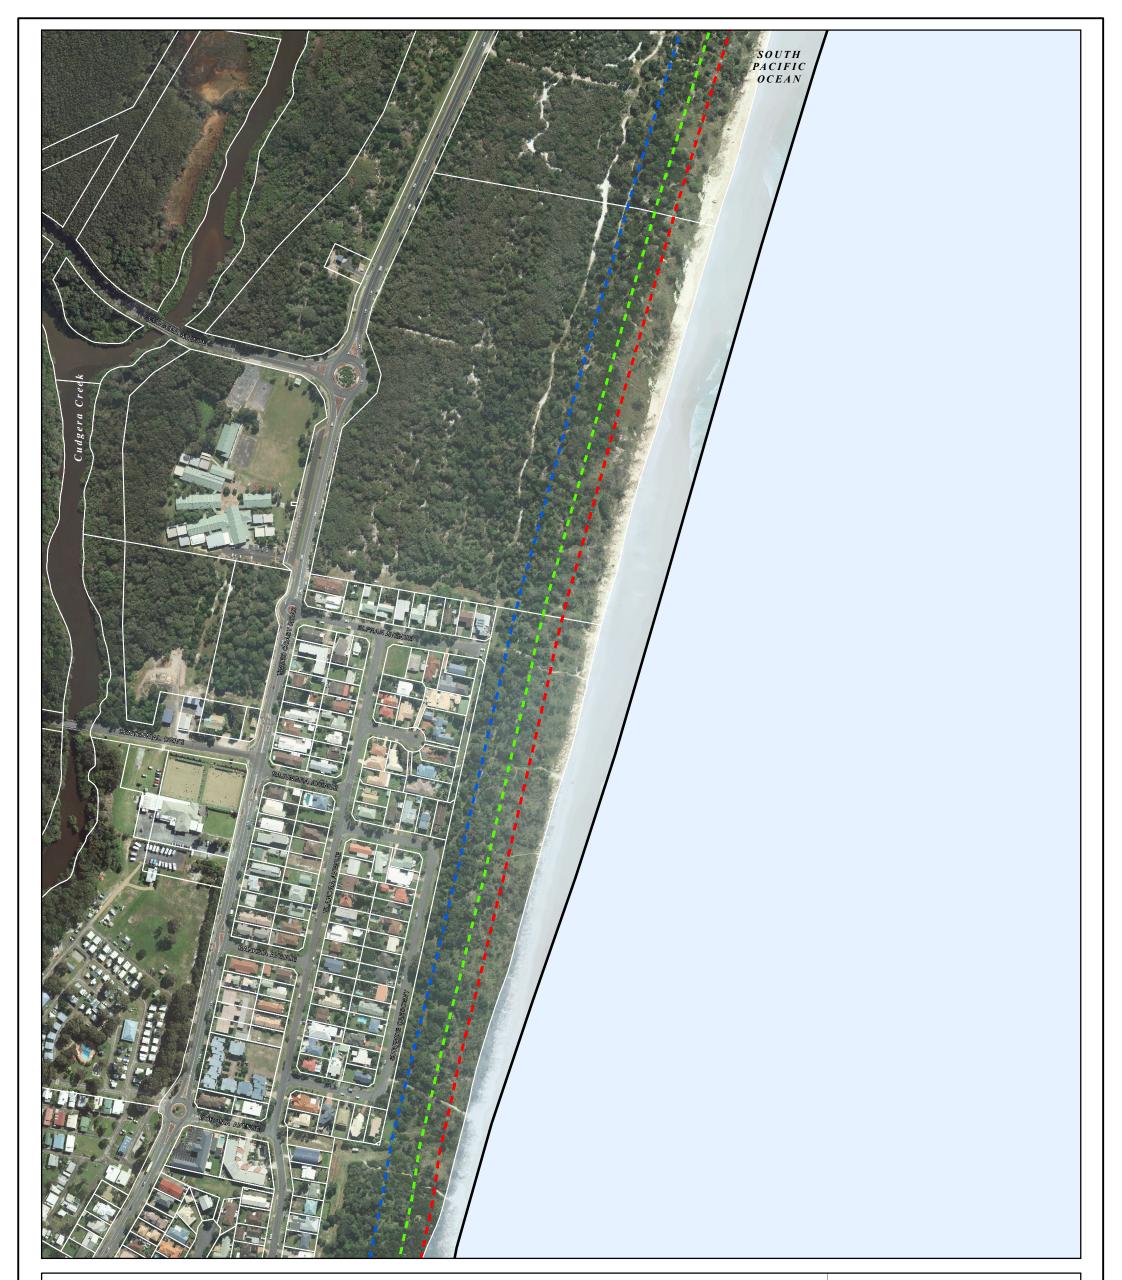
A zone of reduced bearing capacity will exist landward of a receding erosion scarp. Definition of the extent of the zone of reduced bearing capacity will require professional assessment on a site by site basis. An additional allowance in this regard should be included in considering the immediate hazard zone.

The accuracy of predicting these hazard lines is subject to many uncertainties. The existence of bedrock, indurated sands and/or structures may impact on the realisation of the hazards.

Coastal features and structures have been observed and digitally plotted using photogrammetric techniques. Hazard lines have been determined and plotted relative to the photogrammetry data. Cadastral boundaries as shown may not have been survey corrected and are presented for guidance.

- Immediate Hazard Line - - - -
- Maximum 2050 Hazard Line - - - -
- Maximum 2100 Hazard Line - - - -
