COASTAL MANAGEMENT  
BEACHES - EROSION  
KINGSCLIFF BEACH

## Coastal erosion at Kingscliff

Advice to the Minister for the Environment

December 2011

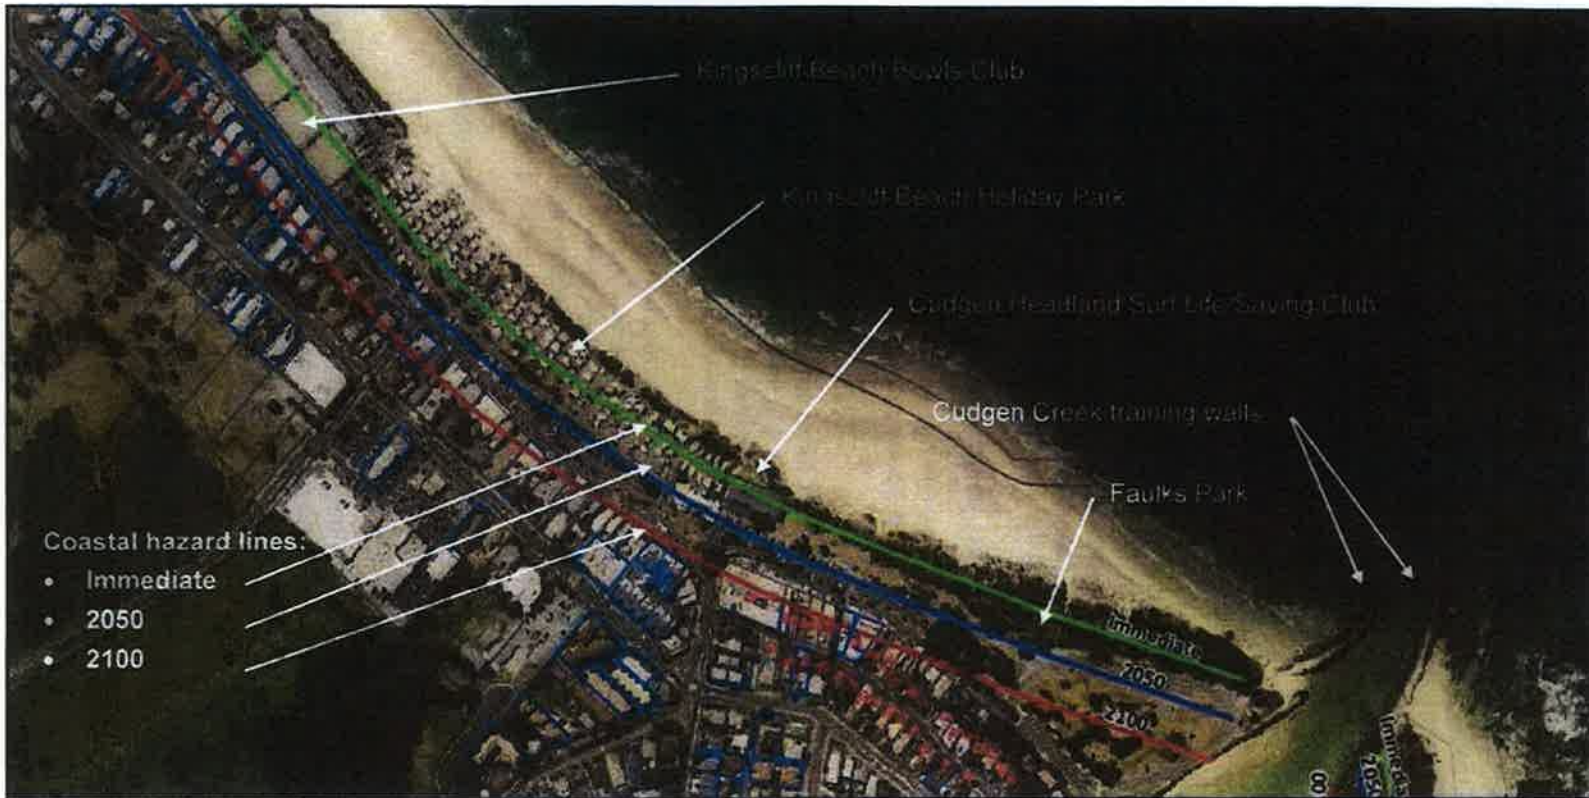
Figure 3 - Kingscliff Coastal Hazard Lines (Immediate, 2050 and 2100) overlaid on aerial image of the area (image courtesy of Tweed Shire Council), based on updated calculation (WRL, 2010).

As part of the 2001 CHDS, a number of assets at Kingscliff were identified as being within the Immediate Coastal Erosion Hazard area (Figure 2 and Figure 3). These included the Bowls Club, Cudgen Headland Surf Club and the Kingscliff Holiday Park. In addition, the Kingscliff Amenities Hall was found to be within the 50 year hazard area. Parts of Marine Parade (including parts of Kingscliff Village and private dwellings) are also under threat in the 50 year and 100 year hazard areas. In response, the 2005 CMP identified five potential management options. These were investigated in terms of their technical feasibility and cost effectiveness, and were the subject of public consultation. Each of these options are discussed below.

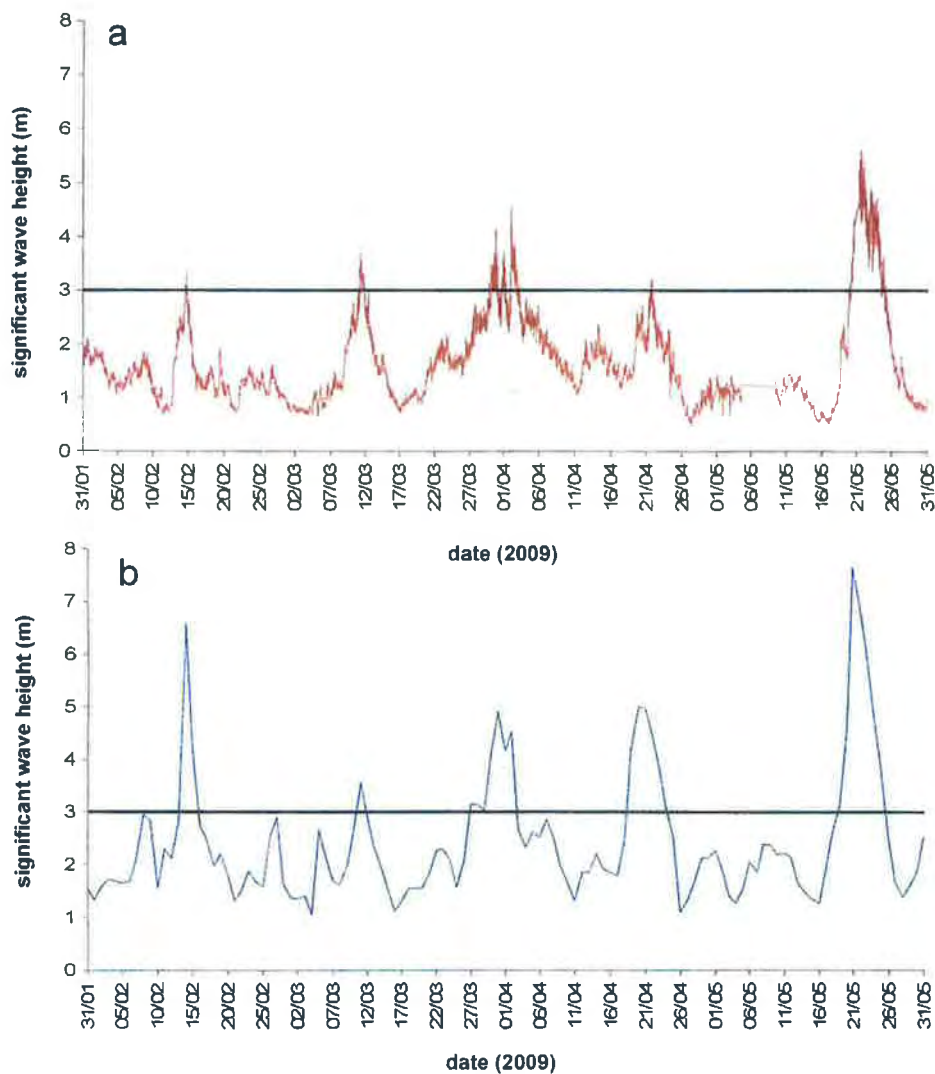
**Figure 5 - Significant wave heights during the 2009 erosion period (January - May) measured at (a) the Tweed Waverider Buoy and (b) the Byron Bay Waverider Buoy. Differences in heights between figures can be attributed to possibly sheltering of the Tweed Buoy due to areas of extensive offshore reef. The horizontal black line illustrates the 5 events with a significant wave height of over 3m.**

More recently events from 2009 to 2011 have resulted in a return of the erosion trend along Kingscliff, the result of which appears to be responsible for the current conditions. Between January and May 2009, the Tweed and Byron Bay Waverider buoys registered five storms in close succession and with significant wave heights greater than 3 metres (Figure 5). This was then followed by a large storm generated from an ECL in May 2009 (Proudfoot and Peterson, 2011). These storms are reported to have caused large amounts of sand to be transported both southward along the beach south of Cudgen Head, and northwest along Dreamtime Beach away from Kingscliff (Patterson, 2010), and resulted in the development of a large erosion scarp along Dreamtime Beach.

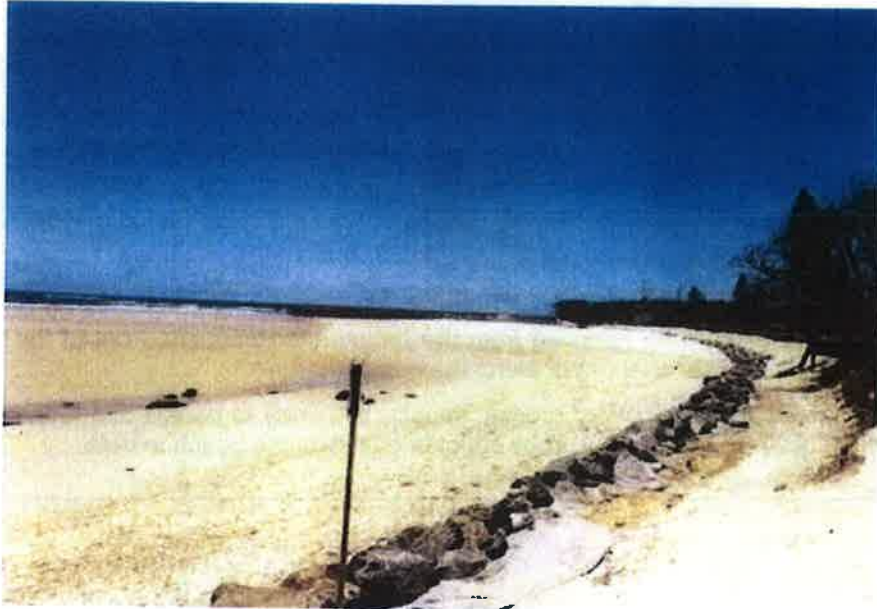
**Figure 6 - Terminal rock revetment between Cudgen Headland SLSC and the Cudgen Creek training wall (present in the background). The photo shows the current sand pulse that has recently moved into the embayment and now resides at the southern end of the compartment in front of the wall.**  
Photo M. Daley 8 November 2011.

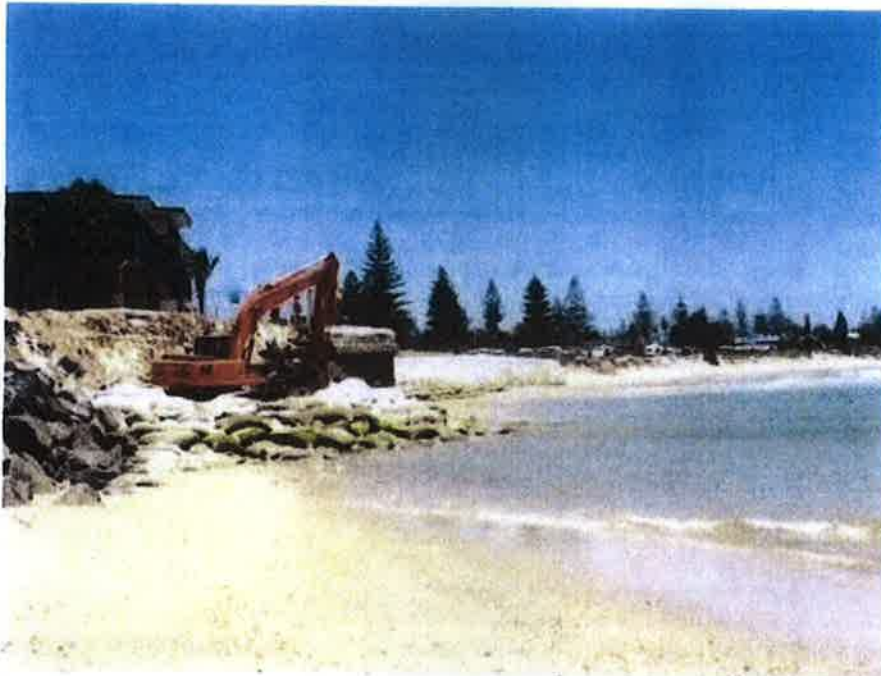
**Figure 7 - Looking north from the terminal rock revetment towards Cudgen Headland SLSC and the Holiday Park showing both the piled concrete foundations and temporary geotextile sandbag wall.**  
Photo: M Daley 8 November 2011.

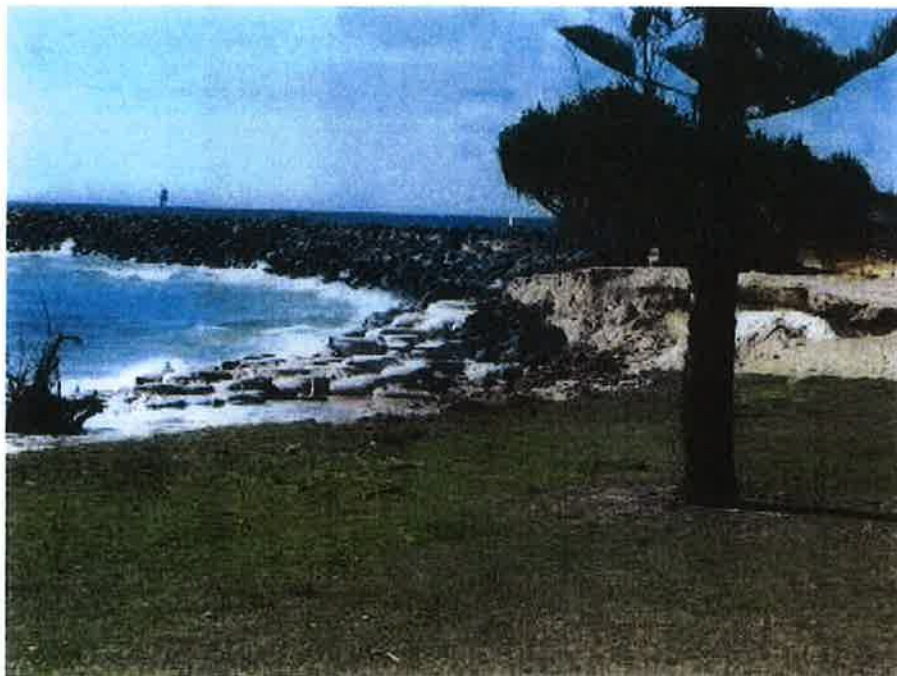
**Figure 9 - Looking south from Faulks Park following erosion events of 2010. Also evident are the end effects of Cudgen Creek training walls. Photo: B Gibbs 12 August 2010.**

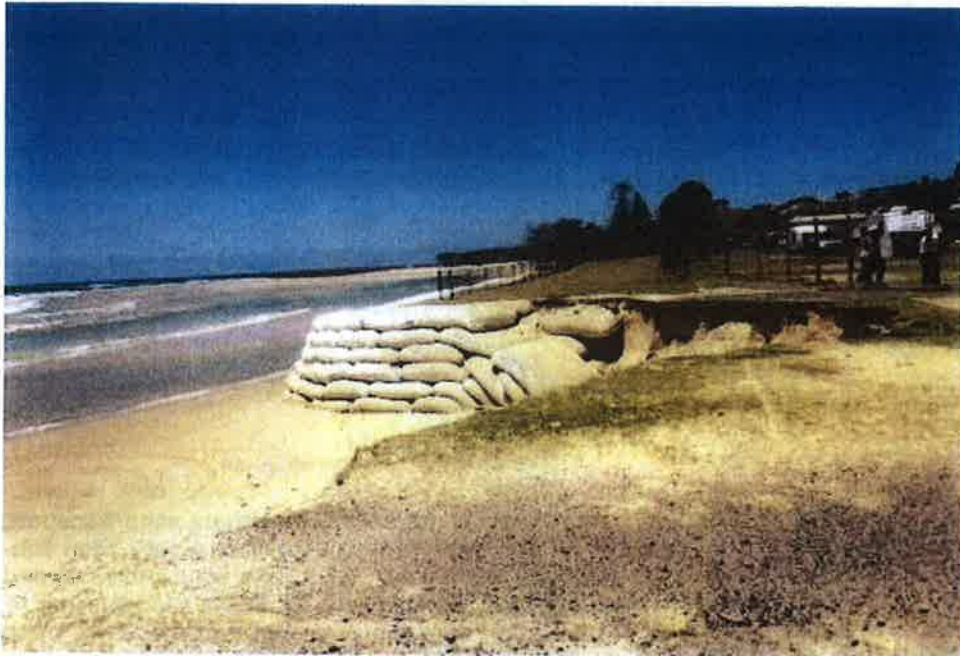
**Figure 10 - Northern end of the geotextile sandbag seawall (looking south) showing both collapse of the wall and end effects which have produced further erosion of the Holiday Park. Photo: M Daley 8 November 2011.**

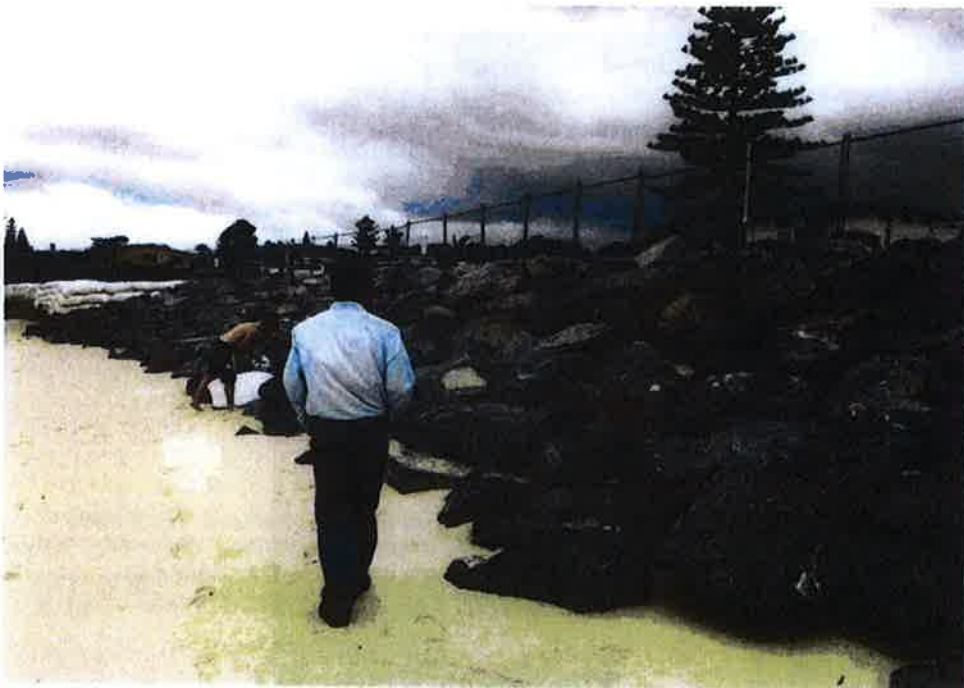
**Figure 11 – Most recent (60 metre) rock extension in front of the further part of the Holiday Park and the amenities block. Photo: B. Fitzgibbon 14 December 2011.**

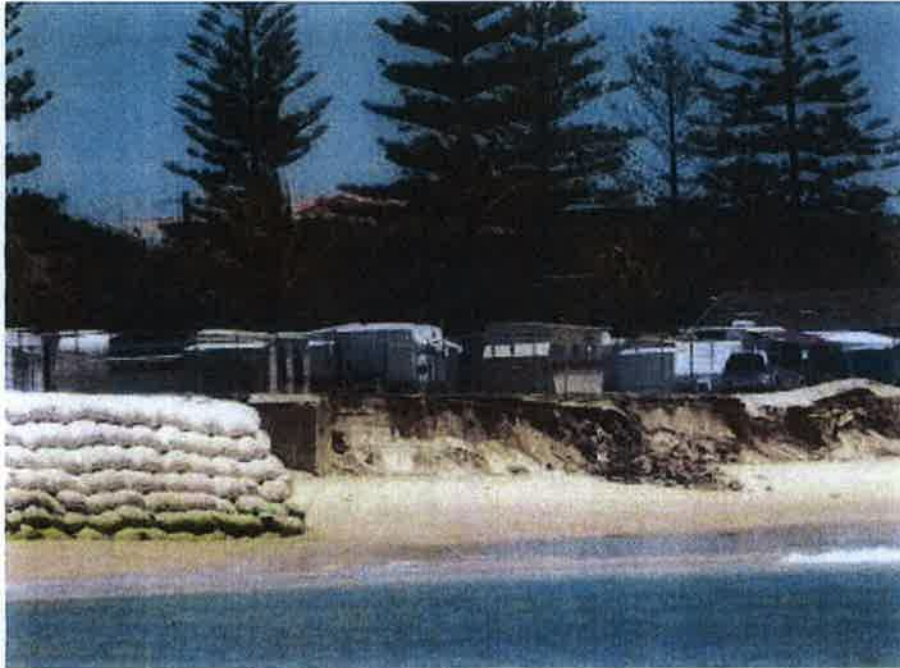
**Figure 12 – Looking towards the Holiday Park showing end effects of temporary protection works and the current risk posed to the amenities block and pumping station located immediately behind the escarpment. Photo: G Pezzimenti 8 November 2011.**

A protection strategy creates a differential potential for erosion between protected and unprotected areas of a beach. Should TSC continue with a protection strategy, then Council will most likely need to implement a full protection strategy along the length of the beach from the Cudgen Creek training walls to the Bowls Club. Such an approach could result in some erosion north of the Bowls Club. However, it should be noted that the current protection structure in front of the Bowls Club does not appear to be suffering from end effects due to the volume of sand in front of that structure, and that this beach has been stable for some time. The likelihood of such erosion occurring would be higher if the beach in front of the existing seawall was depleted of sand and the wall was directly exposed to wave action.

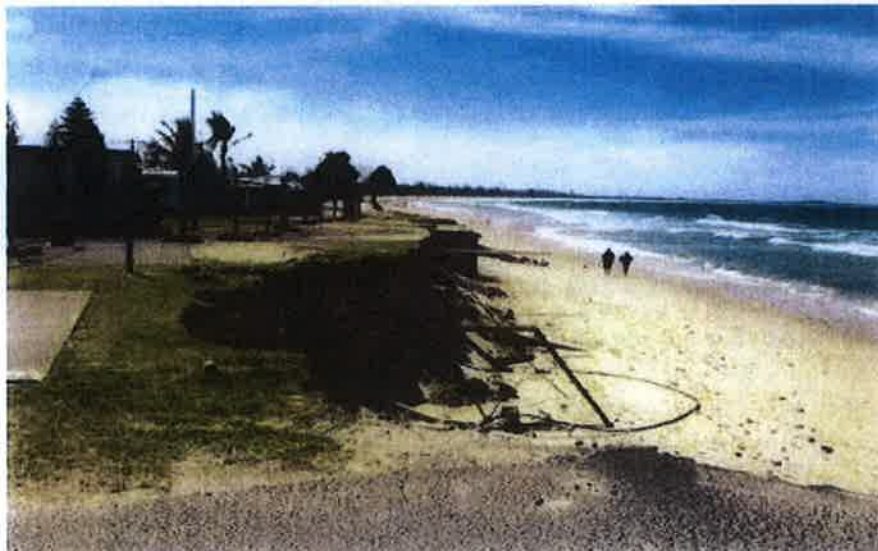
**Figure 13 – Cable and Piping Infrastructure currently protruding from the erosion escarpment adjacent to the Holiday Park. Photo: M. Daley 8 November 2011.**

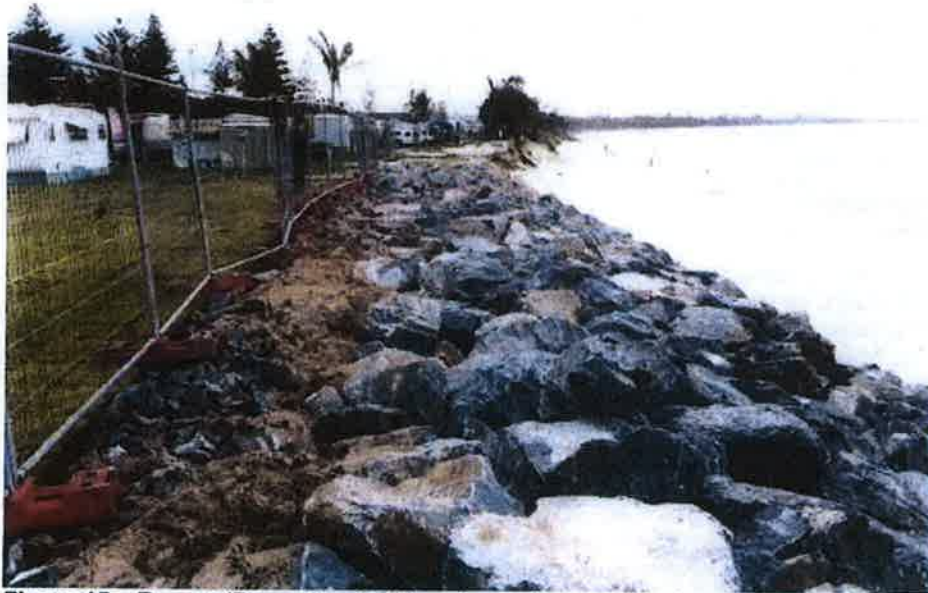
**Figure 15 – Recent (December 2011) rock revetment works installed to protect the amenities block and sewer pumping station of the Kingscliff Holiday Park. Photo: B. Fitzgibbon 14 December 2011.**
