**GEOTECHNICAL INVESTIGATION  
RIVE VUE ESTATE STAGE 4  
MURWILLUMBAH, NEW SOUTH WALES**

# Geotechnical Investigation

## Rive Vue Estate Stage 4

### Murwillumbah, New South Wales

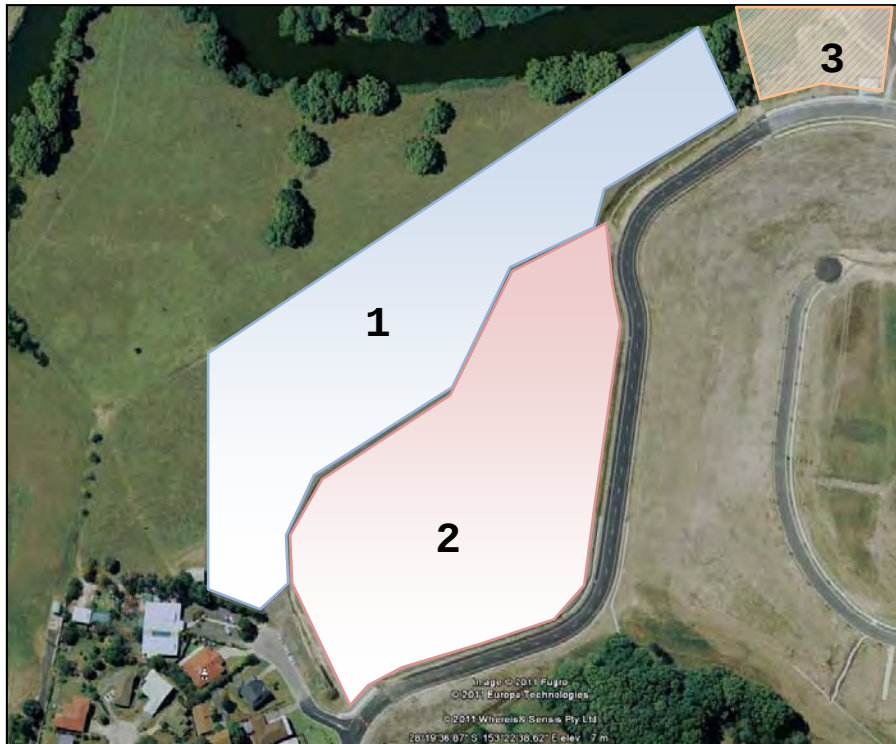
The subject block, at the time of investigation could be broken into three distinct regions as represented below:

**Region 1** was accessed at the end of Joshua St and consisted of a natural level field that was well covered in thick tall grass at the time of investigation. There were also a number of drainage channels running approximately south west across the block and a grass covered road had been mowed along the West and North boundaries of the property.

**Region 2** was boarded by Rous River Way along its southern and eastern boundaries. The southwest portion of this region comprised of a well grassed level fill pad. There region rose to slight hill on the North eastern section of this area where the hill was well grassed and densely treed by large mature gums and juvenile pines perched on the flat top of the hill. There was also an open concrete lined drainage channel running between the site and Rous River Way.

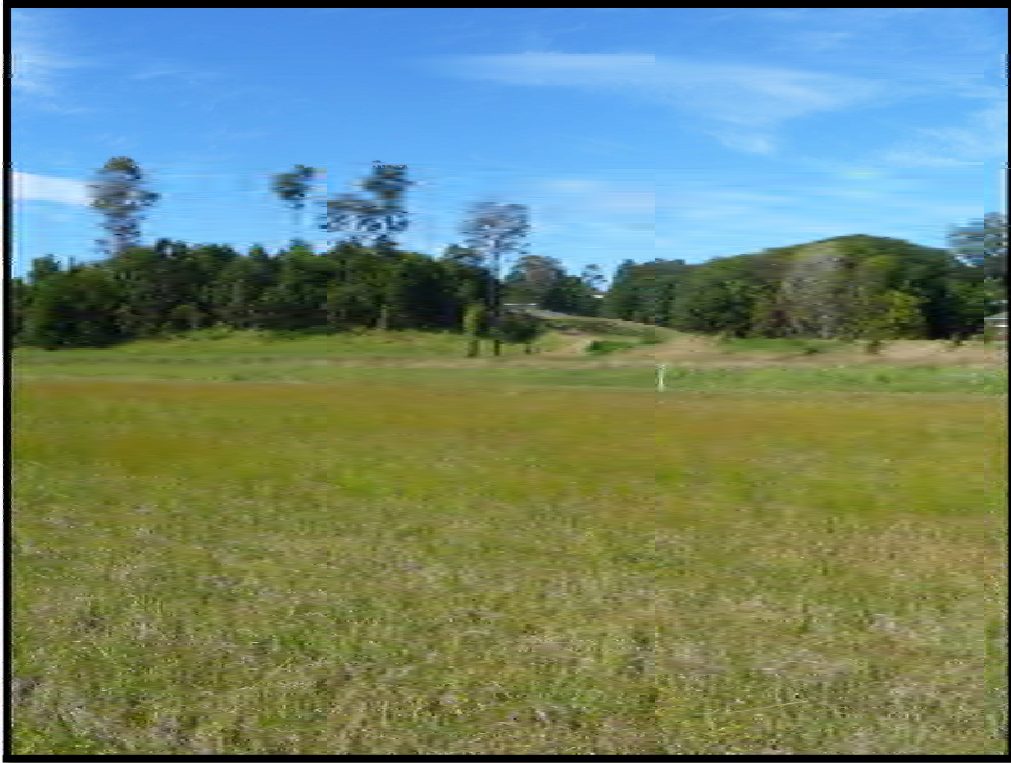
**Plate 1: Looking West across the site from Region 1**

Photographs depicting typical site conditions at the time of the investigation are presented in Plates 1 to 3 following.

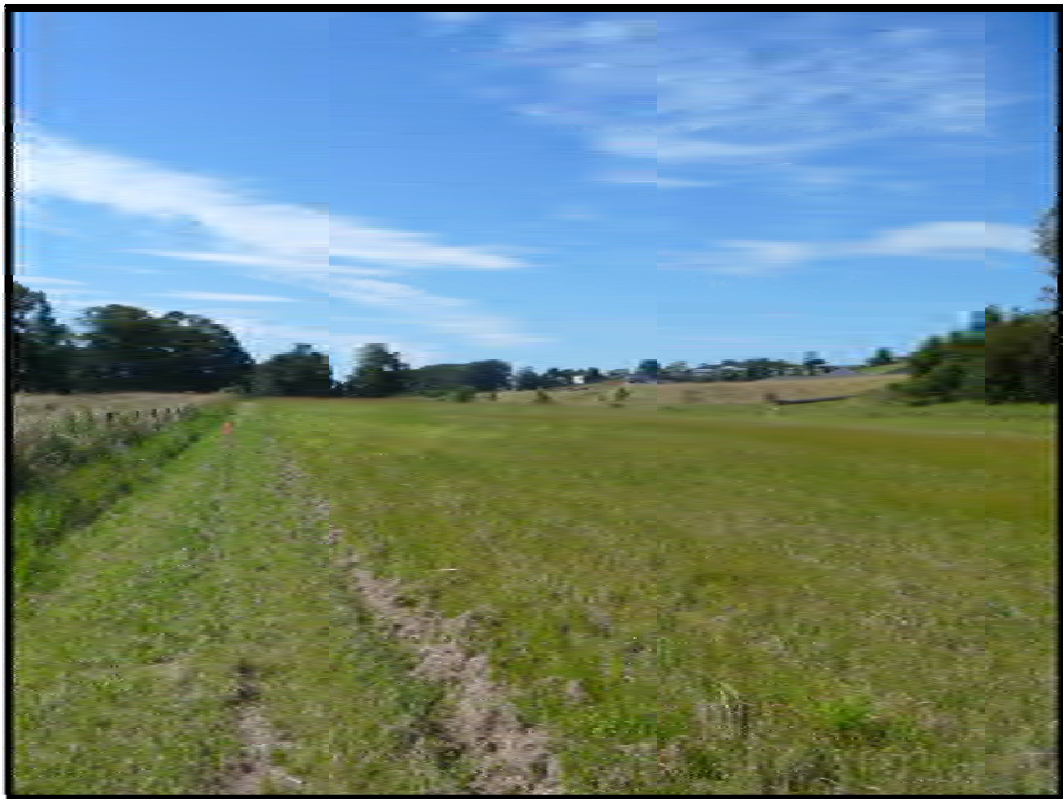
**Plate 2: Looking North East across the site**

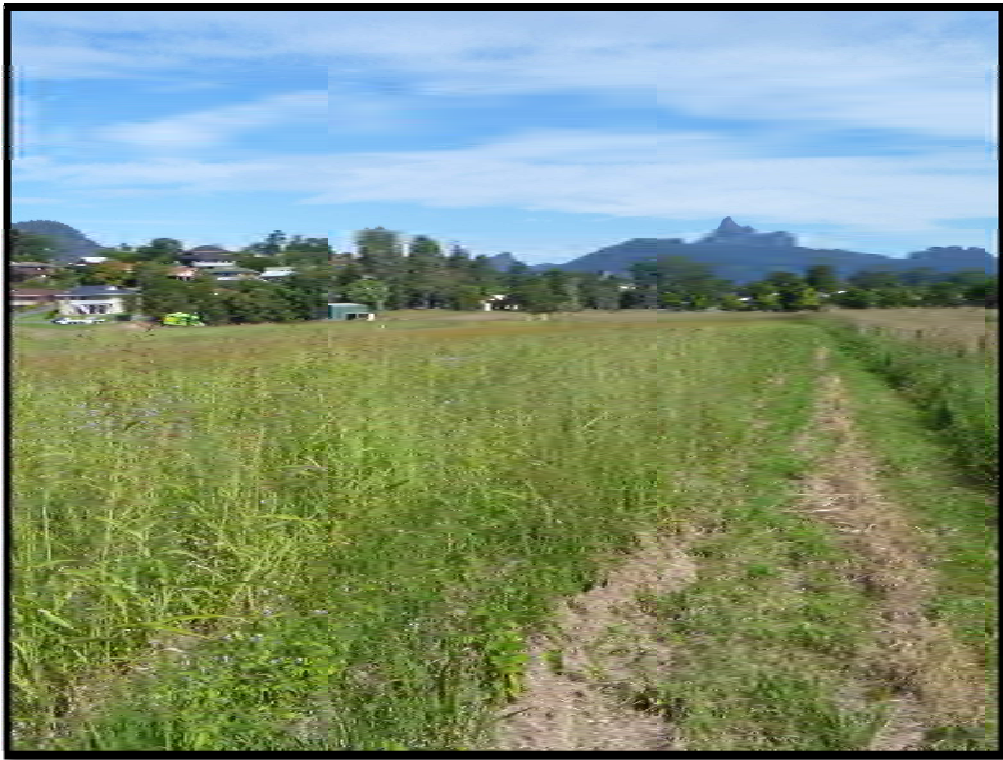
**Plate 3: Looking South West across the site**
