## Preliminary Site Contamination Assessment - Site History

Lots 1 & 6 DP 9042, Lot 14 DP 733411  
Dry Dock Road  
Tweed Heads South

YBOS Pty Ltd

2010.103

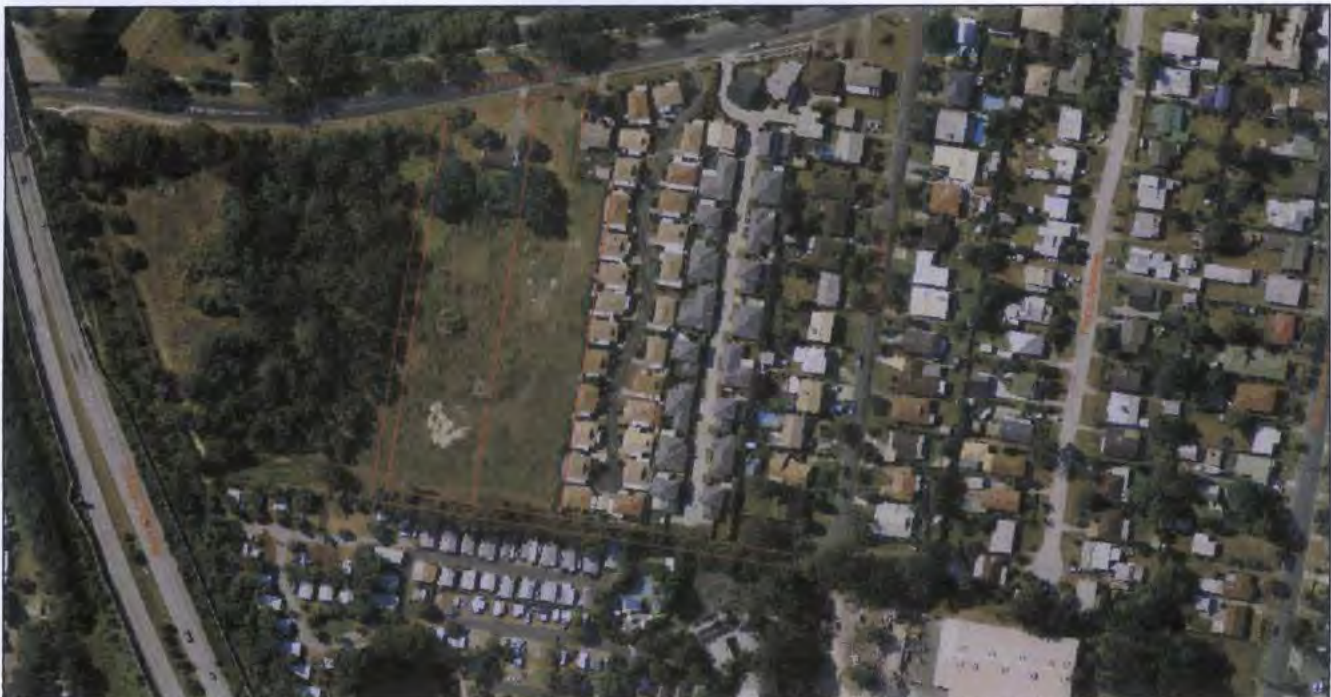
**Photo 1: Location of subject site showing property boundaries**

The subject site is located within the residential area of the Tweed Heads South and is generally cleared and vacant. An existing dwelling and shed is located on the north-west corner of the site.

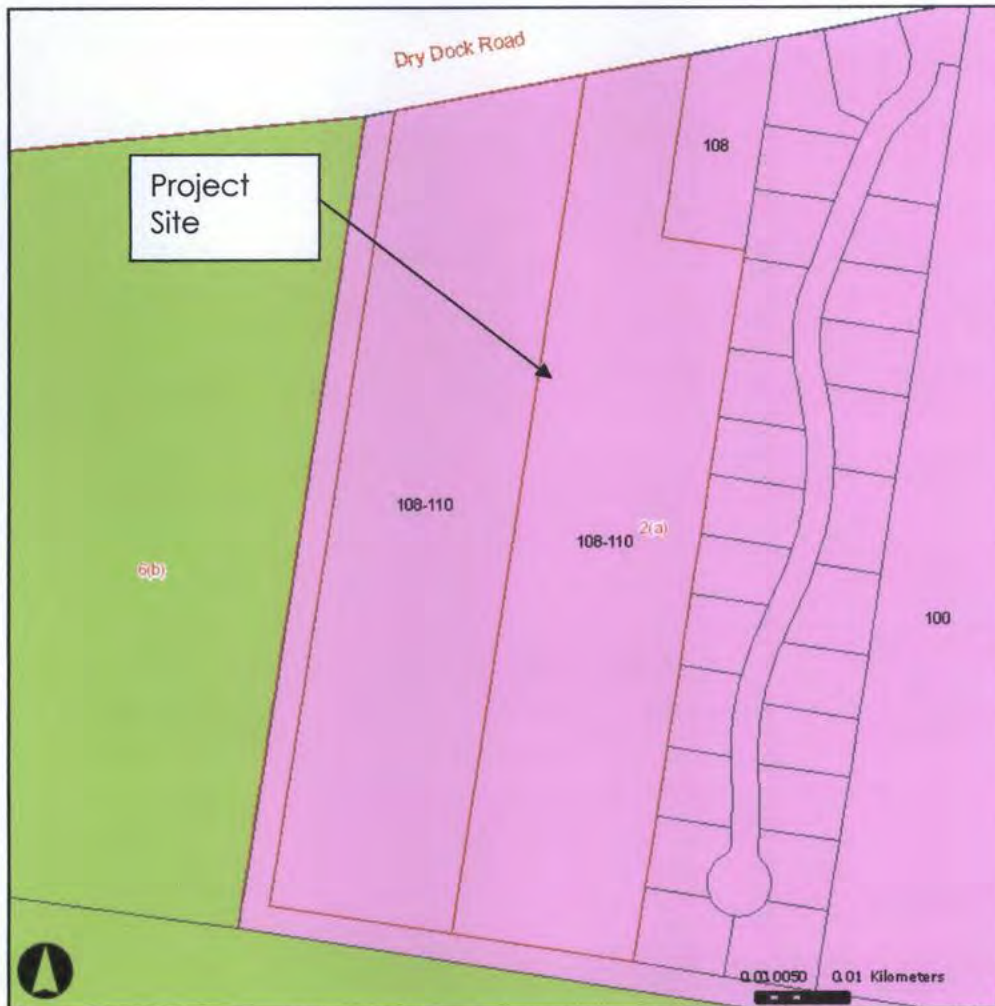
Figure 1 TSC Zoning Map

The subject site is located within the residential area of Tweed Heads South and is zoned 2 (a) Low Density Residential.

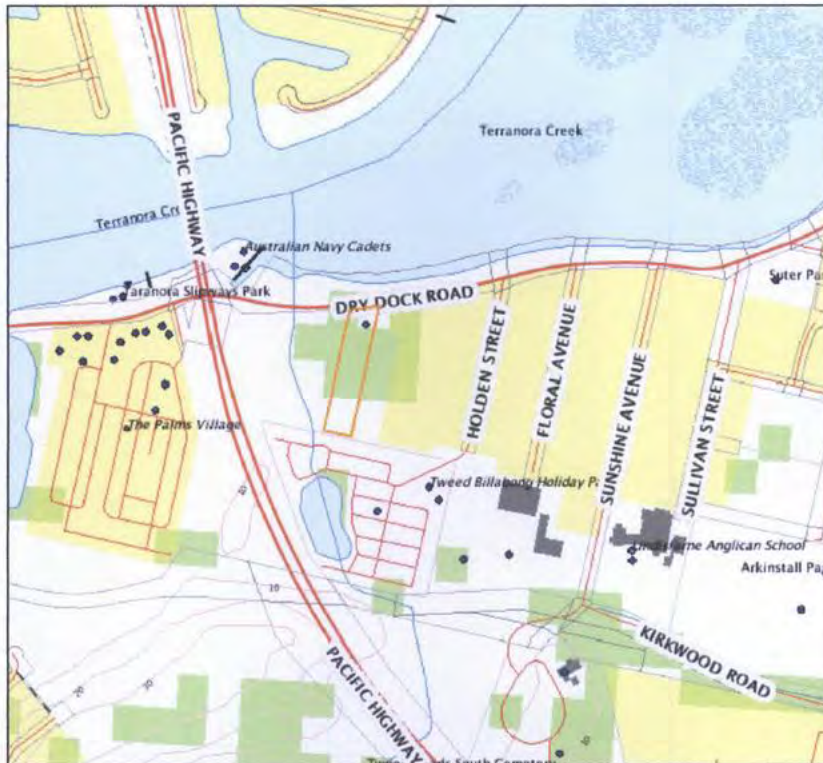
A review of the current and historic topographic mapping (2002 & 1979) available through the NSW Department of Lands online mapping shows open forest on part of the site. No cropping or banana cultivation land is recorded (see Appendix 3).

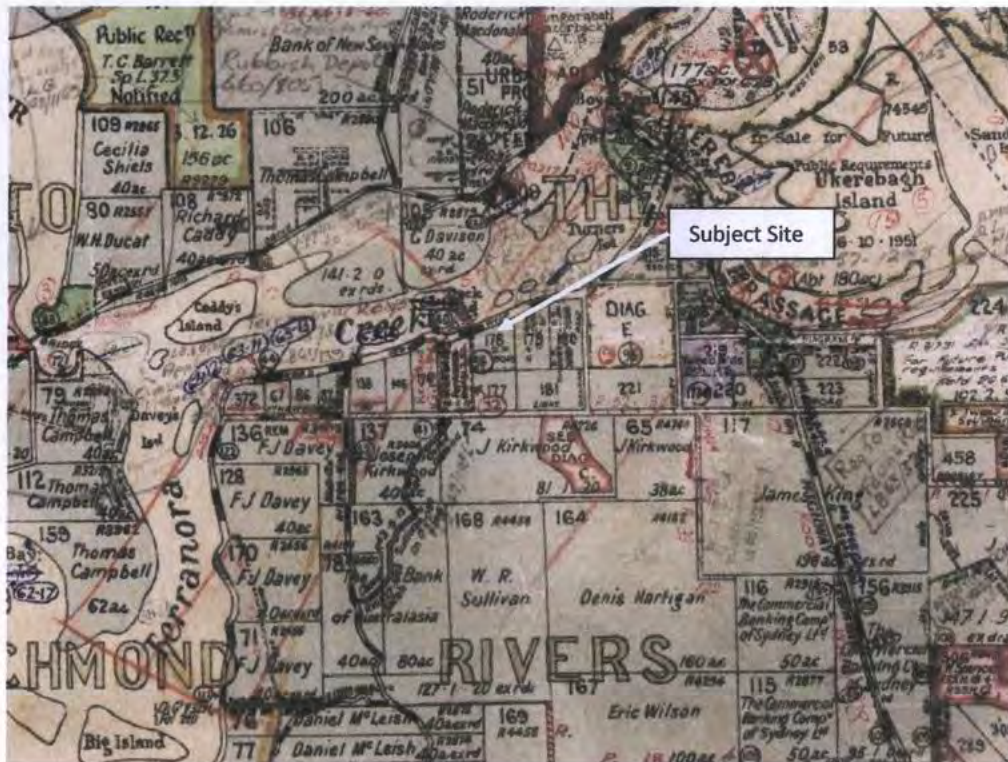
Figure 7 Parish Plan Extract 1959

A search of the Land and Property Information – Parish Maps was requested. Parish maps 1924 & 1959 were reviewed. No change in the lot boundaries occurred during this period. The site was shown within western part of the larger portion 178 that extended south from Dry Dock Road. No land use is recorded however it appears that these large properties would be either agricultural or under native vegetation. A copy of the 1959 Parish map extract showing the Site and surrounding land is provided in Appendix 4.

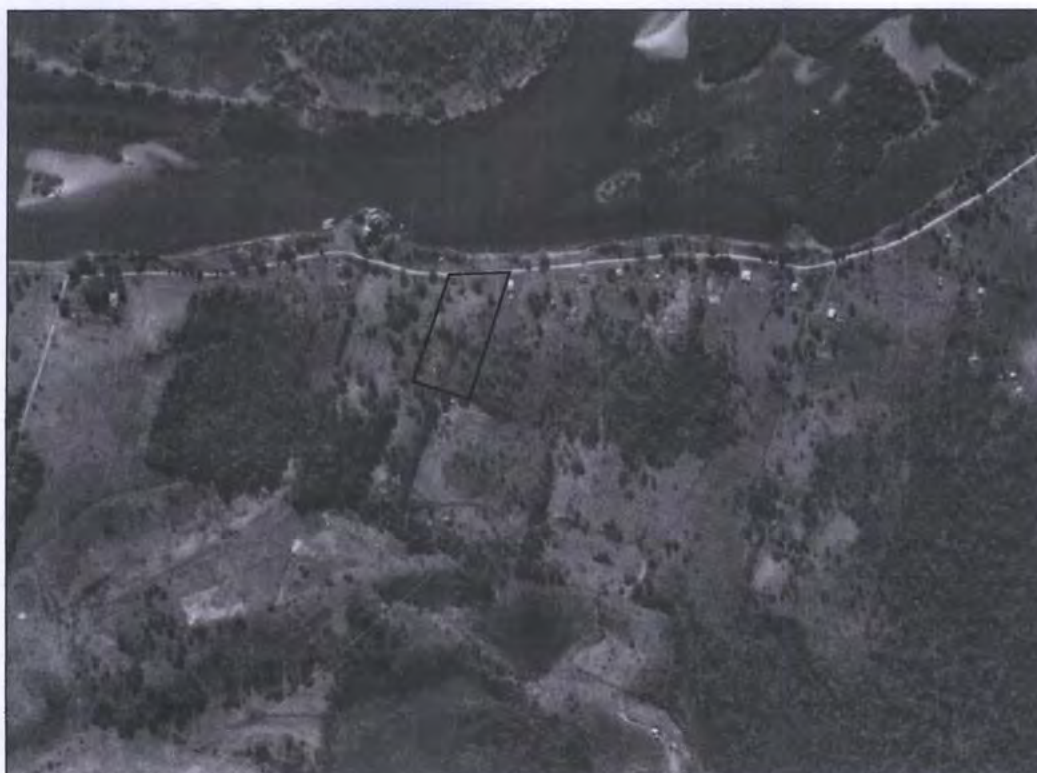
Photo 4 Aerial photo 1947

Photograph Details	Source	
1947	Geoscience Australia	Partially cleared, no structures, no visible cash cropping or intensive cultivation
1962	TSC GIS mapping	Similar to 1947 however vegetative re-growth in southern half of site
1976	TSC GIS mapping	Increased density of re-growth and current dwelling/shed now constructed on northern part of site. No visible cash cropping or intensive cultivation.
1987	TSC GIS mapping	Similar to 1976 however re-growth more dense and increased site coverage
1995	TSC GIS mapping	Heavy re-growth across site except dwelling surrounds and north-east corner
2009	TSC GIS mapping	Vegetation cleared except for scattered mature trees around dwelling.

From the desktop investigation using available information and the site inspections it appears that the site was partially cleared prior to 1947 when the site was within a larger land parcel and was likely used for intermittent grazing. During the next 50 years the land appeared to be allowed to gradually return under native vegetation except the northern portion where a dwelling was constructed between 1962 and 1976.

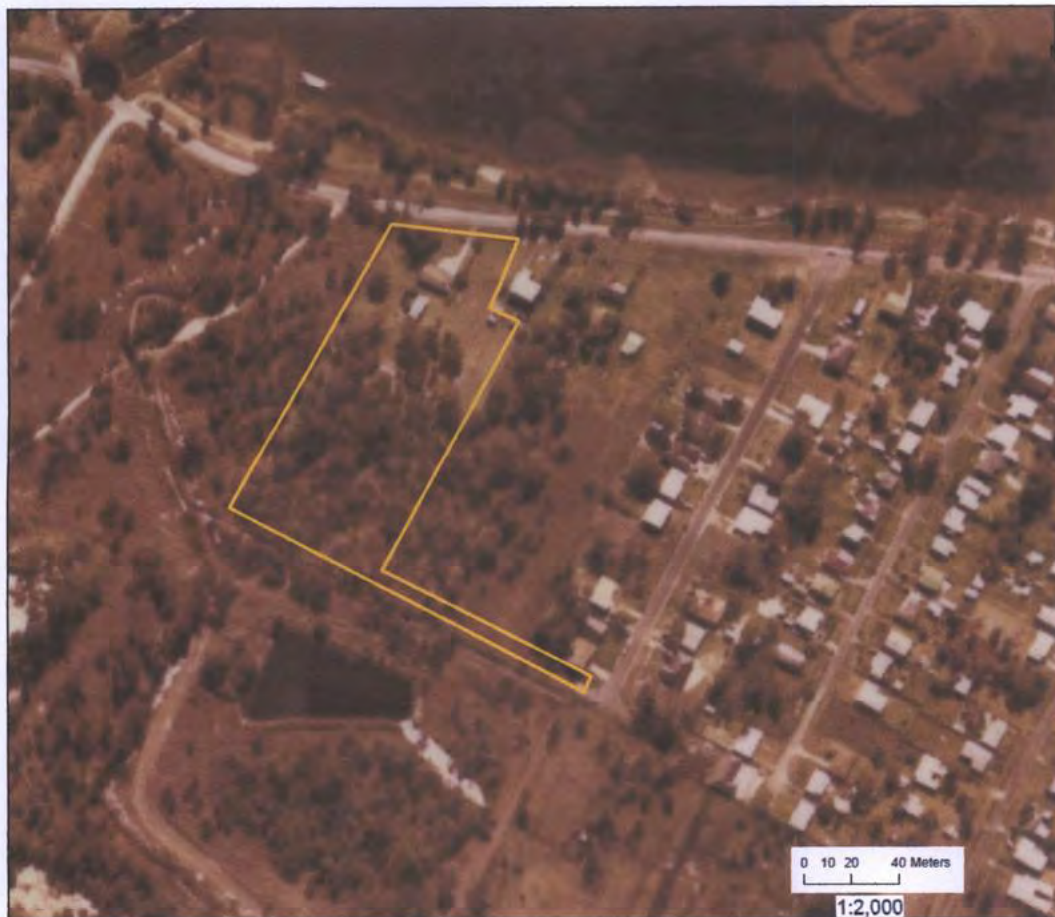
Photo 6 Aerial photo 1976

A review of the historic aerial photography indicates that the existing dwelling and shed were constructed on the site between 1962 and 1976. In 2002 a development application was lodged to Tweed Shire Council seeking and amendment to the LEP to insert an enabling clause to facilitate the development of a caravan park and associated facilities. In June 2004 this development application was withdrawn. An application was also submitted in October 2003 for approval to clear and fill the site. This application was subsequently withdrawn. The current application to amend the LEP was submitted in February 2006 and a Local Environment Study prepared by LandPartners was submitted in November 2008.

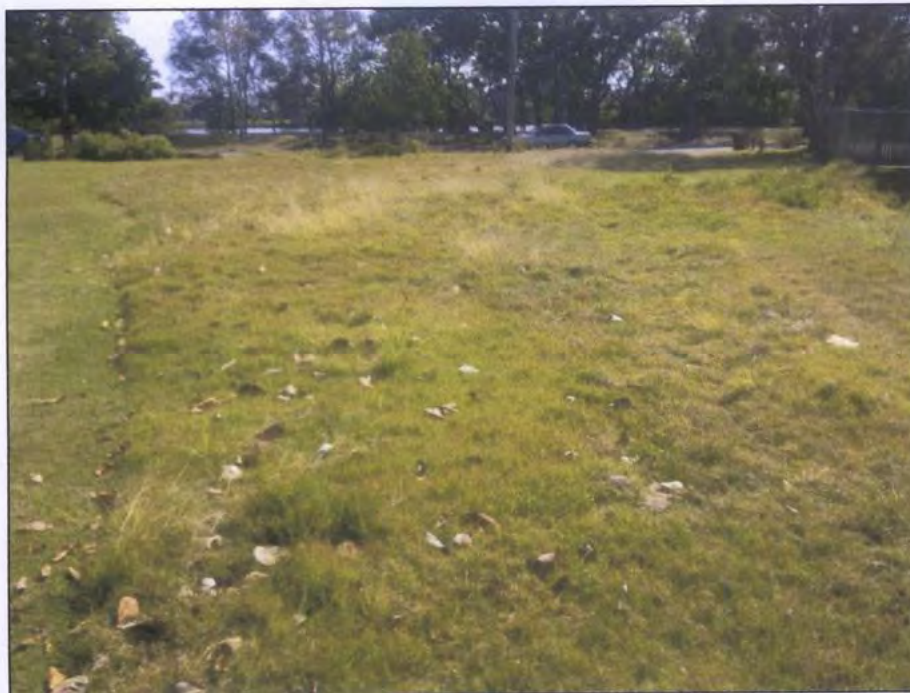
Photo 9 View North

No soil discolouration, vegetative die-off, or chemical odours were noted that might indicate previous agricultural, fuel use/spillages or other “hotspots”.

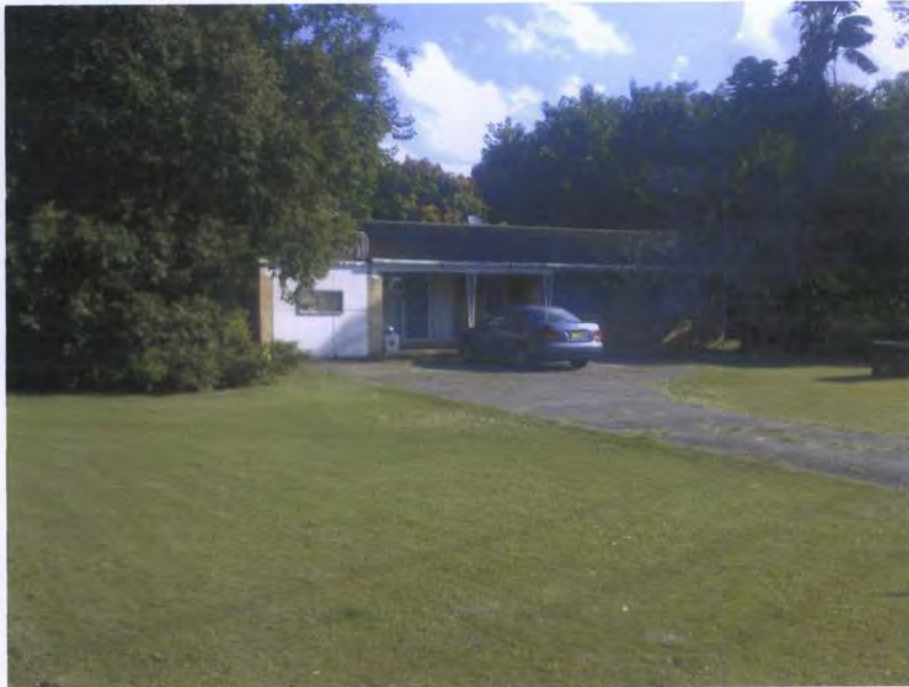
**Photo 13 Existing dwelling**

The existing dwelling appears to have a concrete floor slab and would likely require a pre-demolition underslab contamination investigation. This investigation would be associated with any development application for the construction and operation of the future extensions to the caravan park or other proposed development. Remediation of the small volume of underslab soil material has been shown to be feasible within other sites. The underslab material if found to contain concentrations of residual termite treatment exceeding guideline values is able to be encapsulated and capped within the site. Adequate area is available on the site to remediate any underslab soil found to be contaminated.

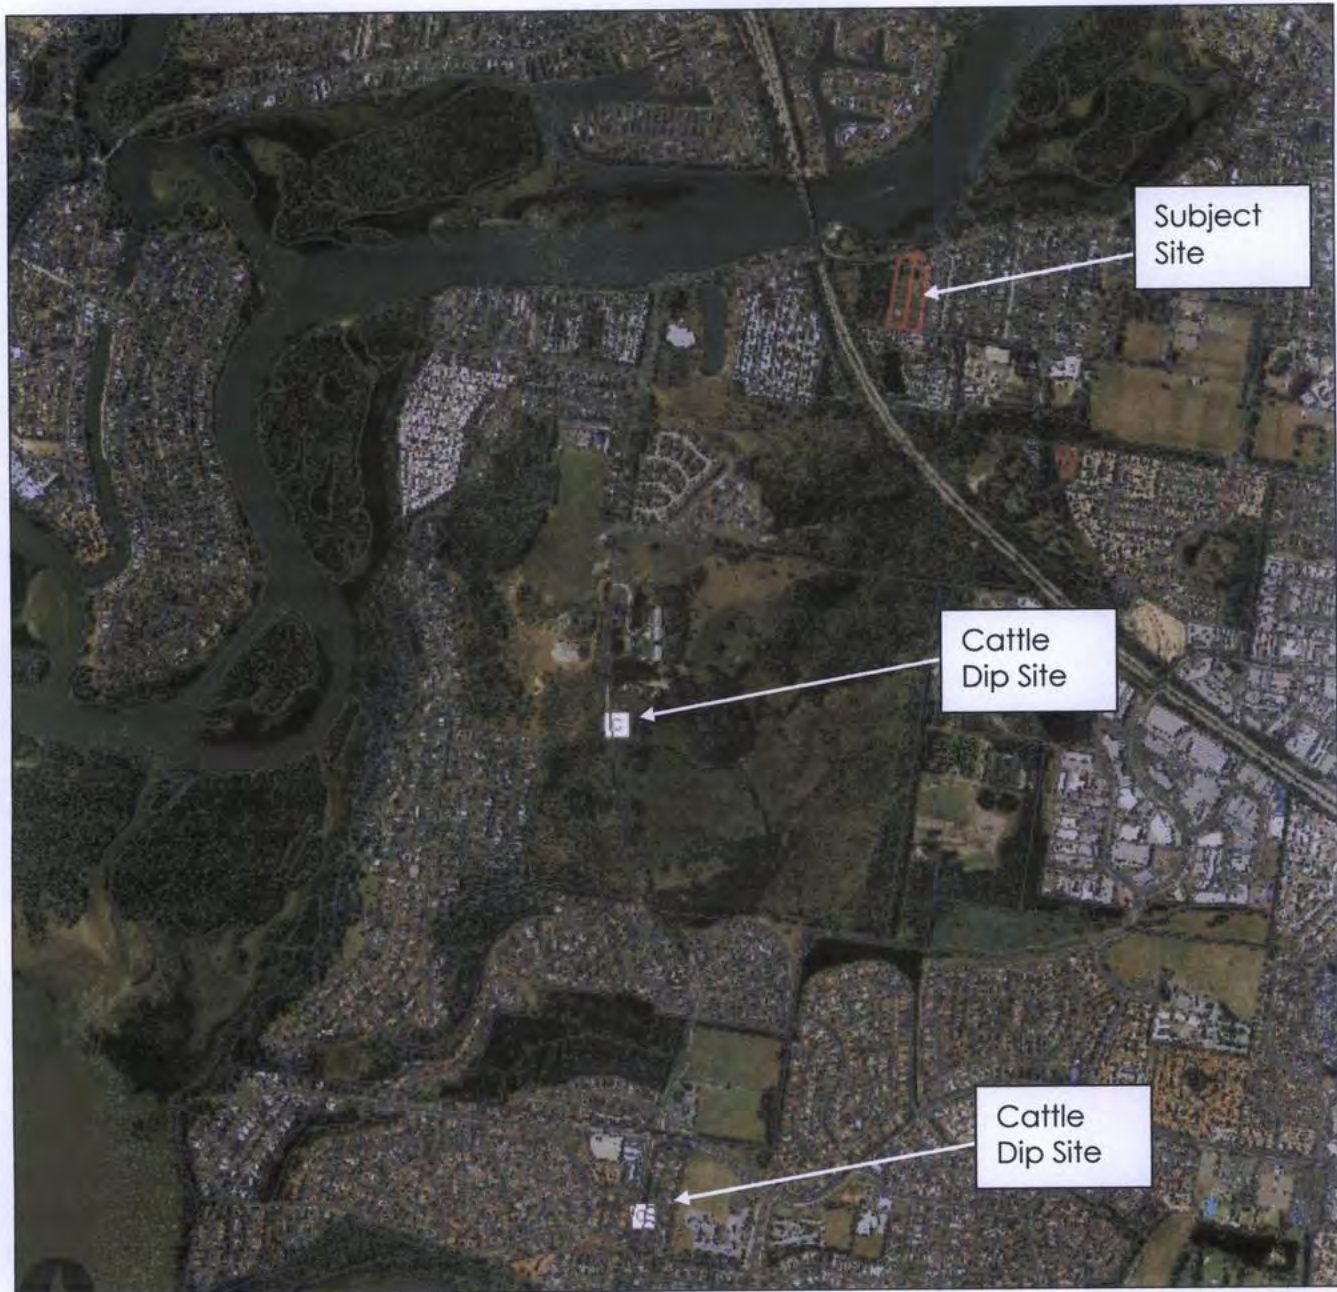
TSC online mapping (<http://mapping.tweed.nsw.gov.au/planningservices/Default.aspx>) also recorded several dips in the area. The nearest recorded cattle dip site (Dry Dock dip) is in Fraser Drive, Tweed Heads South. All recorded cattle dip sites were >200m from the site (see Appendix 9).
