Tweed Riverbank Erosion Management Plan 2014

TWEED SHIRE COUNCIL | TOGETHER FORWARD

The purpose of the Tweed River Estuary Bank Management Plan 2014 is to provide a schedule of works to stabilise riverbank erosion on public land (to be undertaken by Council), as well as updated design advice for works required on private land.

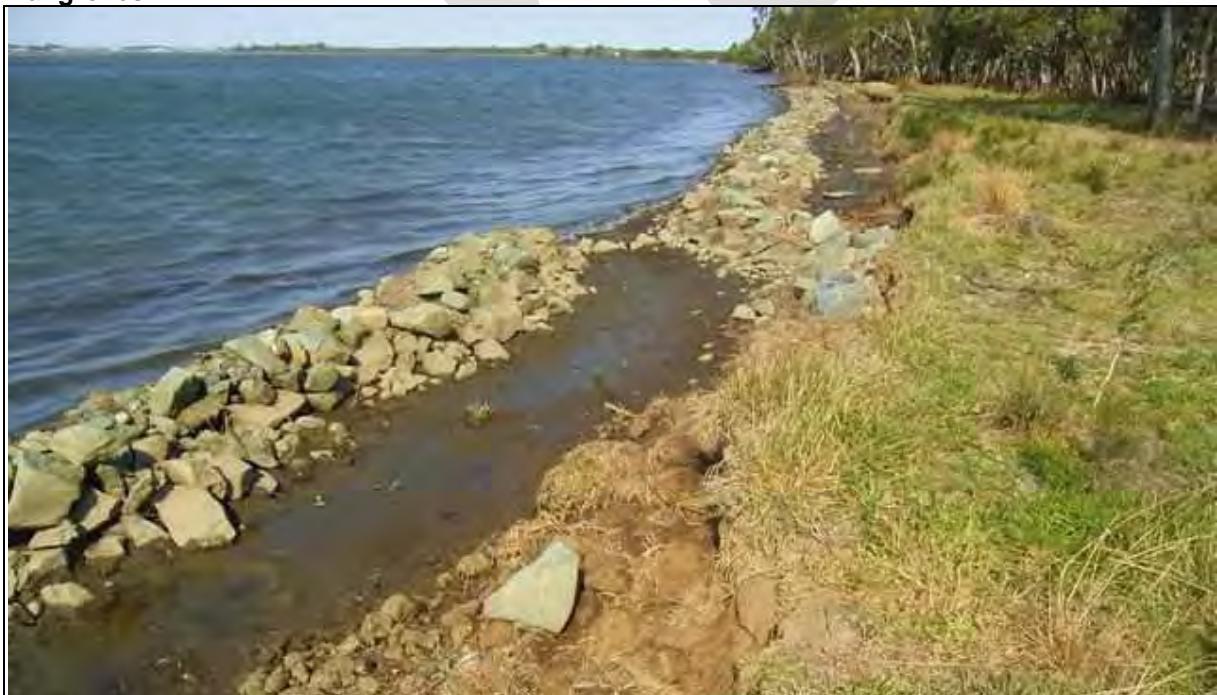
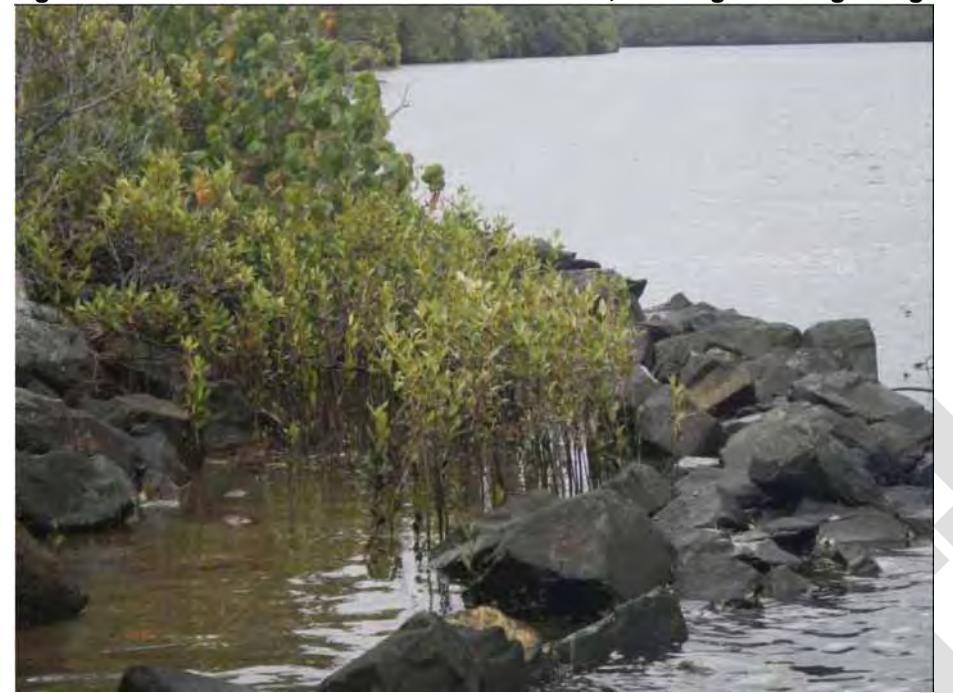
Figure 3. Rock fillets are a common bio-engineered approach to bank stabilisation. The photo below shows rock fillets immediately after construction in the Manning River, prior to colonisation by mangroves.

Figure 4. Rock fillets constructed at Chinderah, with regenerating mangroves.

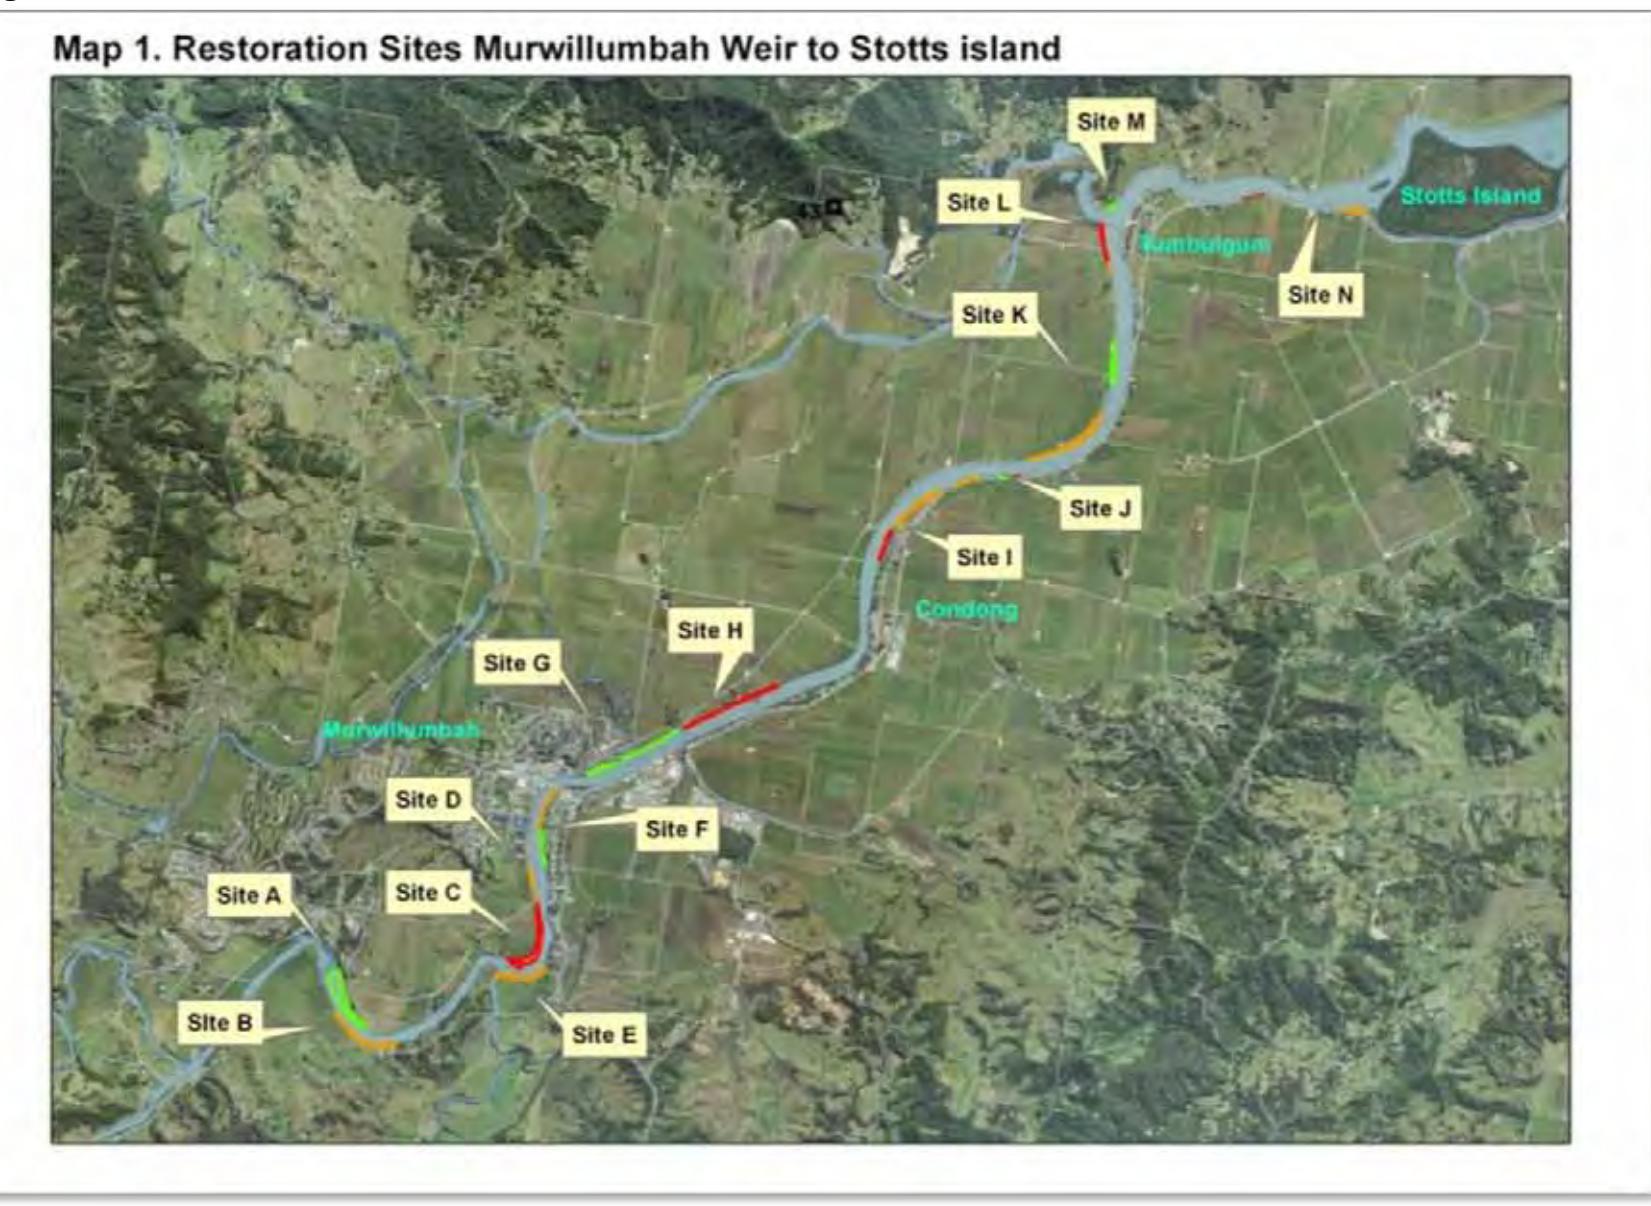
Figure 8. Location of sites referred to in table 5 and 6

Tweed Valley Way, Windmill Corner road reserve (Site N)	Medium- High	480	4800	Downstream sections are vulnerable whilst much of the reach upstream is experiencing severe erosion. Very narrow riparian area along most of Tweed Valley Way. The sites mapped are the only areas with greater than 7m available for planting (accounting for a 3.5m clear zone from road shoulder). Old revetment is providing toe stability, however variable condition is leading to moderate slips. Undercuts are present. Slip and severe erosion near floodgate upstream of site N1. Wide tidal bench upstream of N2/Windmill Corner may permit trial of rock fillets.	\$14,400
Tweed Valley Way Condong (Site J)	Med-Low	415	3700	Bank is vulnerable to erosion along most of Site J, stable where mangroves and cottonwoods are along bank toe, area of severe erosion between flood gates. TSC Road Reserve. Moderate priority due to narrow extent between River and Tweed	\$11,000

Location	Priority	Length	Description	Estimate cost
Philp Parade, South Tweed	Medium- high	200m	Erosion of Terranora Creek bank adjacent to Philp Parade. Bank approx 1.5 m high. Existing revetment has failed. Bank approx 4m from road edge.	\$150,000
Oxley Cove Canal Estate, Banora Point	Medium	60m	Existing rock revetment has failed on the downstream side of entrance to Oxley Cove canal estate. This area has high tidal current and flood flow velocity as well as deep water. Work last undertaken in 2007. Erosion is severe but does not present a safety risk or threaten high value infrastructure or land. Rebuilding the wall will require placement of significant quantities of large rock.	\$50,000
Chinderah Public Foreshore at Hacienda Caravan Park	Medium	200- 300m	Public foreshore in this location is protected by ad-hoc revetment comprised of concrete building waste and rock. Erosion looks bad, but is not severe in terms of the risk posed to public land. Existing revetment provides very poor visual and user amenity, including safety risks from exposed reinforcing steel.	\$200,000

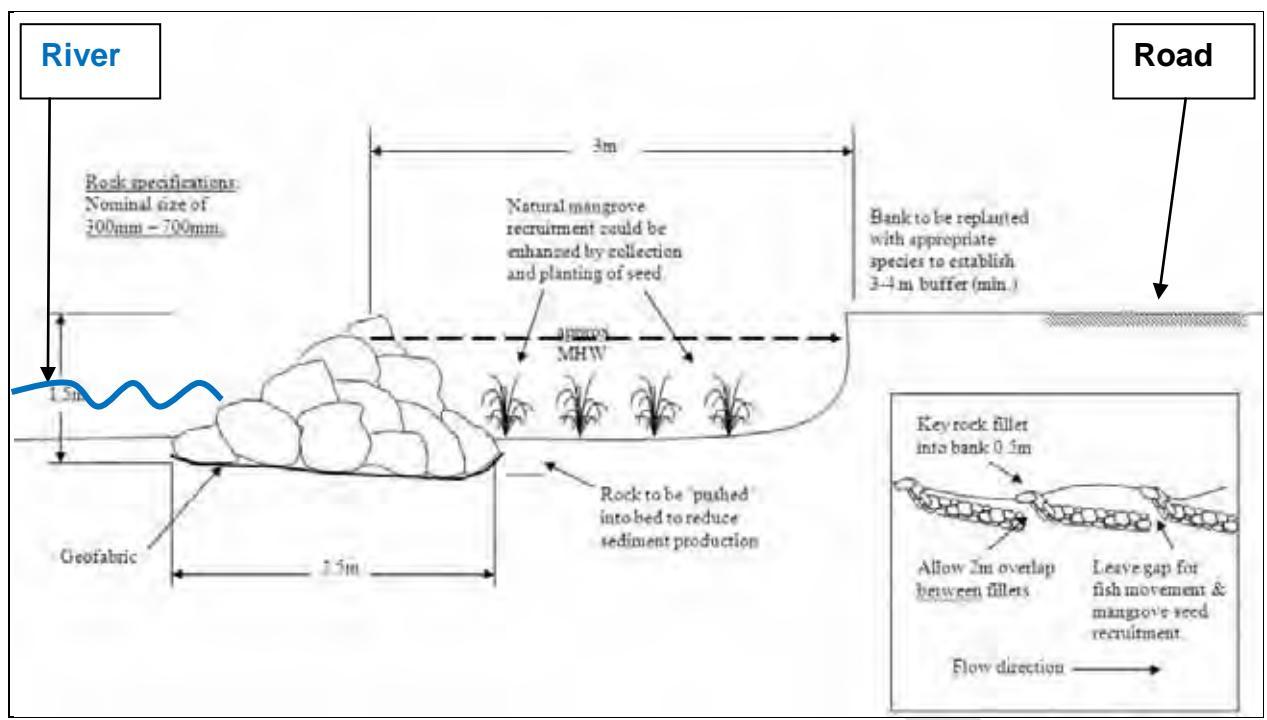
Figure 1. Schematic view of rock fillets including natural and targeted revegetation.

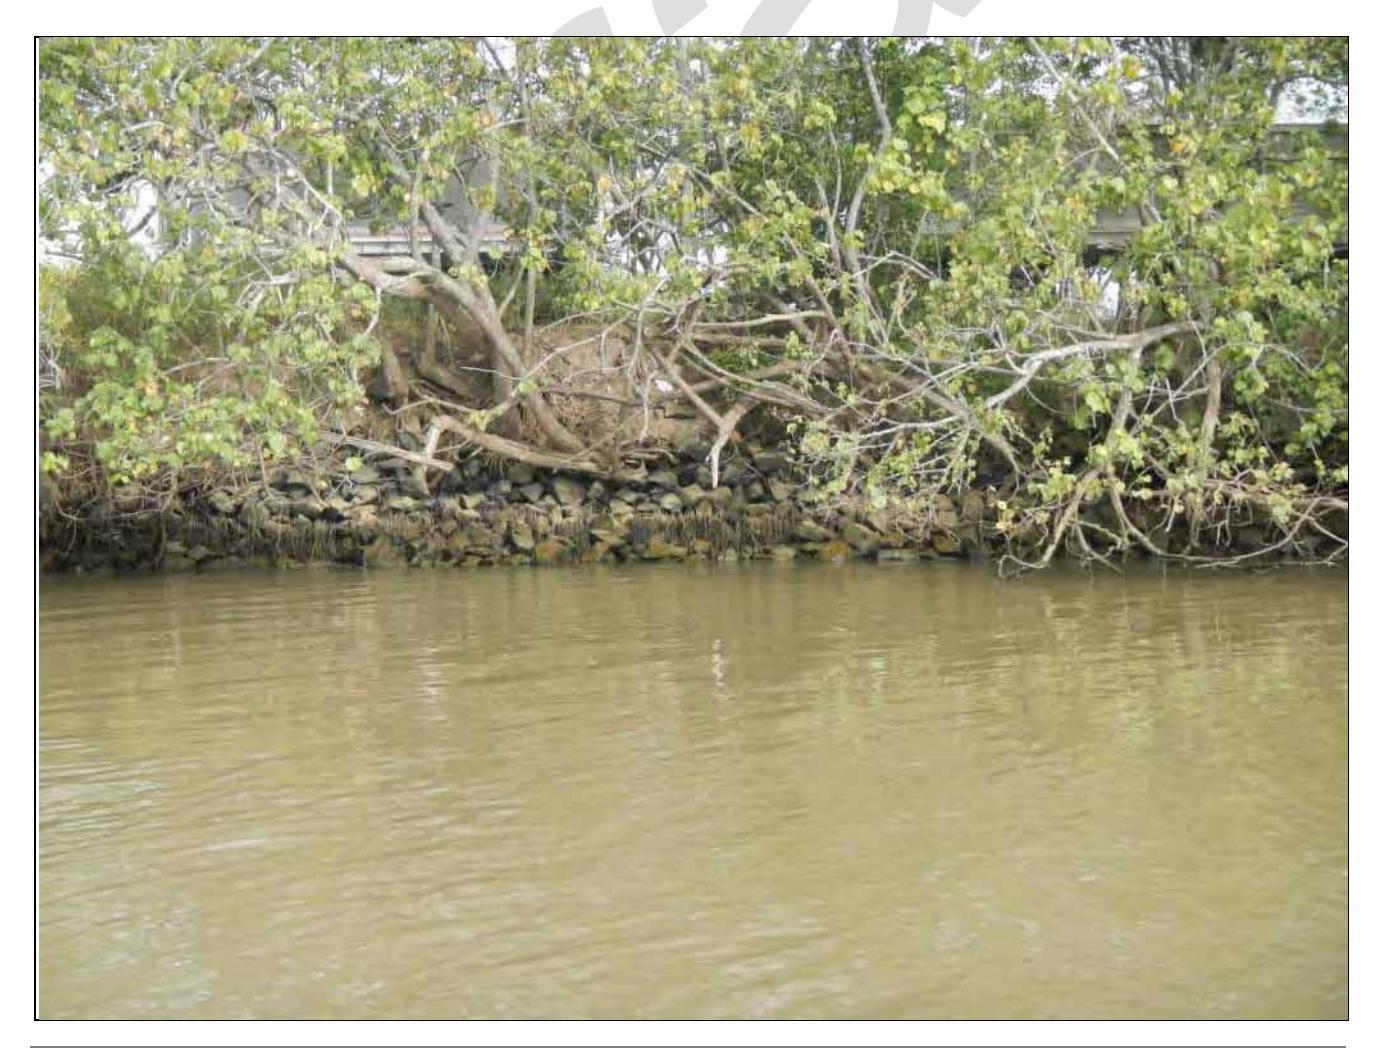
Of particular importance in the existing condition of riverbanks in the priority reach is the presence of significant lengths of old riverbank toe protection. Figure 4 below shows a typical example of this feature. This rock armour is thought to have been constructed during the 1960's and 1970's. The rock armour is situated predominantly at the toe of the riverbank, forming a band approximate 1m high, and was constructed by hand using small (100-300 mm) quarried stone. Where it remains in good condition, this bank protection is significantly increasing bank stability, particularly where it occurs in conjunction with mangroves and top of bank vegetation. Conversely, where it can be seen that the old rock protection has failed or been outflanked, serious bank erosion is occurring.

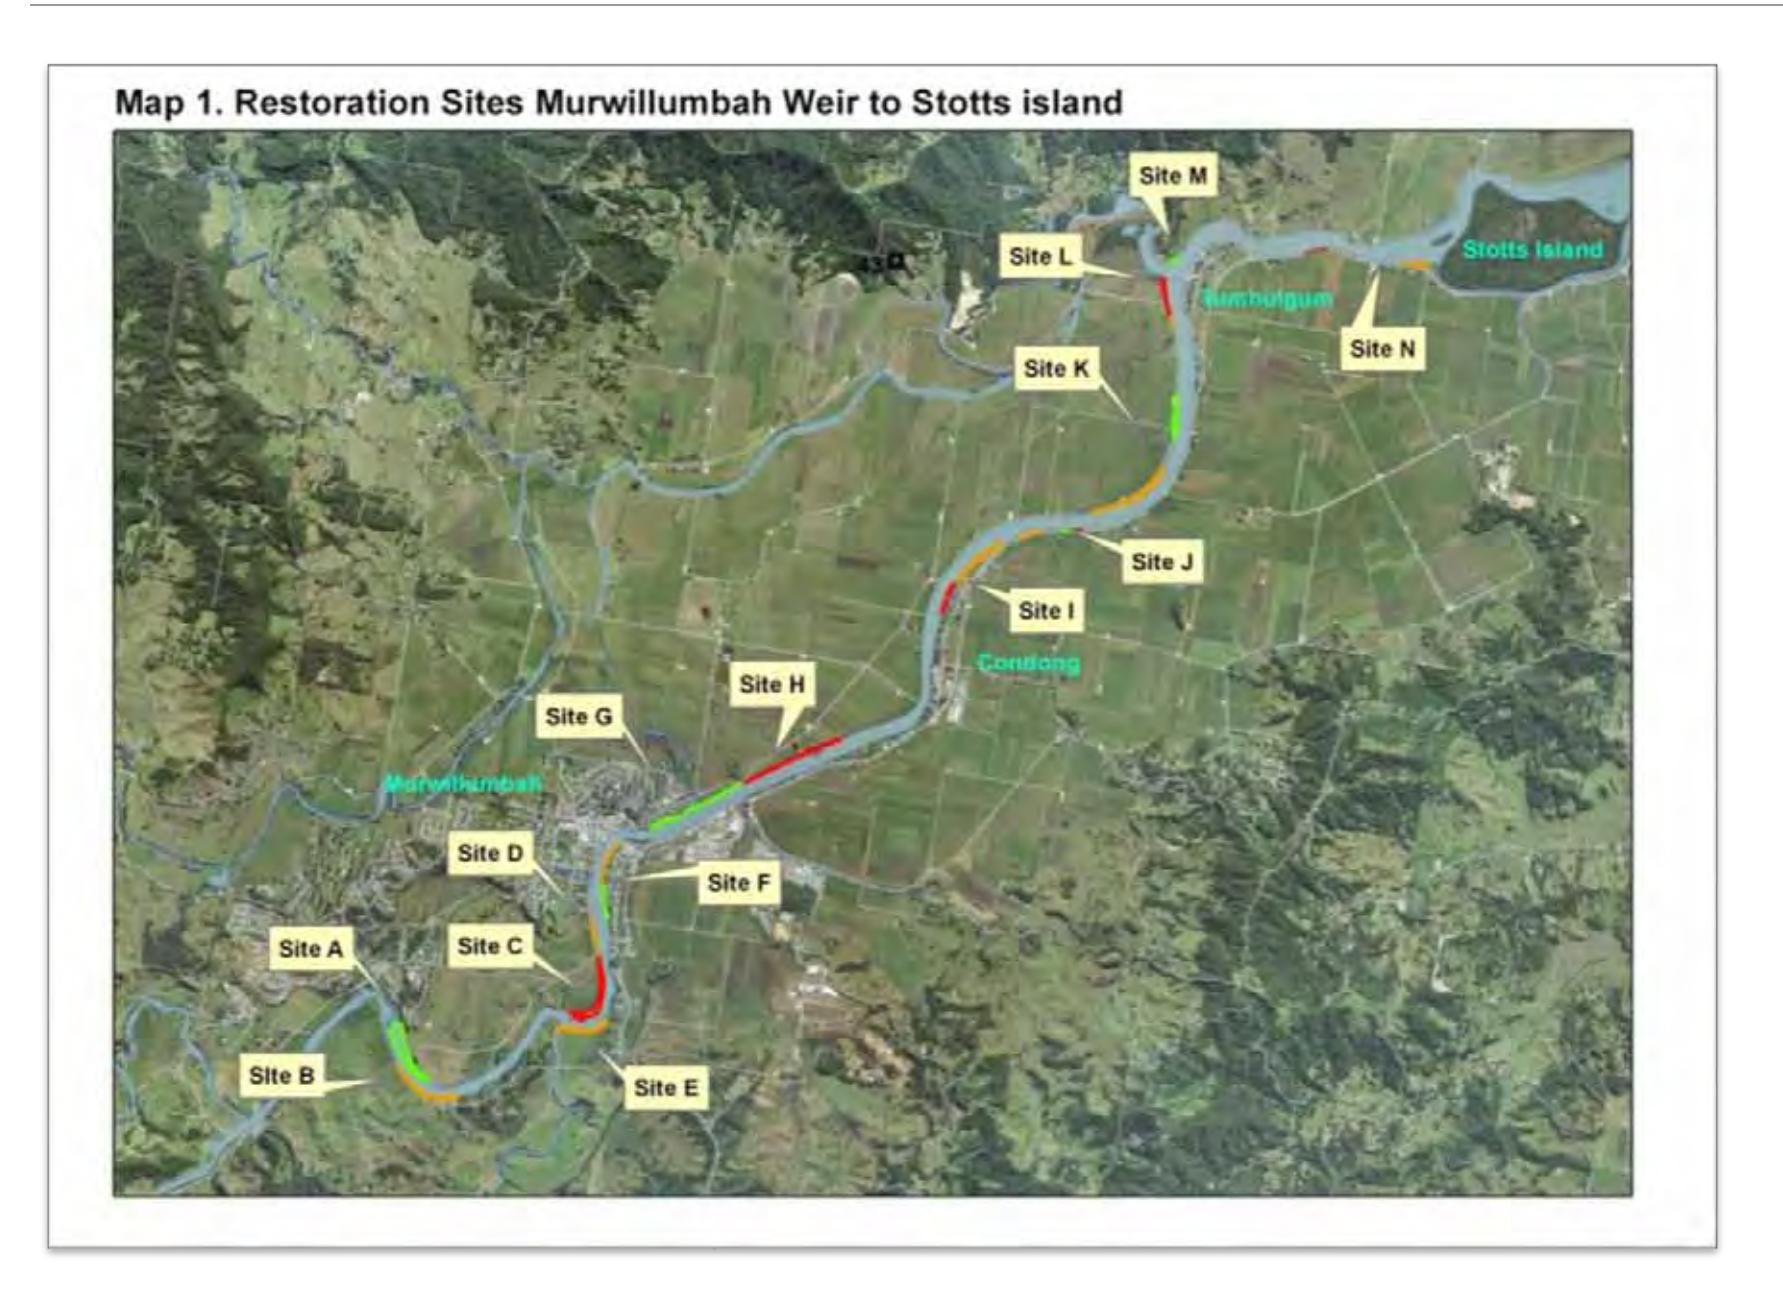
The Tweed River between the weir at Bray Park and Stott's Island was assessed from the water for erosion risk in August 2013 to inform the Tweed Riverbank Management Plan. Figure 1 summarises the erosion risk and bank condition for both left and right banks of the river from field observations and associated data collection.

Erosion risk	Severe/high risk	Vulnerable	Generally Stable
Length of bank (both banks	9,207m	10,381m	16,267m
combined = $35,855m$)

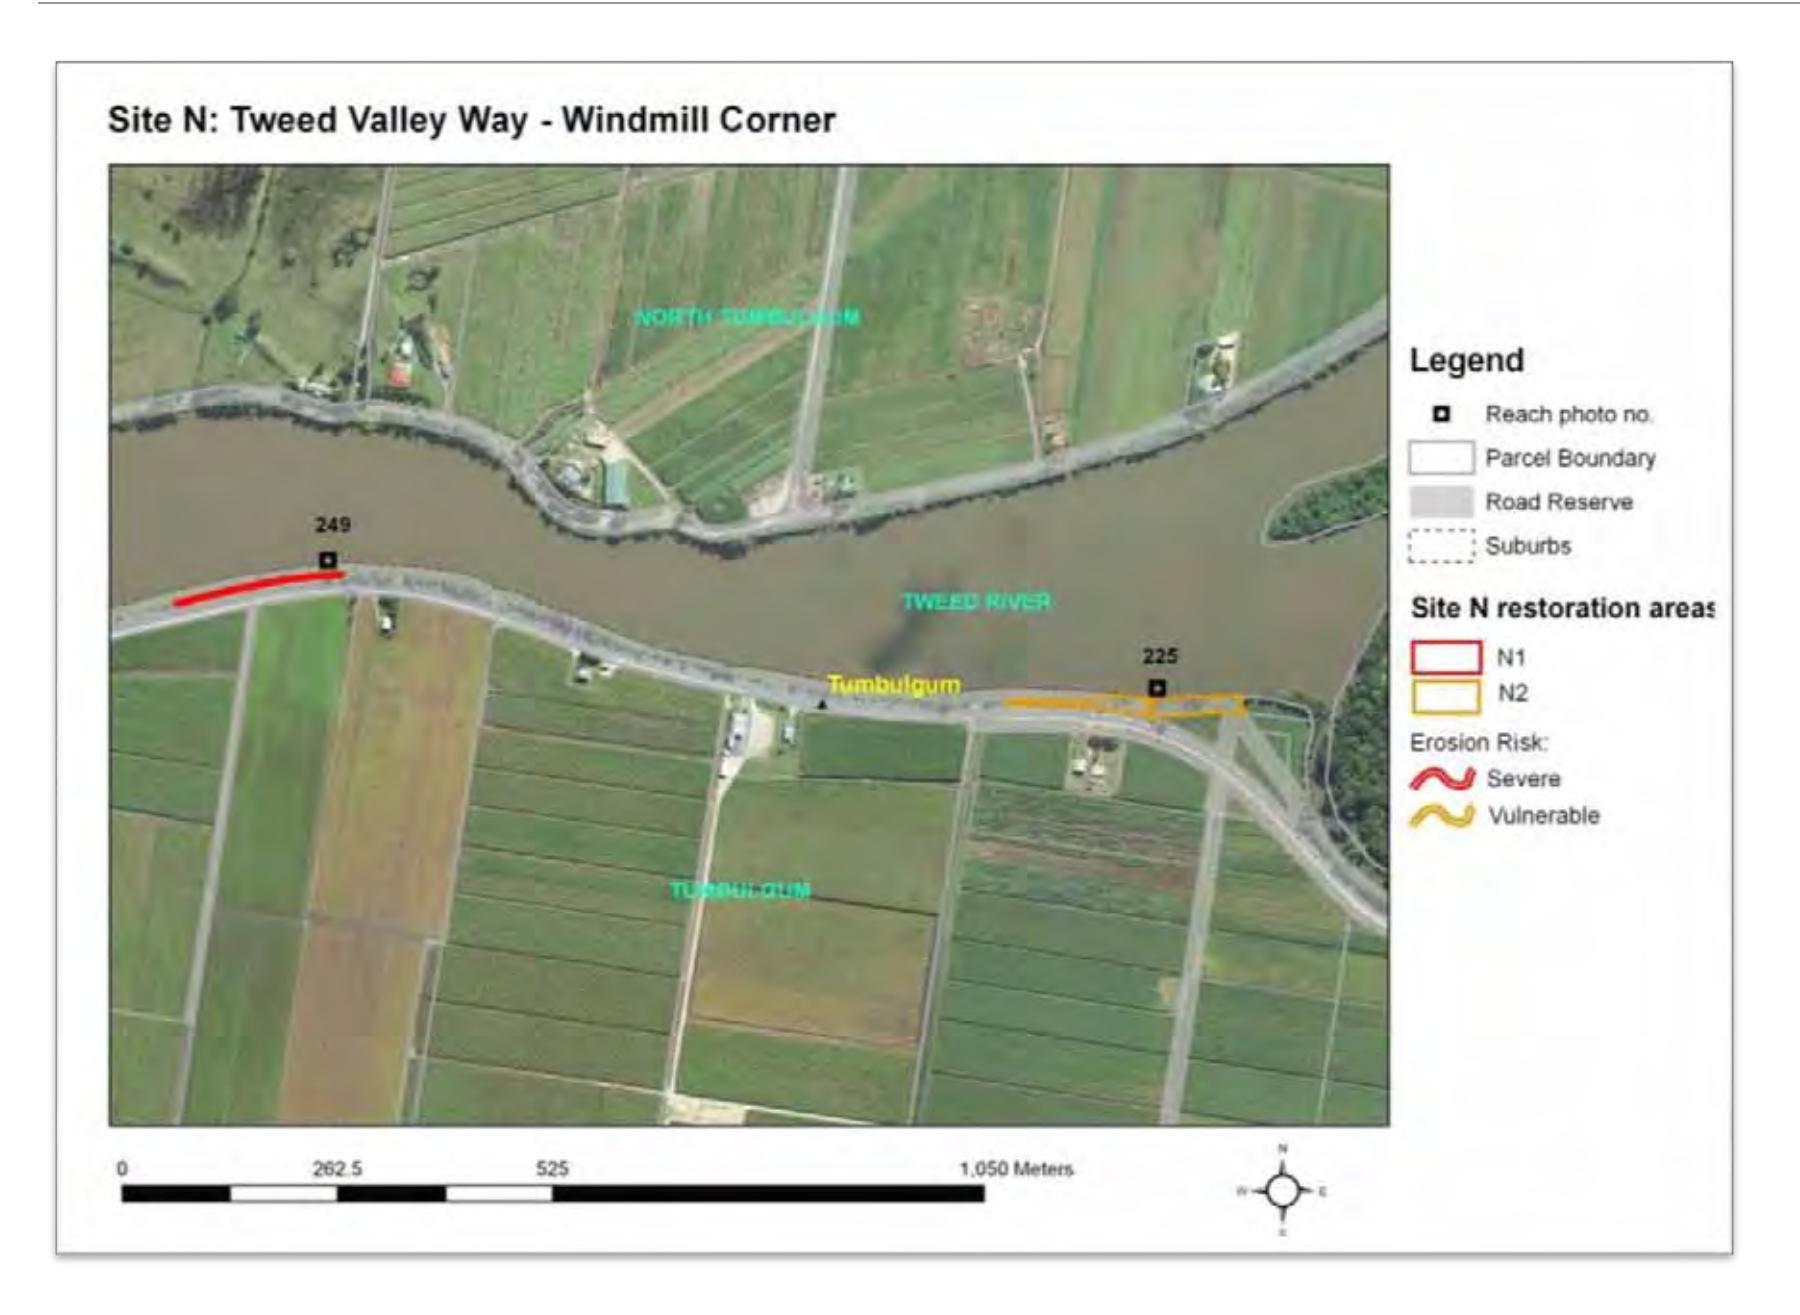
Site N - Bank Restoration Activities

Length (m)	480 (combined)
Width (m)	7-20
Area m ²	4825
Bank height (m)	<2-4
Erosion Risk	Bank is very susceptible to erosion; downstream sections are vulnerable whilst much of
	the reach upstream is experiencing severe erosion.
Tenure	Road Reserve
Restoration potential	Medium - High. High potential at Windmill Corner, more difficult on upstream section due
	to narrow width of riverbank between river and Tweed Valley Way.
Constraints/opportunities	• Very narrow riparian area along most of Tweed Valley Way. The sites mapped are
	the only areas with greater than 7m available for planting (accounting for a 3.5m
	clear zone from road shoulder).
	Old revetment is providing toe stability, however variable condition is leading to
	moderate slips. Undercuts are present.
	 Slip and severe erosion near floodgate upstream of site N1.
	 Wide tidal bench upstream of N2/Windmill Corner may permit trial of rock fillets.
