Impact of Wake on Tweed River Bank Erosion Study

For: Tweed Shire Council

JANUARY 18, 2012

Project Name:	Impact of Wake on Tweed River Bank Erosion Study
Project Number:	3001906
Report for:	Tweed Shire Council

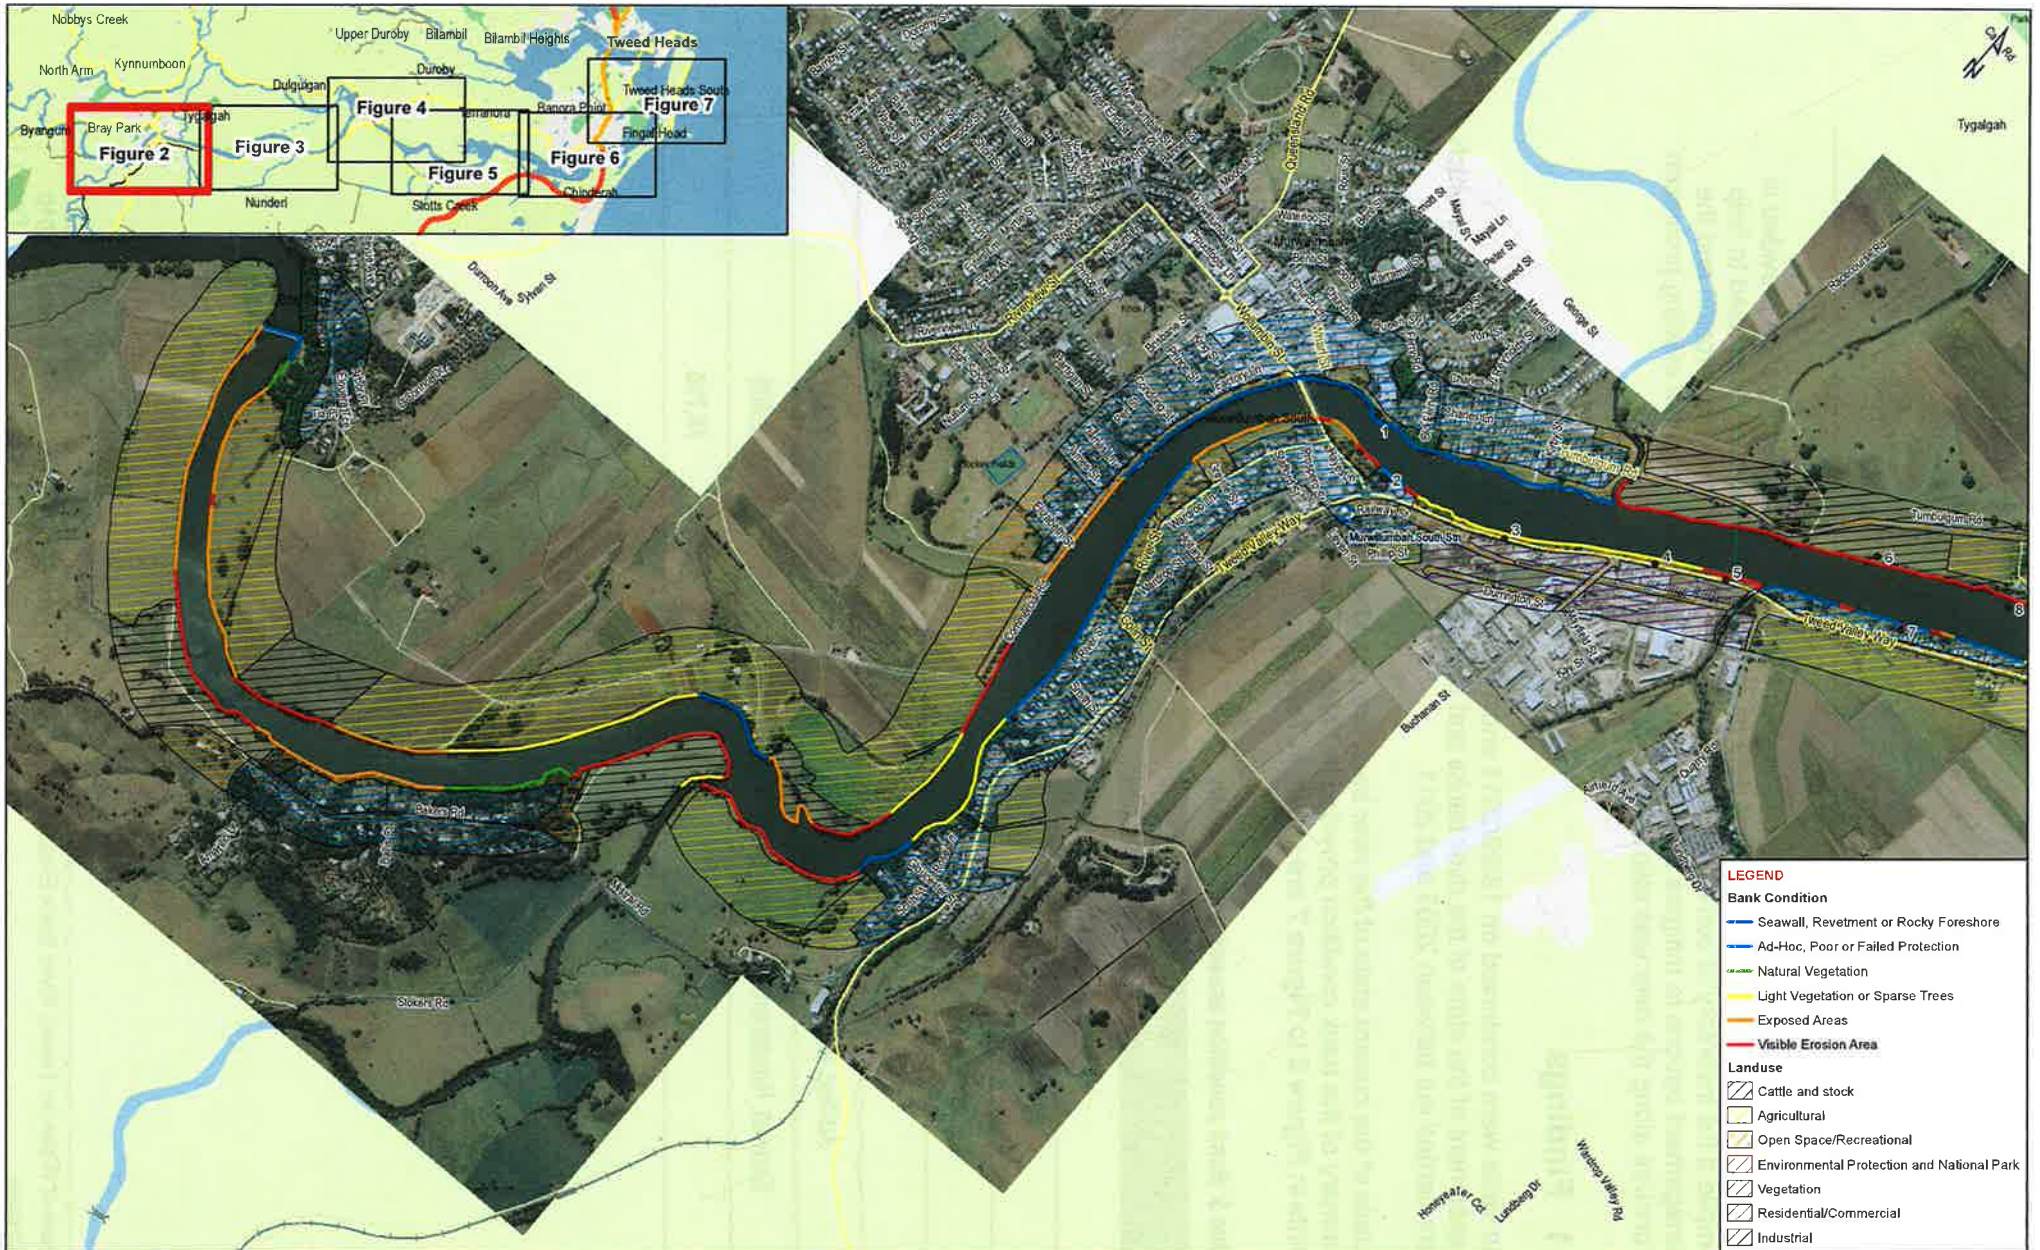
FIG NO. Figure 2

Details of the current state of the river bank are provided in **Figure 2** to **Figure 7** with a summary of the bank condition provided in **Table 3**. Comments relating to the numbered points in **Figure 2** to **Figure 7** are shown in **Table 4**.

FIGURE TITLE Field Map of the Tweed River around Murwillumbah

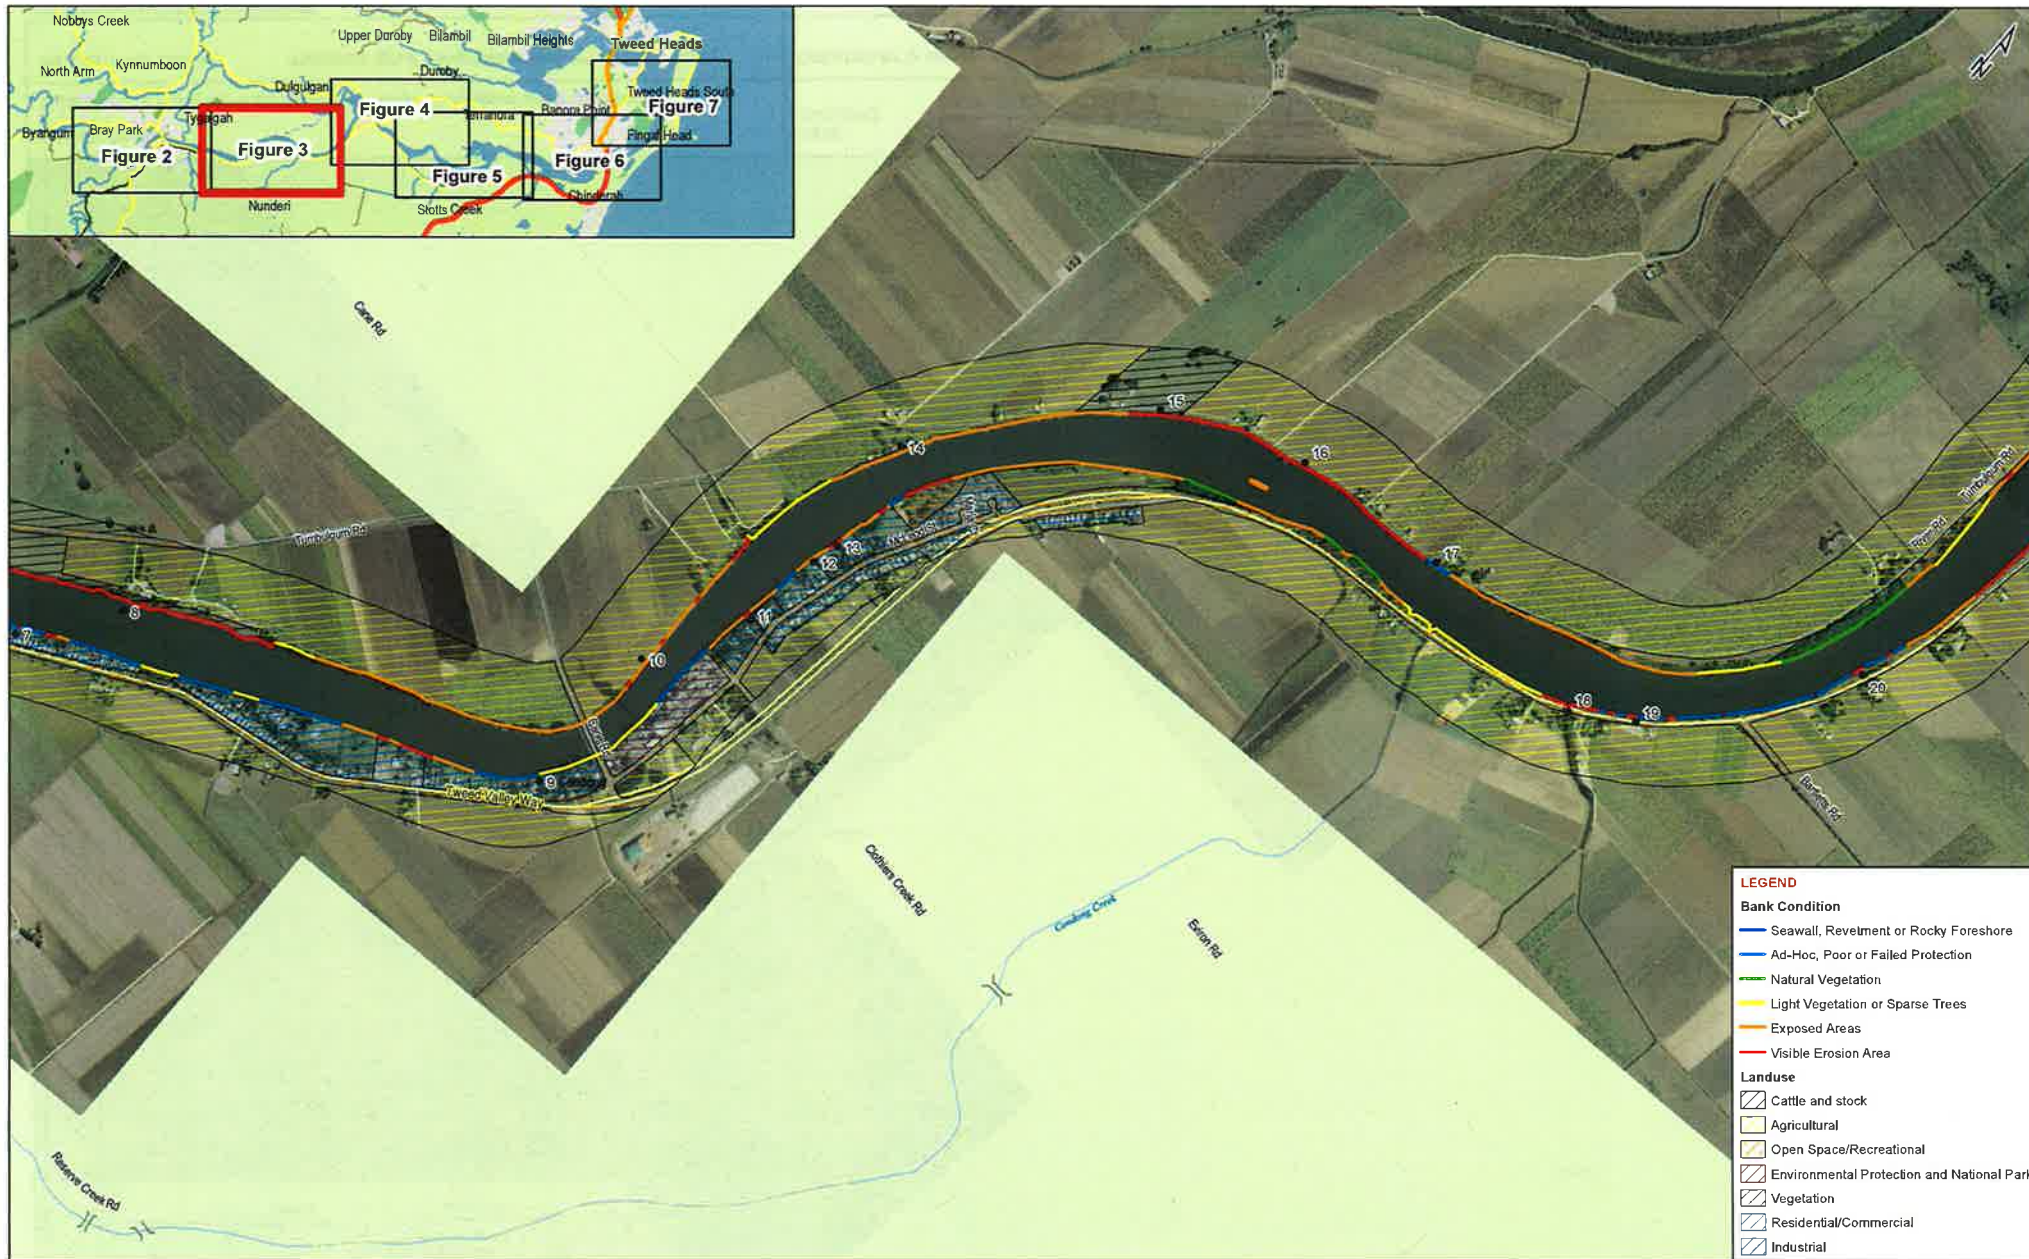
FIG NO. Figure 3

FIGURE TITLE Field Map of the Tweed River around Condong

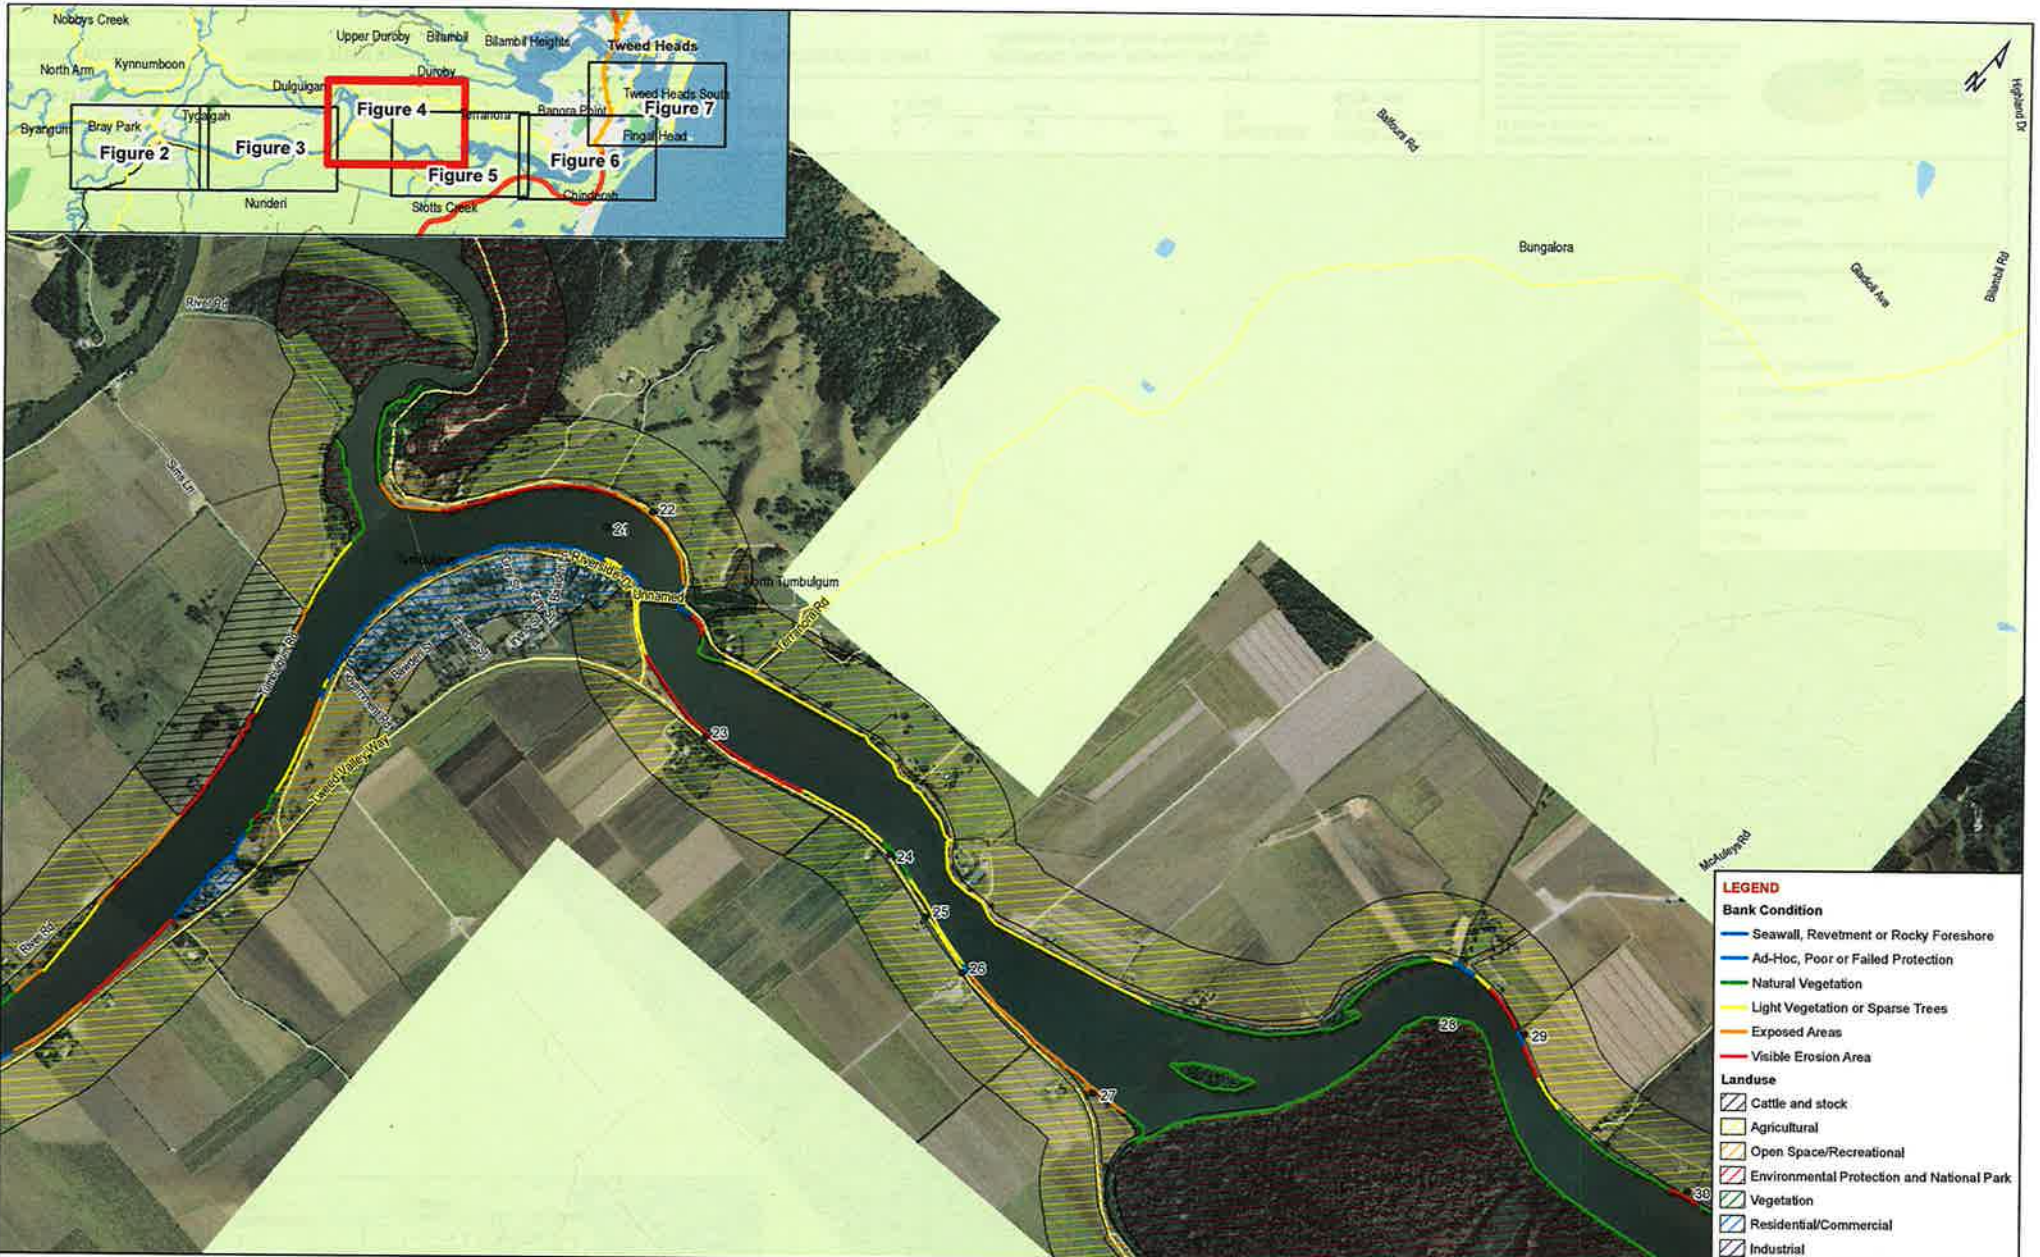
FIG NO. Figure 4
FIGURE TITLE Field Map of the Tweed River around Tumbulgum and Stotts Island
PROJECT NO. 3001906 **PROJECT TITLE** Tweed Heads Bank Wake Erosion Study

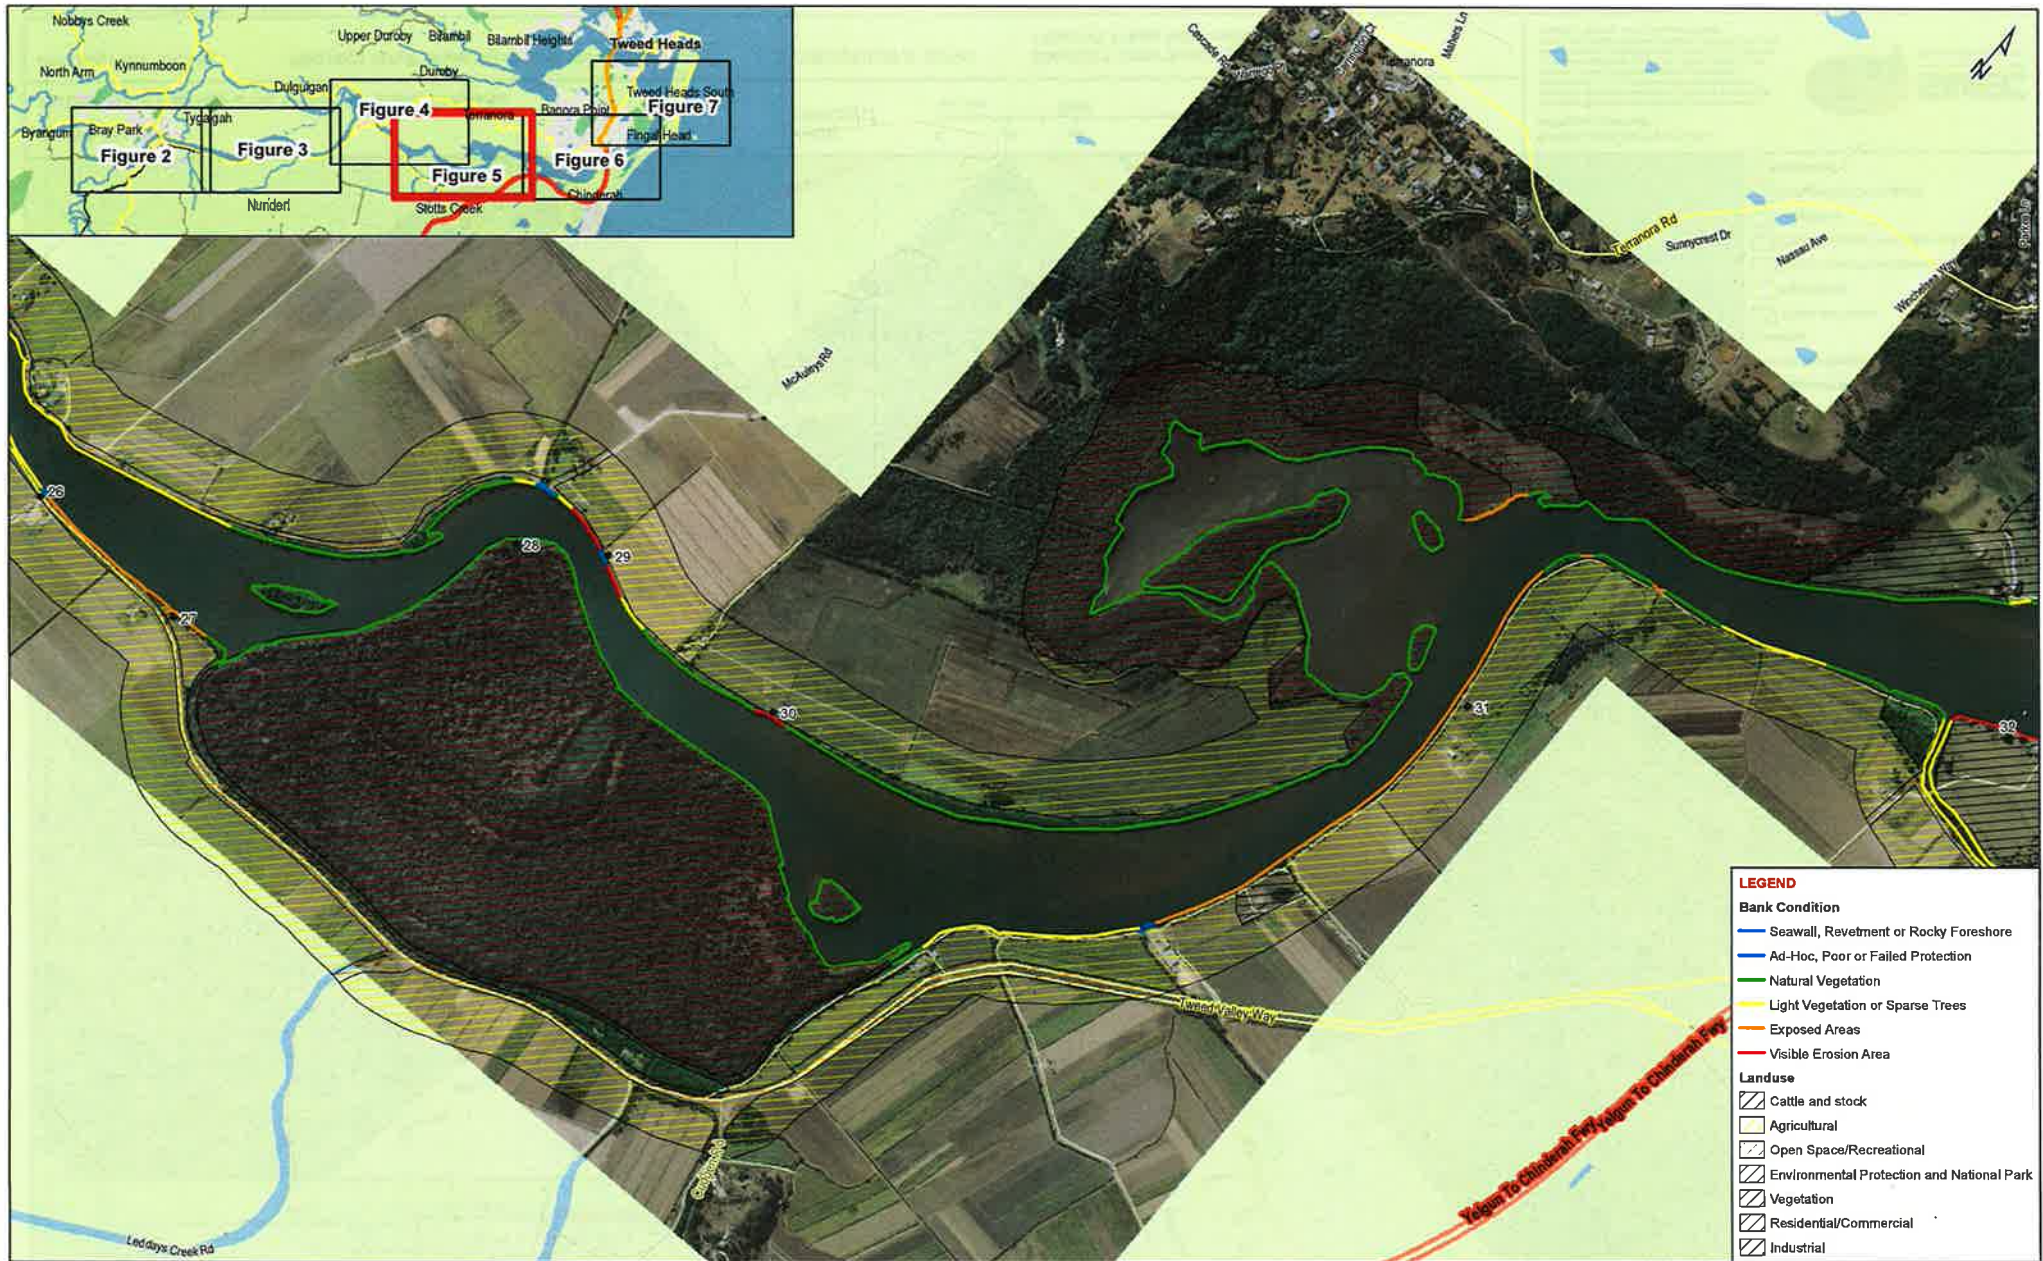
FIG NO. Figure 5
FIGURE TITLE Field Map of the Tweed River around Stotts Island and Tweed Broadwater

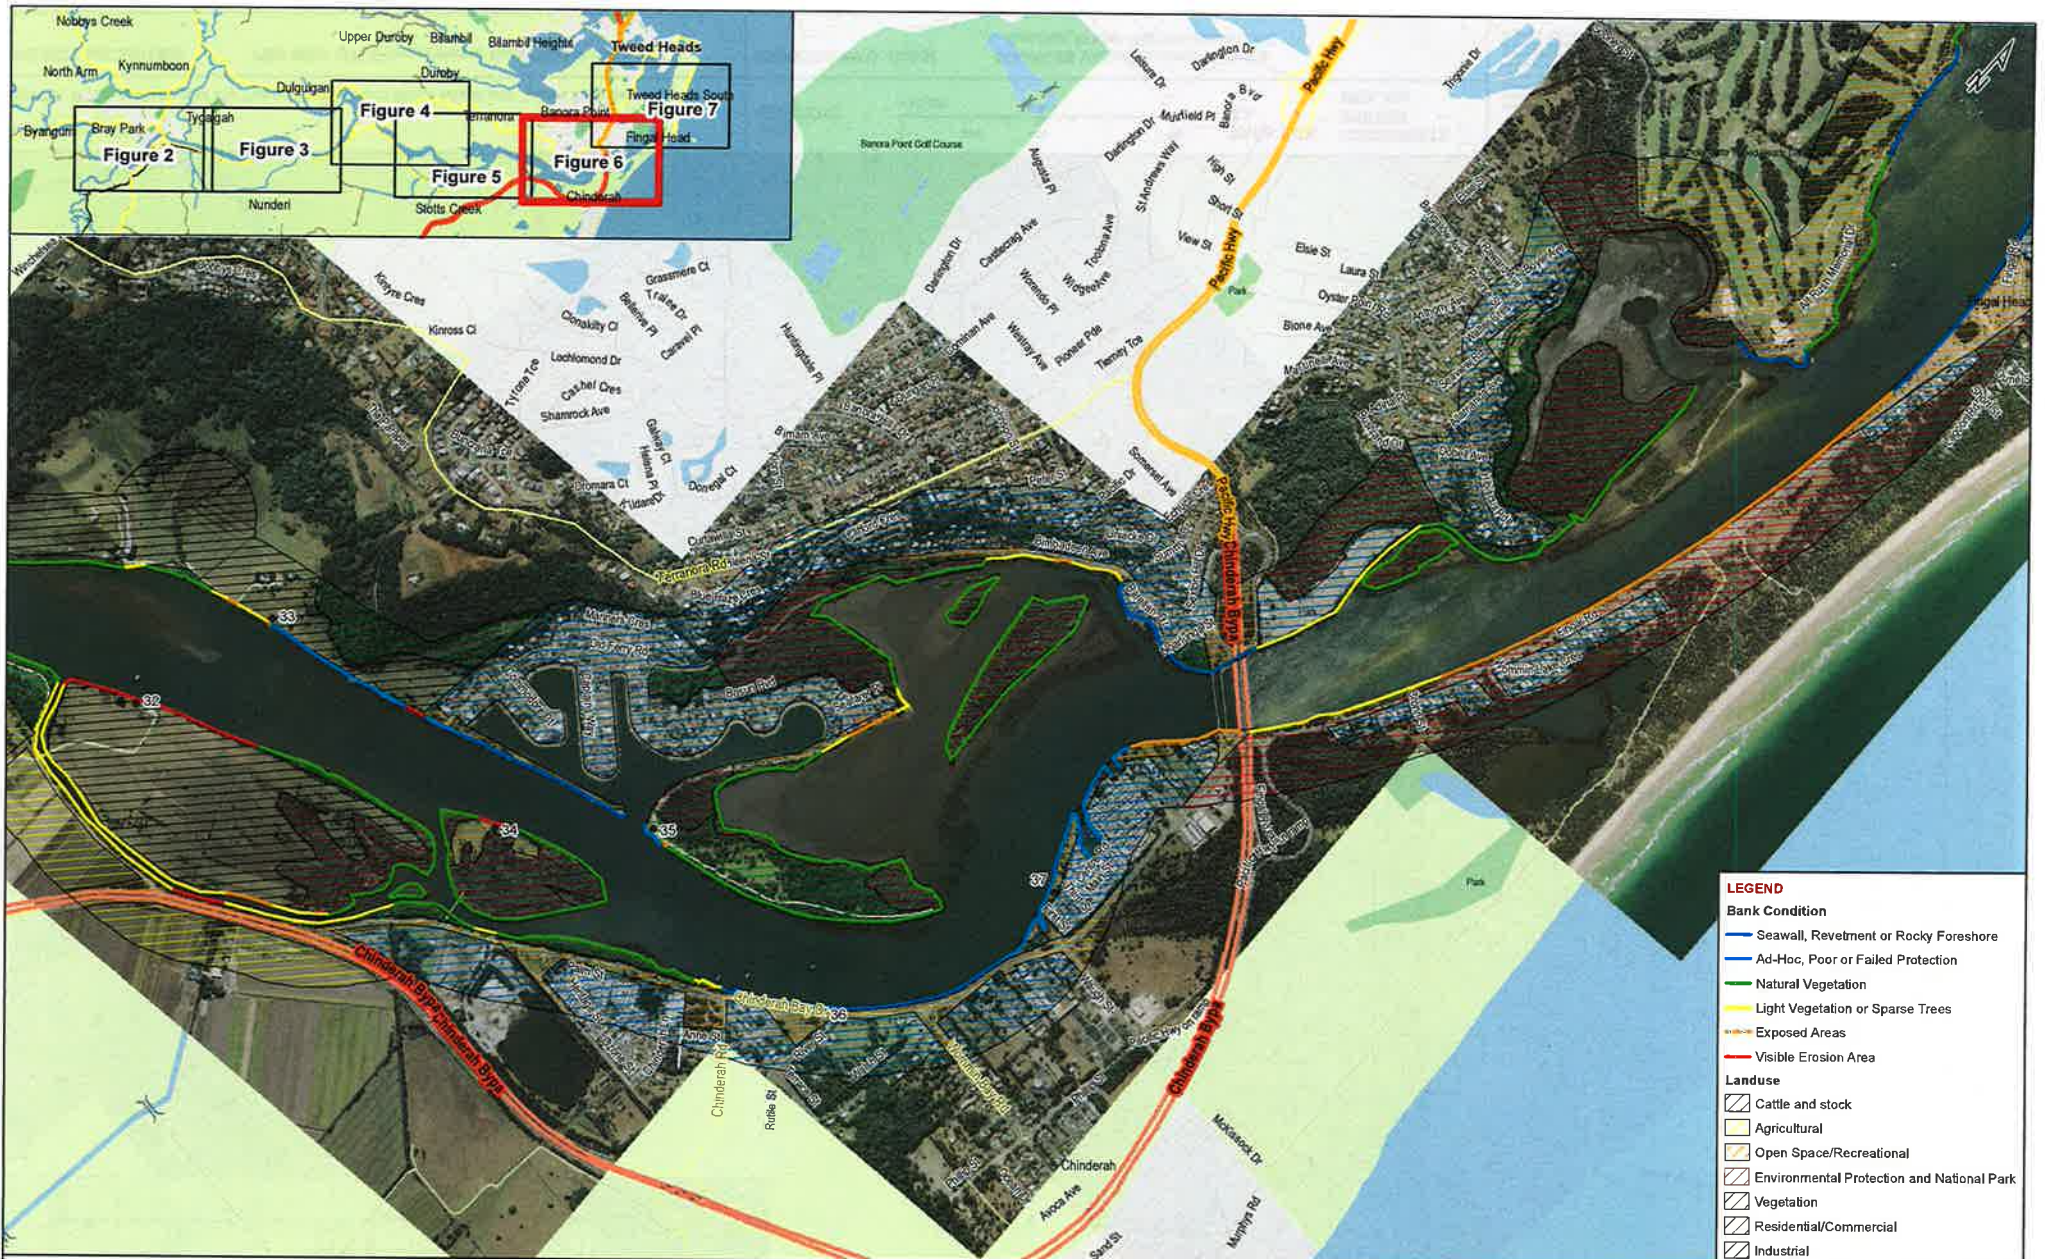
FIG NO. Figure 6

FIGURE TITLE Field Map of the Tweed River around Chinderah

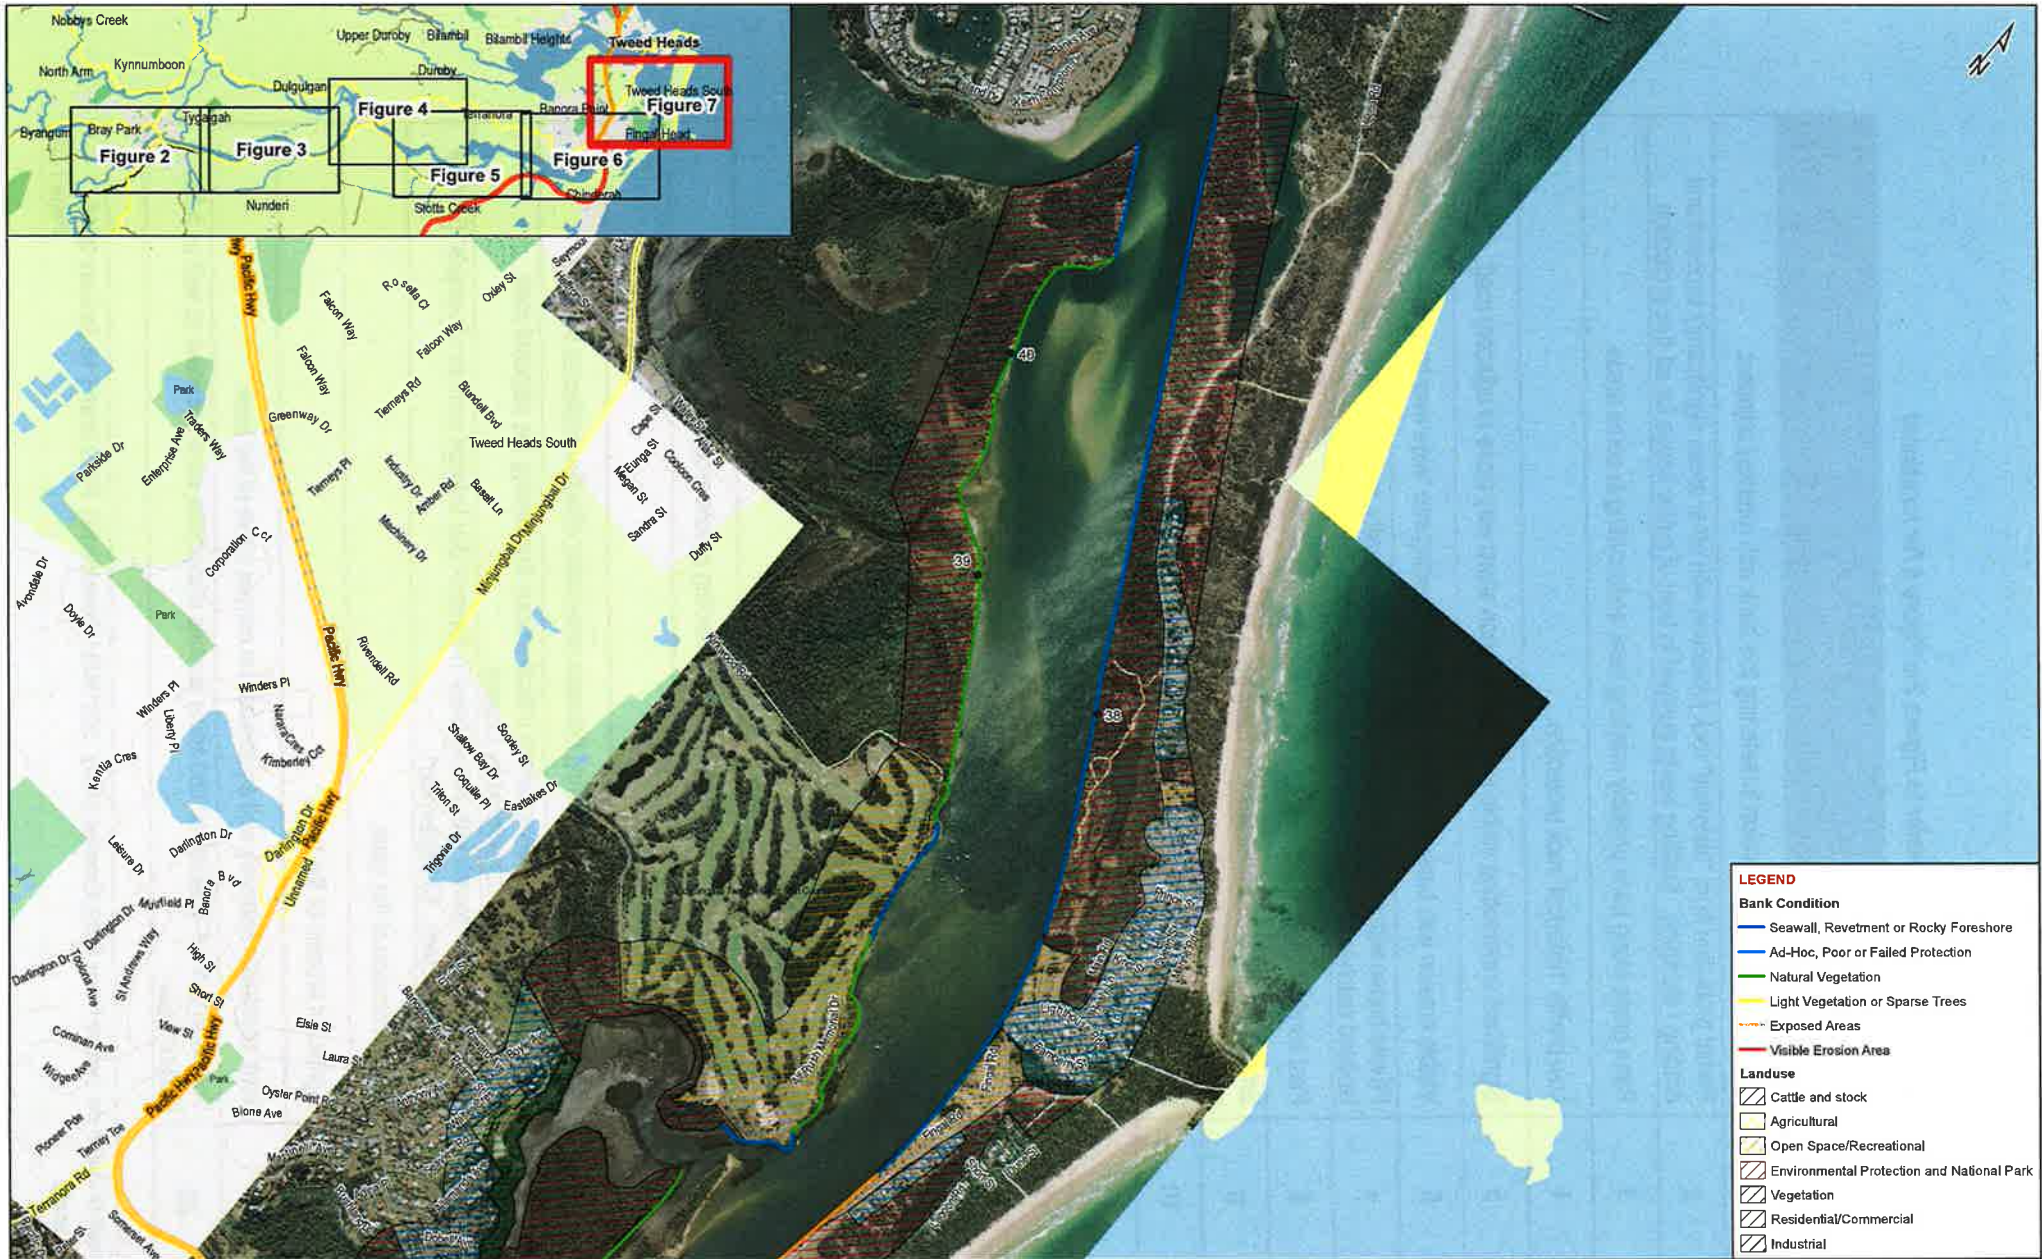
FIG NO. Figure 7
FIGURE TITLE Field Map of the Lower Tweed River up to Terranora Creek
PROJECT NO. 3001906 **PROJECT TITLE** Tweed Heads Bank Wake Erosion Study

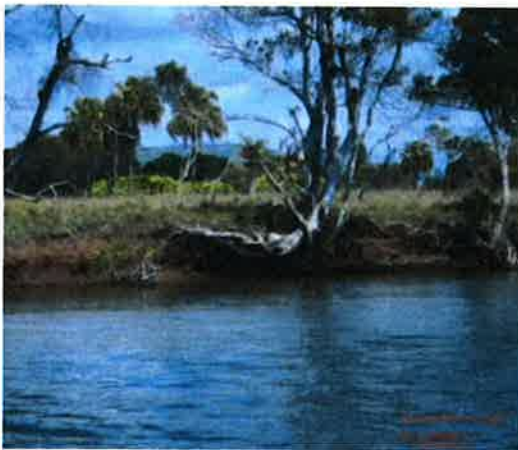
In areas of erosion at the toe of a steep slope, construction of a low crested rock revetment at the bottom of the bank can be an effective option. Designs can be to allow mangrove seedlings to grow amongst the gaps between the rocks (Figure 28 and

Figure 28 Undercutting at Tweed River (left) and possible solution from DECCW, 2009 (right)**

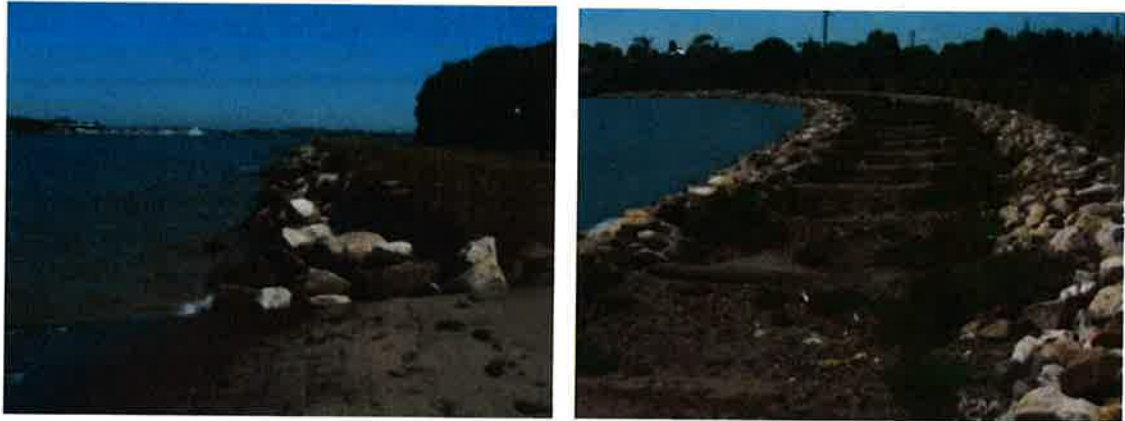
Figure 32 Moderate erosion along low bank (left) and possible solution* e.g. Claydon Reserve at Kogarah bay from DECCW, 2009 (right)

In areas of moderate erosion in low embankment height e.g. along parks and open space areas, a step seawalls with mangrove or saltmarsh benches can be an effective solution (Figure 32).

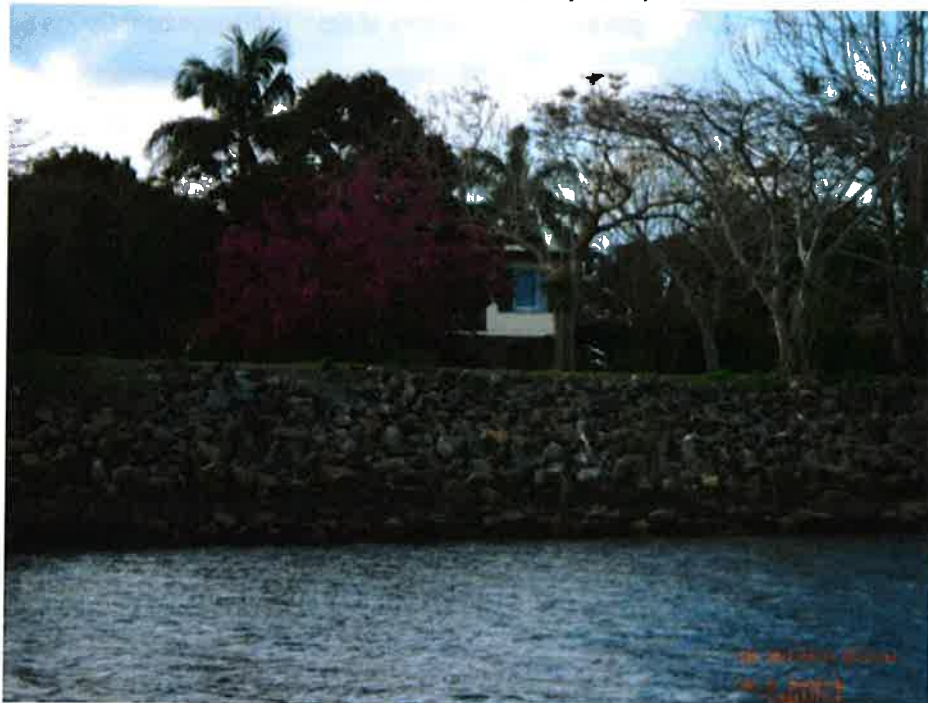
Figure 33 Well designed rock revetment (Tweed River)

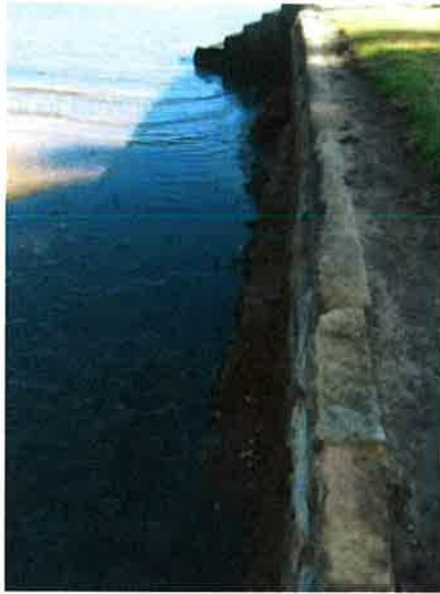
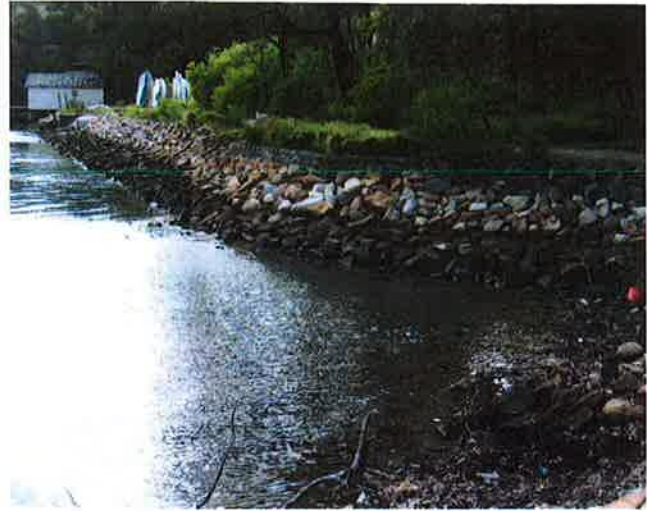
Figure 37 Vertical seawall (left) and possible improvement from DECCW, 2009 (right)

In front of vertical seawalls such as concrete or brick walls, a sloped rock revetment could be constructed to create more habitat for marine organisms and to reduce wave reflections (**Figure 37**).

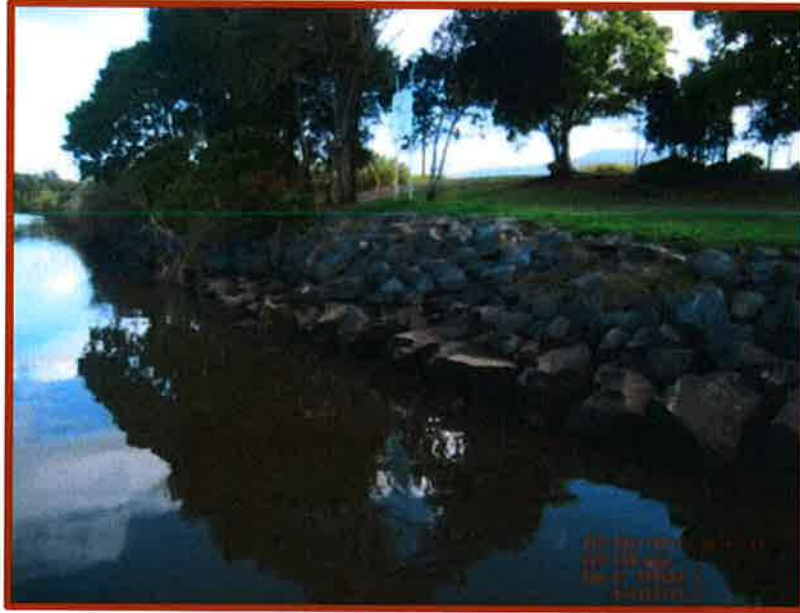
Figure B17 *Revetment adjacent to boat ramp at upstream end of Commercial Road*

It is recommended that the foreshore along Commercial Road be monitored for signs of erosion. The downstream section of foreshore at Commercial Road is very steep but appears to be stable. This area should be monitored for undercutting of the banks. Should this occur, additional rock toe protection may be required. Areas experiencing erosion at present should be repaired and planted with fringing vegetation.

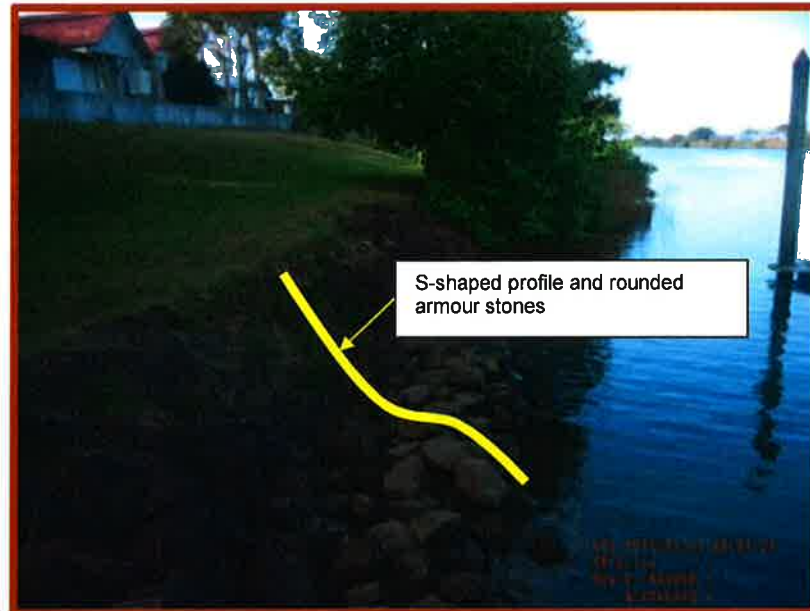
Figure B18 Revetment at Heritage Wharf

Bank erosion was observed on both the upstream and downstream sides of the revetment.

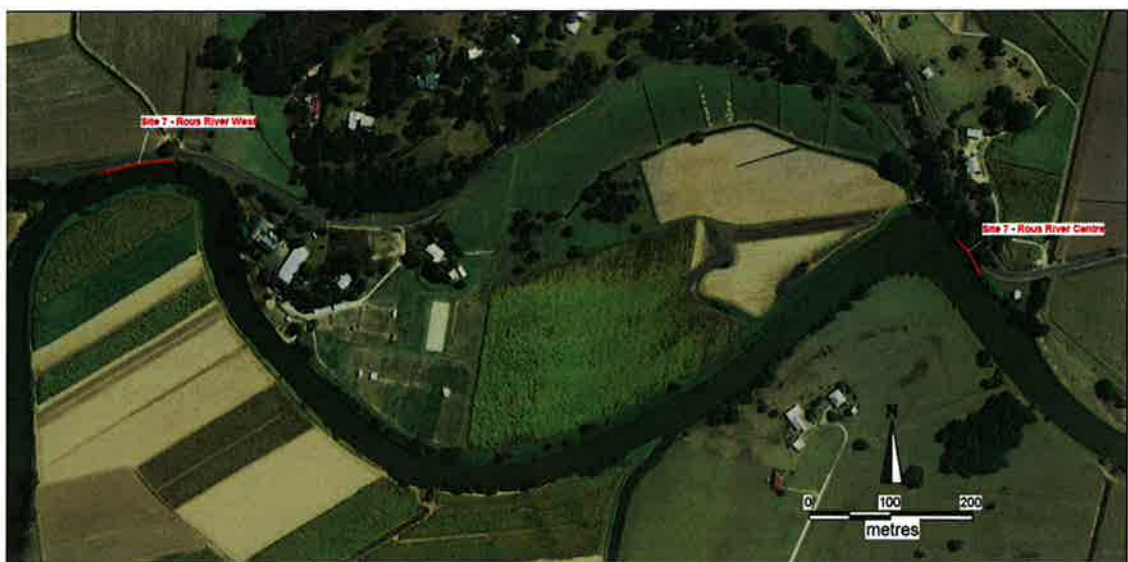
Figure B19 Road embankment protection at Rous River

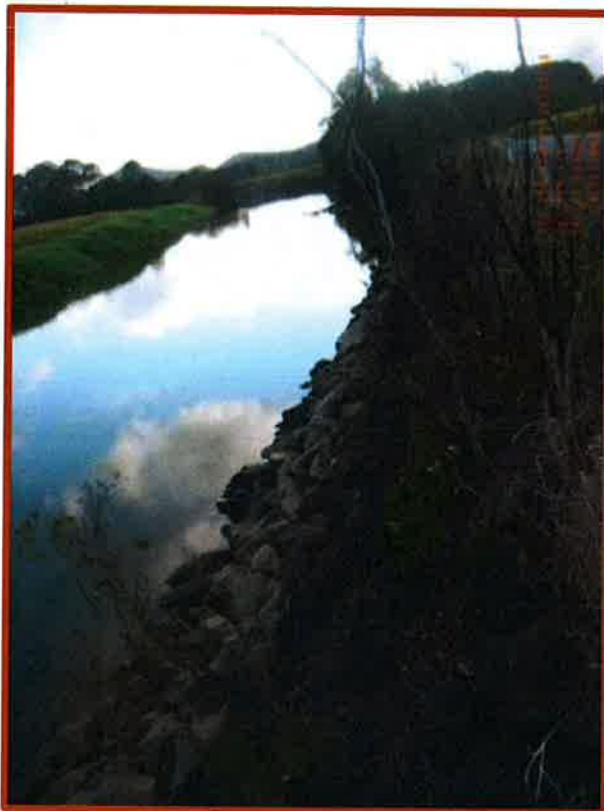
A revetment has been constructed along the road embankment at the upstream section of Rous River, shown in Figure B20. This revetment appeared to be in good condition and was effective in protecting the road embankment against meandering of the river channel.

Figure B20 Revetment along road embankment – Rous River (west)

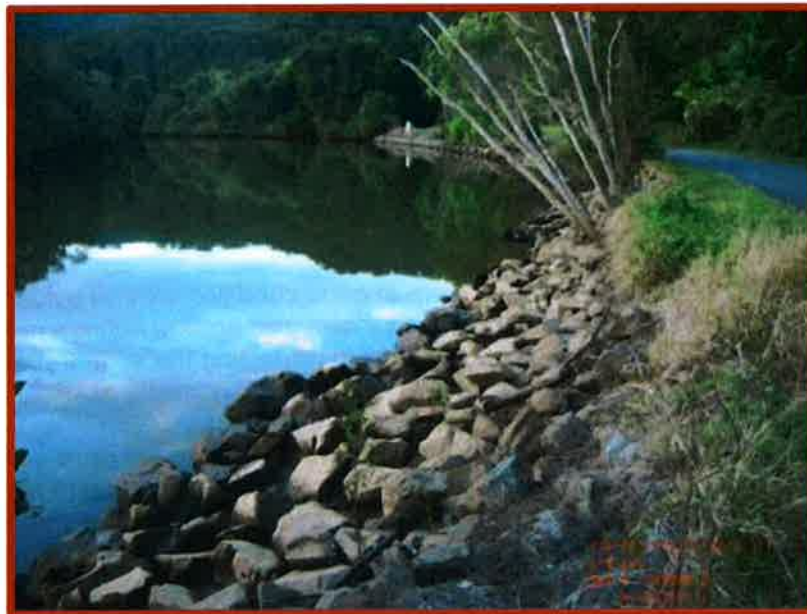
Figure B22 Revetment at downstream end of Rous River

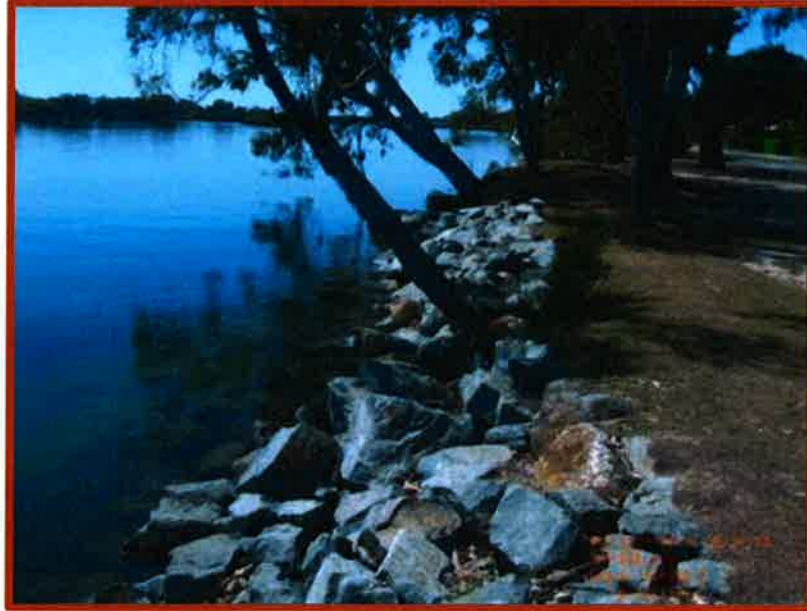
The newly constructed sections were in good condition with no evidence of deformation, slumping or other damage. Rock armour size was around 400mm median diameter. These sections seemed to be successful in protecting the large trees along the foreshore (Figure B24).

Figure B24 *Philp Parade, with newly constructed revetment*

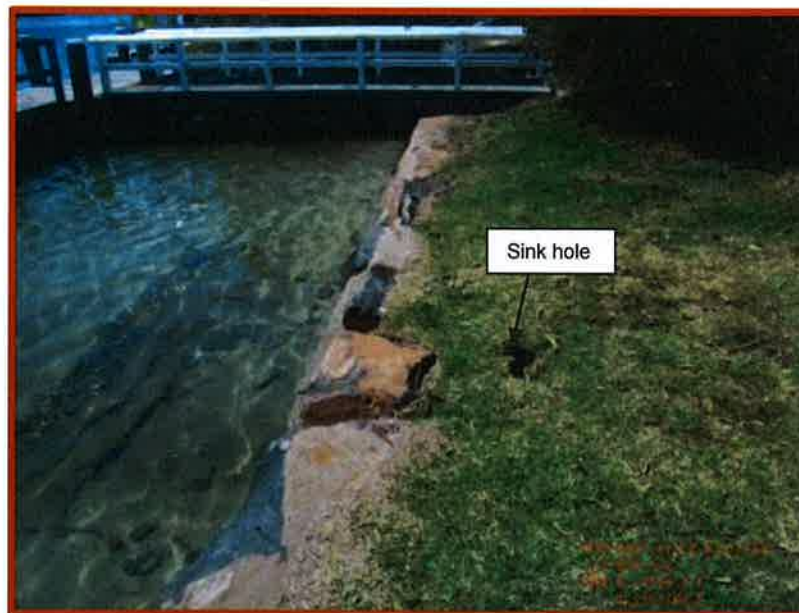
The vertical seawall appeared to be newly constructed and in good condition, with a beach area located on the seaward side. This area was used as a boat launching area for recreational sailing. Some sinkholes have formed behind the seawall, possibly due to inundation of this area during abnormally high tides (Figure B26).

Figure B26 Vertical seawall adjacent to boat shed

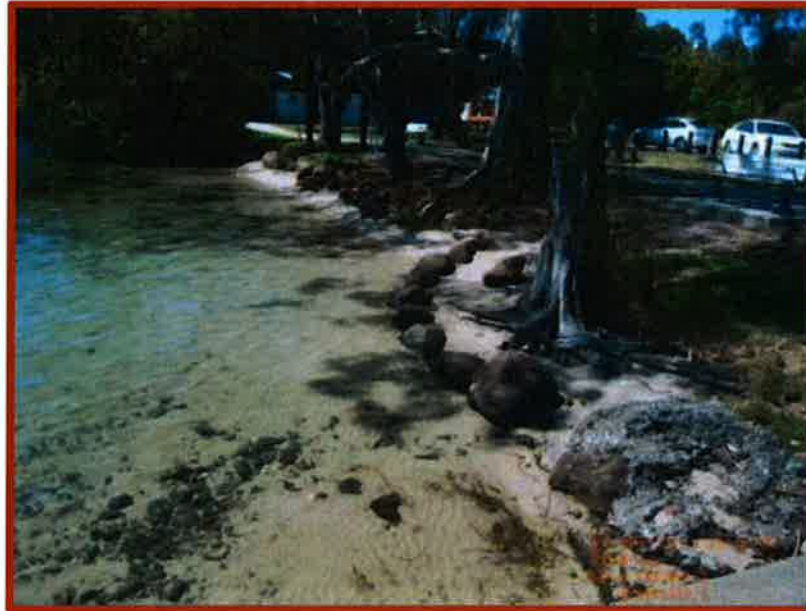
The revetment works west of the boat shed and east of the boat ramp appeared to be largely ineffective, except for a section adjacent to a stormwater outlet. Minor erosion appeared to be occurring in some areas, due to overtopping of the revetments and lack of geofabric (Figure B27).

Figure B27 Rock protection for trees east of boat ramp at Dry Dock Road

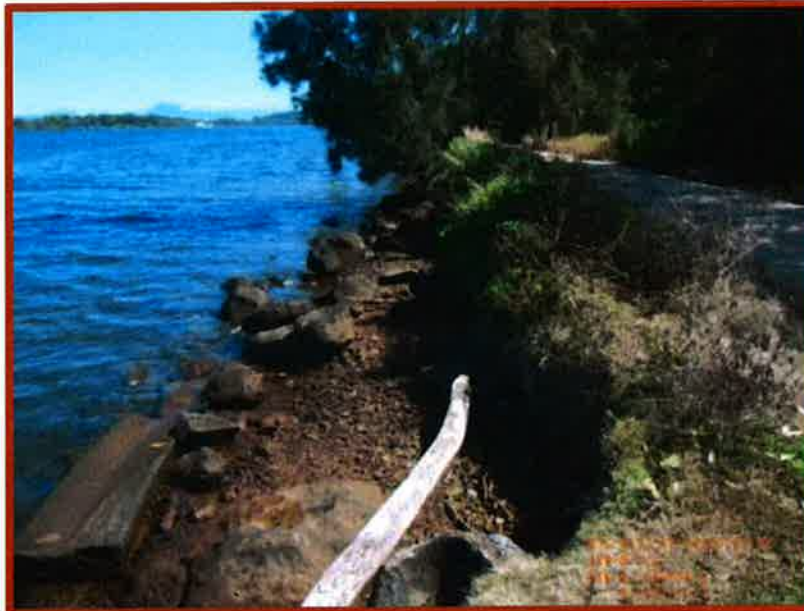
Figure B30 Severe erosion at upstream side of revetment at old Ferry Road
