Impact of Wake on Tweed River Bank Erosion Study

For: Tweed Shire Council

JANUARY 18, 2012

Project Name:	Impact of Wake on Tweed River Bank Erosion Study
Project Number:	3001906
Report for:	Tweed Shire Council

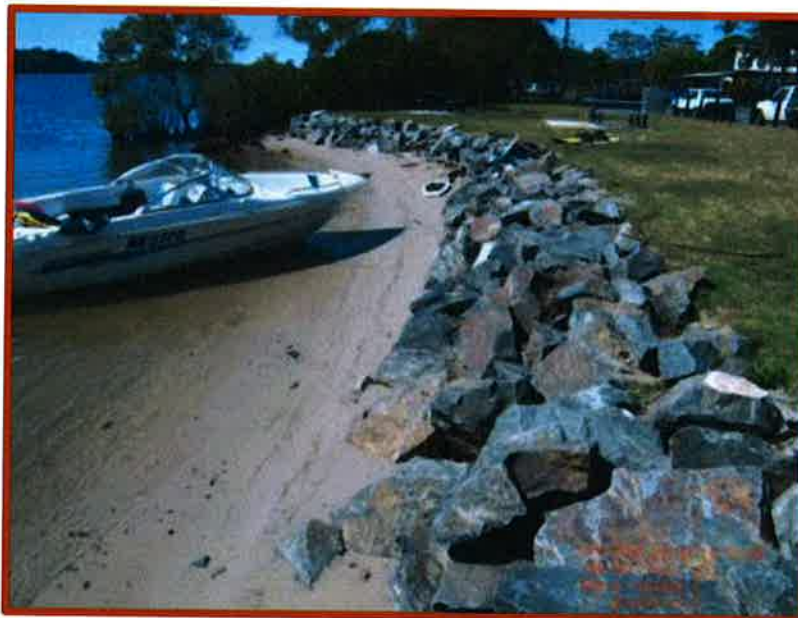
The newly constructed revetment sections at the western end of the Chinderah foreshore were observed to be in good condition, with no evidence of damage (Figure B32). However, the presence of the rocks has made access to the foreshore difficult.

Figure B32 Typical new revetment section, Chinderah

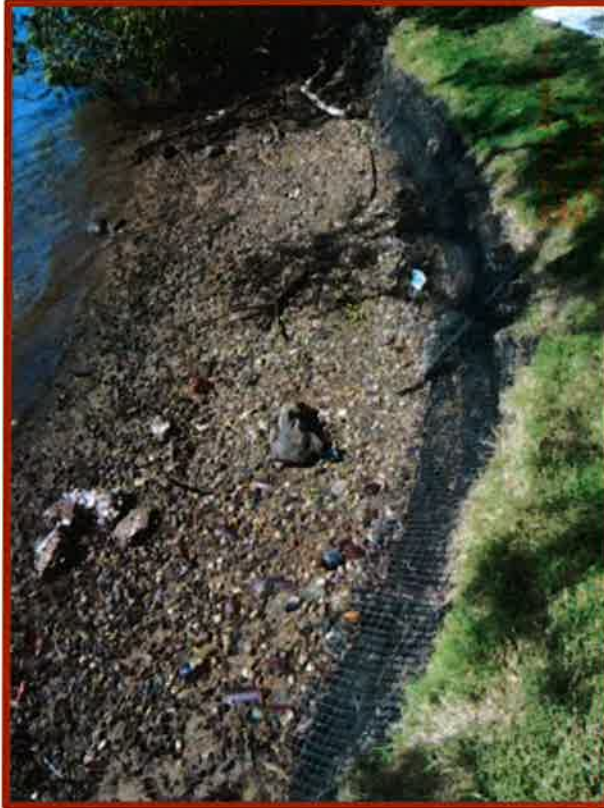
The sections of “living wall” appeared to be performing well, with no signs of damage and much less visual impact compared with the rock revetment (Figure B33). An area of “double wall” had also been constructed to encourage the growth of mangroves, this appears to have been partly successful (Figure B34).

Figure B33 Soft armouring with geogrid and compost-filled mesh containers

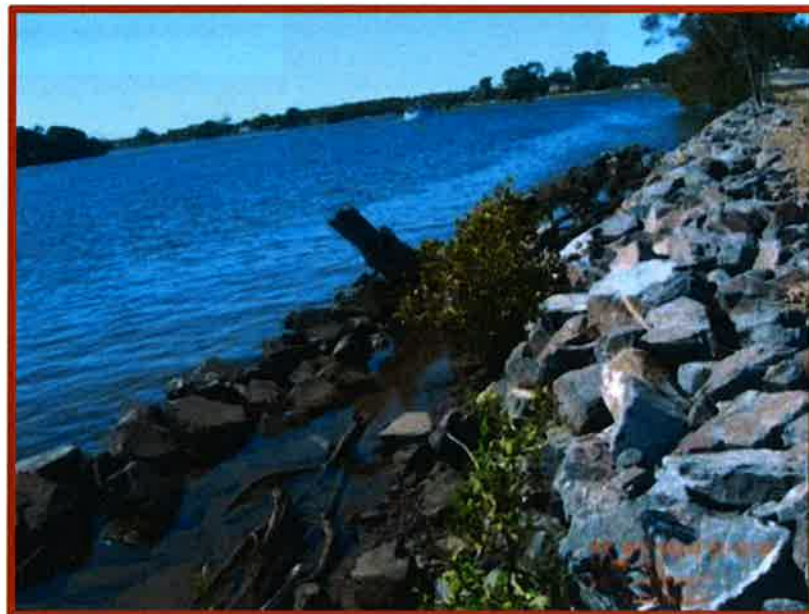
Figure B34 "Double wall" at Banora Point to encourage growth of mangroves along bank

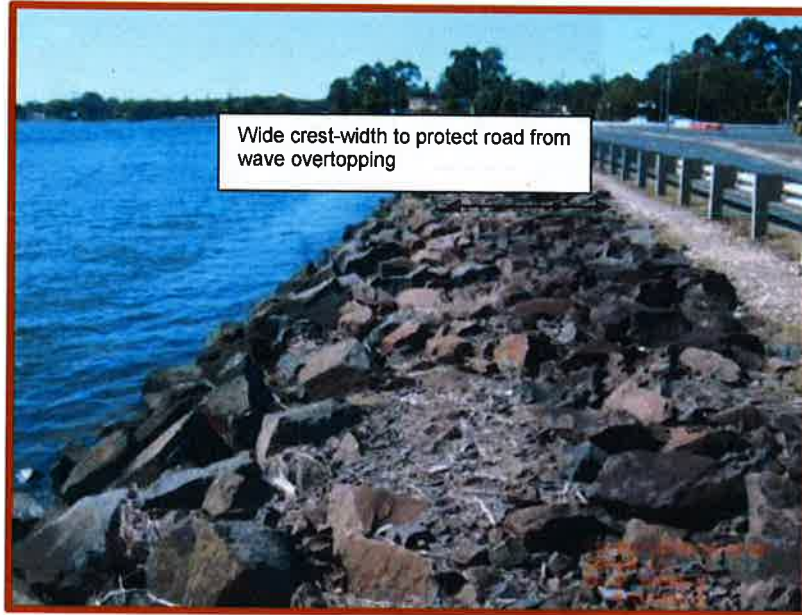
Immediately adjacent to the road embankment, a standard revetment with extensive crest width has been constructed. This revetment appears to be of older construction but is showing no signs of damage as it is well-constructed. Sufficient crest width to protect the road from wave overtopping is provided and there are no signs of damage or deformation to the revetment (Figure B35). Further east, a section of revetment had been constructed without adequate crest width and this section is beginning to suffer damage due to overtopping (Figure B36). This section is subject to a considerable northerly wind fetch.

Figure B35 *Revetment providing effective protection from wave overtopping*
