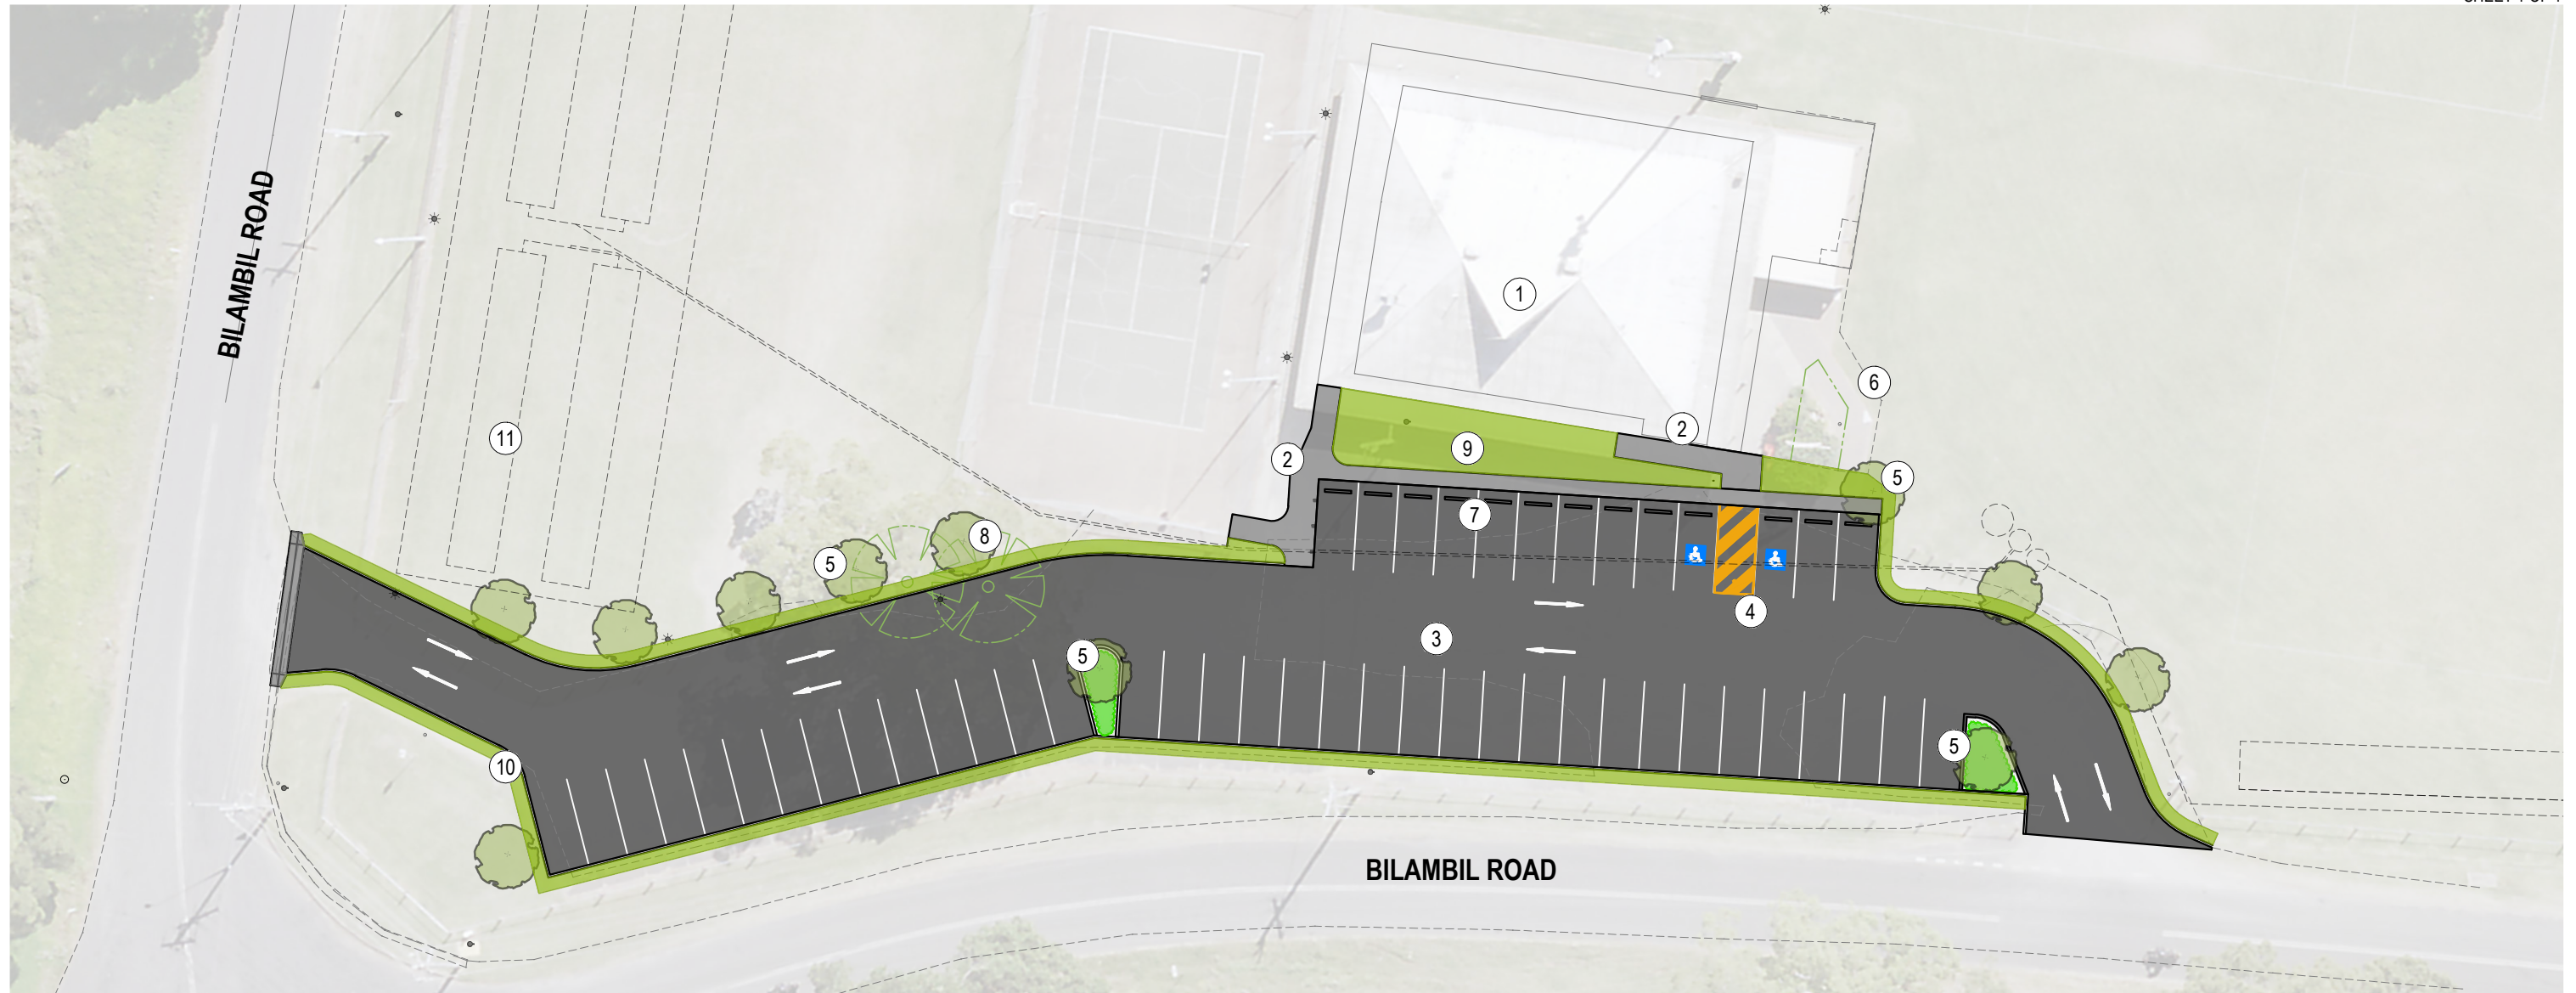
1. Existing clubhouse
2. New ramp and connecting concrete pathway 1.5m wide, to AS1428.1
3. New asphalt carpark area (46 spaces) with kerb and concrete edging
4. Two accessible carparking spaces with improved access to clubhouse
5. New shade trees
6. Existing path to remain
7. Wheel stops
8. Existing trees to be removed due to poor condition
9. Grassed area to replace pavement in front of clubhouse
10. 300mm deep concrete perimeter edging to protect pavement
11. Recently upgraded on-site sewage management system
