## LATE ADDENDUM REPORT

#### a27 [CNR-CM] Kingscliff Foreshore Erosion Emergency Works

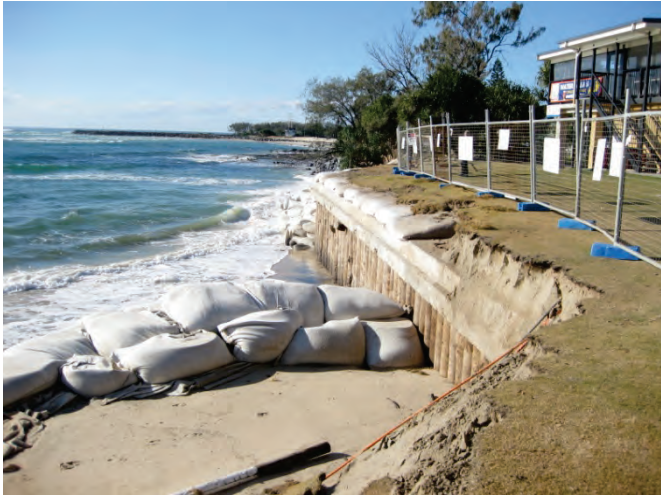
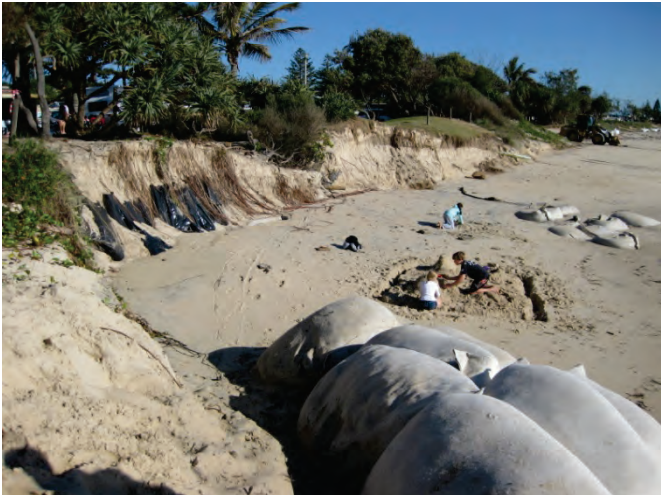
Unfortunately, erosion has reoccurred at the southern end of Kingscliff Beach and the nourished sand has moved out of this section of the beach, most likely to the north and offshore. This has exposed the rock wall and deepened the near-shore area between the Cudgen Creek Training Wall and the Cudgen Headland Surf Club.

In the last week, a combination of spring high tides, high swell and the deepened near-shore conditions has led to partial failure of the sandbag walls constructed in front of the Cudgen Headland Surf Club and Kingscliff Beach Holiday Park. To maintain the foreshore area, these sandbag walls need to be rebuilt and strengthened.

The original works were constructed in an attempt to minimise costs and a more robust design is required for the repairs due to the length of time that the foreshore is likely to be subject to erosion and length of time anticipated for recovery of the beach. Further works are required to reduce erosion impacts on Cudgen Headland Surf Club and Kingscliff Beach Holiday Park.

The amount spent to date that is currently unfunded is \$90,000. The estimated cost for the repair and strengthening of the sandbag walls is an estimated additional \$140,000. Approximately 60% of this is construction of a wall in front of the Kingscliff Beach Holiday Park and the remainder at the Cudgen Headland Surf Club.
