**Coastal Hazard Lines Map**  
 Figure 1.2  
 Sheet 2 of 26

**TWEED DEVELOPMENT CONTROL PLAN**  
 Section B25  
 Coastal Hazards

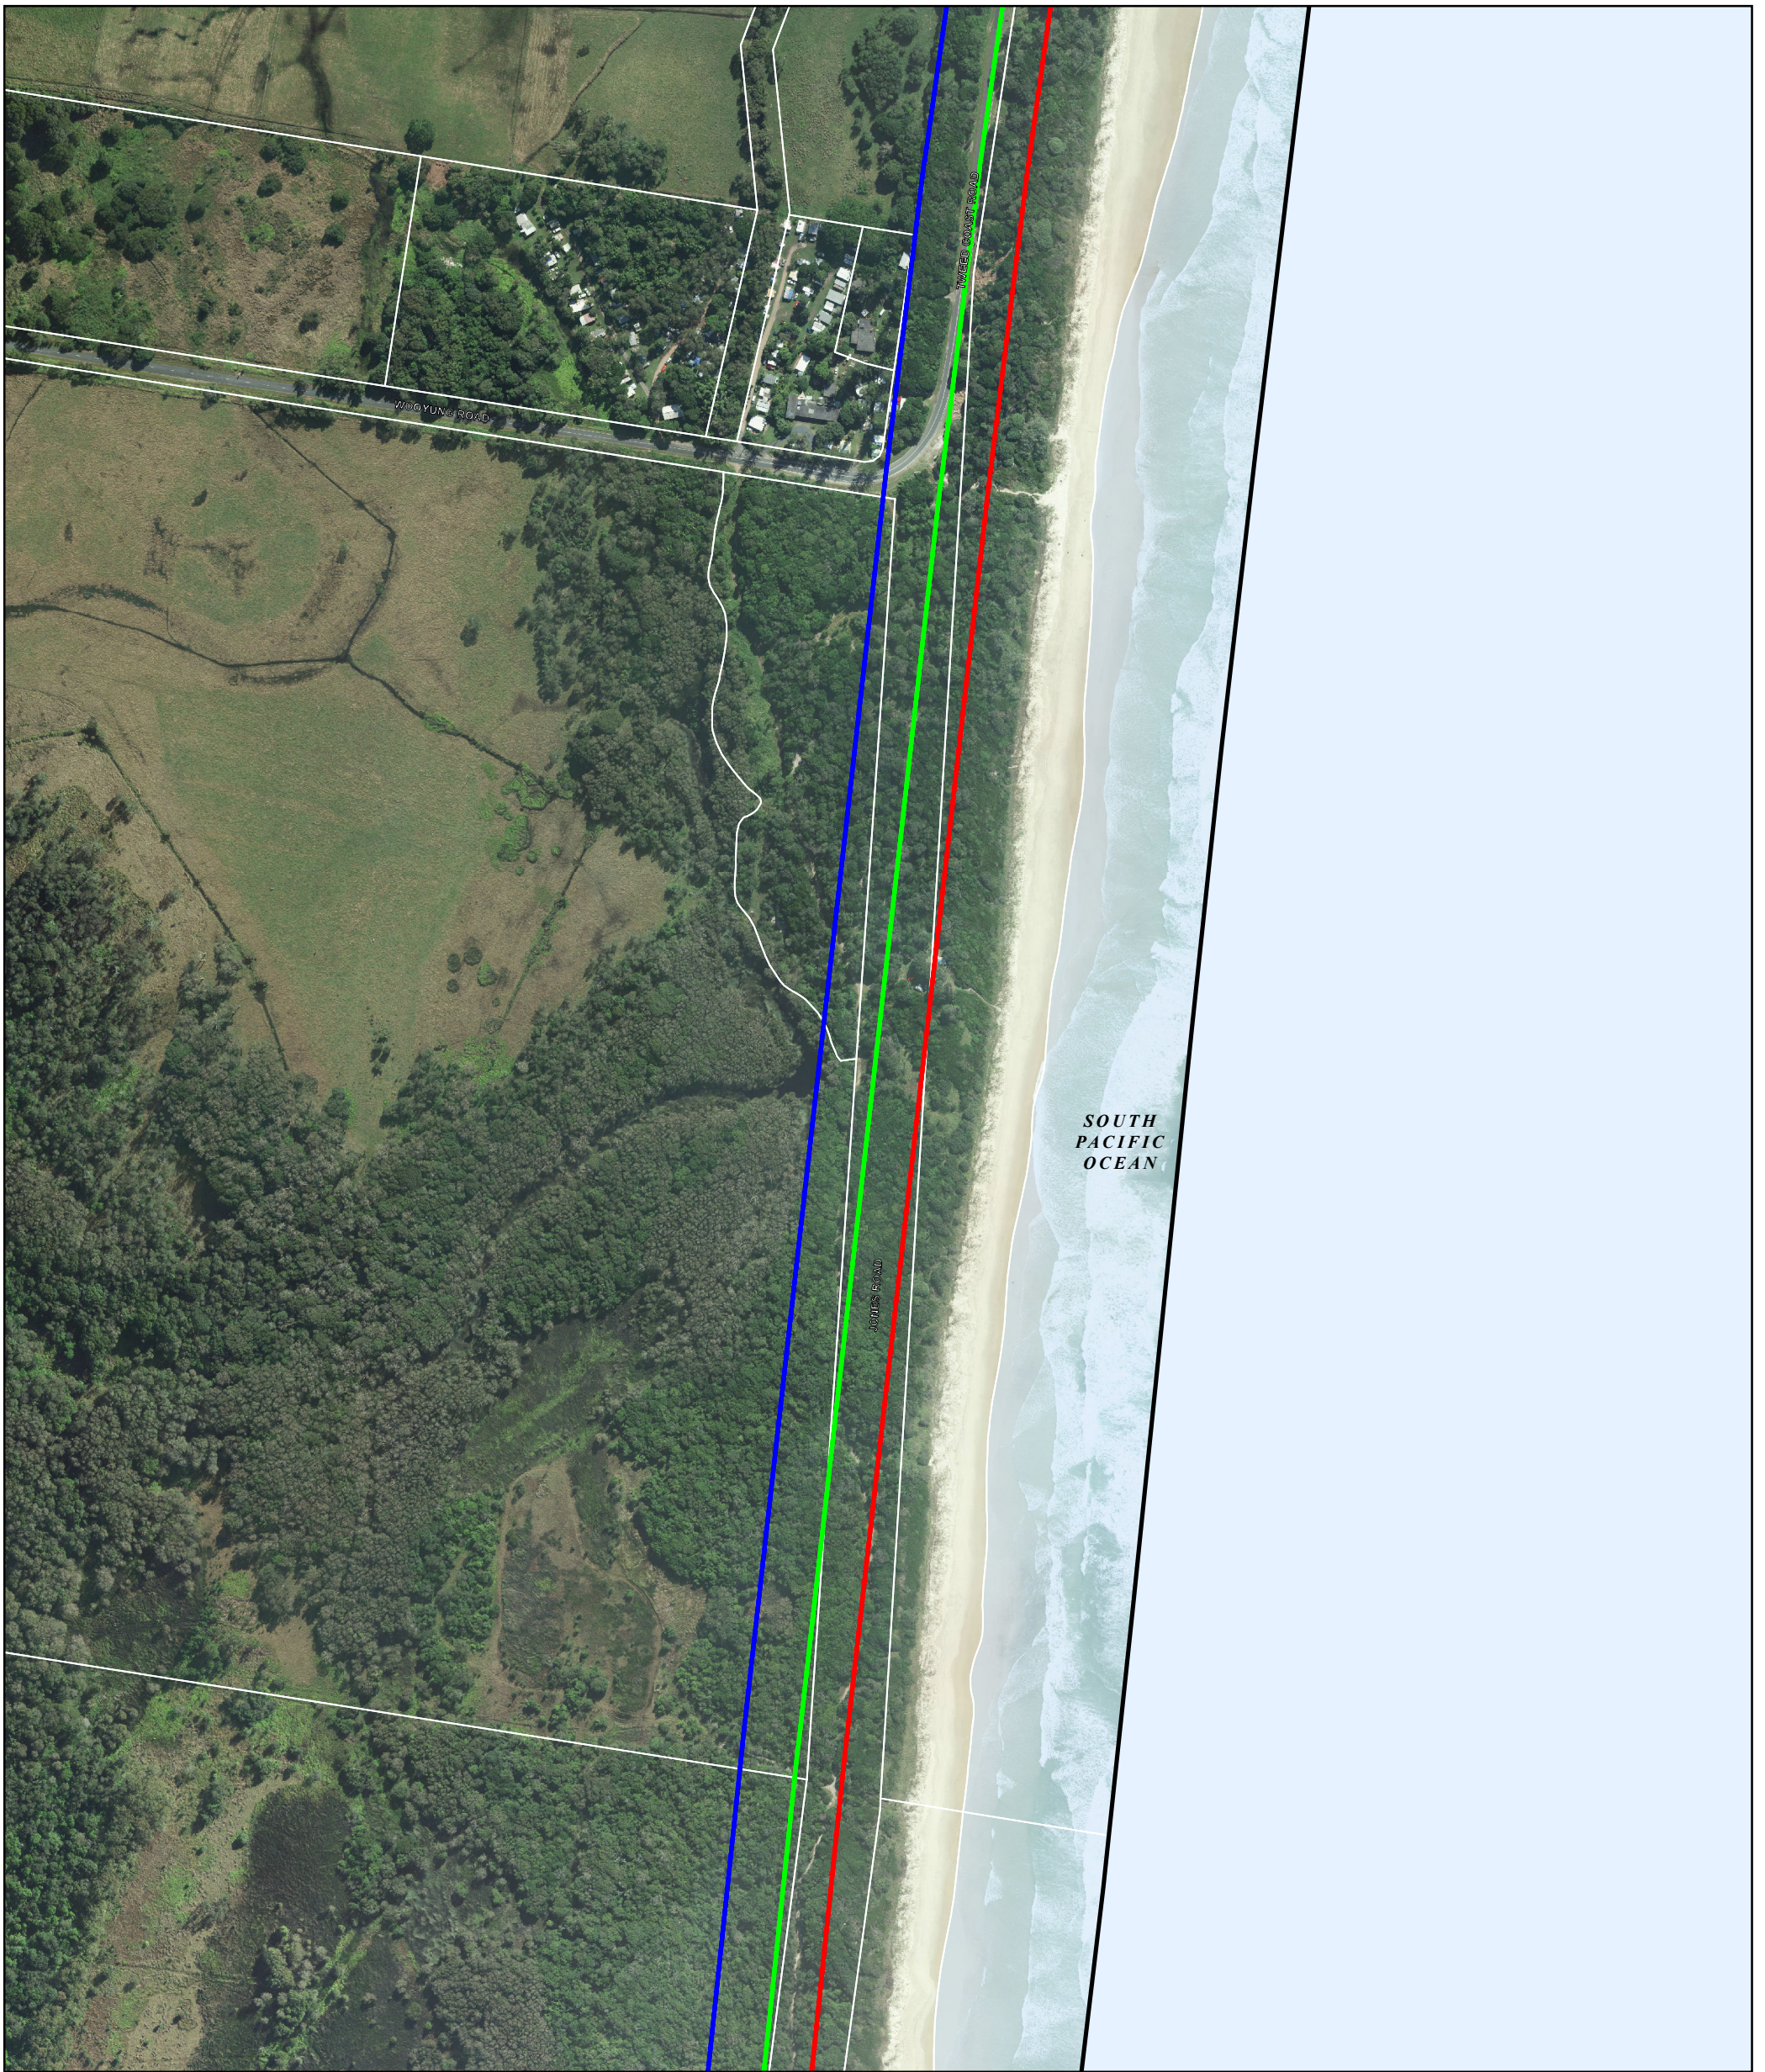
**Notes:**  
 A zone of reduced bearing capacity will exist landward of a receding erosion scarp. Definition of the extent of the zone of reduced bearing capacity will require professional assessment on a site by site basis. An additional allowance in this regard should be included in considering the immediate hazard zone.

The accuracy of predicting these hazard lines is subject to many uncertainties. The existence of bedrock, indurated sands and/or structures may impact on the realisation of the hazards.

Coastal features and structures have been observed and digitally plotted using photogrammetric techniques. Hazard lines have been determined and plotted relative to the photogrammetry data. Cadastral boundaries as shown may not have been survey corrected and are presented for guidance.

- - - Immediate Hazard Line
- - - Maximum 2050 Hazard Line
- - - Maximum 2100 Hazard Line
