Coastal Hazard Lines Map
 Figure 1.4
 Sheet 4 of 26

TWEED DEVELOPMENT CONTROL PLAN
 Section B25
 Coastal Hazards

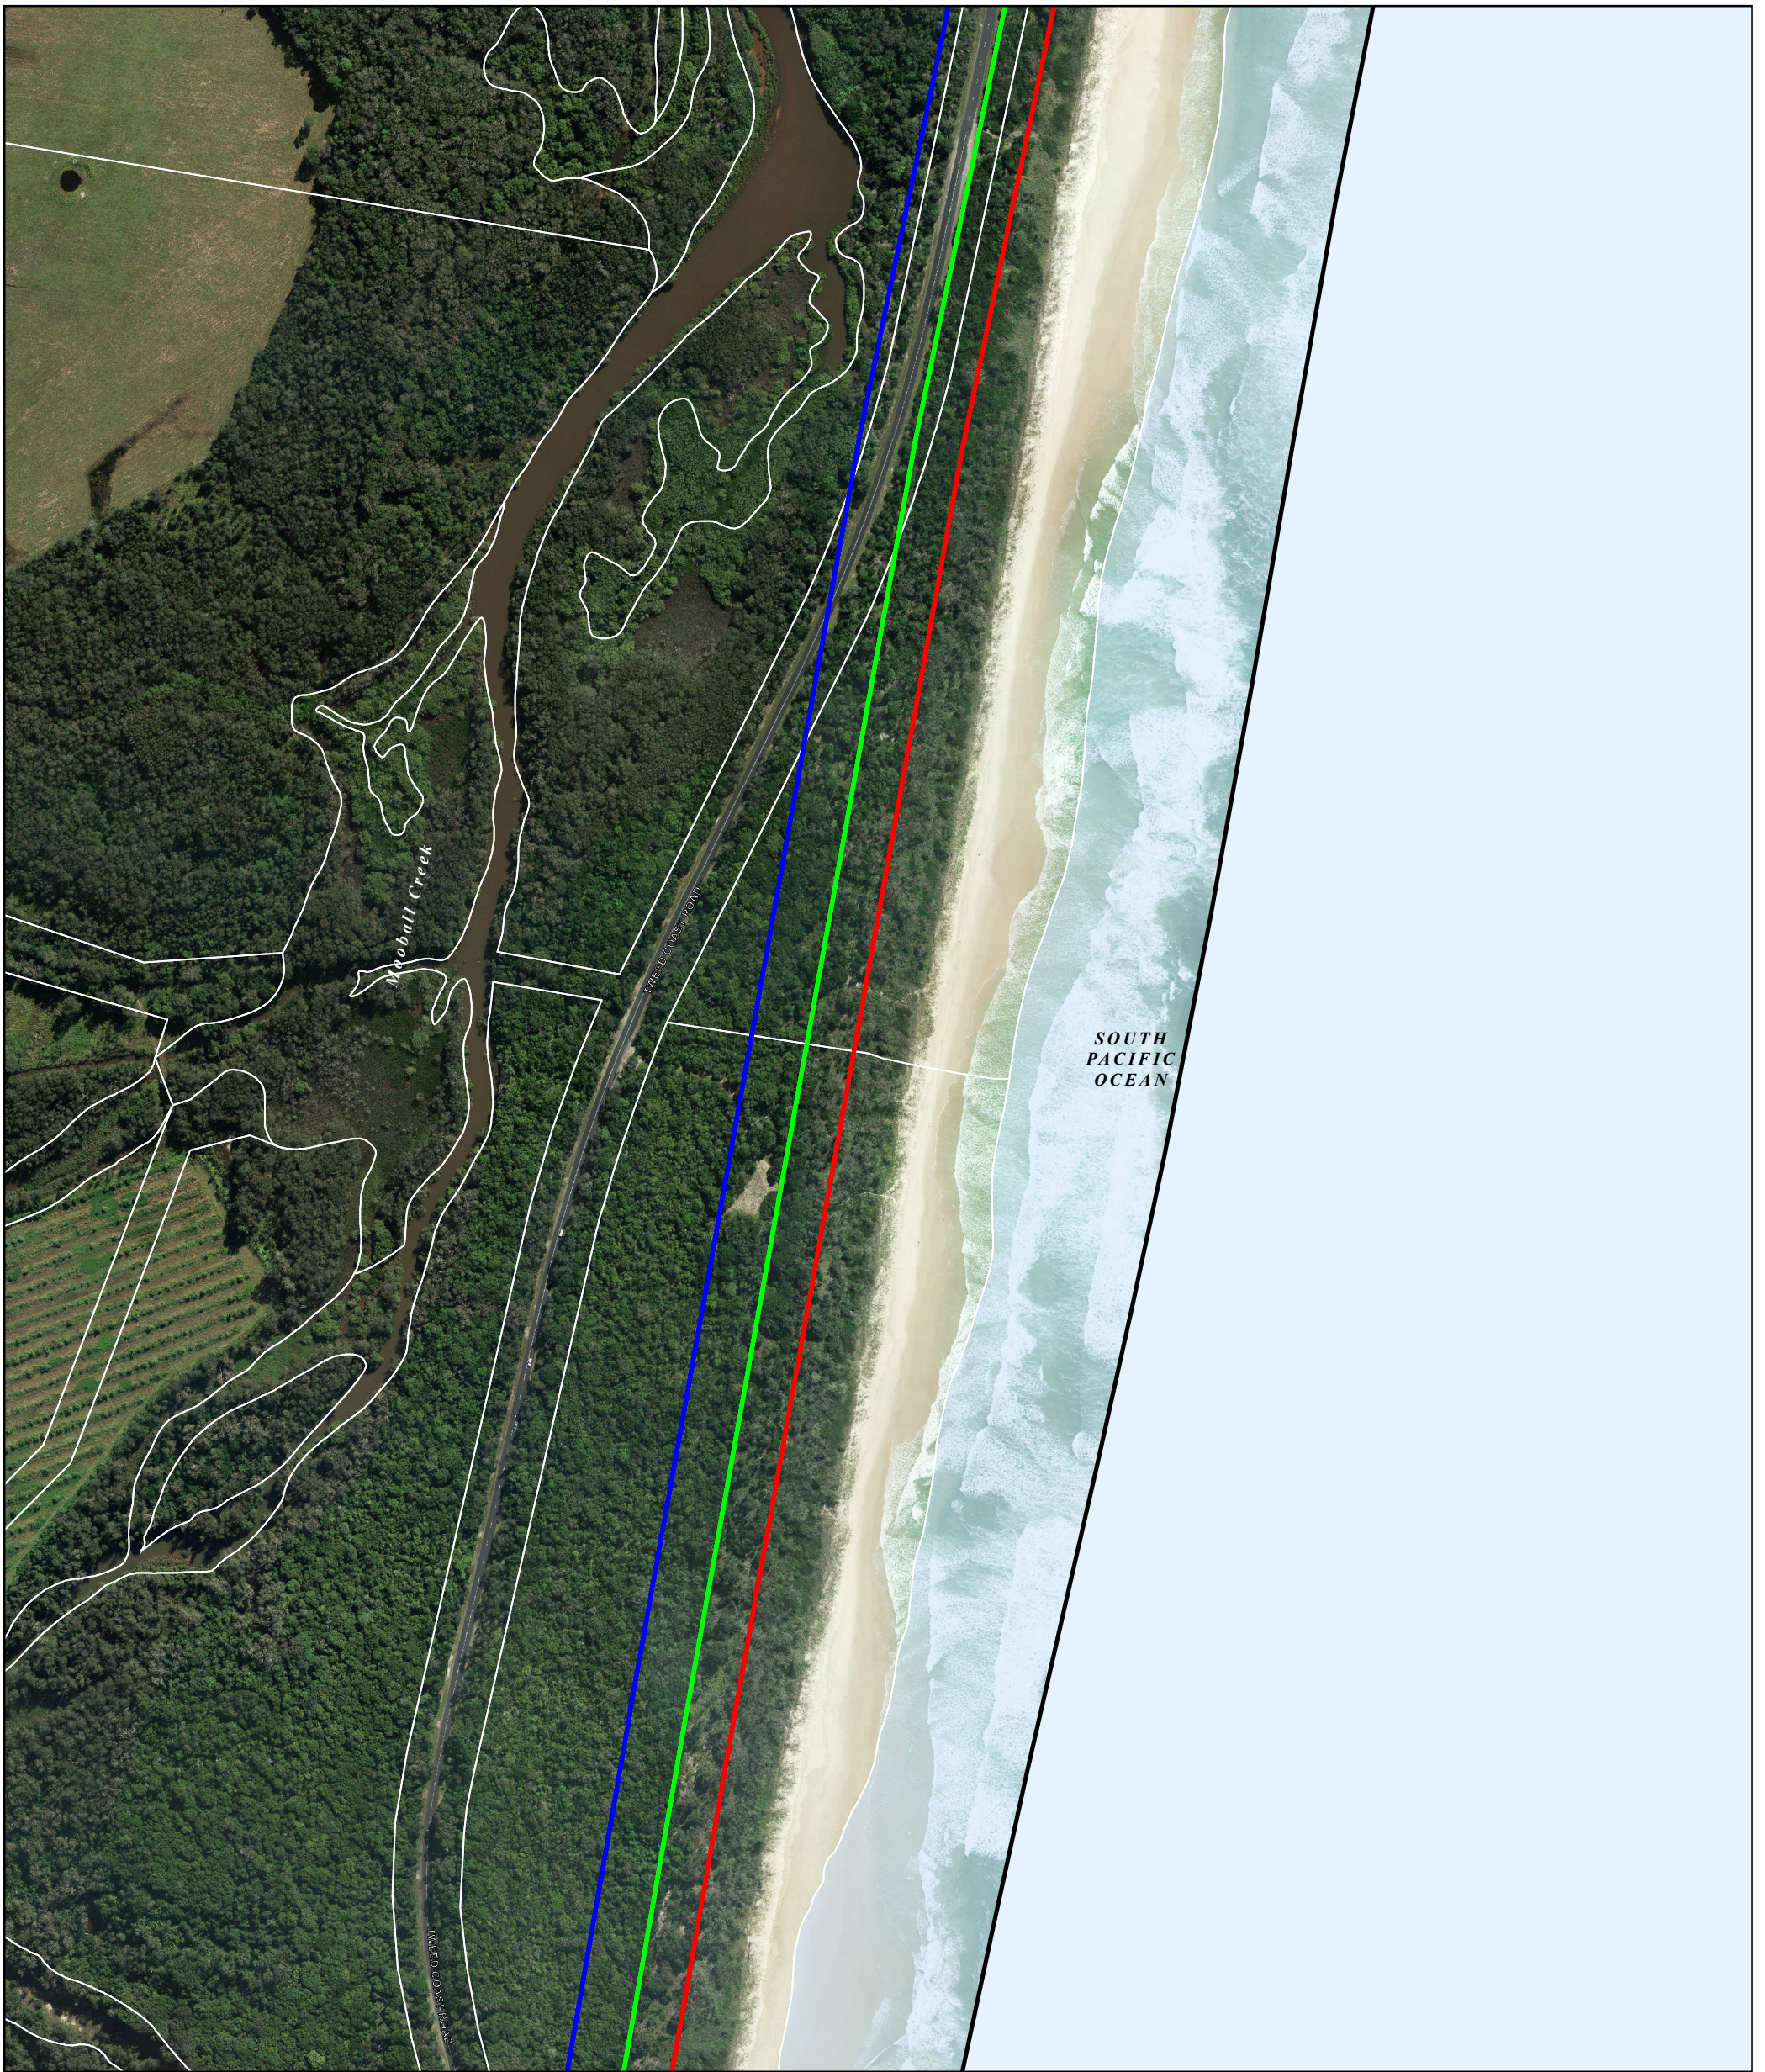
Notes:
 A zone of reduced bearing capacity will exist landward of a receding erosion scarp. Definition of the extent of the zone of reduced bearing capacity will require professional assessment on a site by site basis. An additional allowance in this regard should be included in considering the immediate hazard zone.

The accuracy of predicting these hazard lines is subject to many uncertainties. The existence of bedrock, indurated sands and/or structures may impact on the realisation of the hazards.

Coastal features and structures have been observed and digitally plotted using photogrammetric techniques. Hazard lines have been determined and plotted relative to the photogrammetry data. Cadastral boundaries as shown may not have been survey corrected and are presented for guidance.

- Immediate Hazard Line
- 2050 Hazard Line
- 2100 Hazard Line

- - - Immediate Hazard Line
- - - Maximum 2050 Hazard Line
- - - Maximum 2100 Hazard Line
