Coastal Hazard Lines Map
Figure 1.7
Sheet 7 of 26

TWEED DEVELOPMENT CONTROL PLAN
Section B25
Coastal Hazards

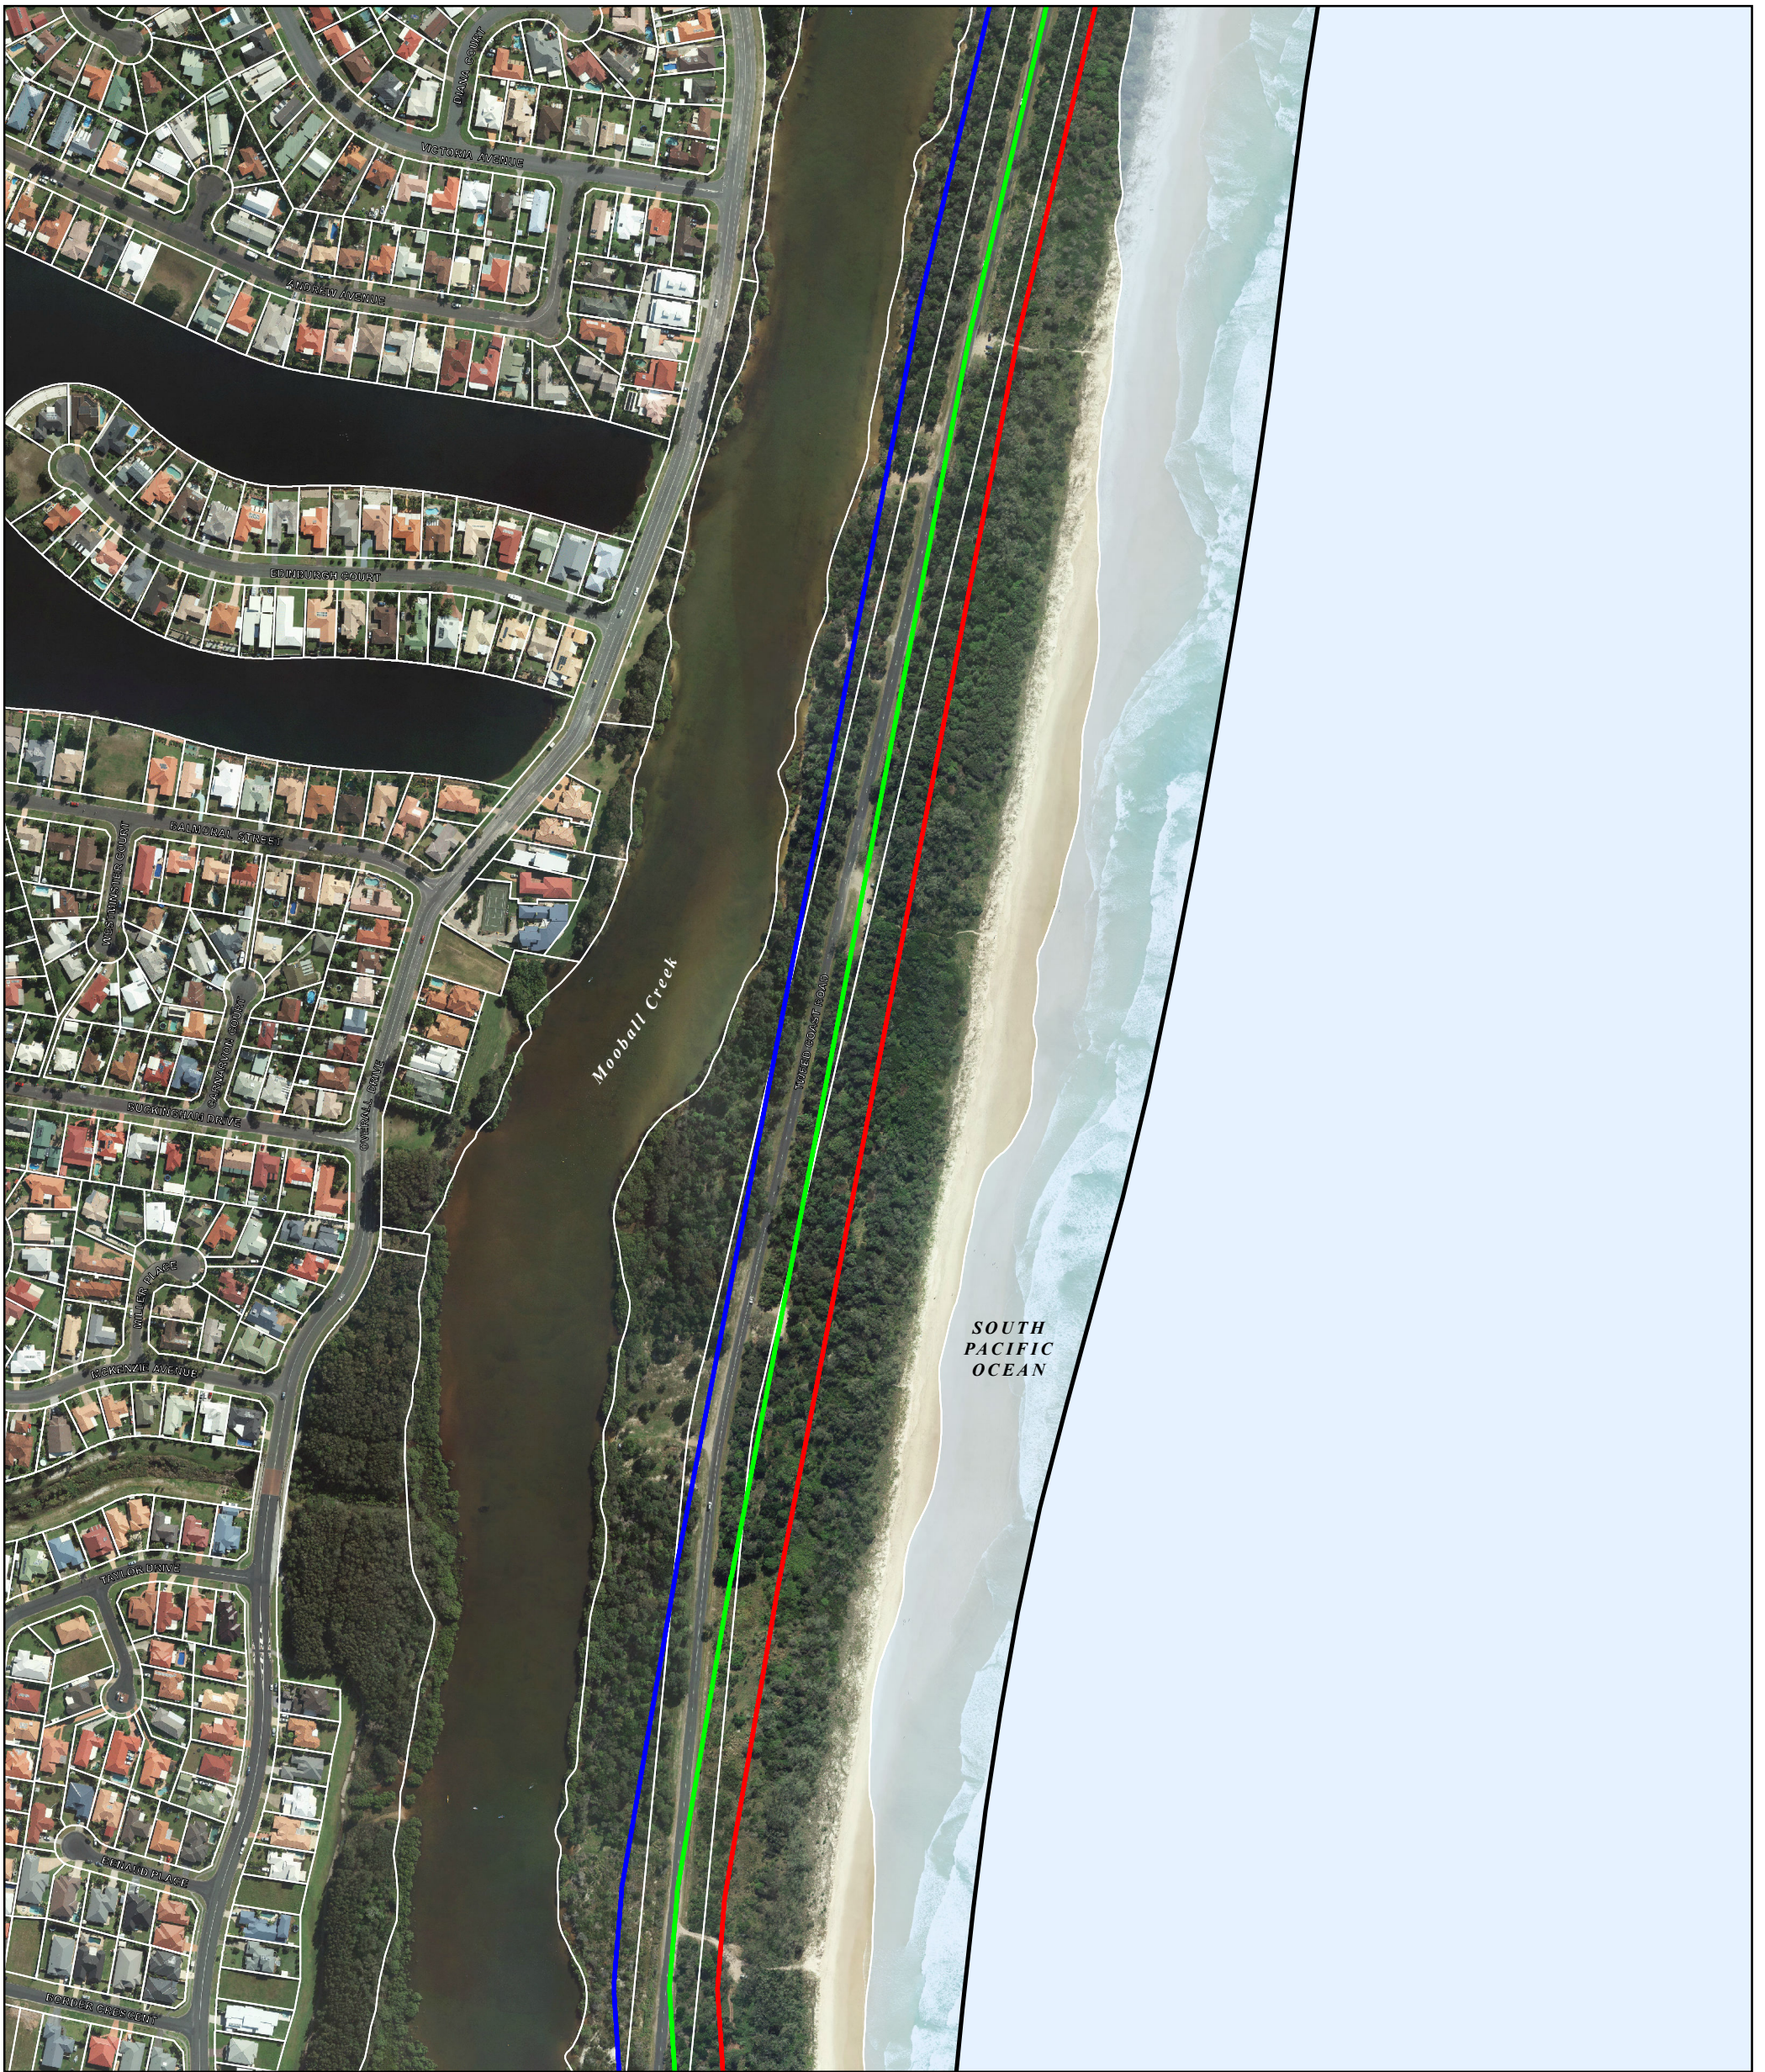
A zone of reduced bearing capacity will exist landward of a receding erosion scarp. Definition of the extent of the zone of reduced bearing capacity will require professional assessment on a site by site basis. An additional allowance in this regard should be included in considering the immediate hazard zone.

The accuracy of predicting these hazard lines is subject to many uncertainties. The existence of bedrock, indurated sands and/or structures may impact on the realisation of the hazards.

Coastal features and structures have been observed and digitally plotted using photogrammetric techniques. Hazard lines have been determined and plotted relative to the photogrammetry data. Cadastral boundaries as shown may not have been survey corrected and are presented for guidance.
