## APPENDIX B. 2017 HYDROLOGIC/HYDRAULIC CALIBRATION LOCATIONS

### B.1. Flow

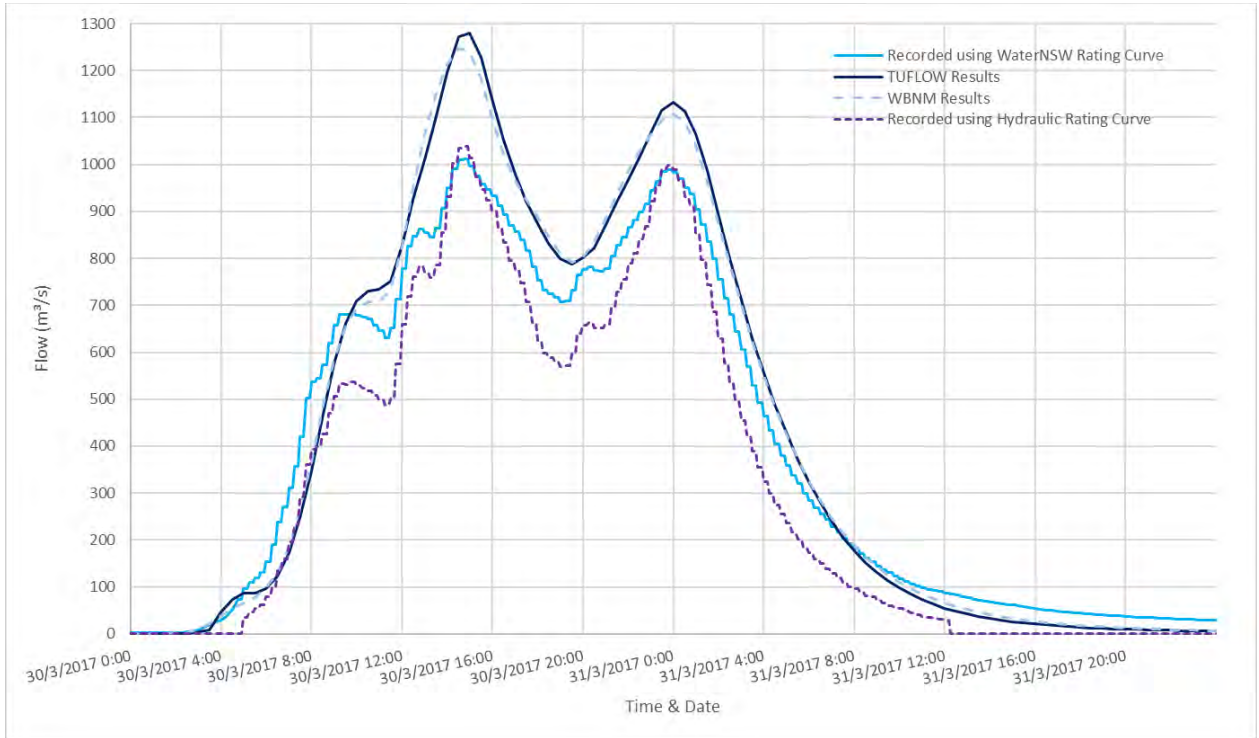
Diagram 59: 2017 Comparison of Flow at Palmers Road

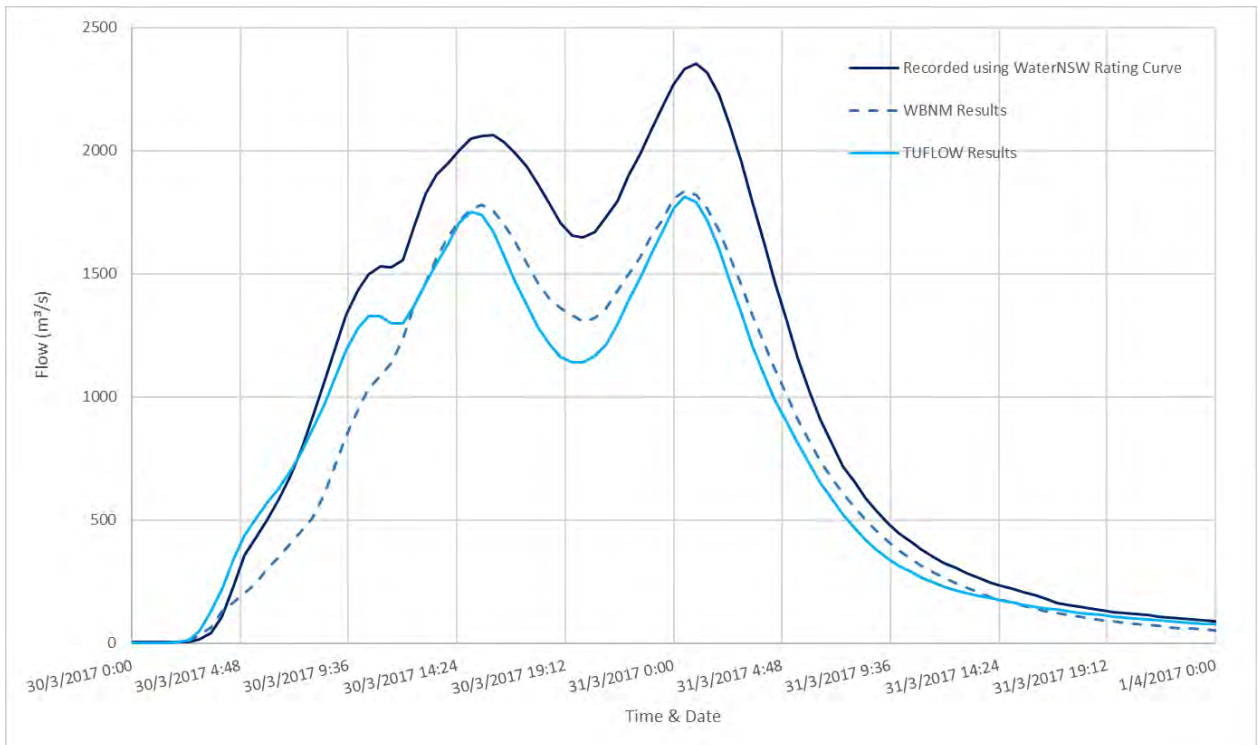
Diagram 60: 2017 Comparison of Flow at Uki

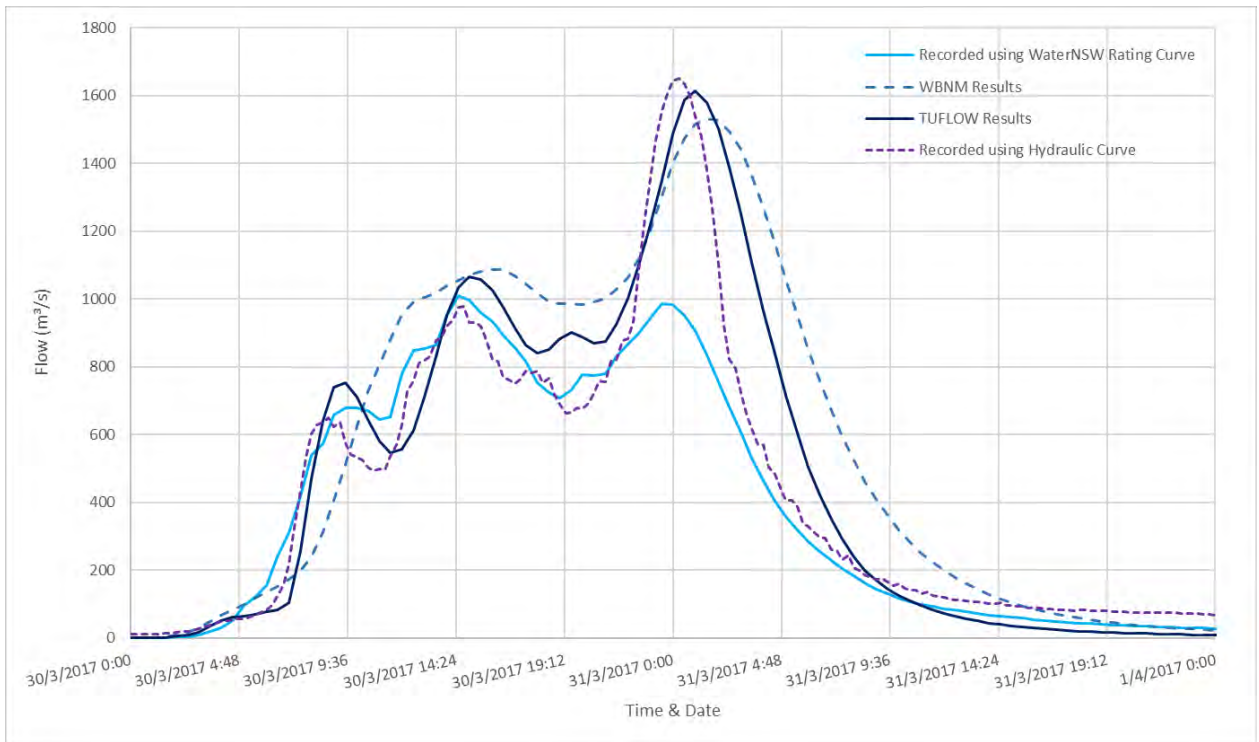
Diagram 61: 2017 Comparison of Flow at Eungella

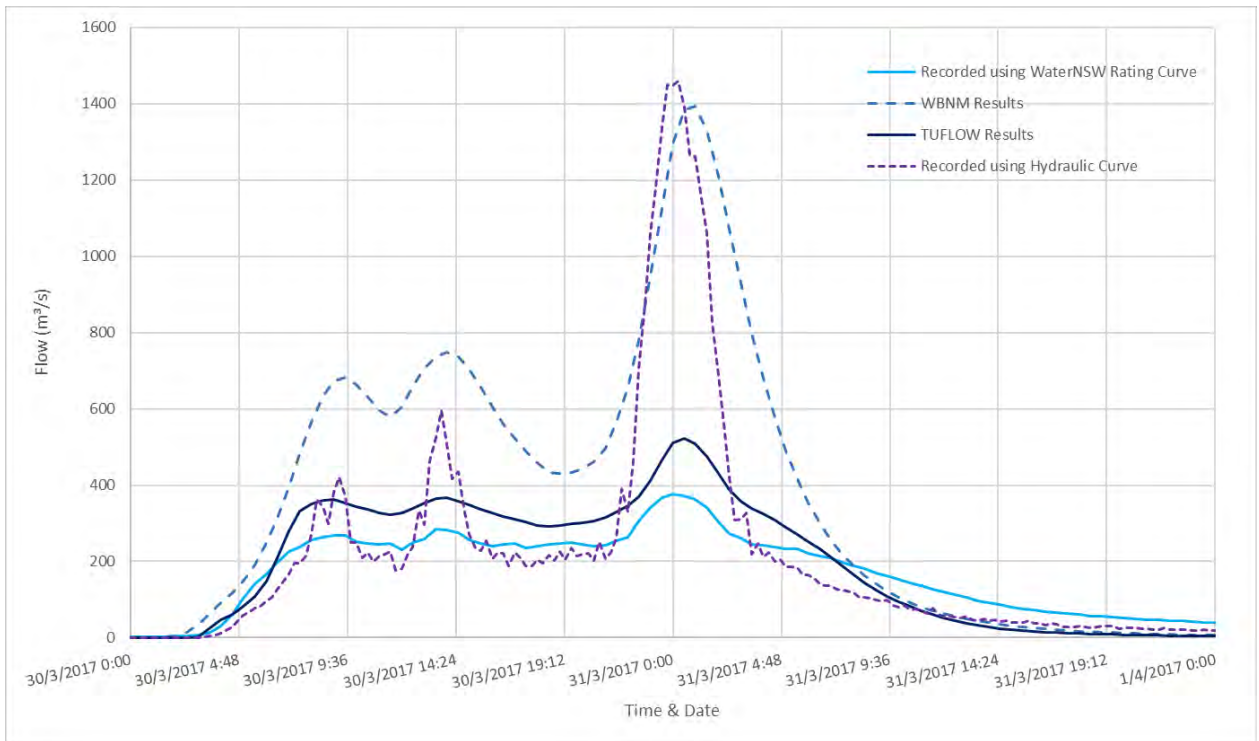
Diagram 62: 2017 Comparison of Flow at Boat Harbour

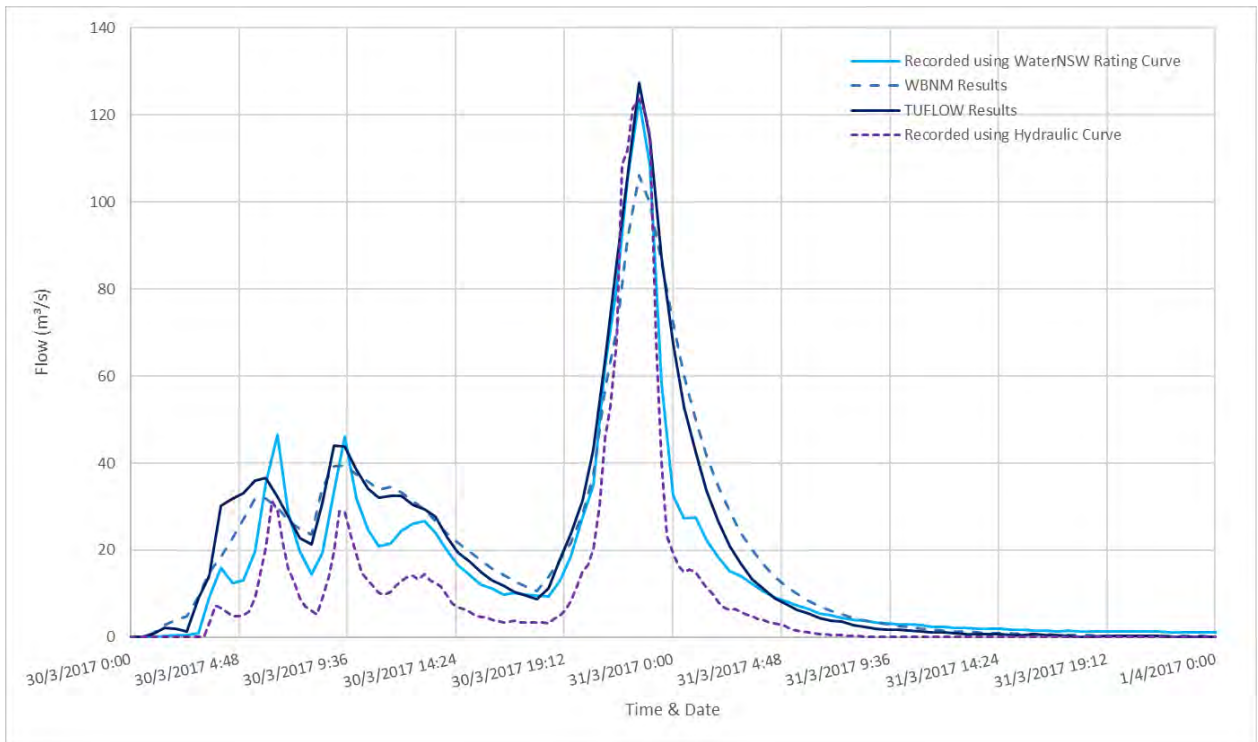
Diagram 63: 2017 Comparison of Flow at Cobaki Creek

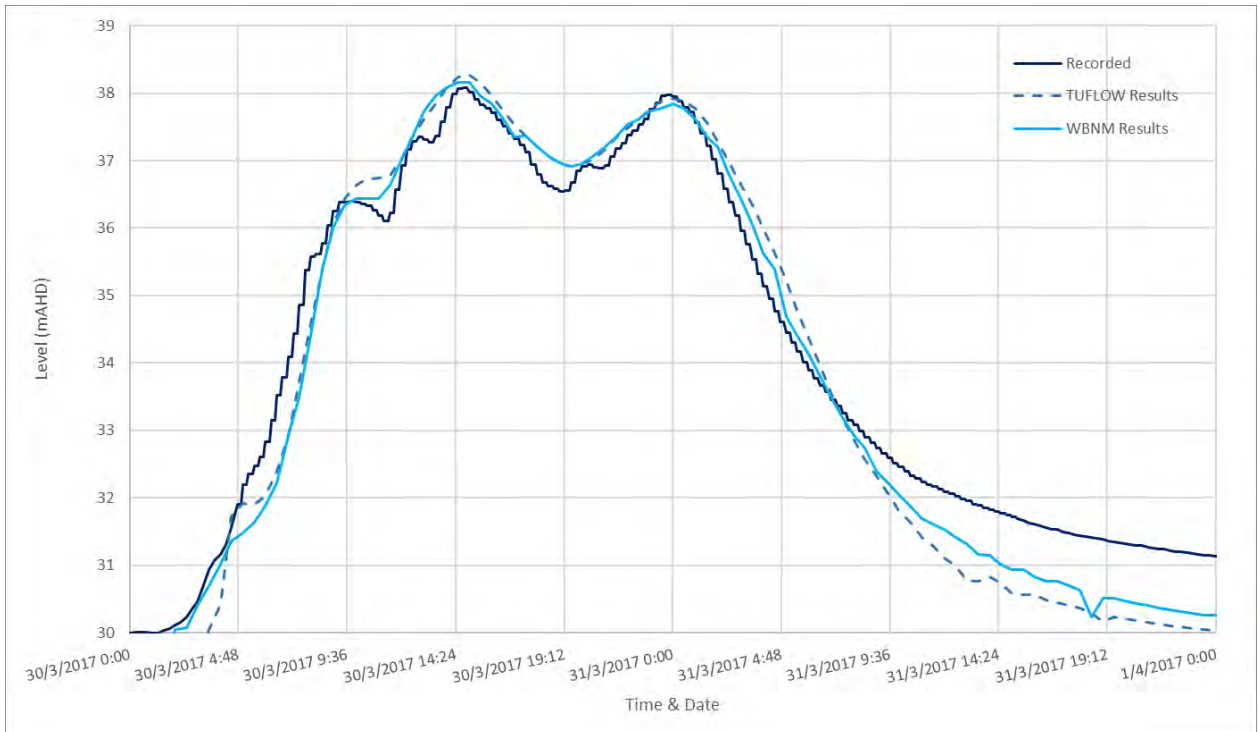
Diagram 64: 2017 Comparison of Water Level at Palmers Road

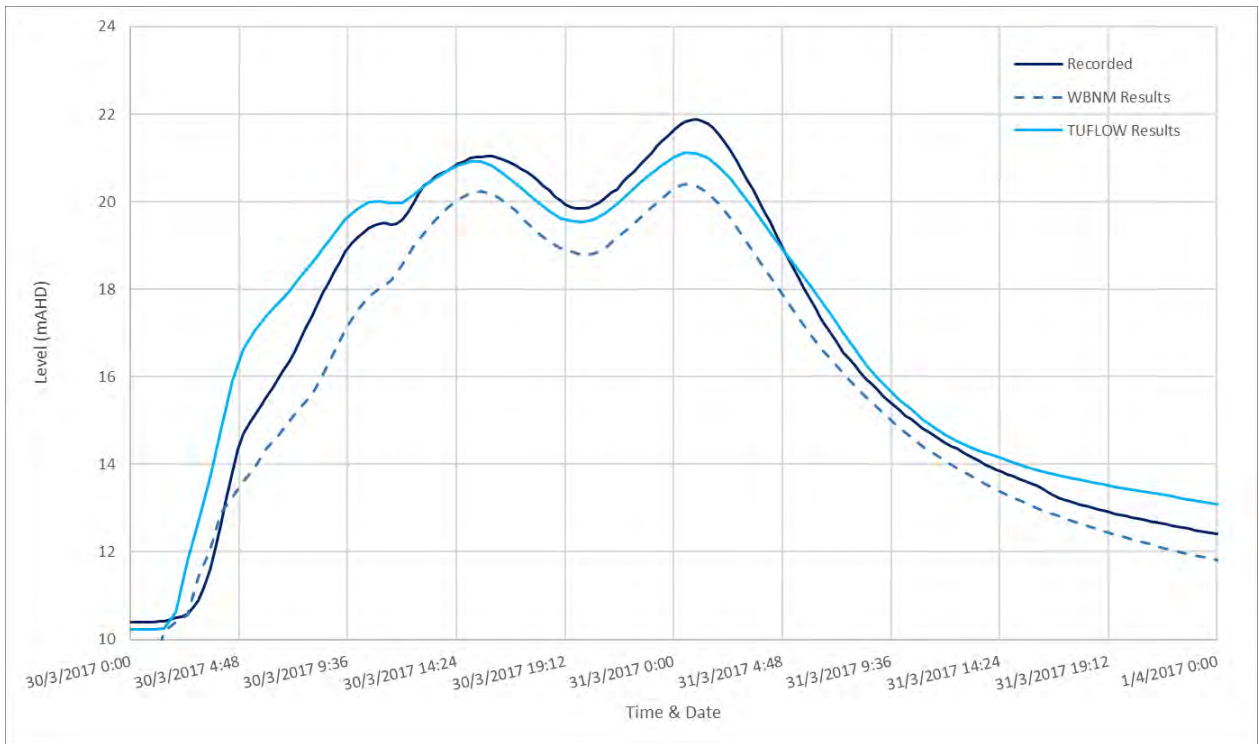
Diagram 65: 2017 Comparison of Water Level at Uki

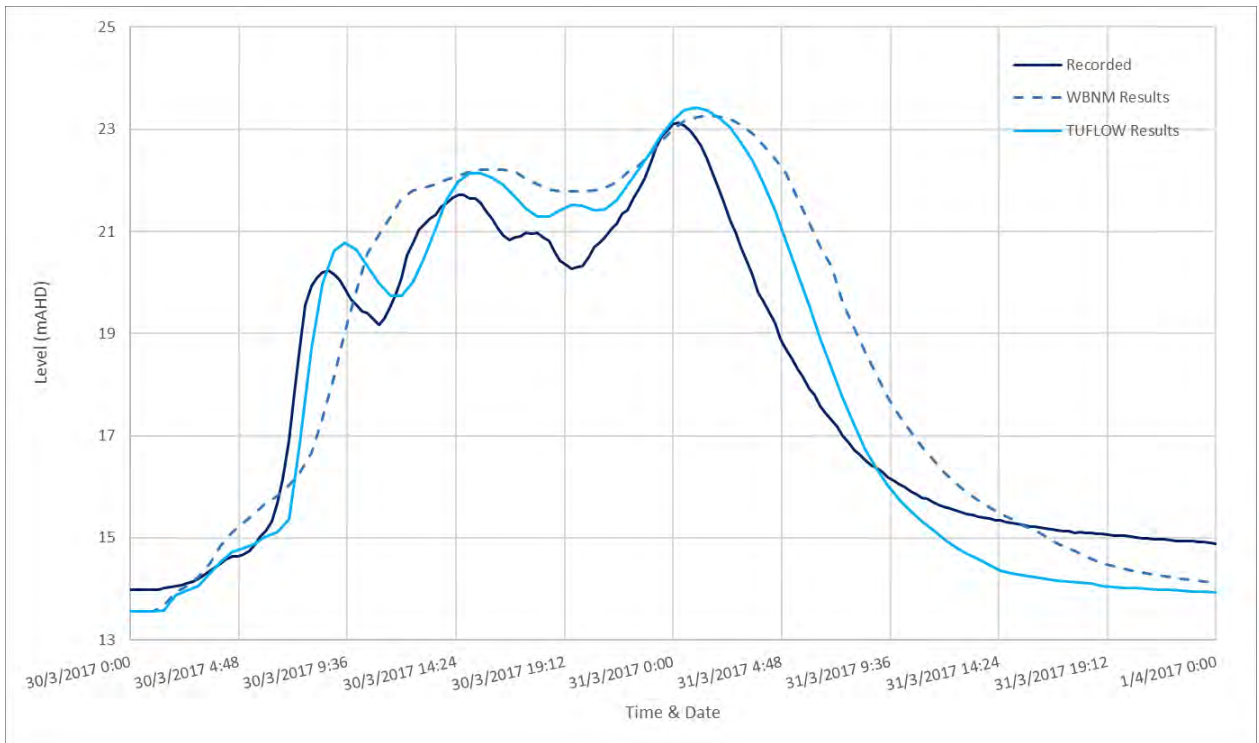
Diagram 66: 2017 Comparison of Water Level at Eungella

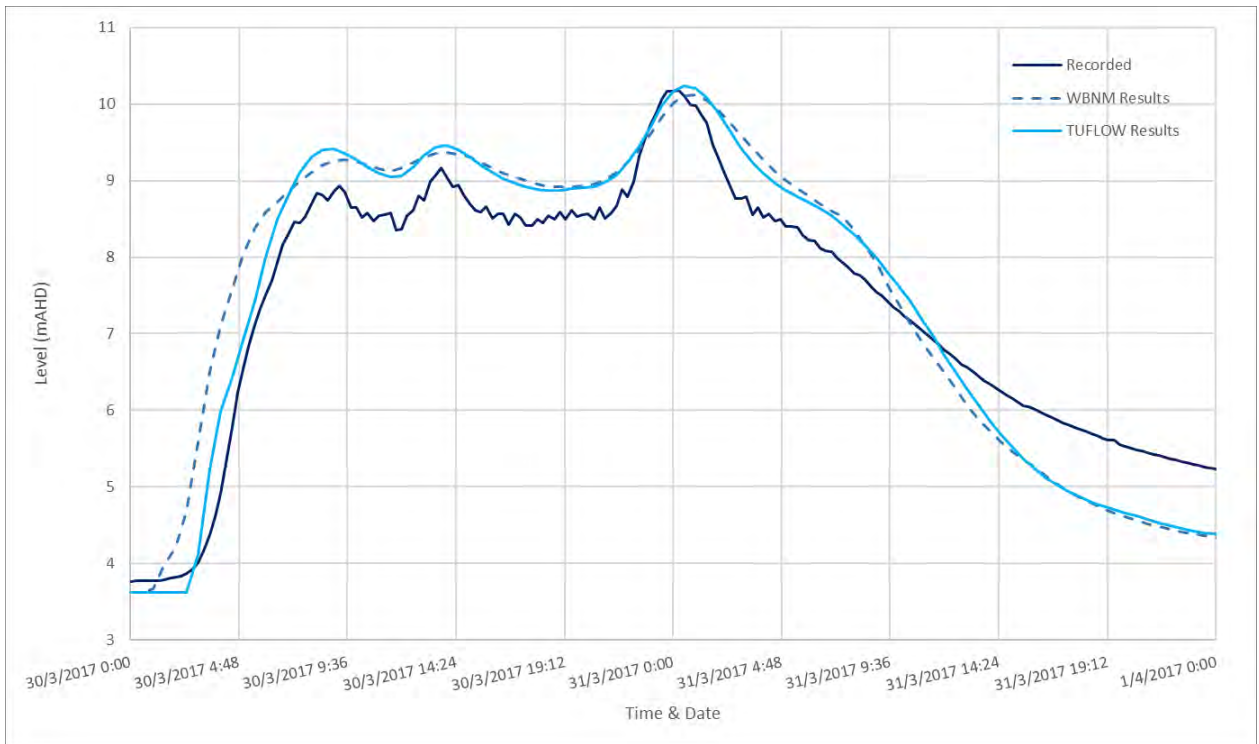
Diagram 67: 2017 Comparison of Water Level at Boat Harbour

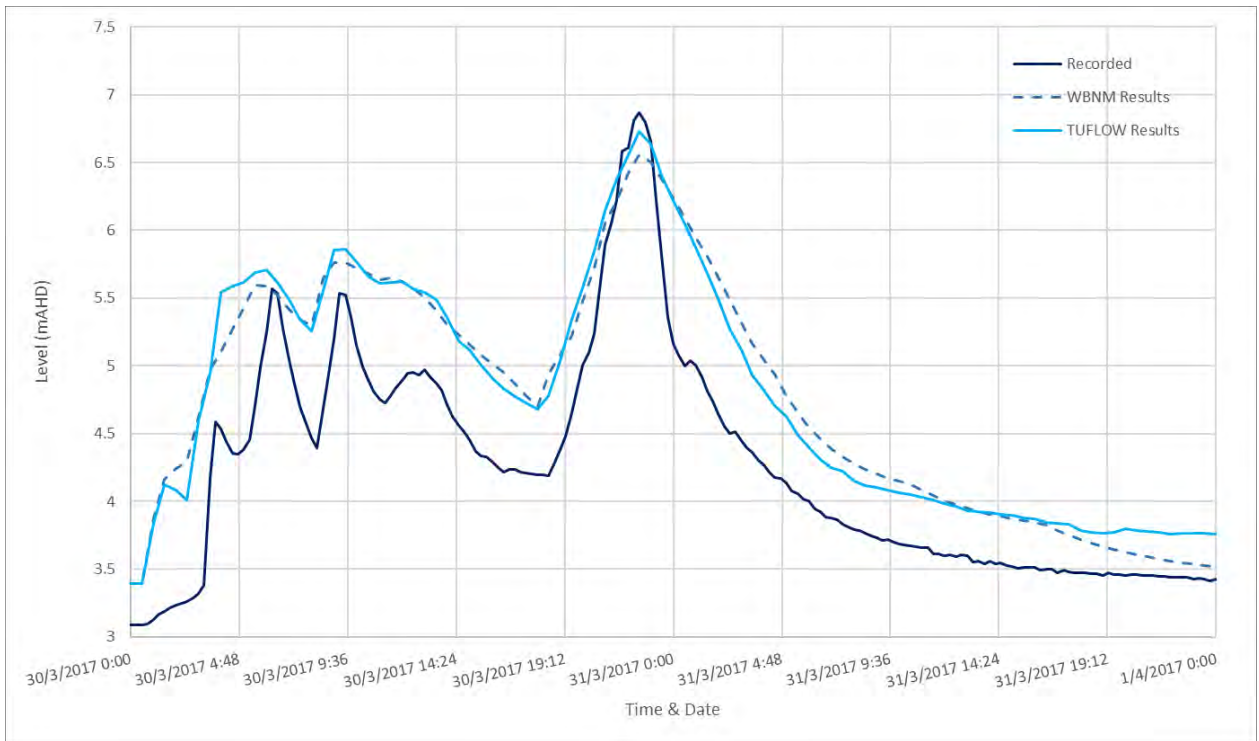
Diagram 68: 2017 Comparison of Water Level at Cobaki Creek
