Review of Environmental Factors

CAP031 – Relocate flood inundated toilet from Buckley Park to Rail Trail and Buckley park upgrade
INF10 – Northern Rivers Rail Trail Murwillumbah Railway Station Upgrades
South Murwillumbah

January 2025

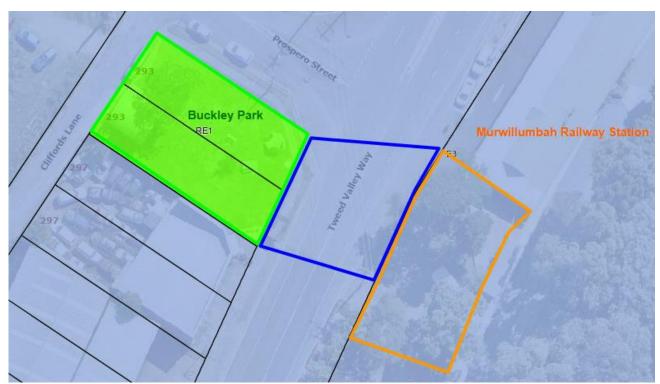
Figure 2: Site (green polygon = Buckley Park extent of works; blue polygon = Tweed Valley Way extent of works; orange polygon = Murwillumbah Railway Station extent of works)

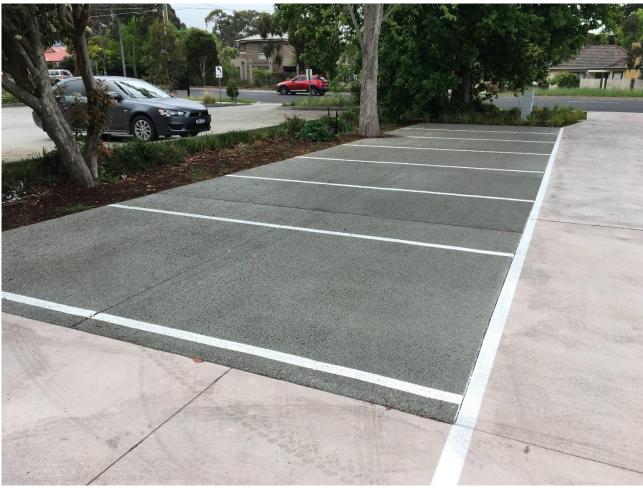
Figure C1: WaterPave carpark in structural root zone and tree protection zone of tree

- How deep do we need to excavate near the tree? Will the excavation cause minimal disturbance?
 - Every arborist/tree is different. Here in Victoria, we are allowed a maximum of 50mm excavation depth around some trees. When this is the case, we simply build/follow grade.
- Can we work as close to the tree as shown in the attached drawings?
 - o Absolutely, unless a tree root is not disturbed you can work as close as desired.
- Is WaterPave a suitable product for this project?
 - Our permeable concrete was designed for this reason allowing it to be used around trees.
- Do you have any example of carparks near existing trees?
 - See attached images (below).

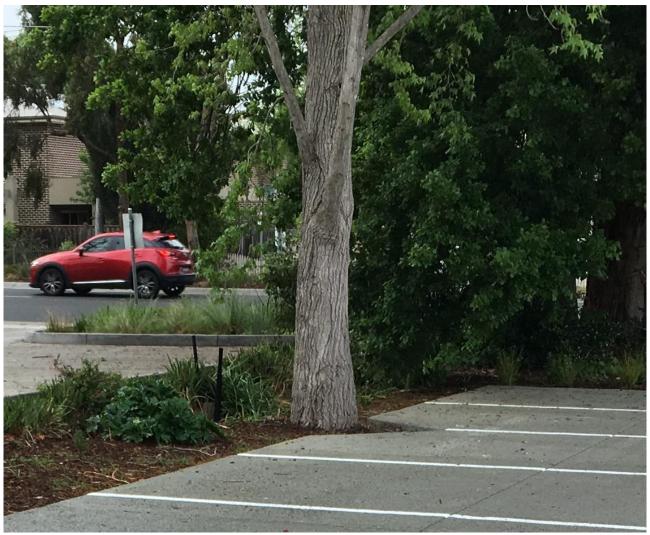
Figure C2: Zoomed in photo of above photo showing WaterPave carpark in structural root zone and tree protection zone of tree

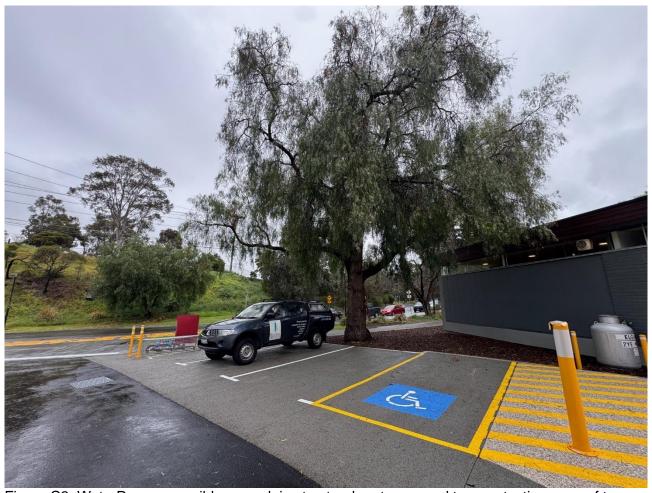
Figure C3: WaterPave accessible carpark in structural root zone and tree protection zone of tree

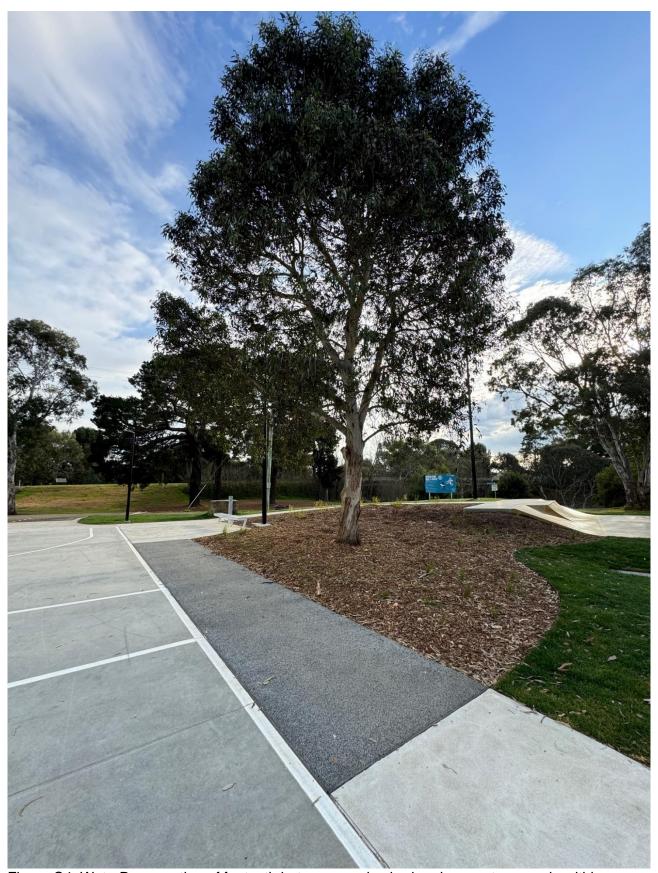
Figure C4: WaterPave section of footpath between garden bed and concrete carpark, within structural root zone and tree protection zone of tree

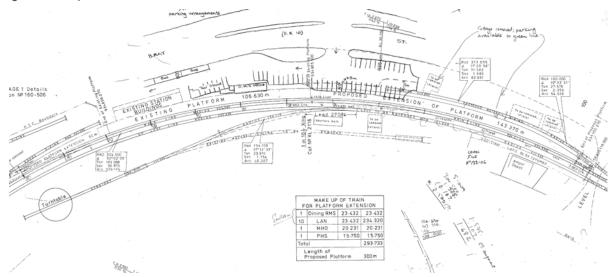
Figure 6 - Proposed Platform Extension

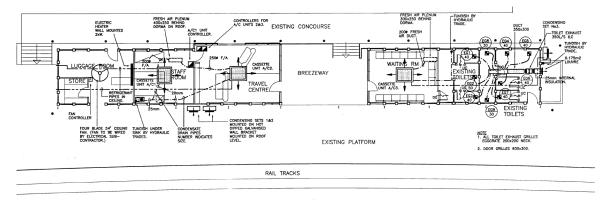
Figure 7 – Internal Layout of Passenger Station in 1992

A new station building containing a booking office was erected between the 1922 station building and 1980s station master's house shortly before train services to Murwillumbah Railway Station ceased in 2004. Services were replaced with daily bus services, and the station continued to operate as a Country link bus terminal using the recently refurbished waiting room and booking office.

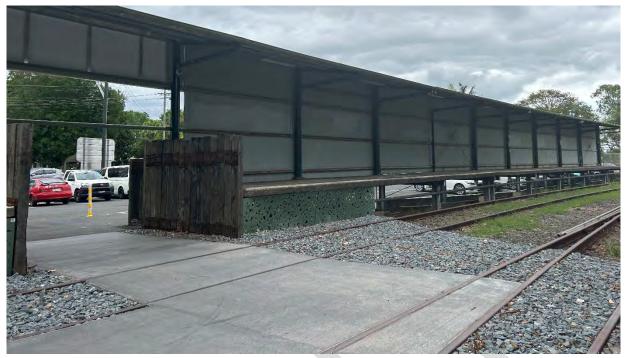
Picture 41 Ground surface treatment of northern access point

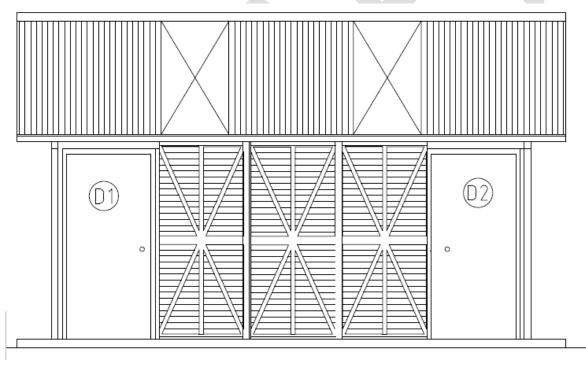
Figure 12 Western elevation of proposed amenities block

The existing toilets located within the 1920s station building are not equitable accessible, and development is constrained due to the presence of original and significant fabric, and the adjacent tenancy. Furthermore additional amenities are required to cater to the increased use by visitors using the NRRT. The new amenities block will provide additional compliant facilities for all visitors, including those with disabilities.

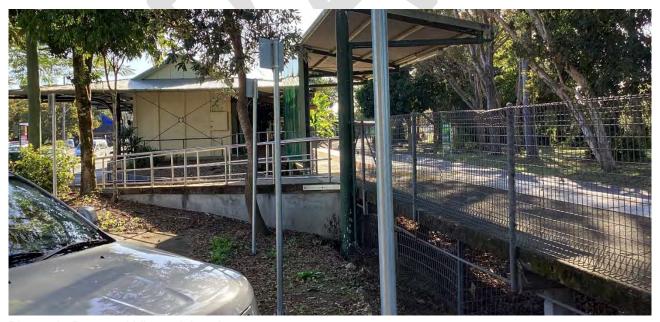
Picture 47 Proposed bike rack location

Bike racks are proposed to be sited at the street level west of the platform between the platform and the proposed amenities block (Picture 47). It is proposed to be of steel construction and fixed to the pavement, similar to what has been installed near the northern access point (Picture 48).

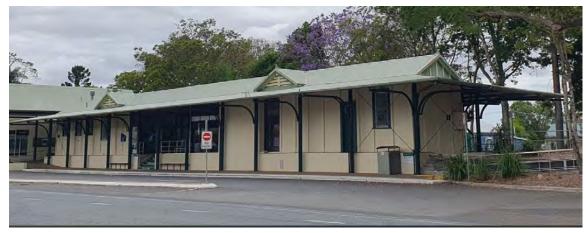
Picture 6 Western elevation of 1920s building

Two air conditioning units are positioned on the eastern side of the roof. While roofing and guttering has been replaced, the building retains the zinc ridge horns and cowl vents which were also part of the original roof design.

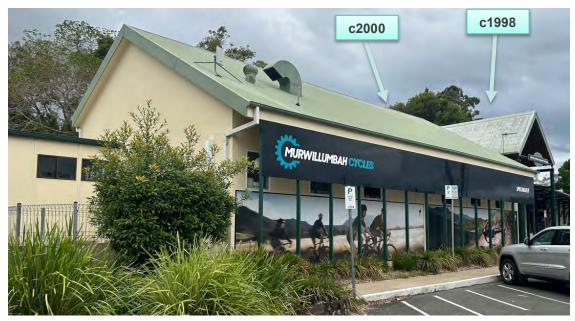
Picture 14 Western elevation of 1990s and 2000s roofs (Picture 14)

The early 2000s building and late 1990s walkway awning structures also have Colorbond roofs with roundline/ quarter round gutter profile gutters, as does the platform awning in this location. The paint to the 1990s roof is much more deteriorated than the 2000s fabric, however no corrosion was evident. No loose flashing or missing fixings were noted, and no evidence of failing flashings or leaking was noted upon inspection of the interior ceiling.

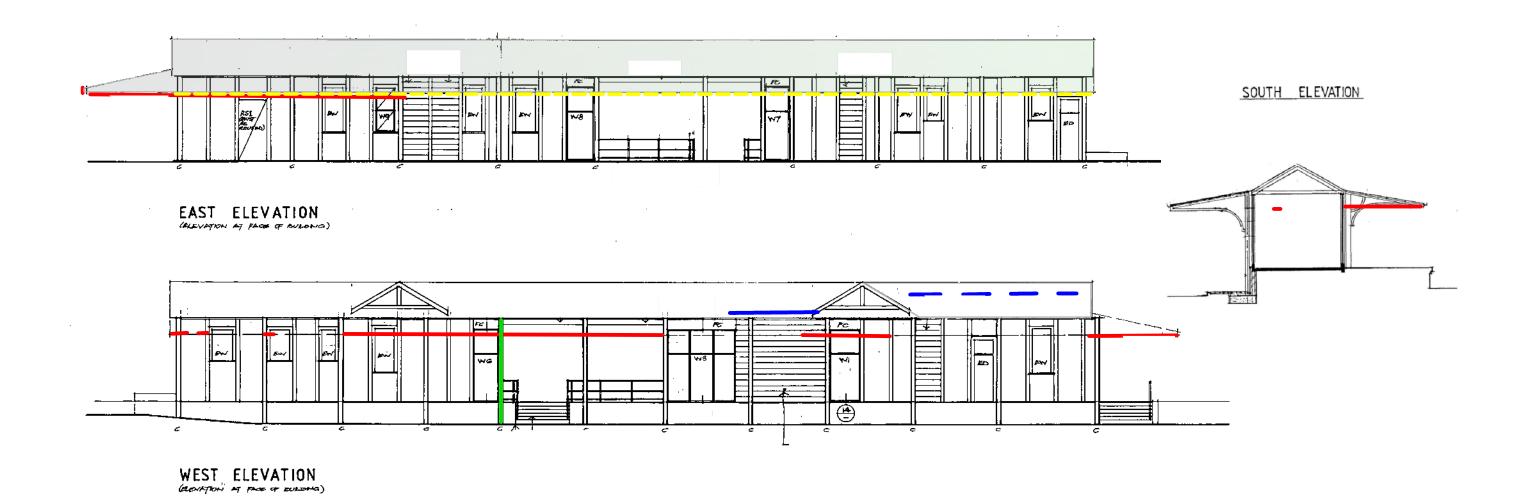
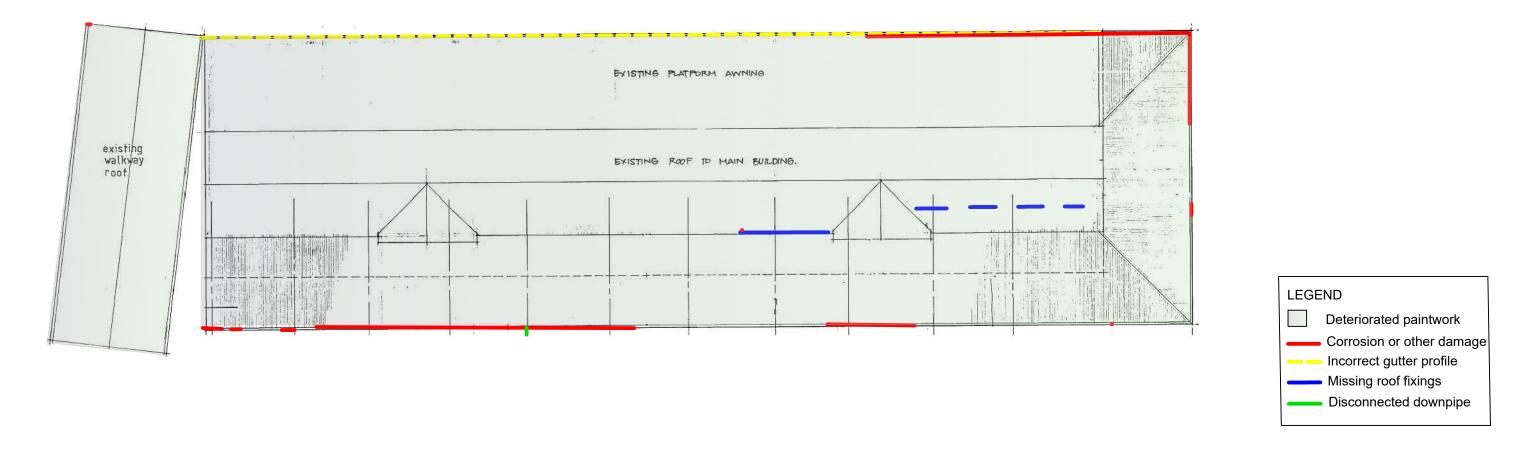
Figure 1 - Roof and Gutter Assessment 1922 Station Murwillumbah Railway Station Refurbishment

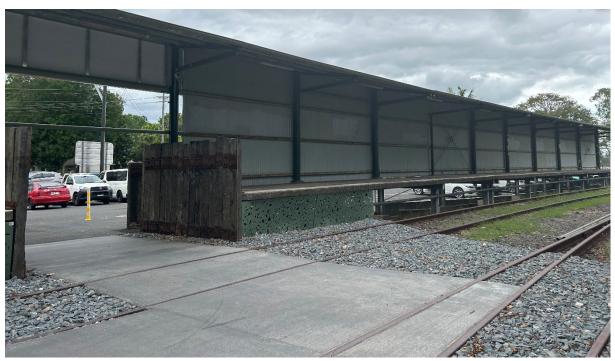
Picture 5 Ground surface treatment of northern access point

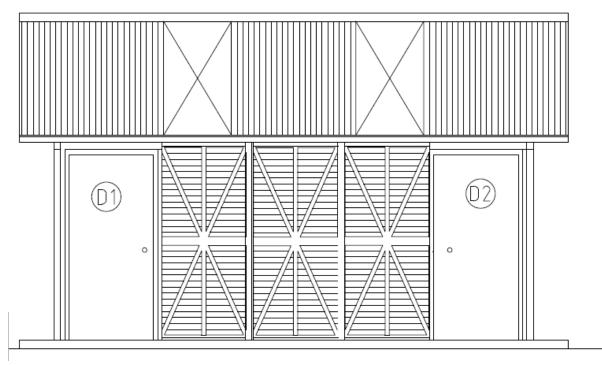
Figure 4 Western elevation of proposed amenities block

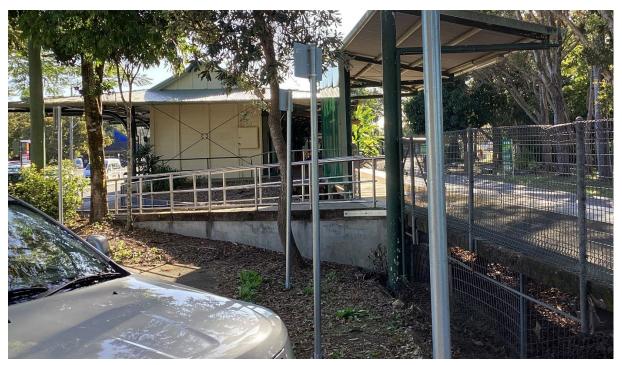
Picture 11 Proposed bike rack location

Bike racks are proposed to be sited at the street level west of the platform between the platform and the proposed amenities block (Picture 11). It is proposed to be of steel construction and fixed to the pavement, similar to what has been installed near the northern access point (Picture 12).
