# Tweed River Bank Erosion Management Plan 2014

The purpose of the Tweed River Estuary Bank Management Plan 2014 is to provide a schedule of works to stabilise river bank erosion on public land (to be undertaken by Council), as well as updated design advice for works required on private land.

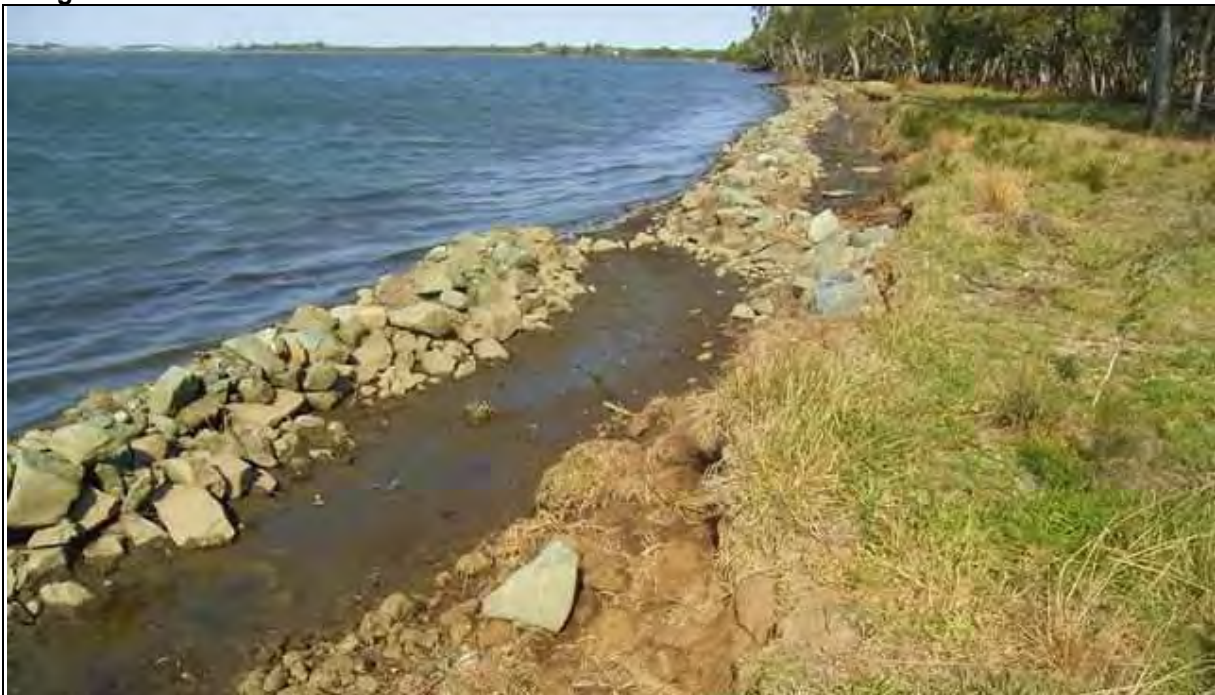
**Figure 3. Rock fillets are a common bio-engineered approach to bank stabilisation. The photo below shows rock fillets immediately after construction in the Manning River, prior to colonisation by mangroves.**

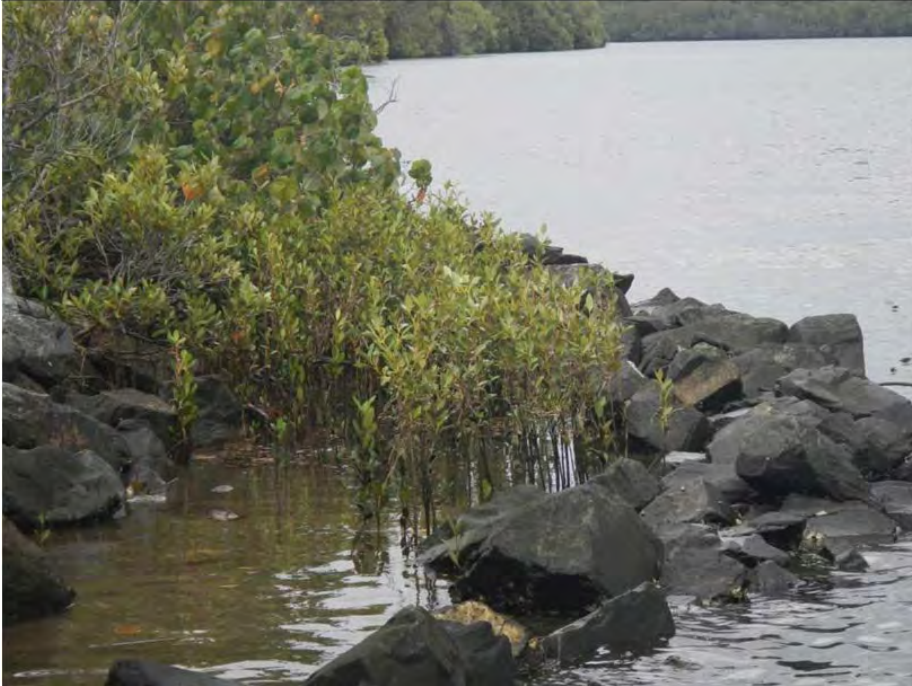
**Figure 4. Rock fillets constructed at Chinderah, with regenerating mangroves.**

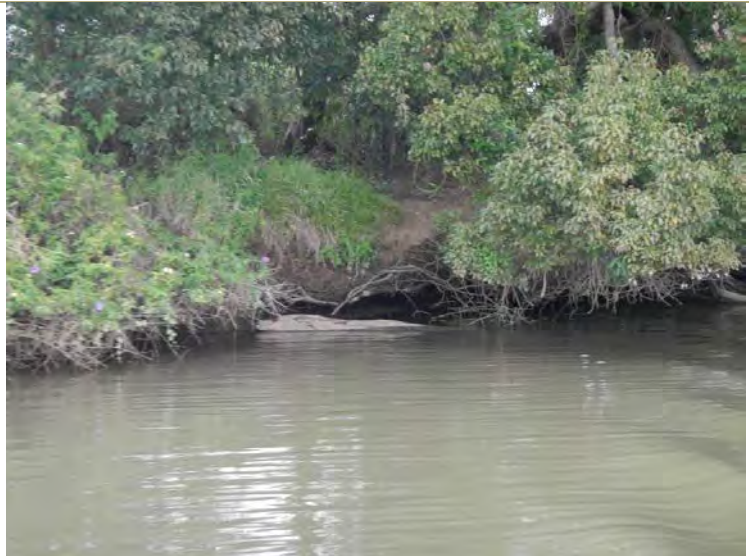
**129**

<p>Photo 129 – bank undercutting increases risk of failure especially where camphor laurel occur.</p>

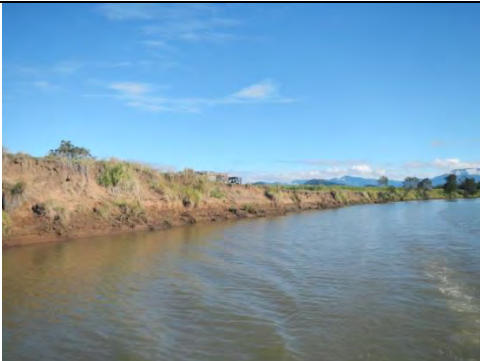
<p>Photo 17 – severe erosion on mid-section of site, grassed bank upstream considered vulnerable to erosion.</p>

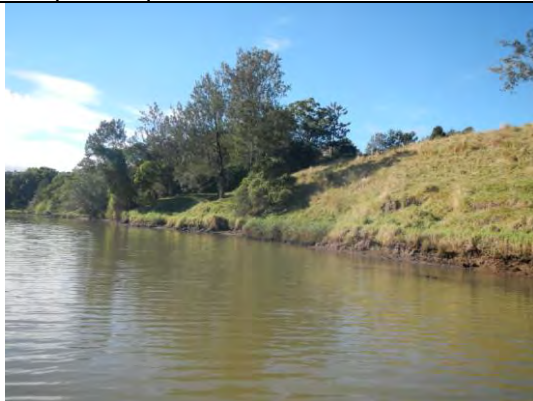
<p>Photo 19 – Downstream section of site. Bank is stable due to bed rock control on right bank.</p>

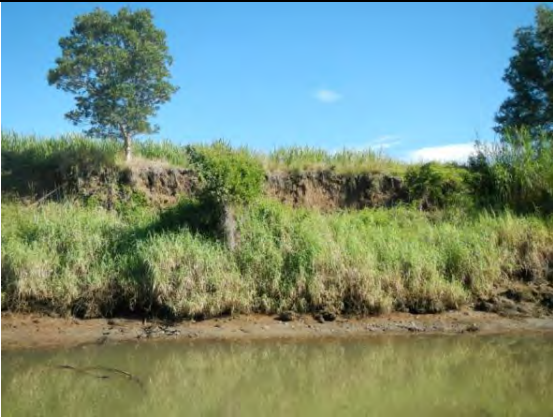
<p>Photo 58 – showing bank slump with cane land on top of bank.</p>

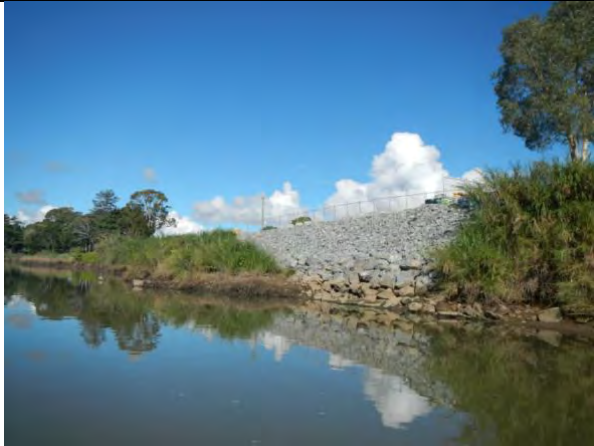
<p>Photo 50 – rock revetment of slump downstream of site D</p>

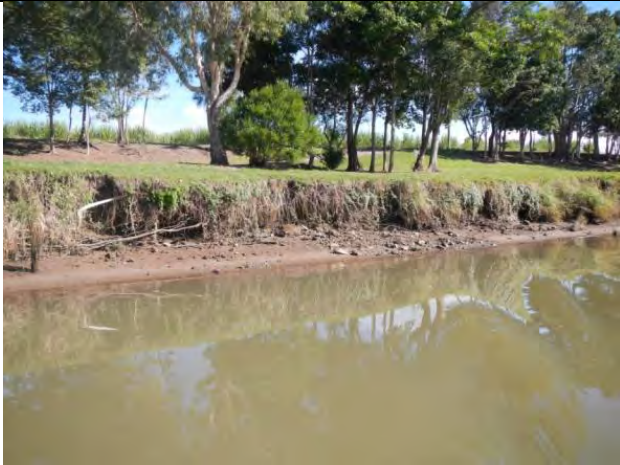
<p>Photo 51 – active bank erosion adjacent to boat ramp.</p>

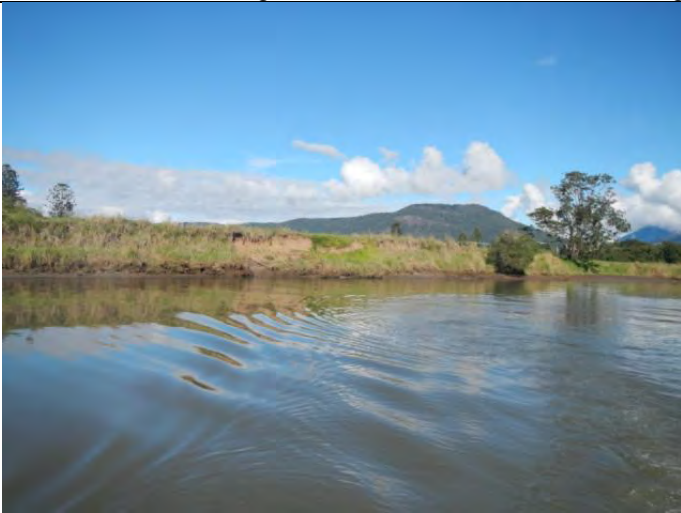
Photo 25 – Site E right bank	Photo 27 – active bank erosion

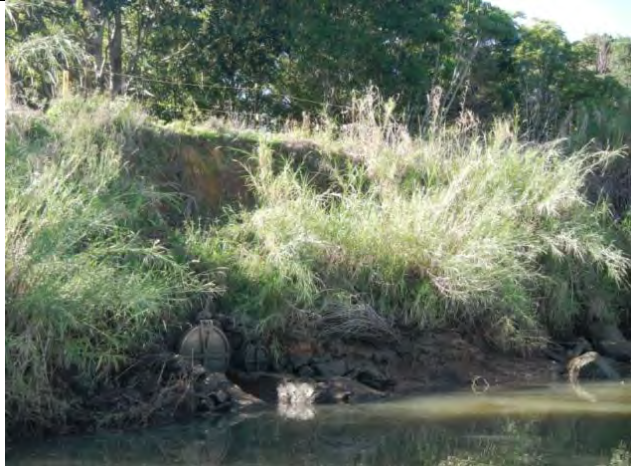
<p>Photo 40 – Site F1 showing slump at drain outlet</p>

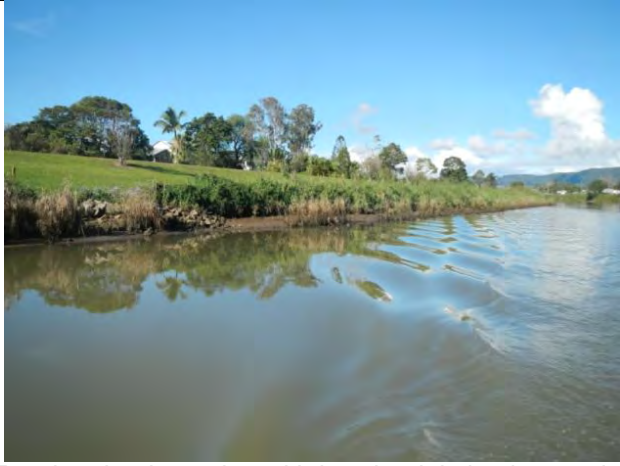
<p>Photo 43 – Site F2 minor bank erosion with levy bank in background</p>

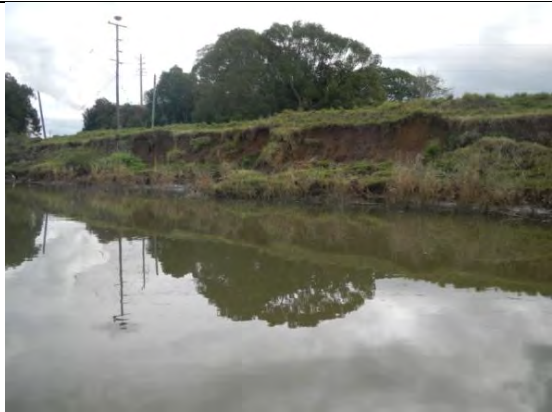
<p>Photo 99 – severe bank erosion</p>

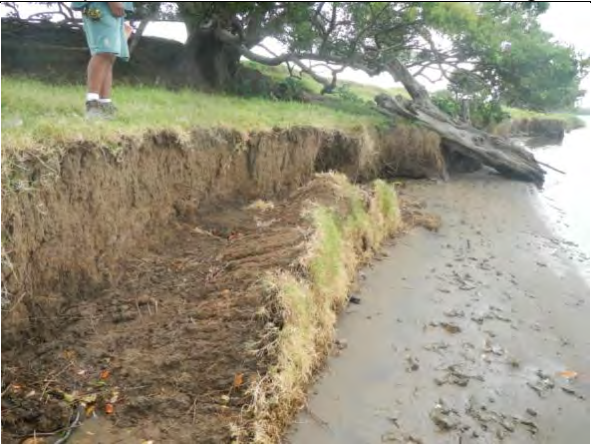
<p>Photo 108 – bank collapse is occurring along most of this site</p>

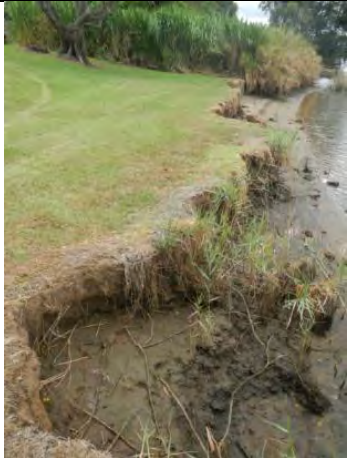
<p>Photo 119 – bank toe erosion above boat ramp</p>

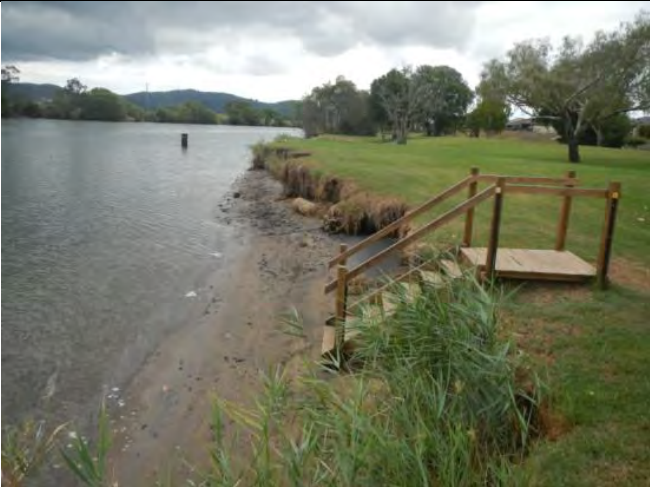
<p>Photo 122 – bank toe erosion downstream of boat ramp</p>

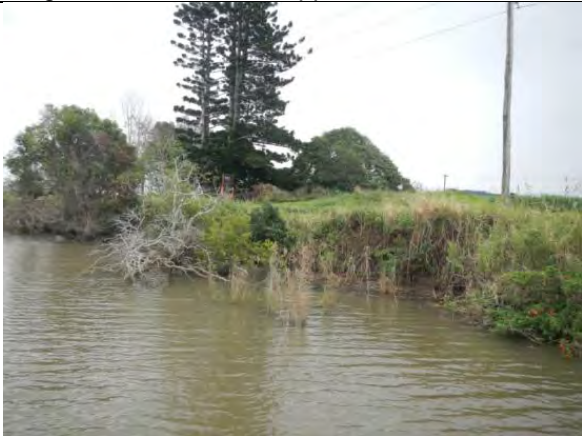
<p>Photo 194 – bank erosion immediately upstream of site (note this area is too narrow to revegetate and may require alternative approaches (fillets and or toe revetment).</p>

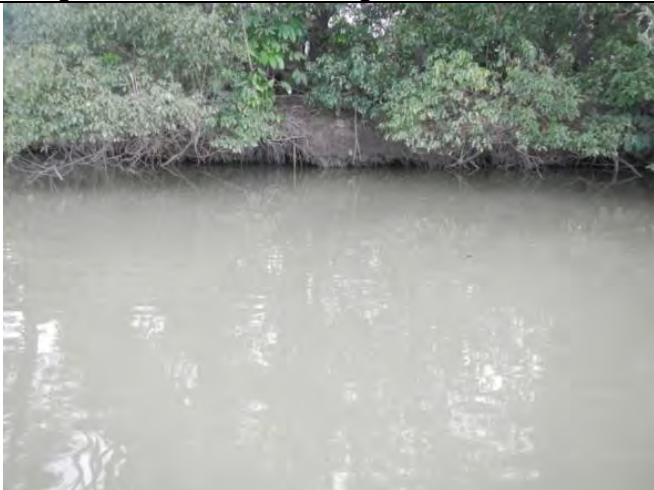
<p>Photo 175 – camphor laurel along bank showing undercutting (note photo taken at high tide).</p>

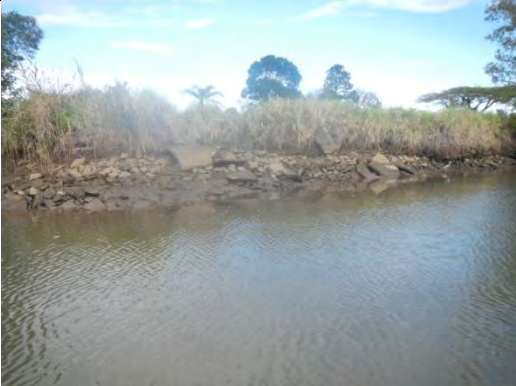
<p>Photo 225 – old rock revetment at Windmill Corner (L2)</p>

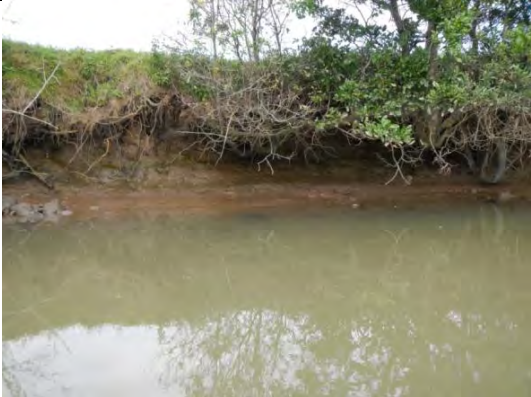
<p>Photo 249 – Undercutting at site L1</p>
